STAGE 1 & LIMITED STAGE 2 ENVIRONMENTAL SITE ASSESSMENT:
LOT 11 DP229784, TEMPLAR ROAD, ERSKINE PARK, NSW
PREPARED FOR WORLEYPARSONS GROUP

REPORT ID: CES080106-WPG-01-F

Date: 27 February 2008

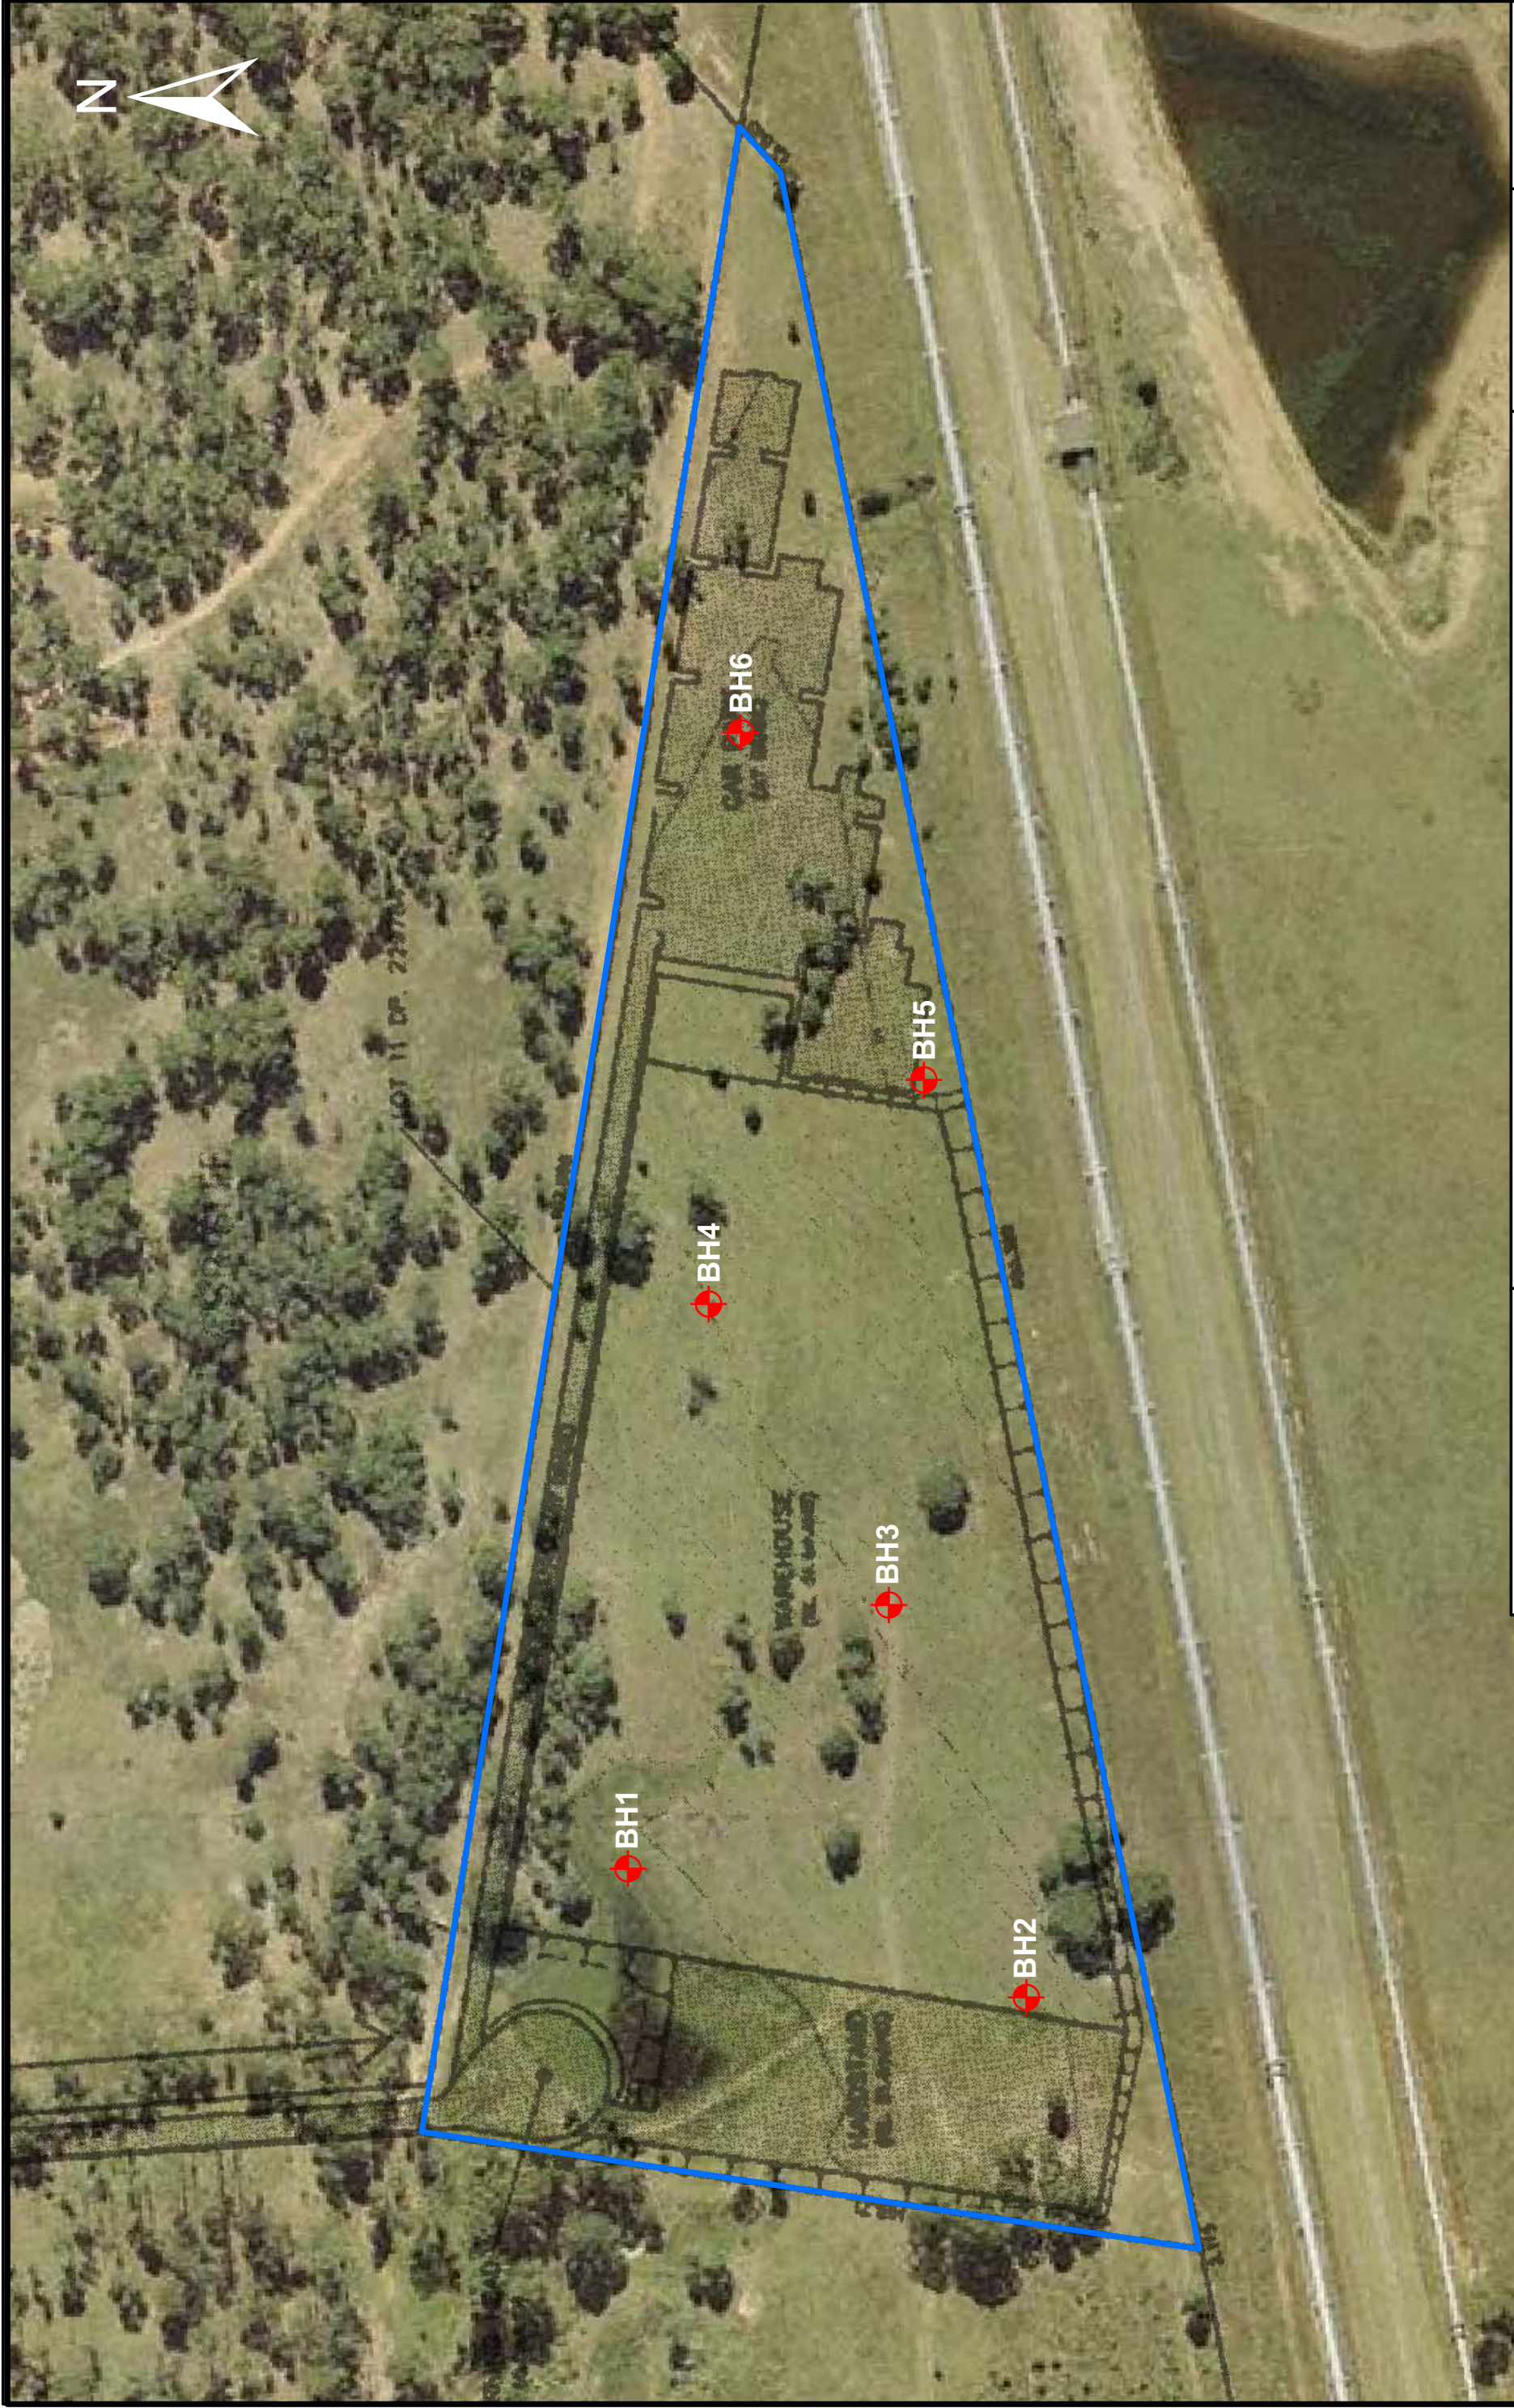
Title
Figure 2: Site plan showing borehole locations and proposed development

- The drilling of six boreholes (BH1, BH2, BH3, BH4, BH5 and BH6) across the site and the collection of soil samples from each of these boreholes for subsequent laboratory analysis. Each of the boreholes were drilled to 0.5m depth with a 80 mm diameter stainless steel hand auger which was decontaminated in between borehole locations. It was intended to use a mechanical drilling rig, however, recent rainfall made the site inaccessible, even with a 4WD rig;
- The collection of soil samples for subsequent laboratory analysis. Soil samples were collected from the near surface soils (topsoil) and from the underlying natural silty clay soil; and
- Field screening of soil samples (where quantity allowed) for Volatile Organic Compounds using a Photoionisation Detector (PID).

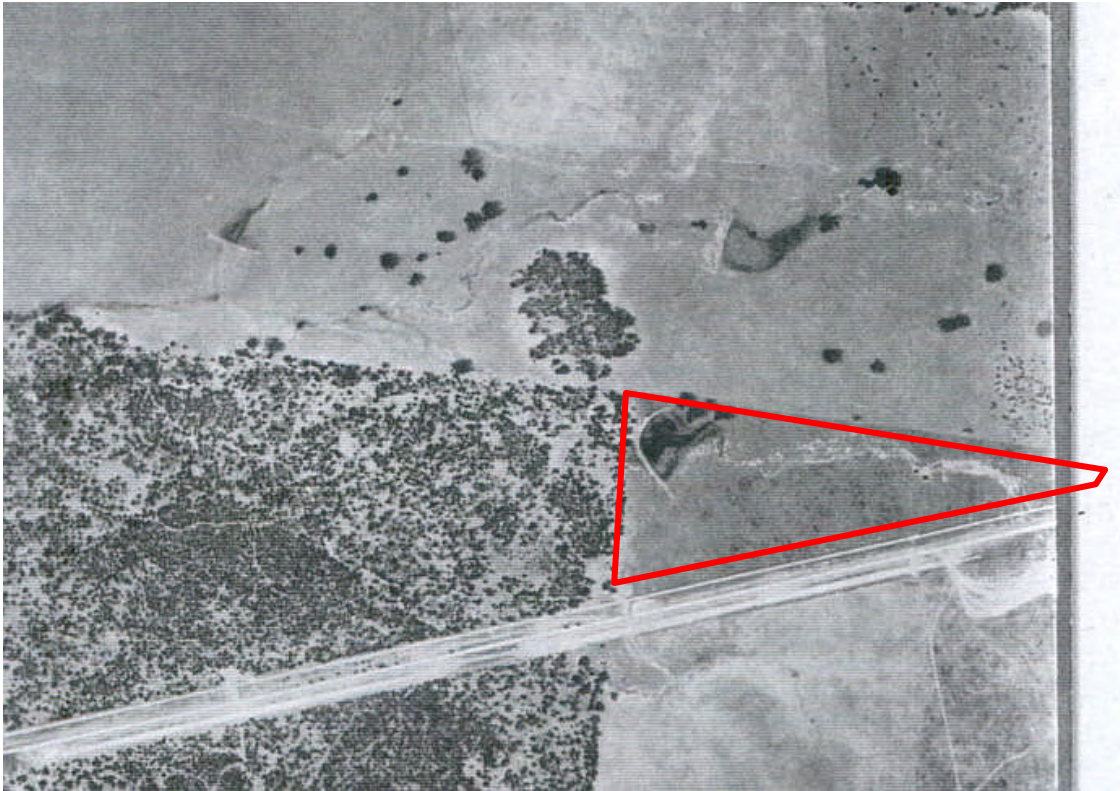
Photograph 1: 1947 aerial photograph of the site

<u>Year</u>	<u>Description</u>
1947	<p><u>Site:</u> The site appeared to be generally cleared. No discernable structures were observed on the site. A dam was located in the north-western corner of the site.</p> <p><u>Surrounding Area:</u> The surrounding area was predominantly occupied by cleared open space areas likely to be used for grazing. Excavation of a quarry (now Enviroguard Landfill) had commenced to the northwest of the site.</p>
1956	<p><u>Site:</u> The site appeared unchanged compared to the 1947 aerial photograph.</p> <p><u>Surrounding Area:</u> The surrounding land use had changed little since the 1947 aerial photograph with the exception of a dam being constructed to the south east of the site. Further excavation of the quarry was observed.</p>
1961	<p><u>Site:</u> The site appeared unchanged compared to the 1956 aerial photograph.</p> <p><u>Surrounding Area:</u> The surrounding land use had changed little since the 1956 aerial photograph with the exception of the clearing of the land to the south west of the site. Further excavation of the quarry was observed.</p>

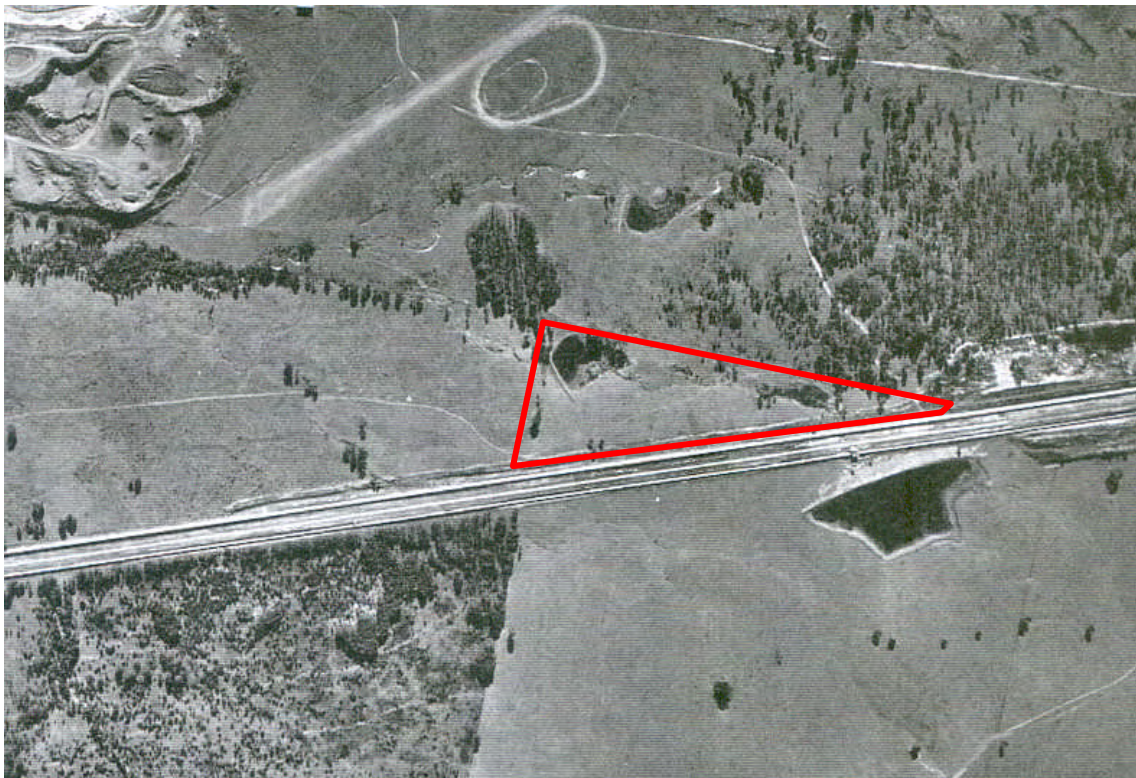
Photograph 4: 1970 aerial photograph of the site

1970	<p><u>Site:</u> The site appeared unchanged compared to the 1961 aerial photograph.</p> <p><u>Surrounding Area:</u> The surrounding land use had changed little since the 1961 aerial photograph with the exception of the clearing of the land to the west and revegetation of land to the south west of the site. Further excavation of the quarry was observed.</p>
1978	<p><u>Site:</u> The site appeared unchanged compared to the 1970 aerial photograph.</p> <p><u>Surrounding Area:</u> The surrounding land use had changed little since the 1970 aerial photograph with the exception of revegetation of the land to the west of the site.</p>
1986	<p><u>Site:</u> The site appeared unchanged compared to the 1978 aerial photograph.</p> <p><u>Surrounding Area:</u> The surrounding land use had changed little since the 1978 aerial photograph.</p>
1994	<p><u>Site:</u> The site appeared unchanged compared to the 1986 aerial photograph.</p> <p><u>Surrounding Area:</u> The surrounding land use had changed little since the 1986 aerial photograph with the exception of a development (Emmaus Village) which had been constructed on land to the south west of the site between 1986 -1994.</p>

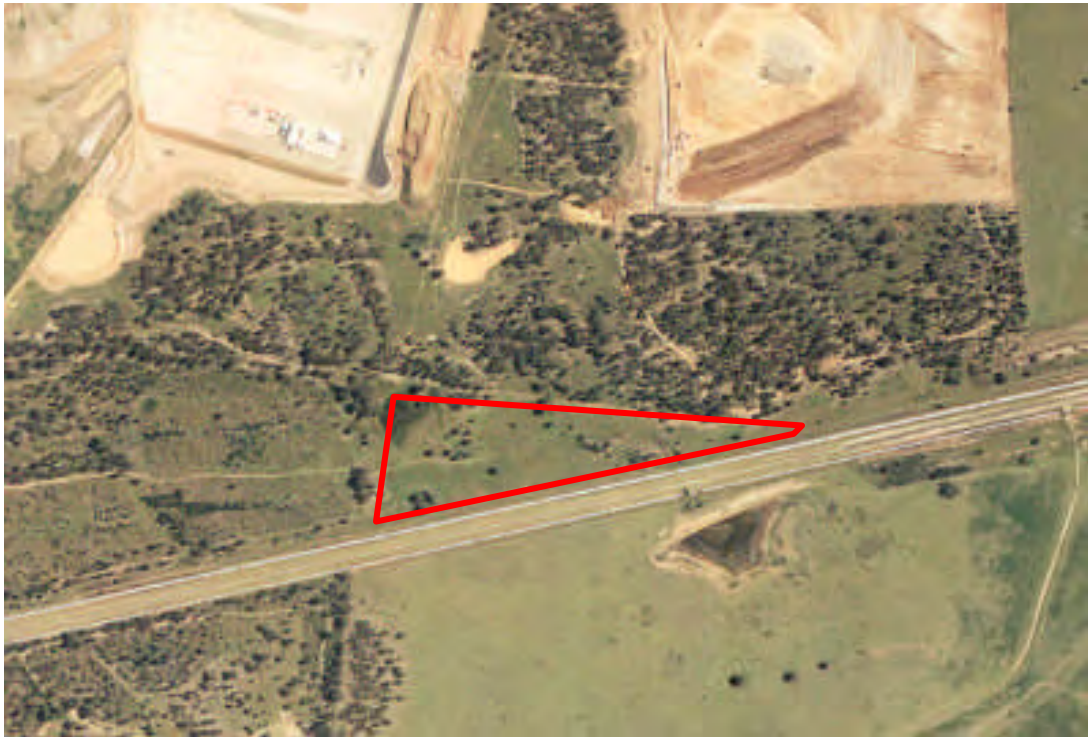
Photograph 9: 2005 aerial photograph of the site

2005 **Site:** The site appeared unchanged when compared to the 2002 aerial photograph. Additionally, the site appears similar to the condition of the site as determined from a site inspection carried out on 14 March 2008.

Surrounding Area: The surrounding land use had changed little since the 2002 aerial photograph with the exception of the expansion of landfilling activities and industrial development on land to the north of the site. With the exception of further industrial development on the land to the north, the surrounding area also appears similar to existing site conditions as determined on 14 March 2008.
