## **Abercrombie Street Economics Precinct Development**

### **PHASE 1 ENVIRONMENTAL ASSESSMENT**

- Final
- 14 September 2010

The University of Sydney

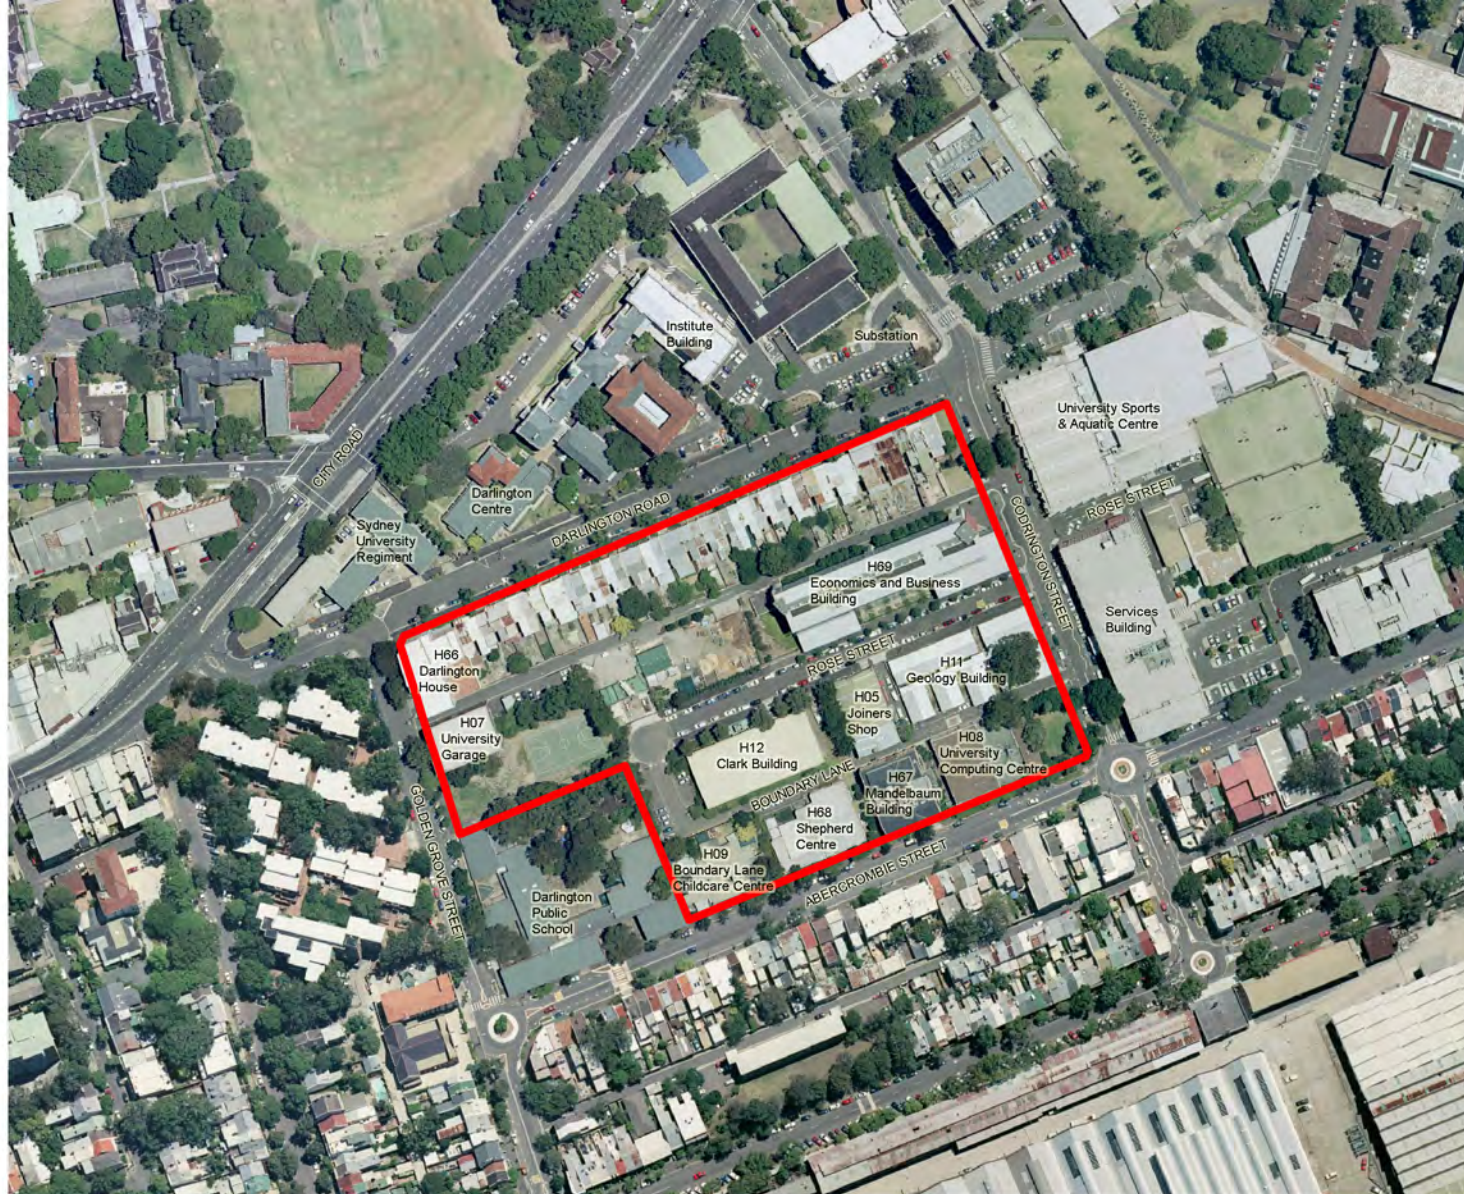
## Figures

SKM understands a Stage 2 Contamination Assessment was undertaken by Aecom at the University Garage building (identified in **Figure 1**). A copy of the report was unavailable at the time of writing the Phase 1 report. It is recommended that a review of the Aecom Stage 2 Investigation Report be undertaken prior to, or in parallel with, any additional contamination assessment being undertaken with the Precinct.

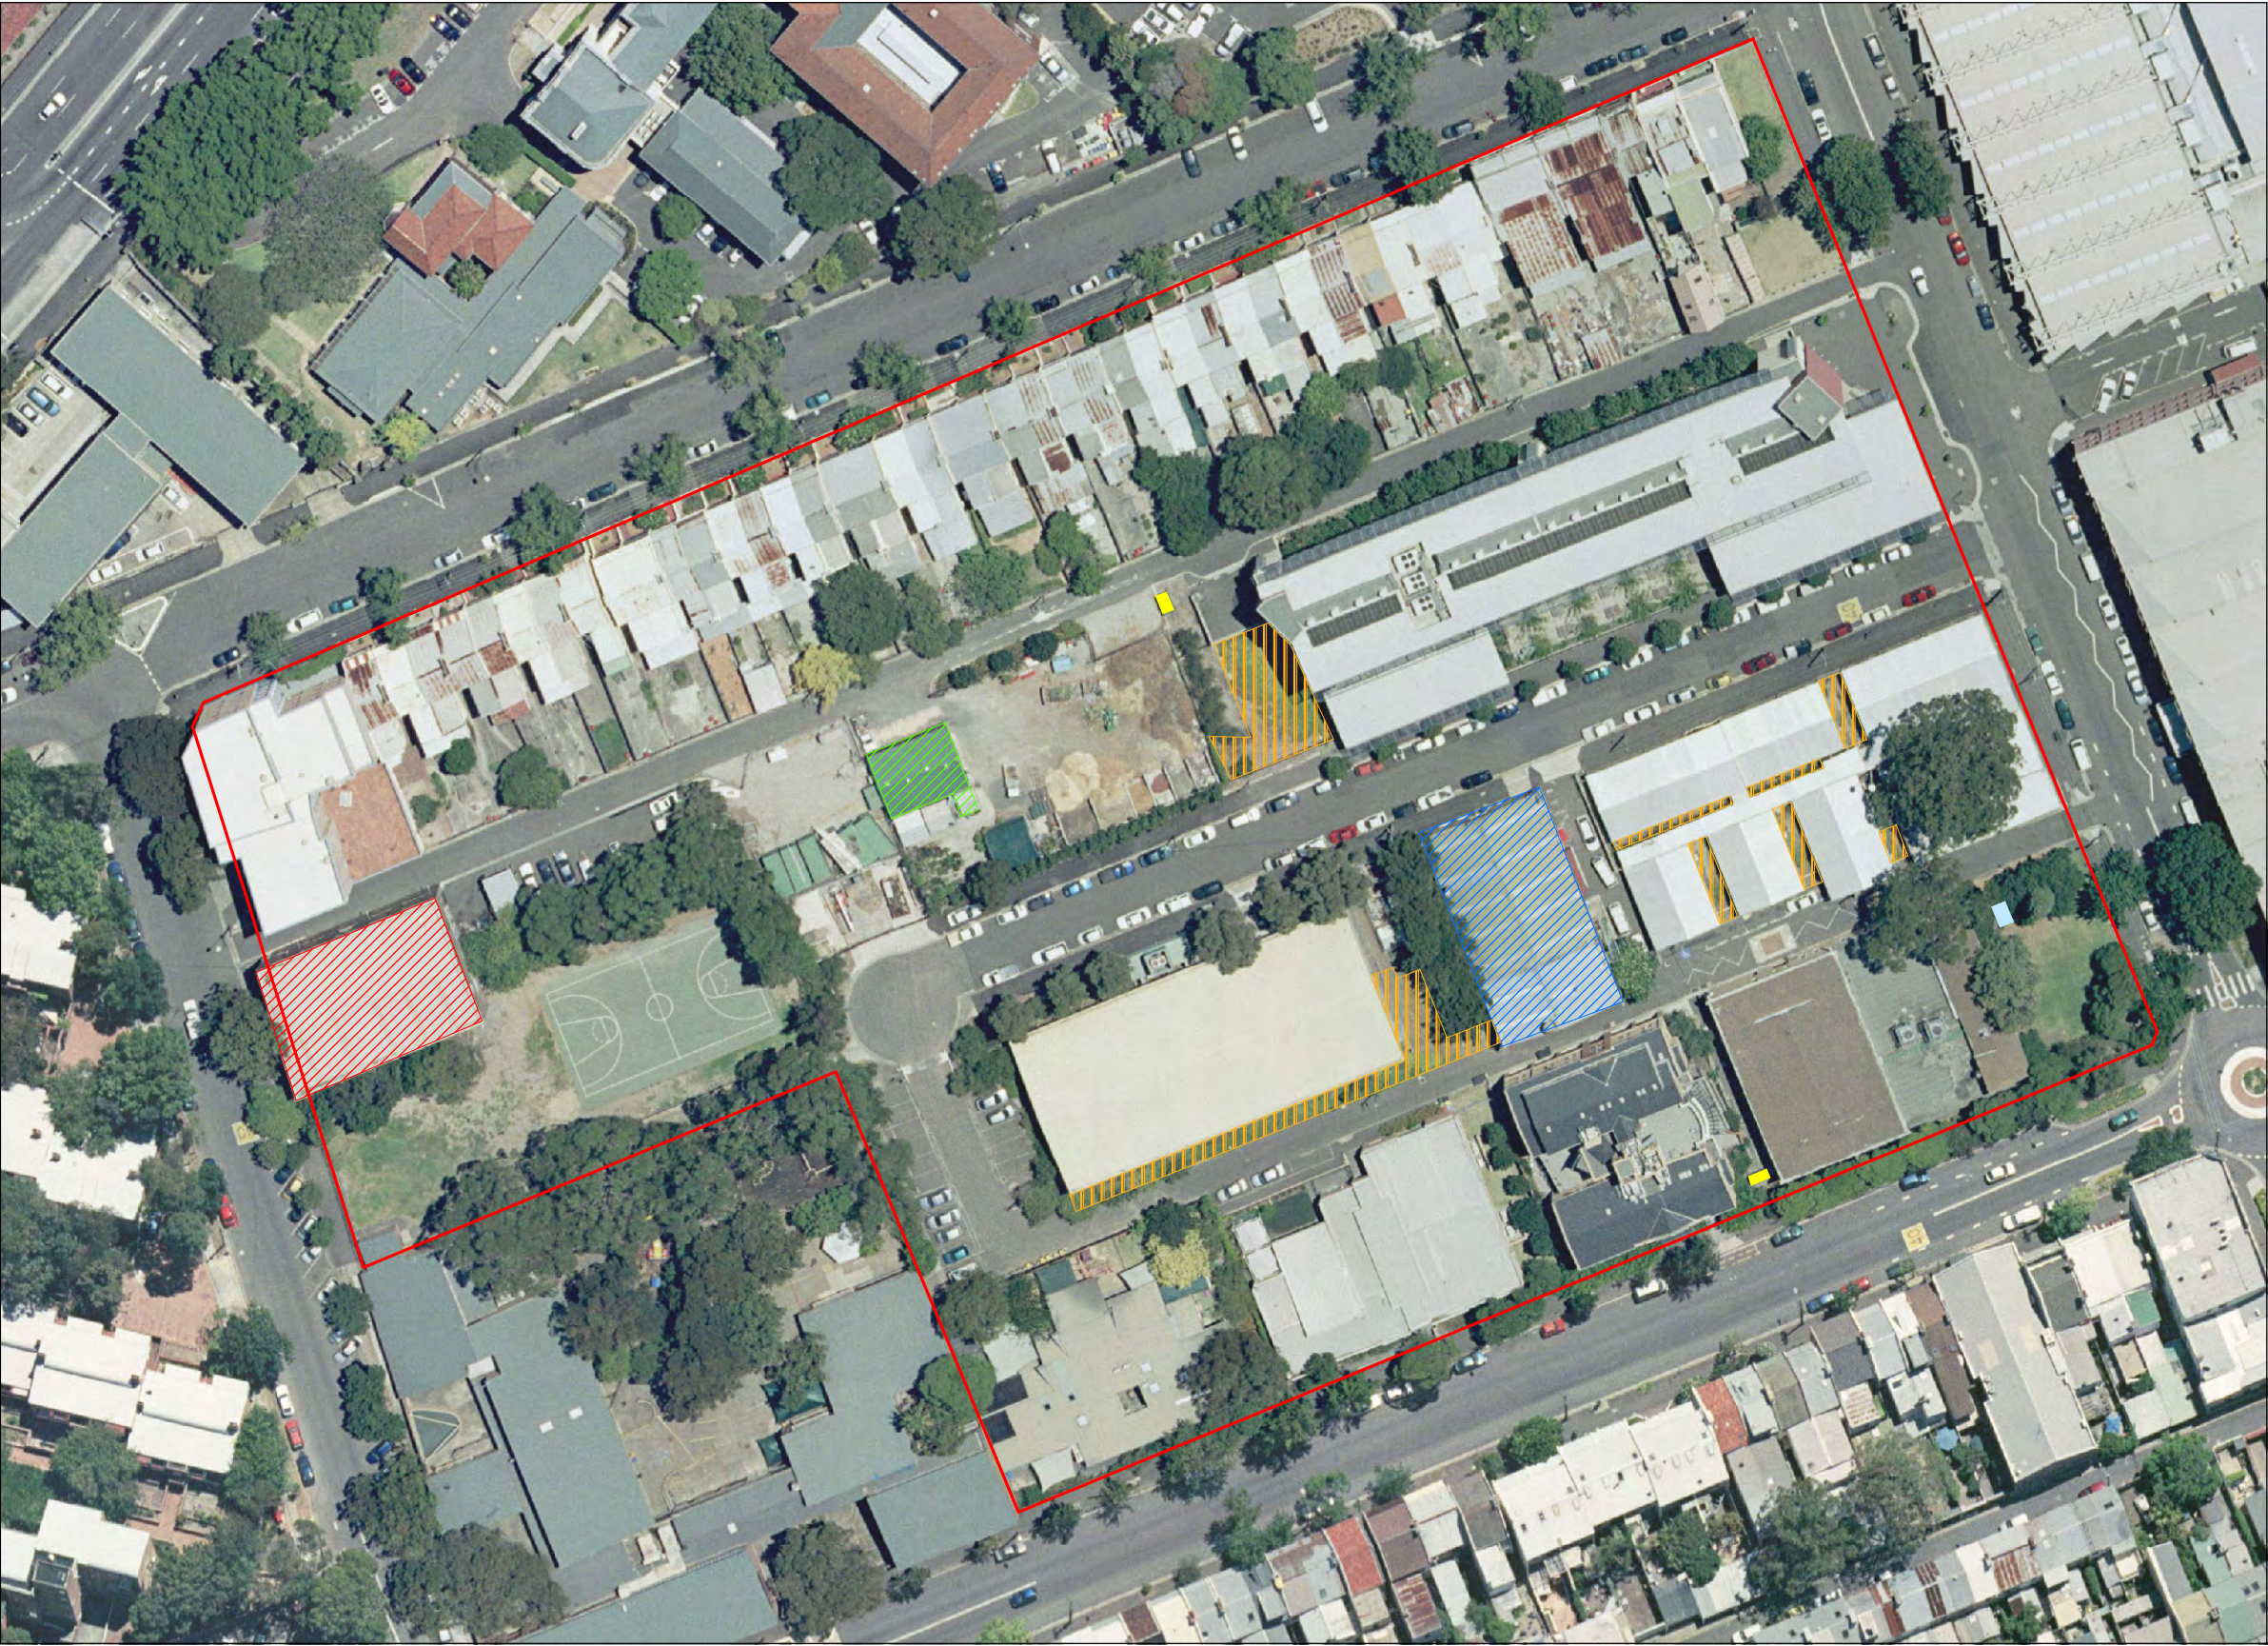
The Precinct is currently occupied by a number of buildings as shown in **Figure 1** and listed below:

- Legend**
- Study Area
  - Garage
  - Joiner's Shop
  - Potential Fill Areas
  - Recycling Centre
  - Transformers
  - Generator

- Potential sources or causes of contamination identified at the Precinct include:
  - Fill areas around the borders of existing buildings, including larger areas identified to the west of the building H69 and between building H12 and building H05;
