## **Appendix D**

### **Geotechnical Investigation, Soil Resistivity and ASS Reports**

**REPORT ON  
GEOTECHNICAL INVESTIGATION  
PROPOSED ZONE SUBSTATION  
YAEGERS LANE  
BYRON BAY**

**9<sup>TH</sup> APRIL 2008  
REF No : 1234-001-001**

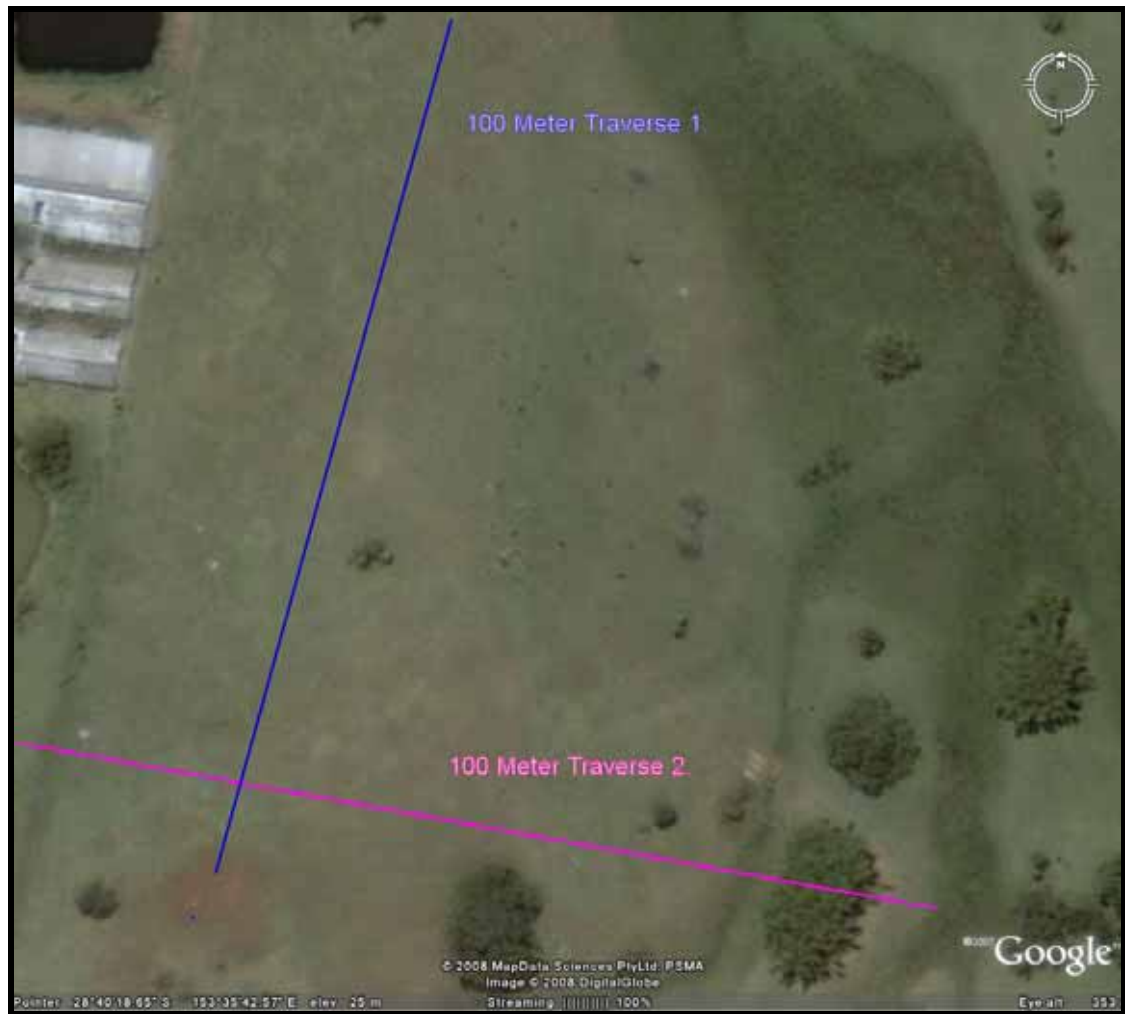
Suffolk Park Site 7. Soil Resistivity Traverses.

Spacing Metres	Apparent Resistivity Traverse 1.
0.5	386.74
1	347.81
2	293.11
4	306.41
6	319.69
8	273.88
10	219.78
20	254.76
30	299.66
40	419.02
60	449.24
80	447.58
100	484.76

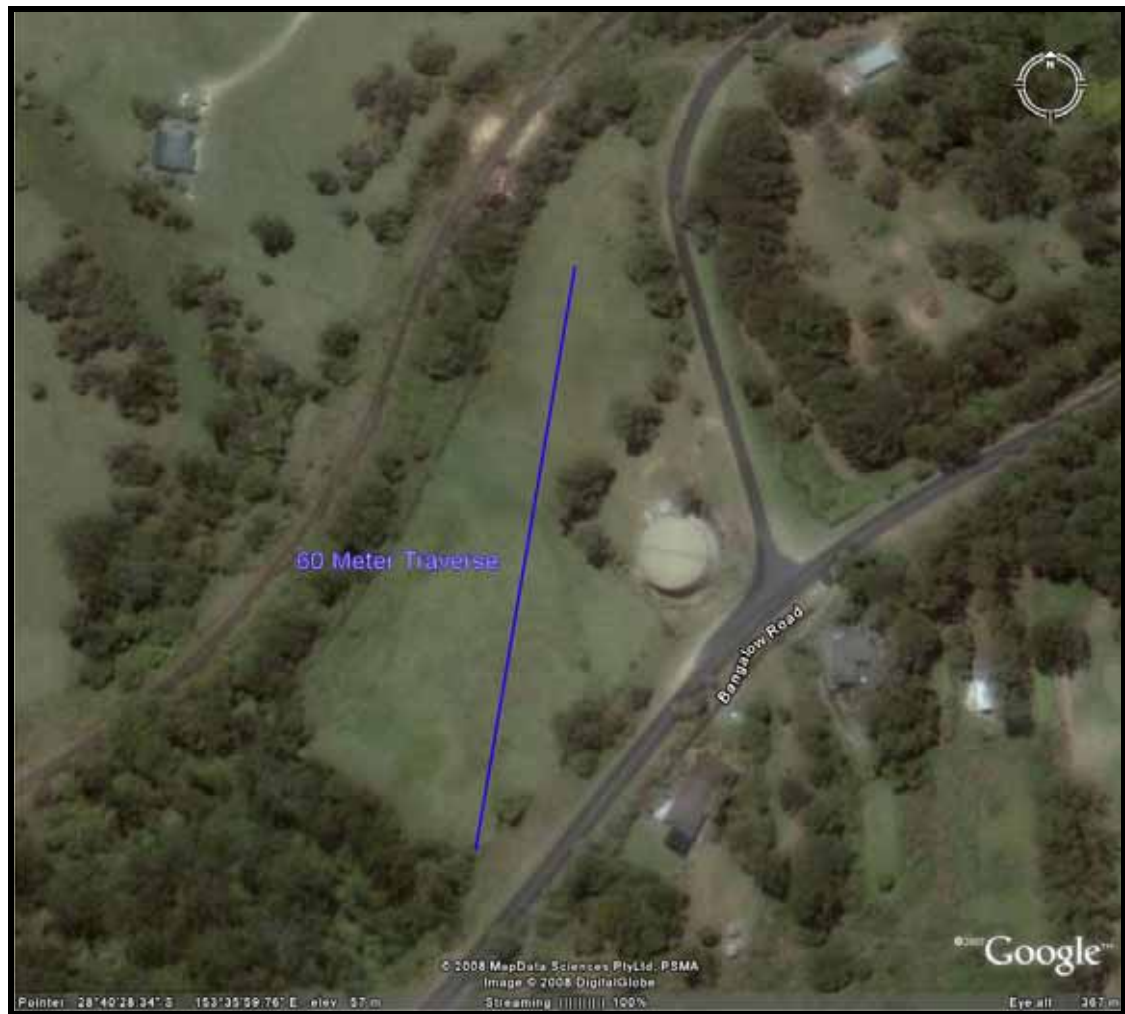
Site 12.

Spacing Metres	Apparent Resistivity
0.5	687.32
1	775.84
2	761.24
4	903.48
6	1019.59
8	1049.36
10	995.21
20	929.1
30	774.25
40	667.77
60	681.33
