Modification of Project Approval

Lismore to Mullumbimby Electricity Network Upgrade

Acid Sulfate Soil Investigation

**Emergency Access Road
Zone Sub-station
Yagers Lane
Suffolk Park NSW 2481**

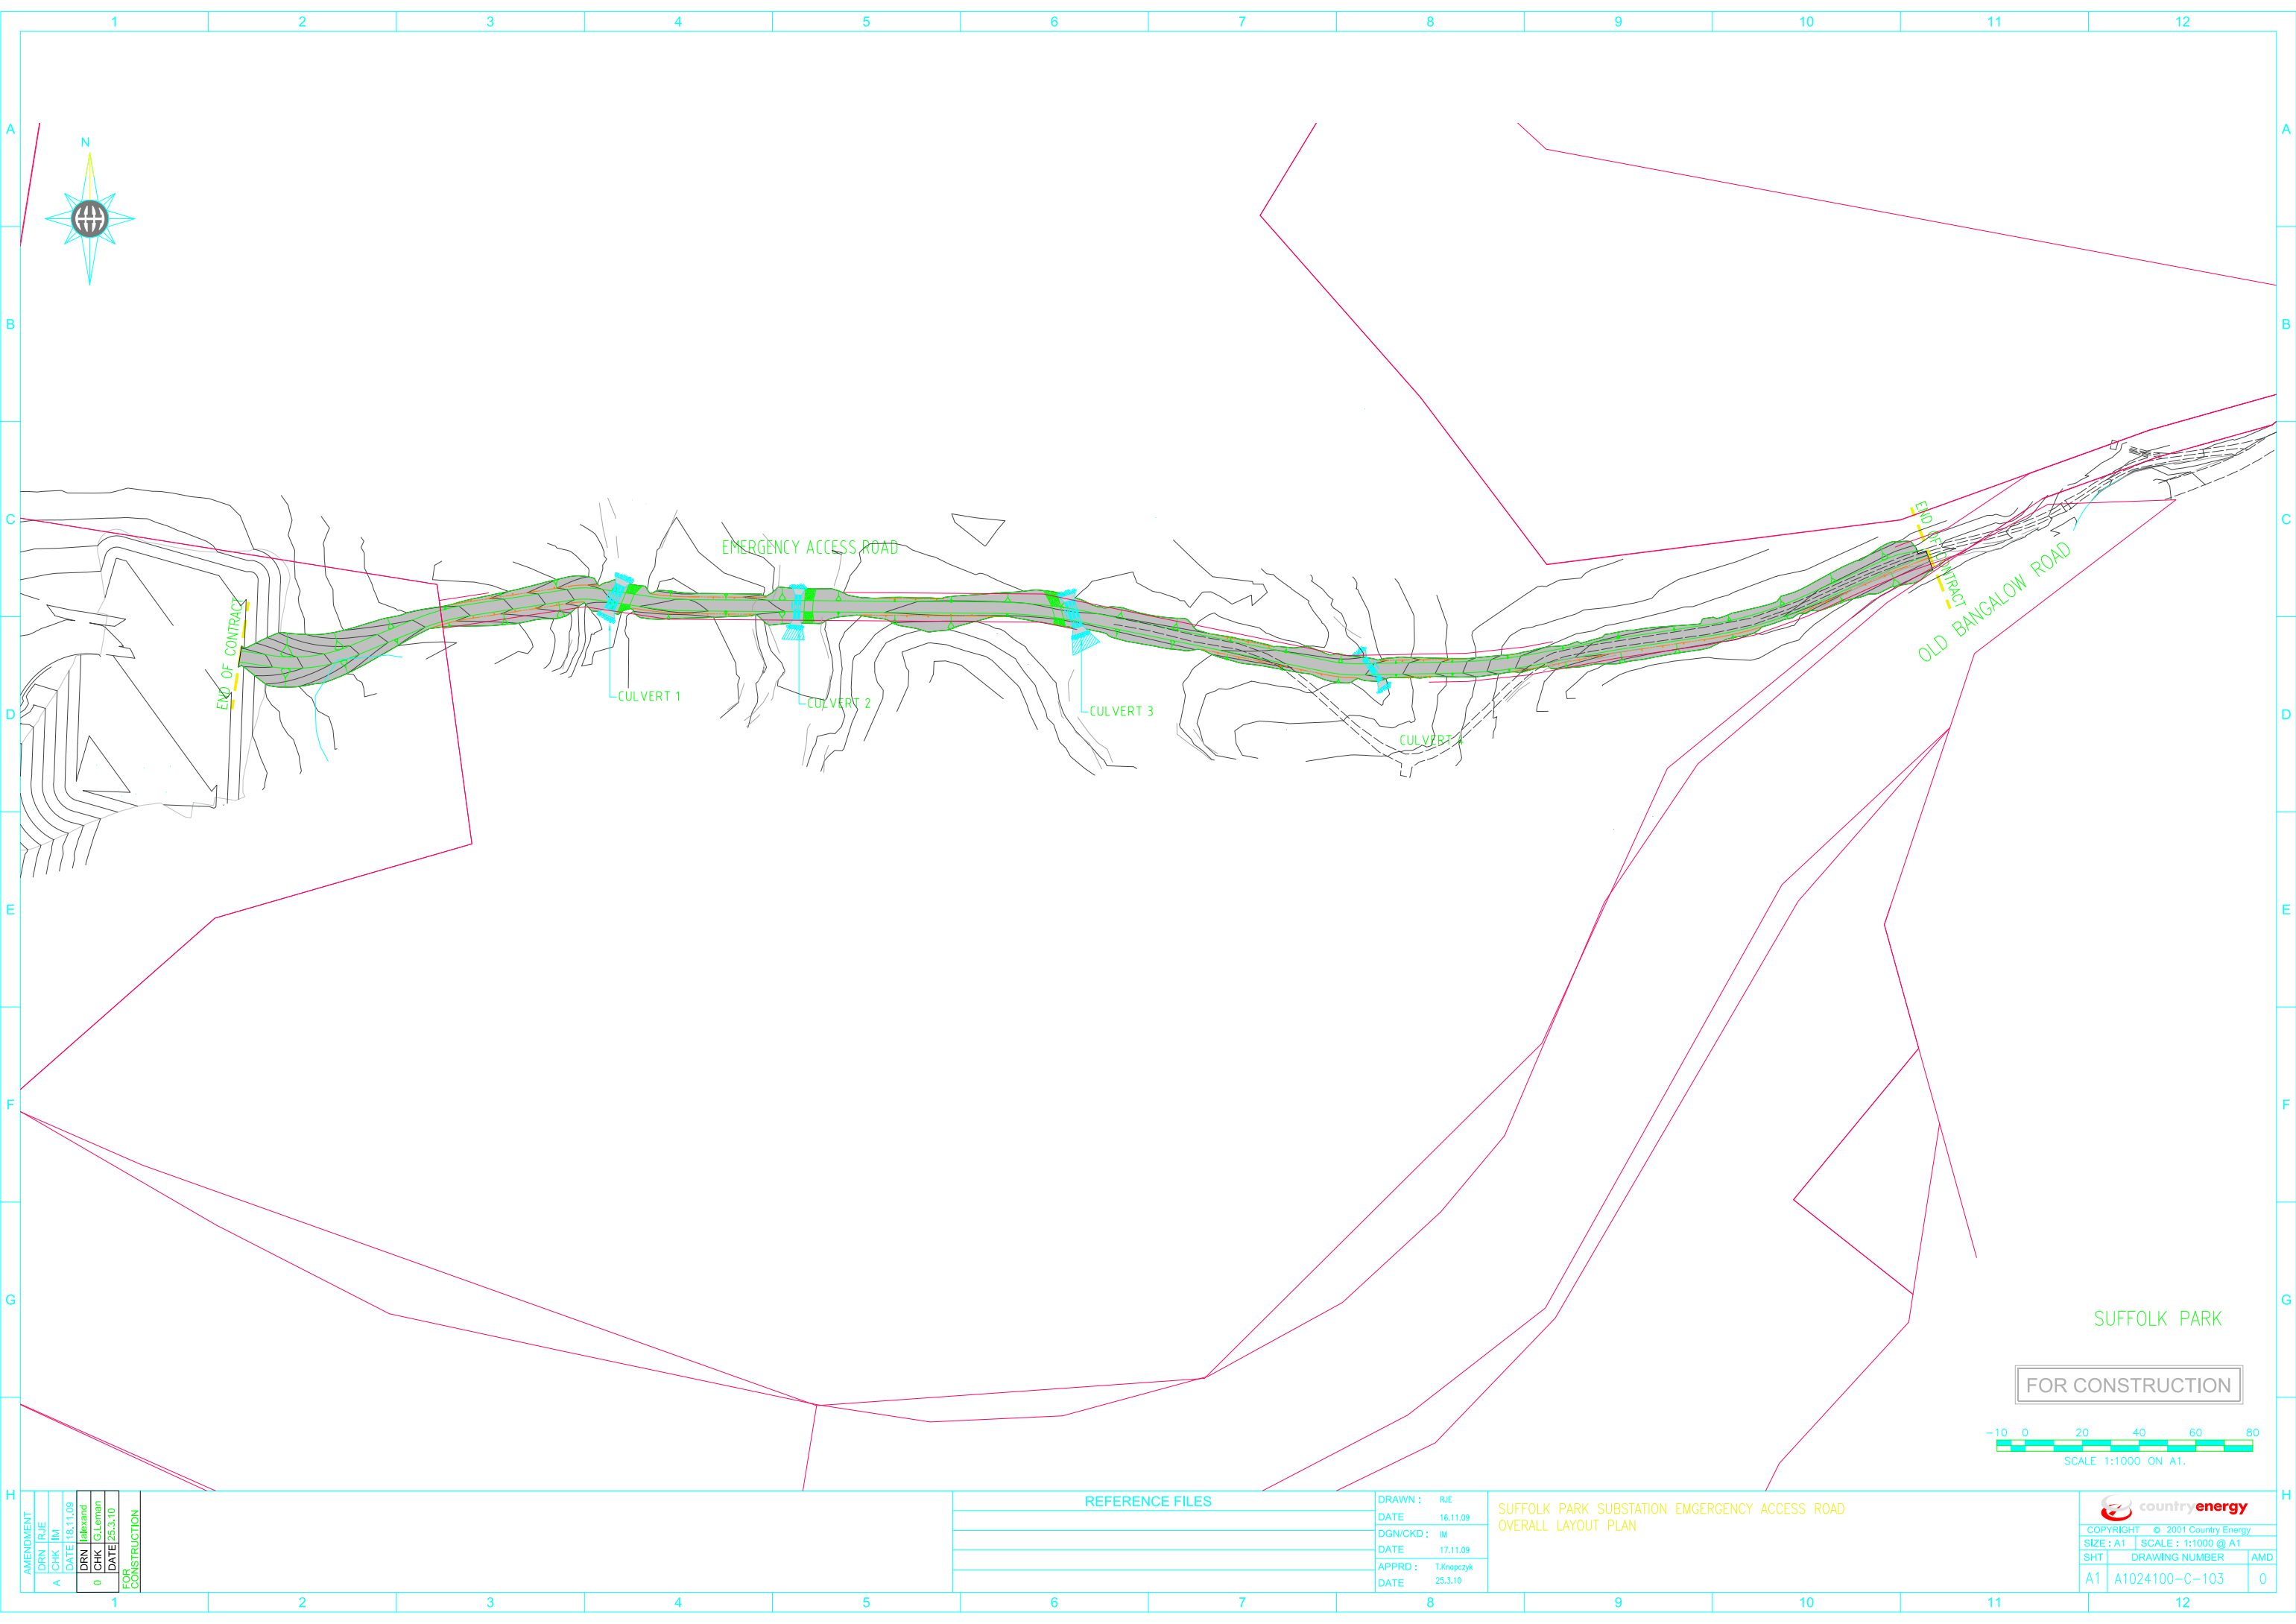
SUFFOLK PARK SUBSTATION EMERGENCY ACCESS ROAD
OVERALL LAYOUT PLAN

The proposal is to construct a formed all weather road approximately 500 metres across Lot 9/588885 from Old Bangalow Road to the Suffolk Park Zone Substation site. The road is to be designed with suitable gully crossings and culverts/drainage to minimize impact to the natural gully flows into Belongil Creek and minimise environmental impact by limiting clearing and utilising the approved 11kV underground corridor. Works will commence from the substation site eastwards towards Old Bangalow Road over private property and will utilise excess fill from the Suffolk Park substation site and entry road, thus removing the need for an amended traffic management plan and ensuring fill material is consistent with the soil types found in the area. Plans for the proposed access road upgrade can be seen in Appendix A Suffolk Park Zone Substation Emergency Access Road Plans.
