***Heritage and Archaeological Assessment  
Proposed Upgrade of  
Lake Macquarie Yacht Club***

**Report to:**

**De Witt Consulting**

**June 2010**

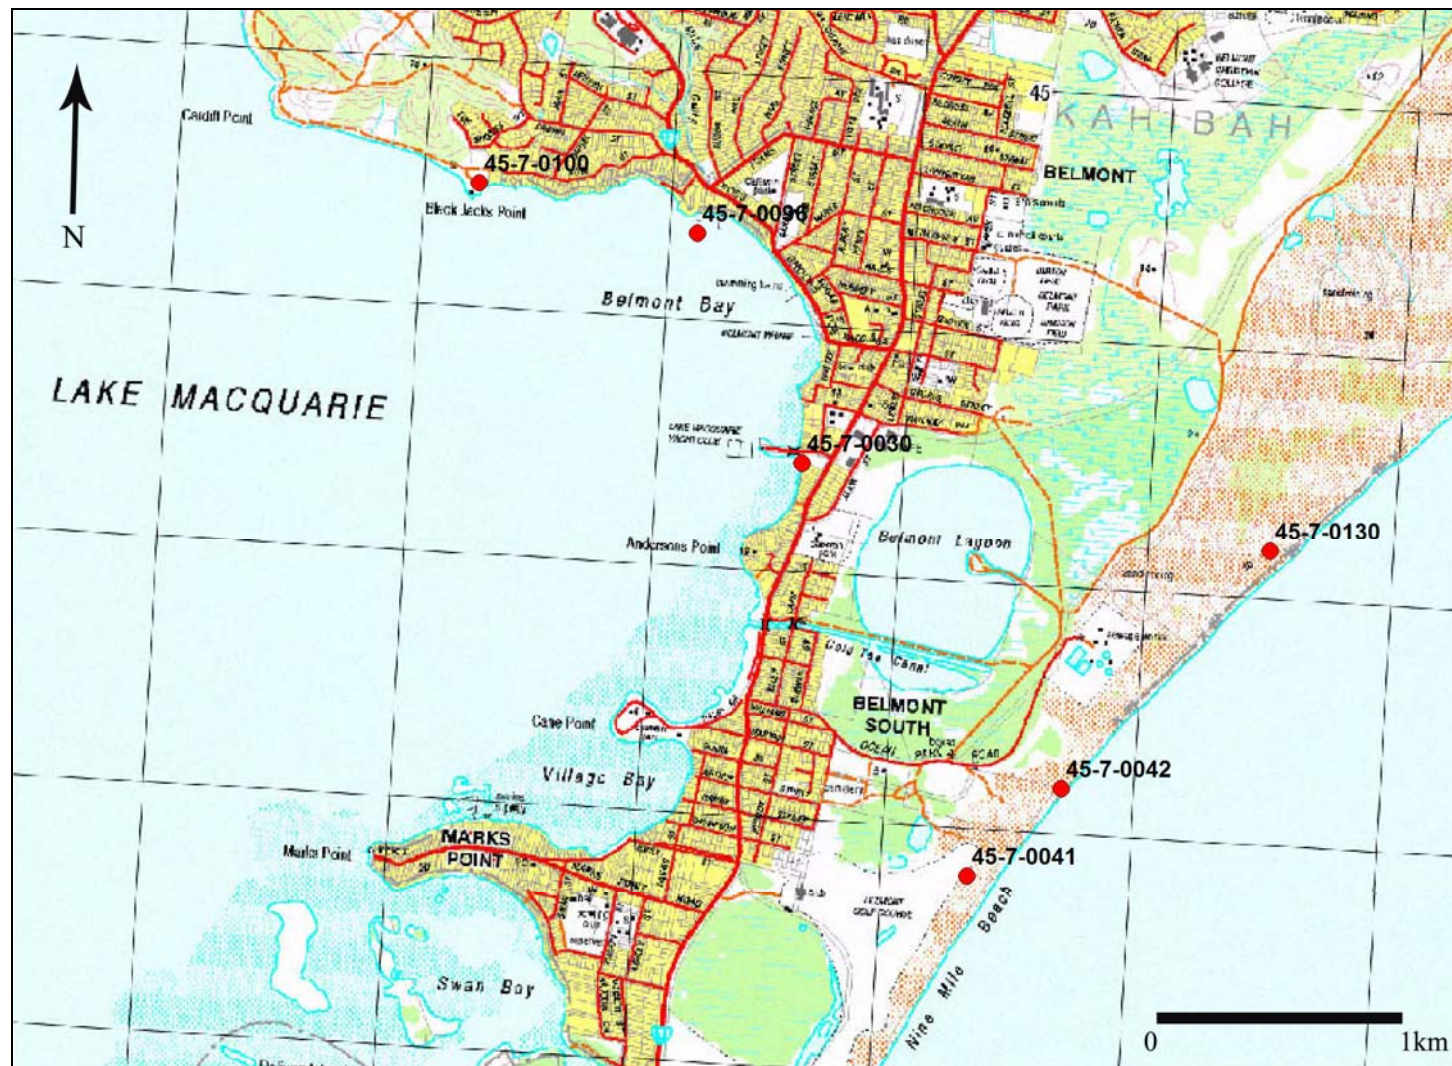
Figure 4 AHIMS sites plotted on the Swansea 1:25,000 topographic map.

Sites 45-7-0041 & 42 and 45-7-0130 are open camp sites located on Nine Mile Beach to the east. Site 45-7-0096 is a midden and 45-7-0100 comprises a shelter with deposit. These sites are located on more elevated sections of the lake margins.

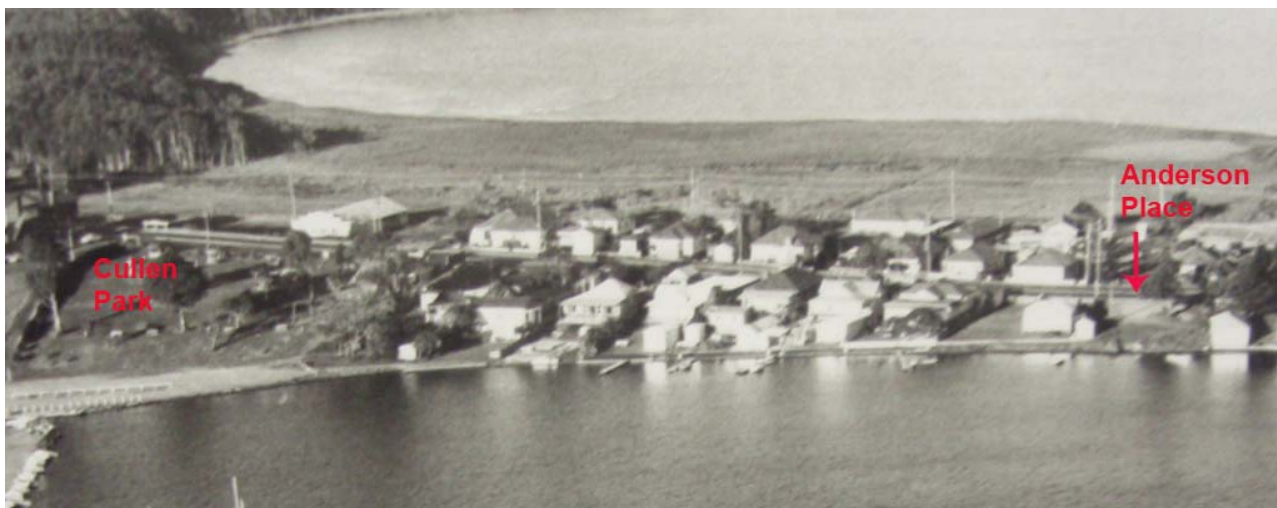
**Plate 1** Foreshore circa pre 1959 - note proximity of development to the water line

Plates 1, 2 & 3 show the pre 1959 foreshore between the Yacht Club, the circa 1959 foreshore and the contemporary foreshore. In recent years the jetties have been removed. The introduction of mains sewer services has necessitated the construction of a retaining wall, on the lake side of the waterfronts, to house the sewer pipes. The buildings that were boatsheds on the water are now set back about two metres from the waters edge.

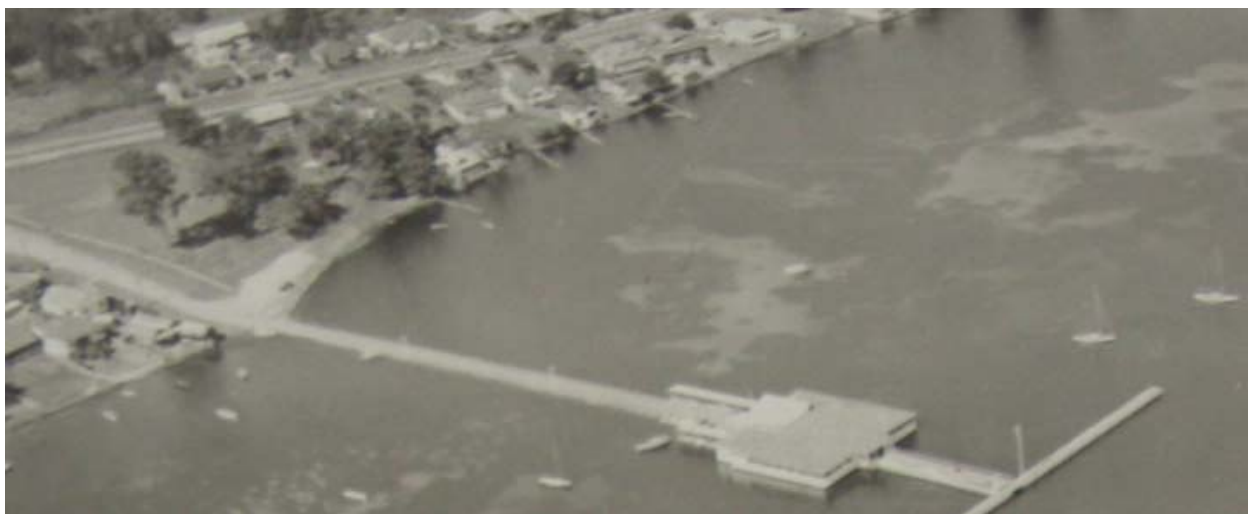
**Plate 2** Circa 1950's view of boatsheds and jetties, note their proximity to the water line. Also note the low sandy beach now filled and extended for the car park.

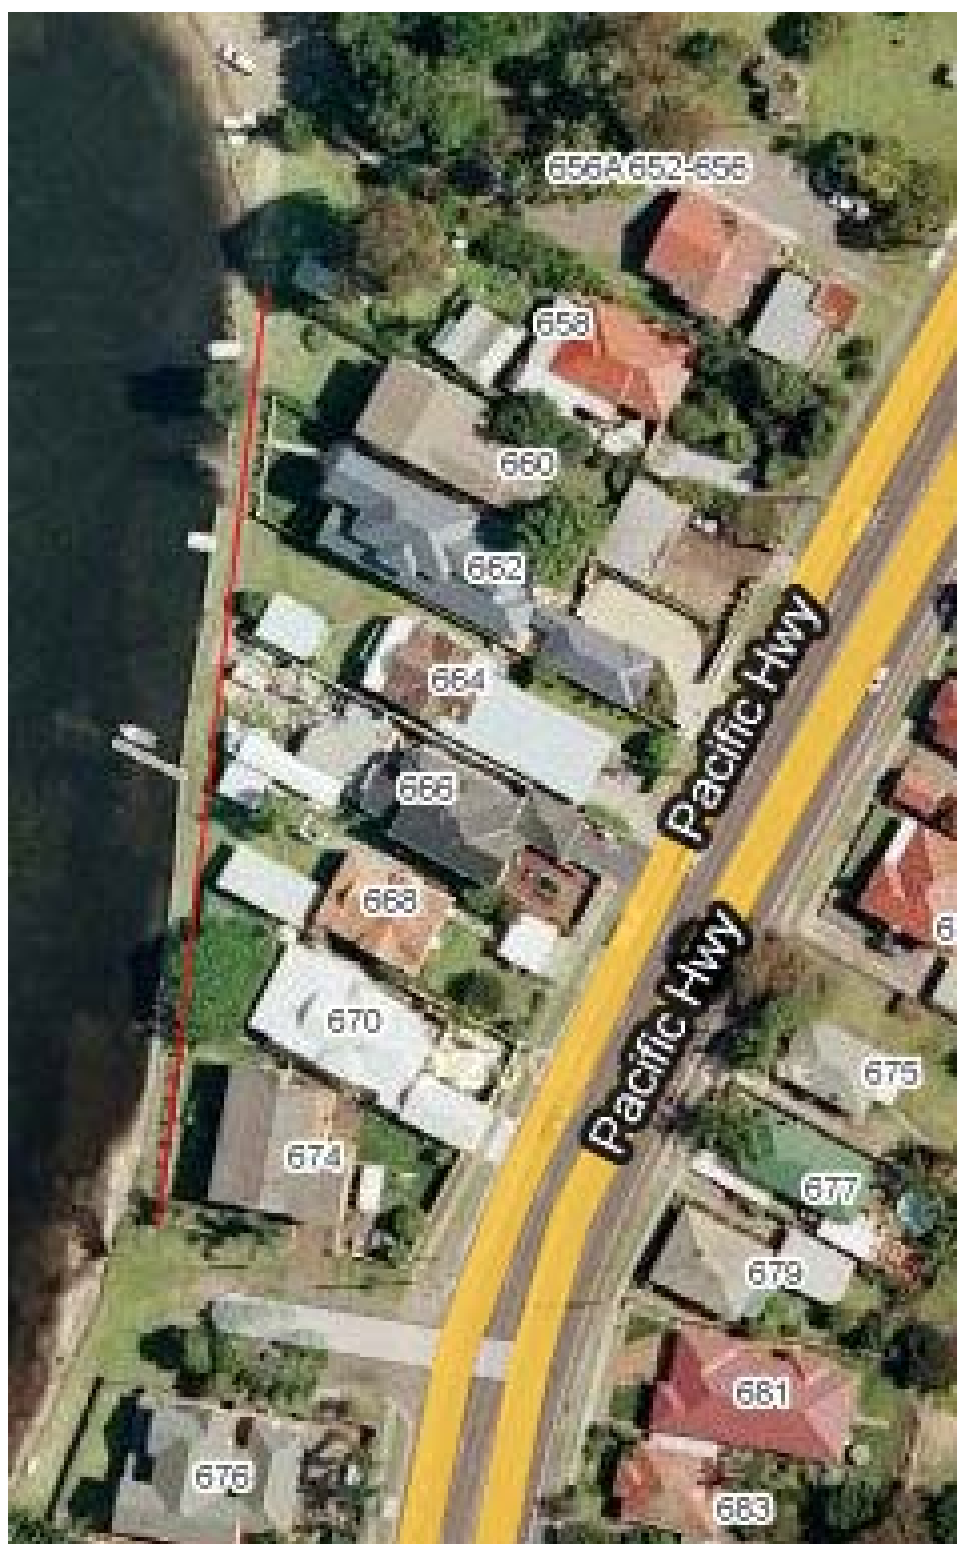
Plate 3 Red line denotes the waterline in earlier periods. The straight retaining wall retains the sewer line and fill.

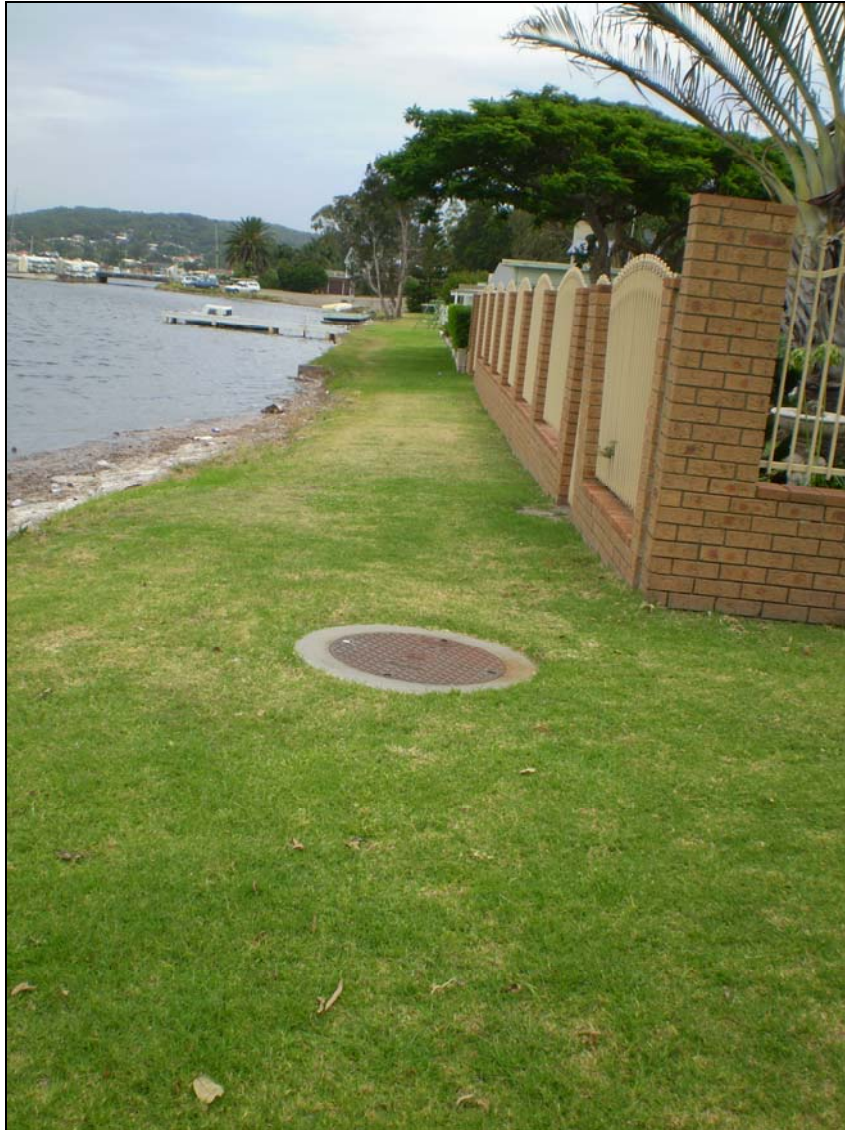
**Photo 1 View north along proposed route of cycle / pedestrian path.**

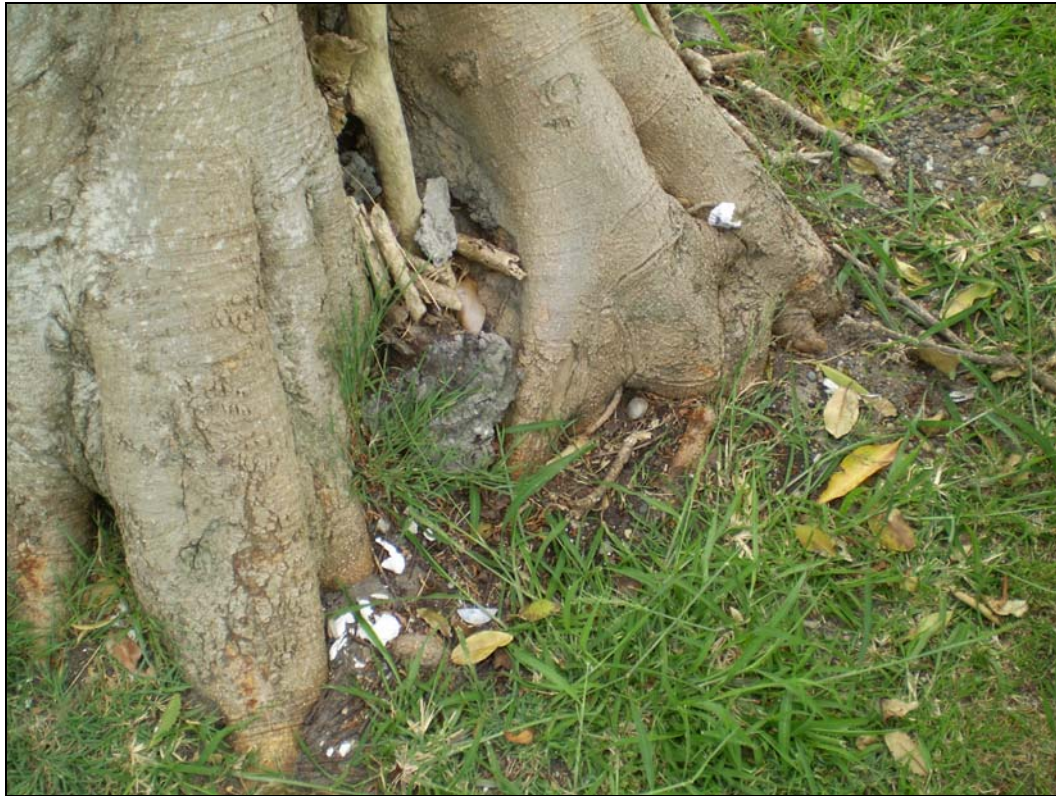
An additional area of fragmented midden shell was found in an 8m x 7m exposure adjacent to Anderson place, on the southern side about 10 m from the Pacific Hwy (Transect 2).

**Photo 2 Shell in Anderson Place. Transect 2.**

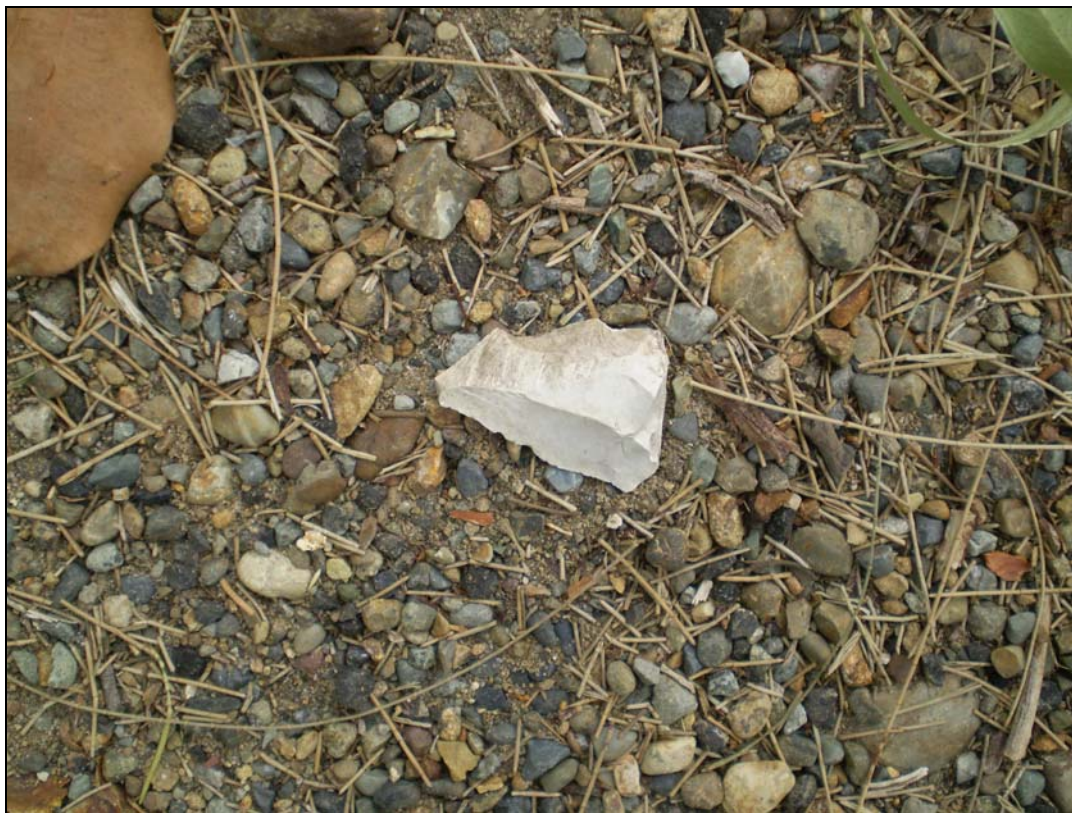
Site 45-7-0030 was relocated with numerous exposures of fragmented shell and some stone artefacts being located within Cullen Park. A flake made on tuff with a prepared platform was found on the south side of the old road that accessed the rear of the previous Baby Health Centre. The flake was found on the shoulder of the access road in amongst road gravels. The flake measured 40 x 30 x 10 mm (Transect 3).

**Photo 3 Artefact in Cullen Park adjacent to BHC access road.**

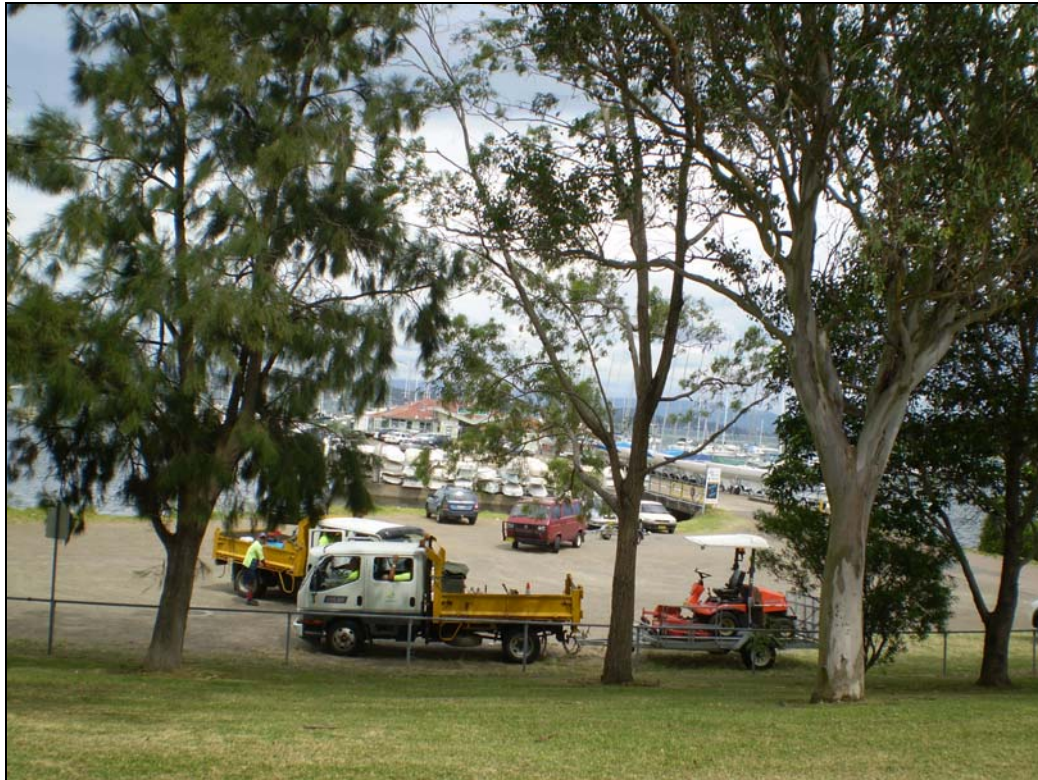
**Photo 4 View from Cullen Park to LMYC.**

The margin between the existing carpark and the grassed area may require a minimal cut and the trees on the margin of the park are too remain. The carpark area has been filled.

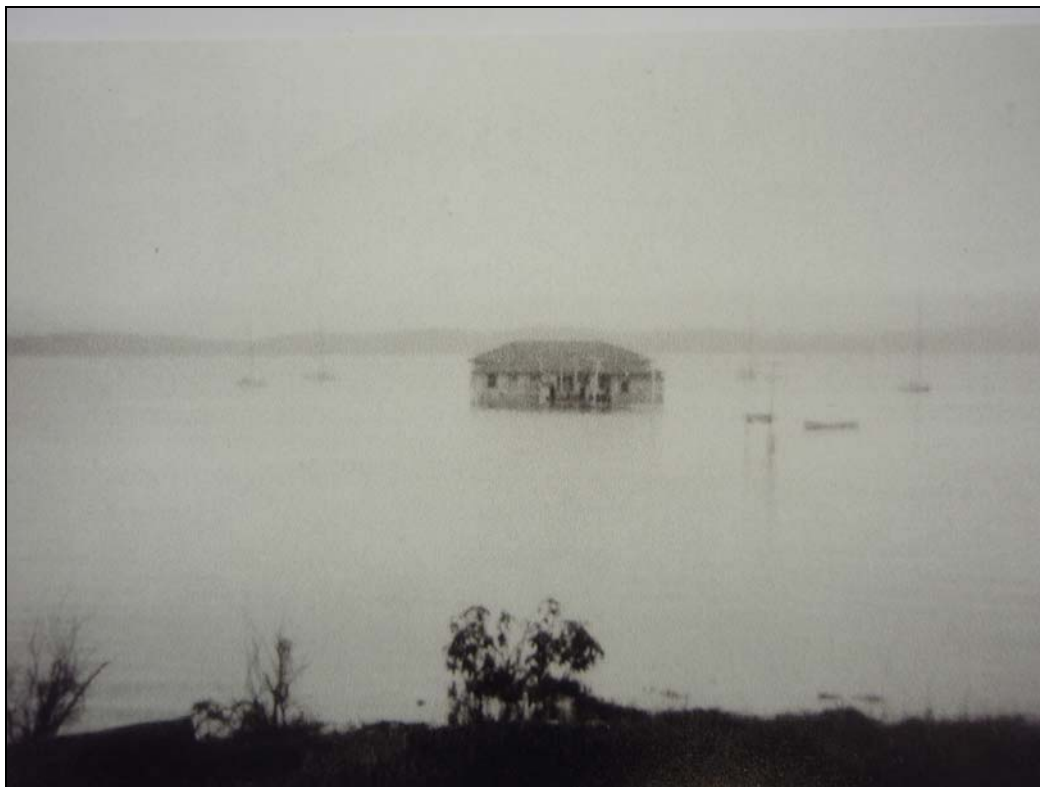
**Plate 4 The club house during 1949 flood (Ref 05426)**

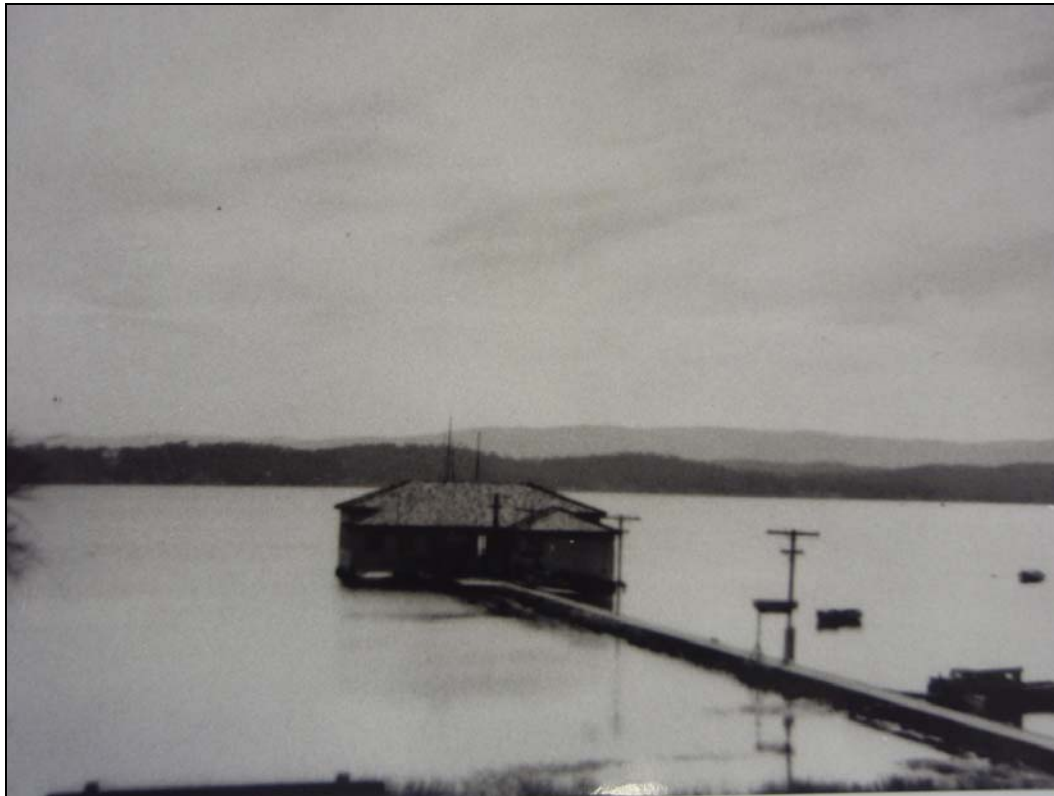
**Plate 5 LMYC no date, but prior to jetty widening and installation of awning at entry, prior to 1959 (Ref 0488).**

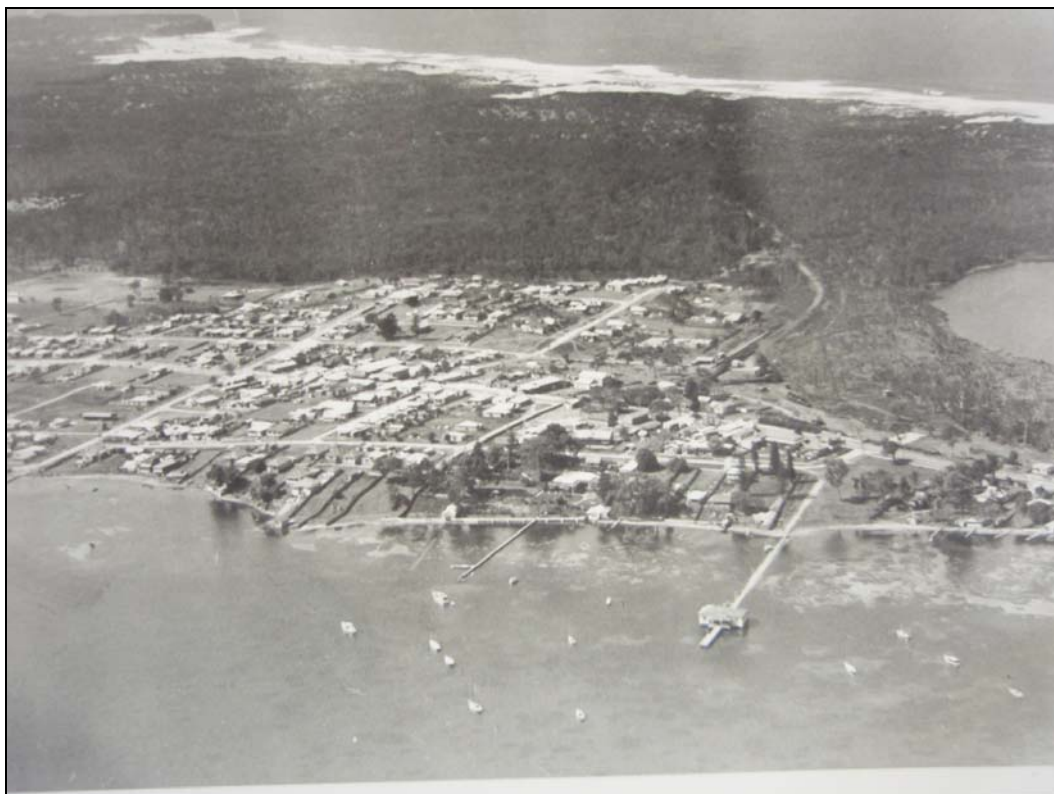
**Plate 6 Aerial photograph club house in foreground, no date. Prior 1959 as western wharf extension not yet completed (Ref 0282)**

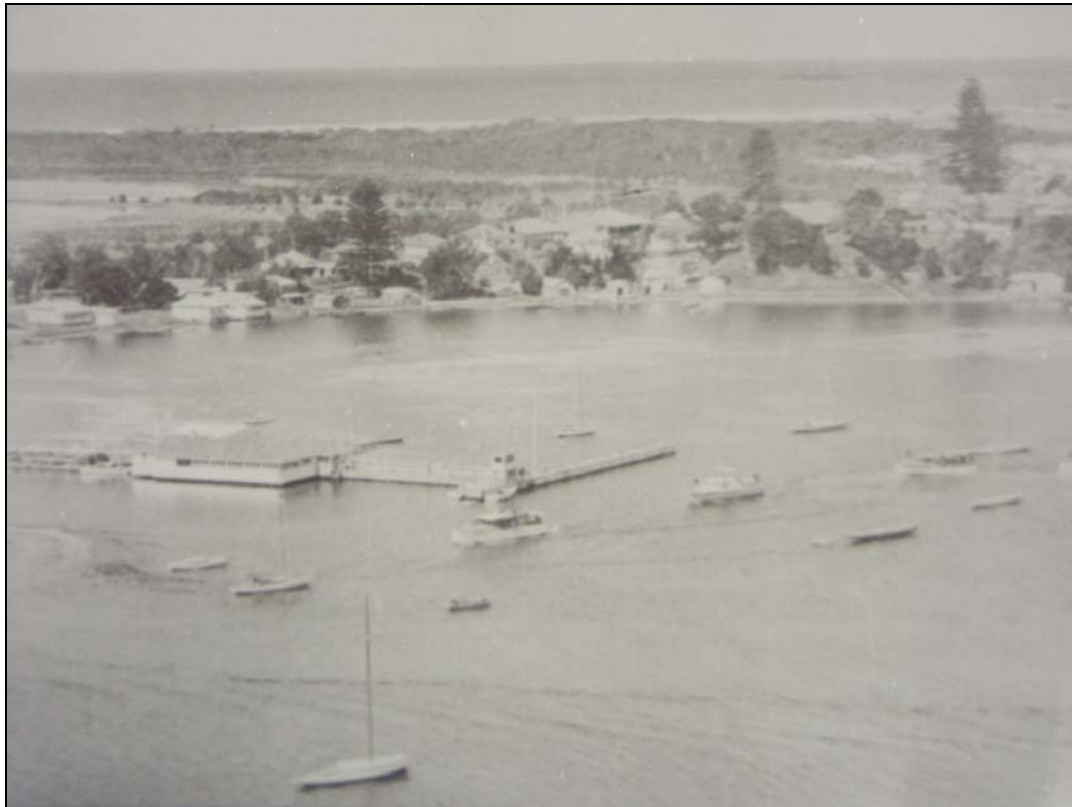
**Plate 7 Aerial photograph of yacht club 1959. Car ports and awning over entry just visible on eastern side of club house (Ref 00009).**

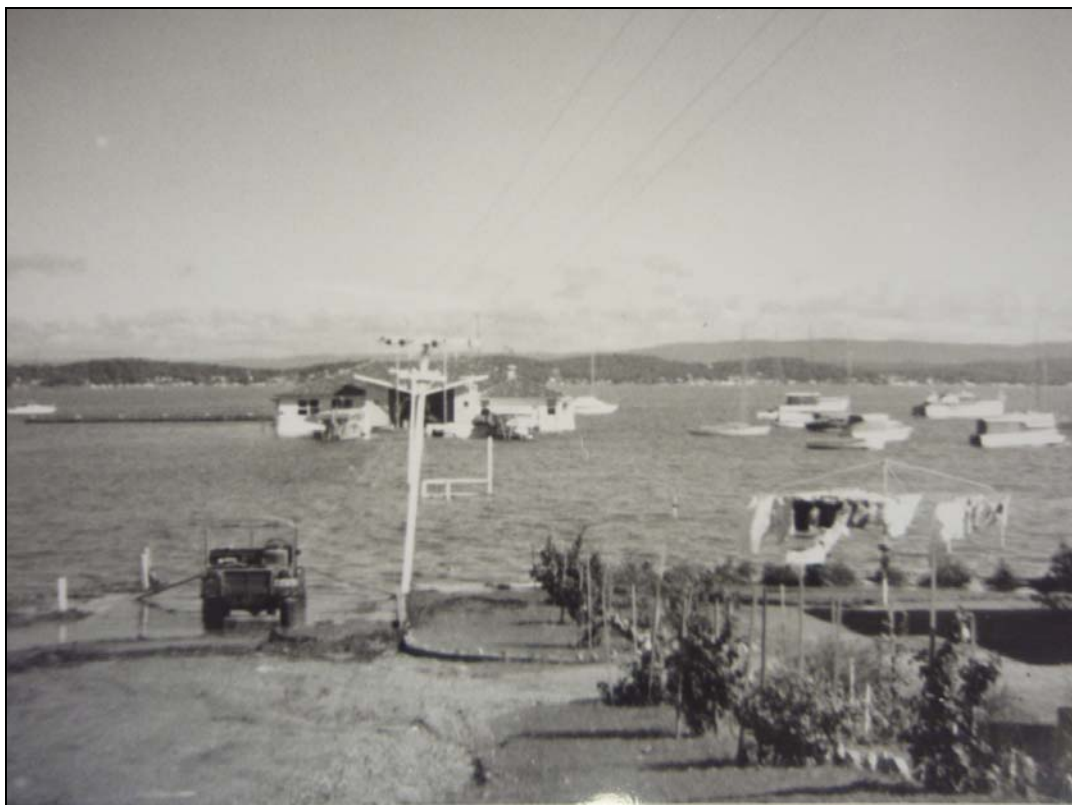
**Plate 8 LMYC during 1963 flood (Ref 02057).**

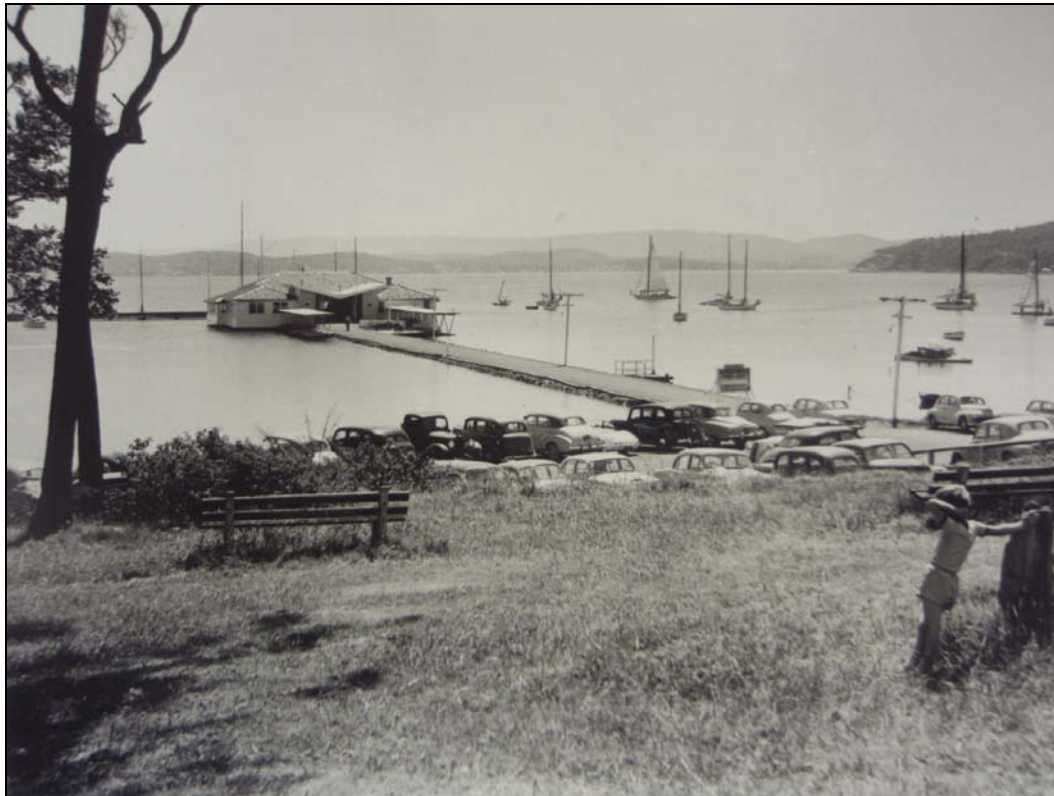
**Plate 9** The club house facing north west. Date unknown. Additional awning on front of clubhouse, widening of wharf, age of cars in car park possibly taken c.1959 but prior to the car park extension in 1966 (Ref 02317).

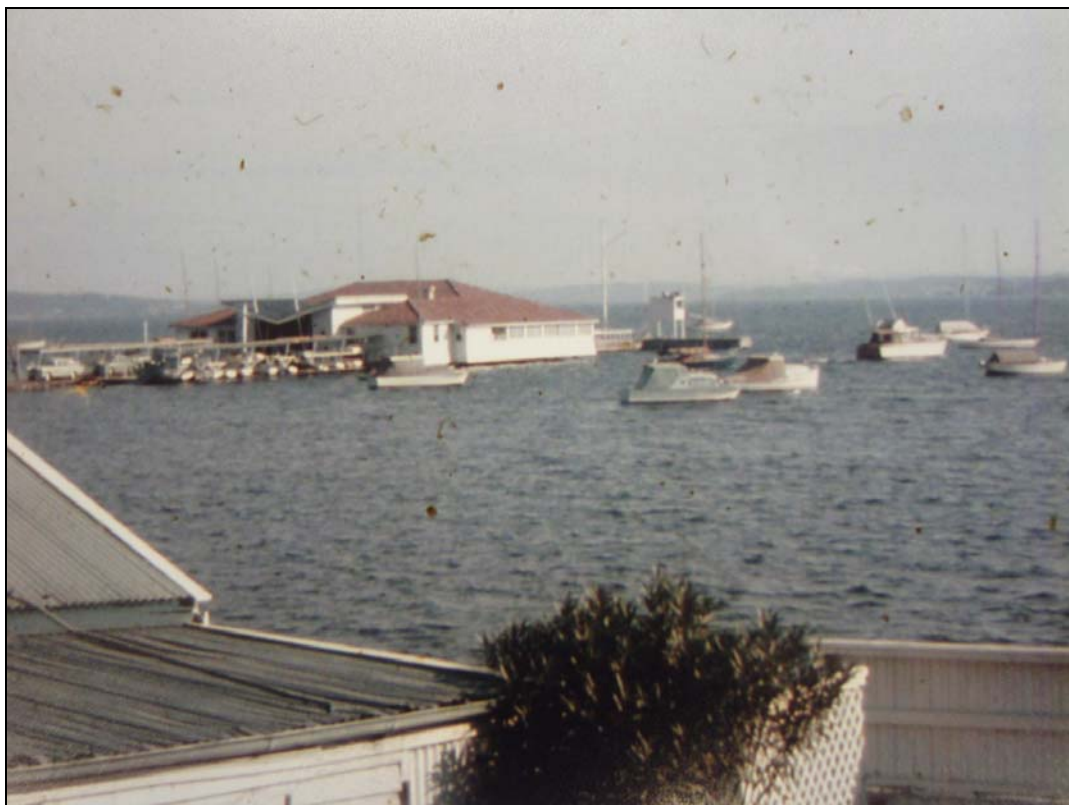
**Plate 10** The club house date unknown. Front awing and expansion of wharf already completed, photograph taken prior to car park extension in 1966 (Ref 05612).

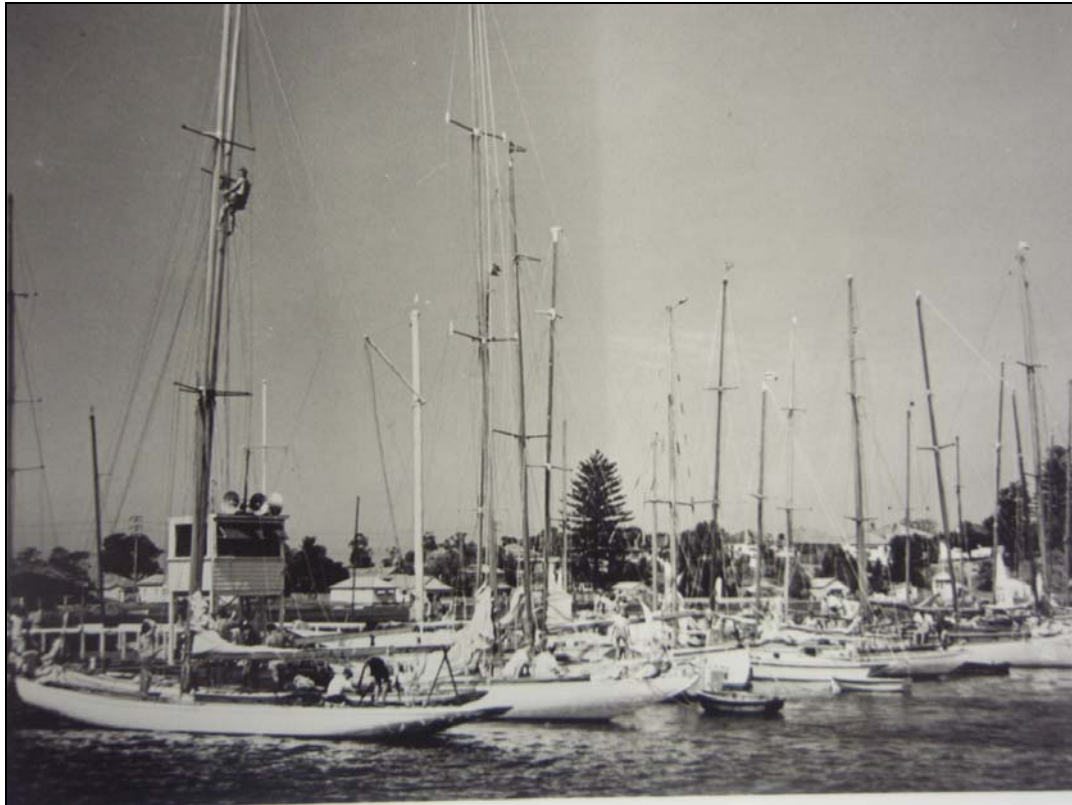
**Plate 11 Note with photograph - Location of the yacht club prior to construction of the club house. This may not be the case as due to the line up of boats it appears as though the western jetty has been erected. The boats are also very similar to those in the image below.**

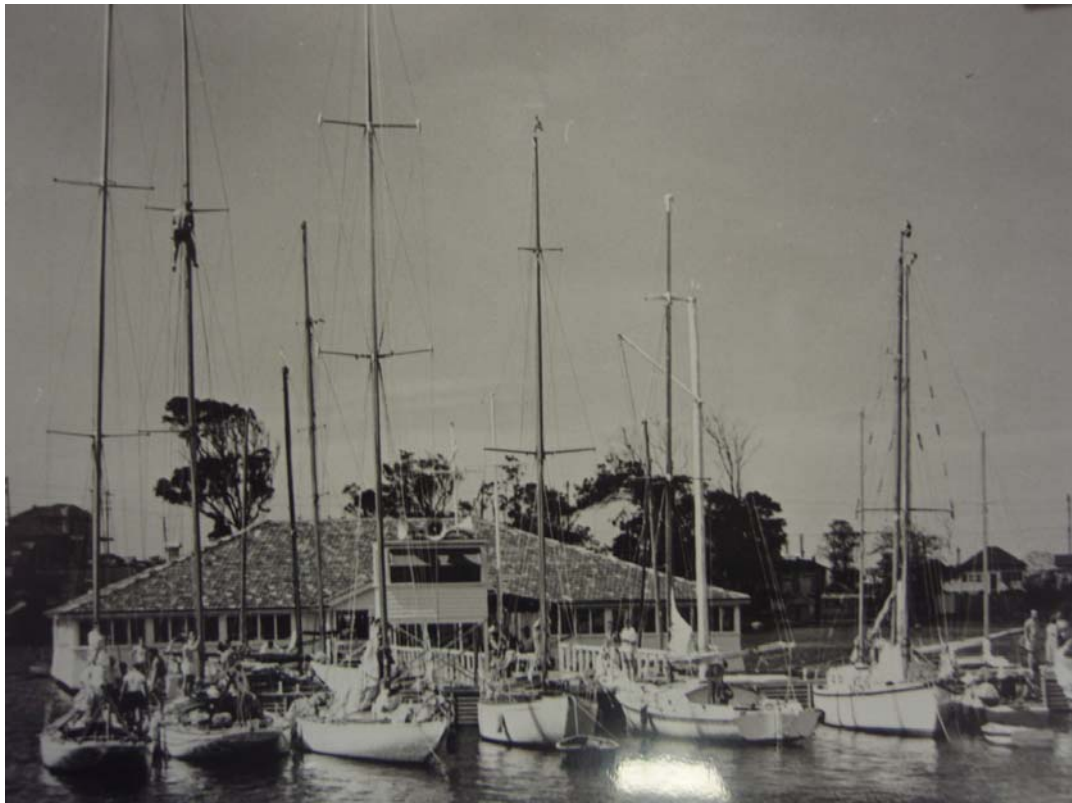
**Plate 12 LMYC date unknown (Ref 02309).**

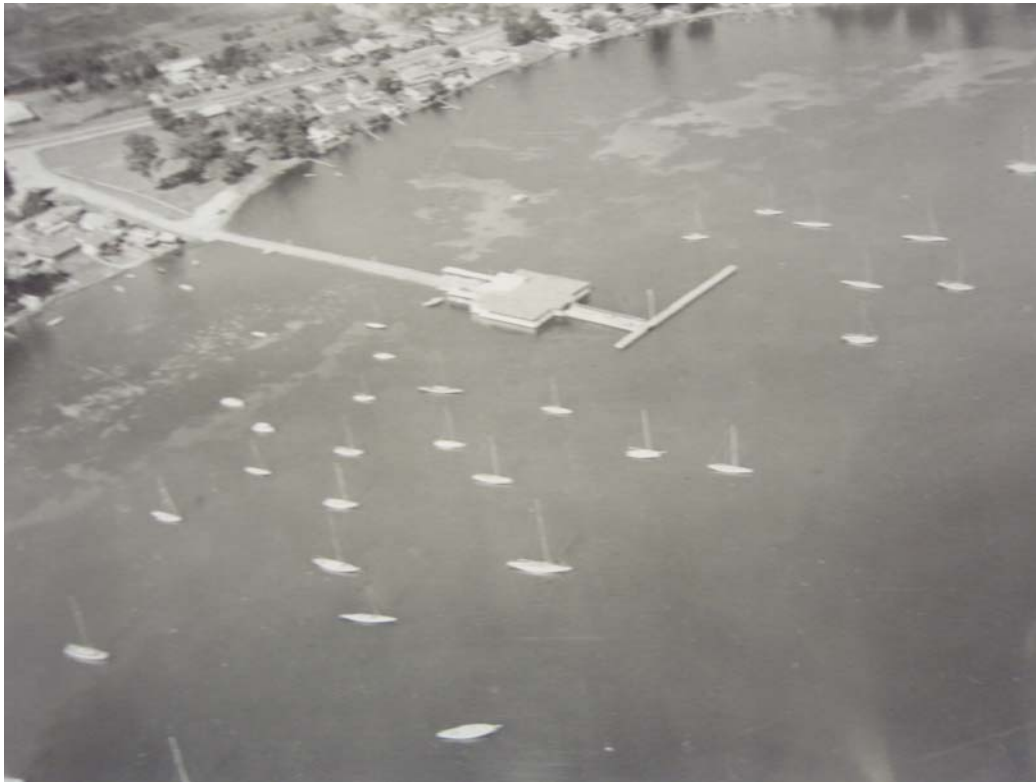
**Plate 13 Aerial view LMYC date unknown. Prior to 1966 car park extension, additional jetty on the western side and widening of wharf , similar to 1959 aerial (Ref02331).**

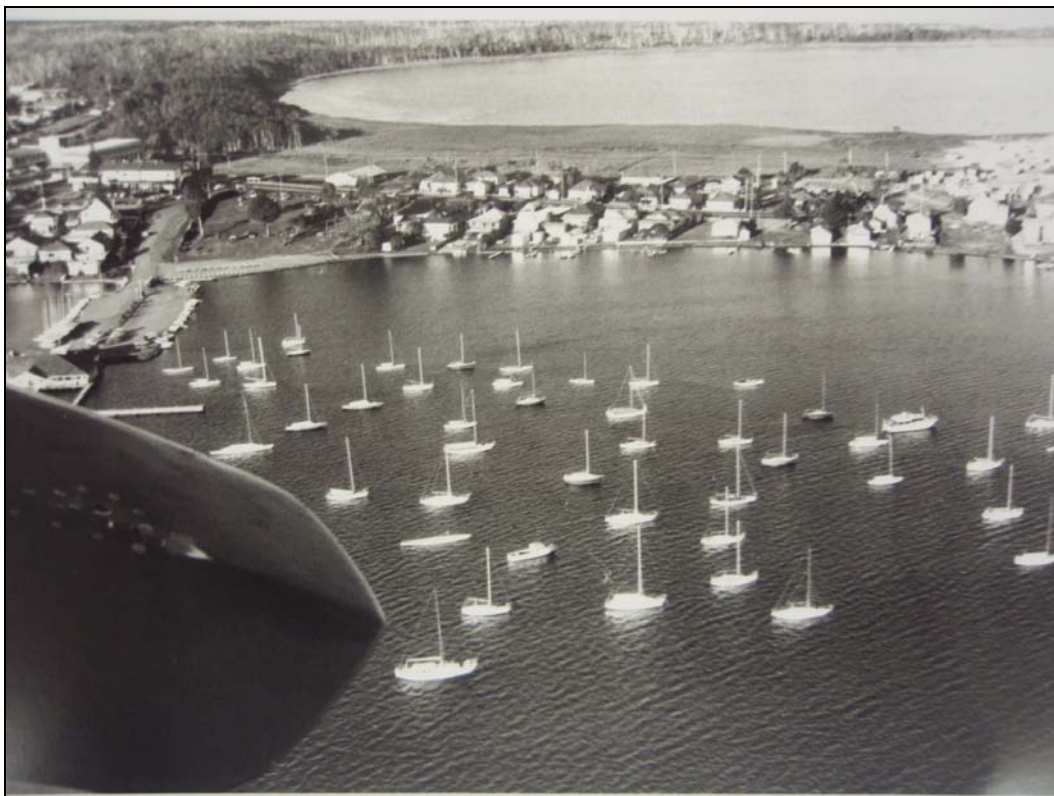
**Plate 14 1975 Aerial LMYC Club house to far left (Ref 02130).**

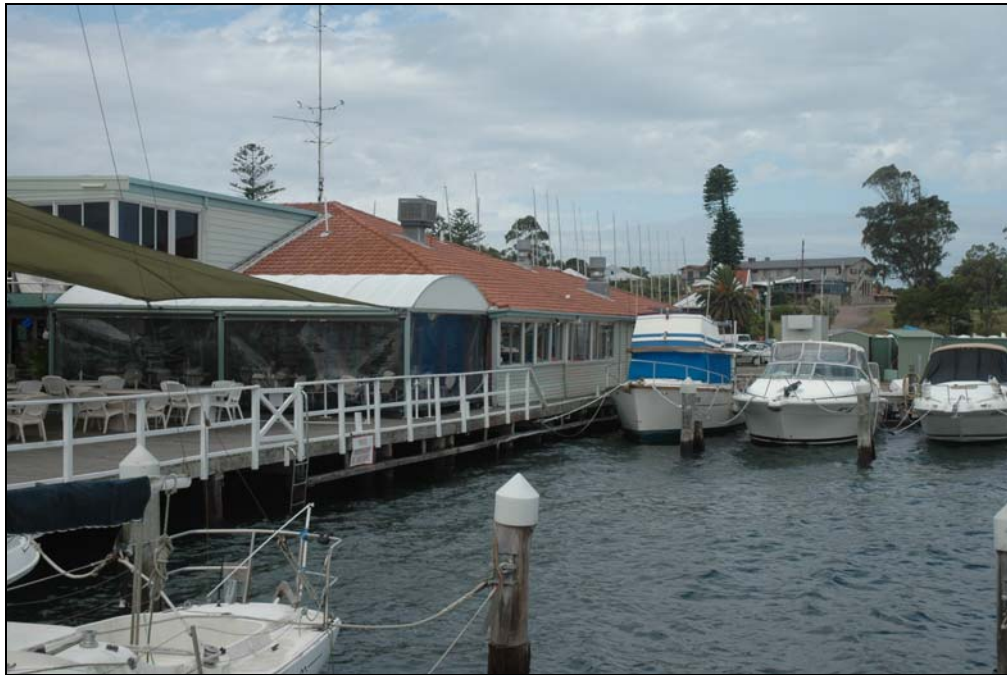
Extensive remodelling of the interior to meet changing requirements over time has occurred as required creating a patchwork effect of modifications. The building is also deteriorating. Built on piles over the lake the building has been subject to settlement and weathering. The instability of the foundations are evident in the variable floor and roof levels. Attempts to stabilise the worst of the affected areas is evident with props noticed under one section of floor. Repairs have been made over time however unsympathetic materials have been used.

**Photo 5 The south west corner of the building showing numerous stages of modification.**

It is recommended that an archival recording of LMYC club house be undertaken prior to demolition. The recording should include the collection and collation of all documentary records including plans, council records and club records that may discuss building modifications. Documentation may include photographs, member interviews, and a photographic record of the building and construction detail. A photographic record of the sub- floor, wall and roof construction detail (particularly the large trusses spanning the auditorium) should be taken during the demolition process.

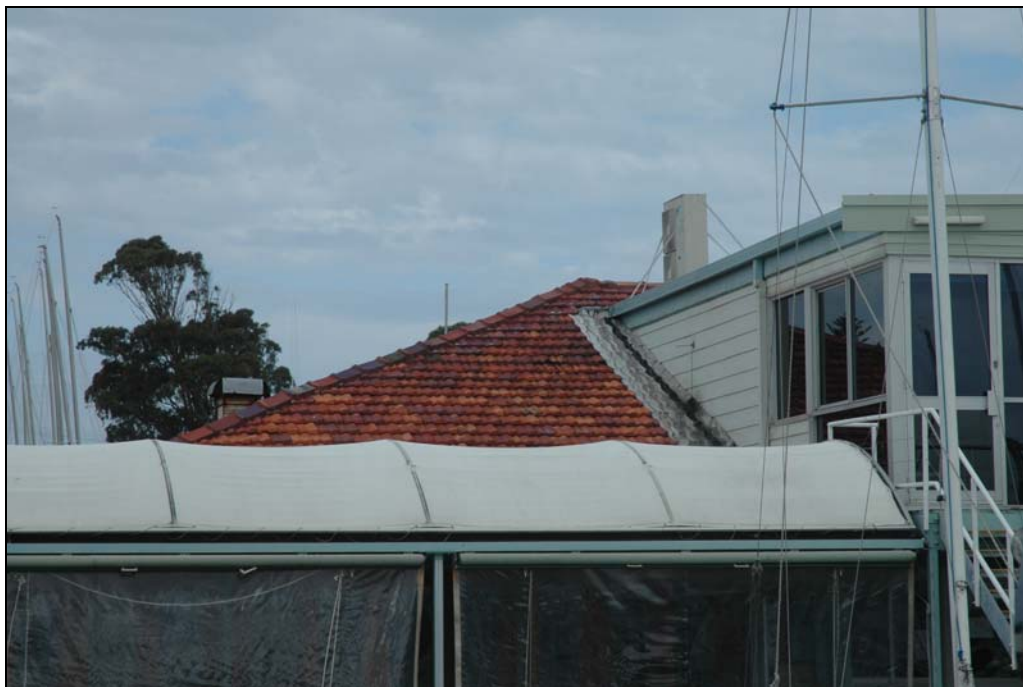
**Photo 6 South east corner roof modifications.**

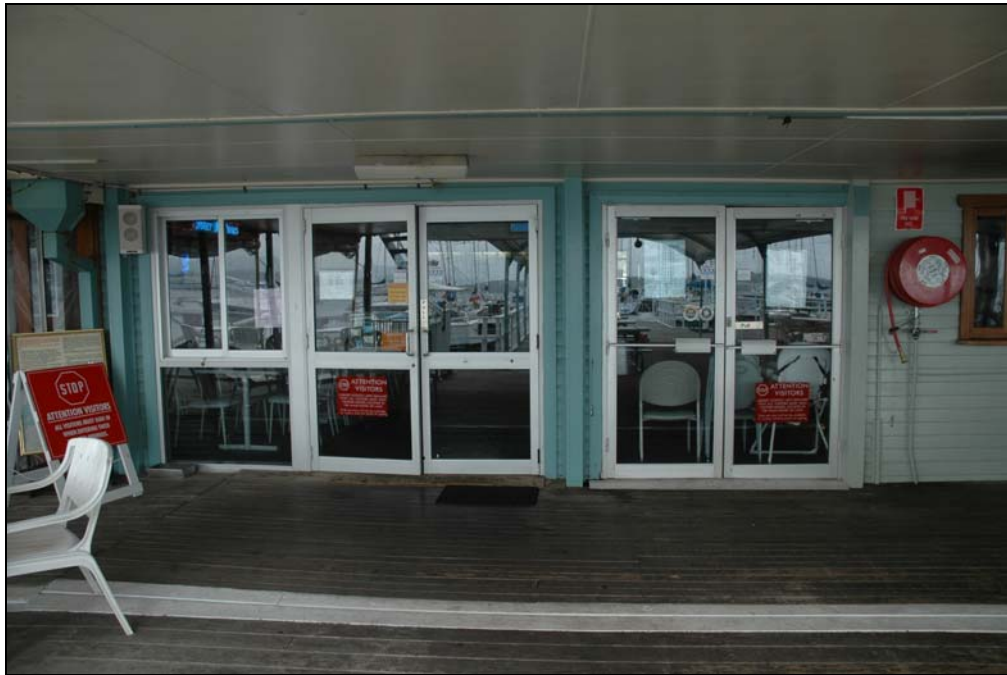
**Photo 7 Inclusion of unsympathetic fabric - rear of building.**

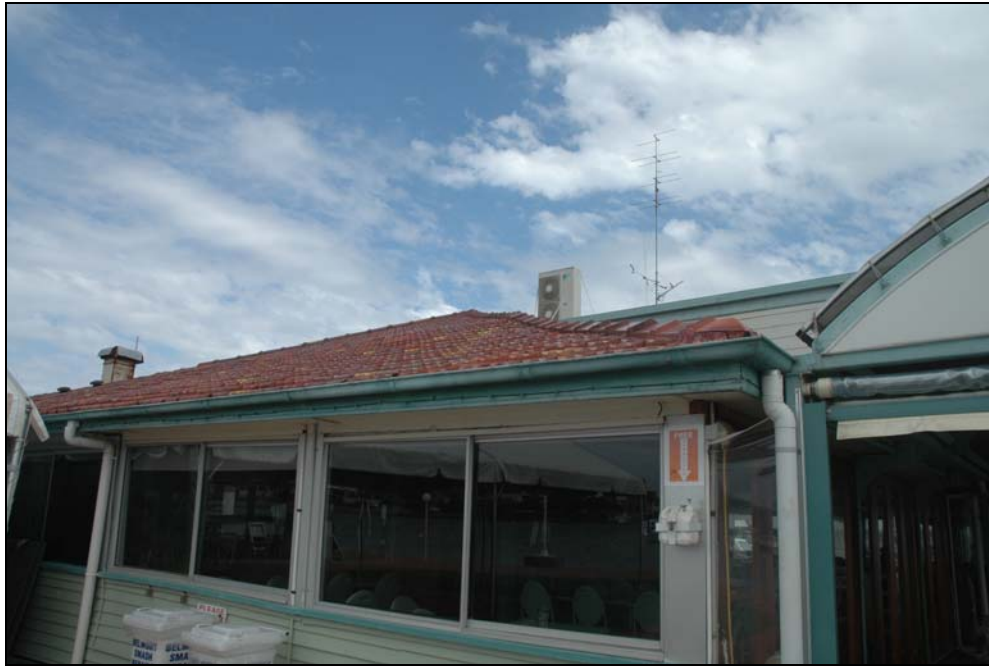
**Photo 9 Aluminium window that do not match the original period of construction**

MODIFICATIONS: Extensions outlined above. Main roof structure altered and the cladding changed from cgi or corrugated asbestos to glazed tct. Timber window frames around verandahs replaced by aluminium.

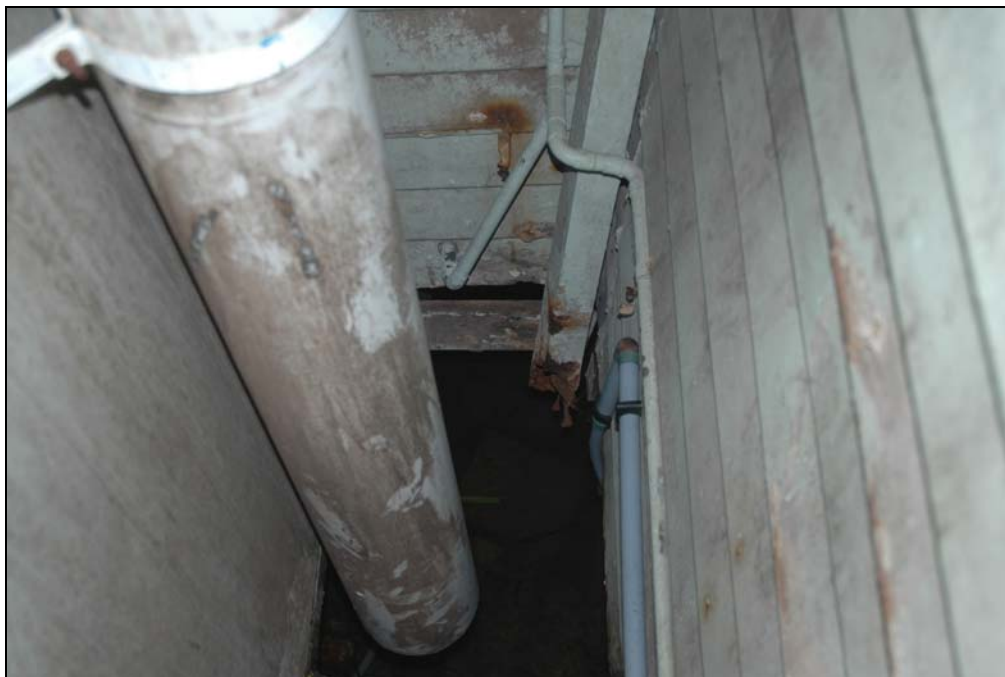
Subsidence and deterioration of timber, particularly flooring and decking has resulted in many areas being unsafe. The movement in areas of floor are evident in the unlevel floors with ridges or gaps that create trip hazards. Deck timbers are rotten in areas and sub floor structural timbers show signs of rot

**Photo 10 An example of support structures subject to rot.**

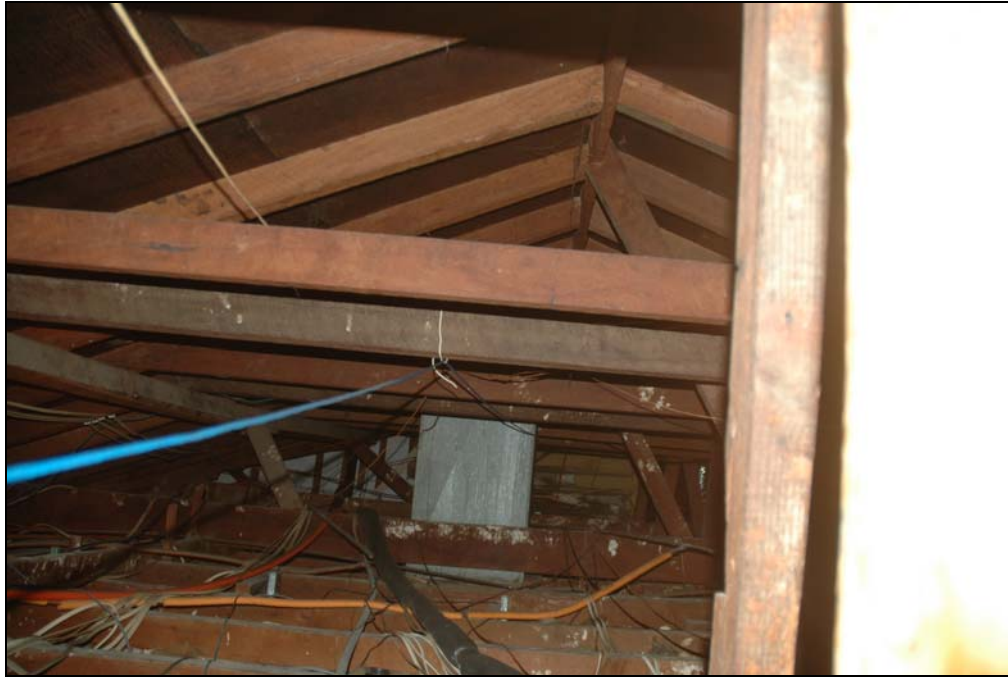
**Photo 11 Replacement trusses in the ceiling**
