***Heritage and Archaeological Assessment  
Proposed Upgrade of  
Lake Macquarie Yacht Club***

**Report to:**

**De Witt Consulting**

**June 2010**

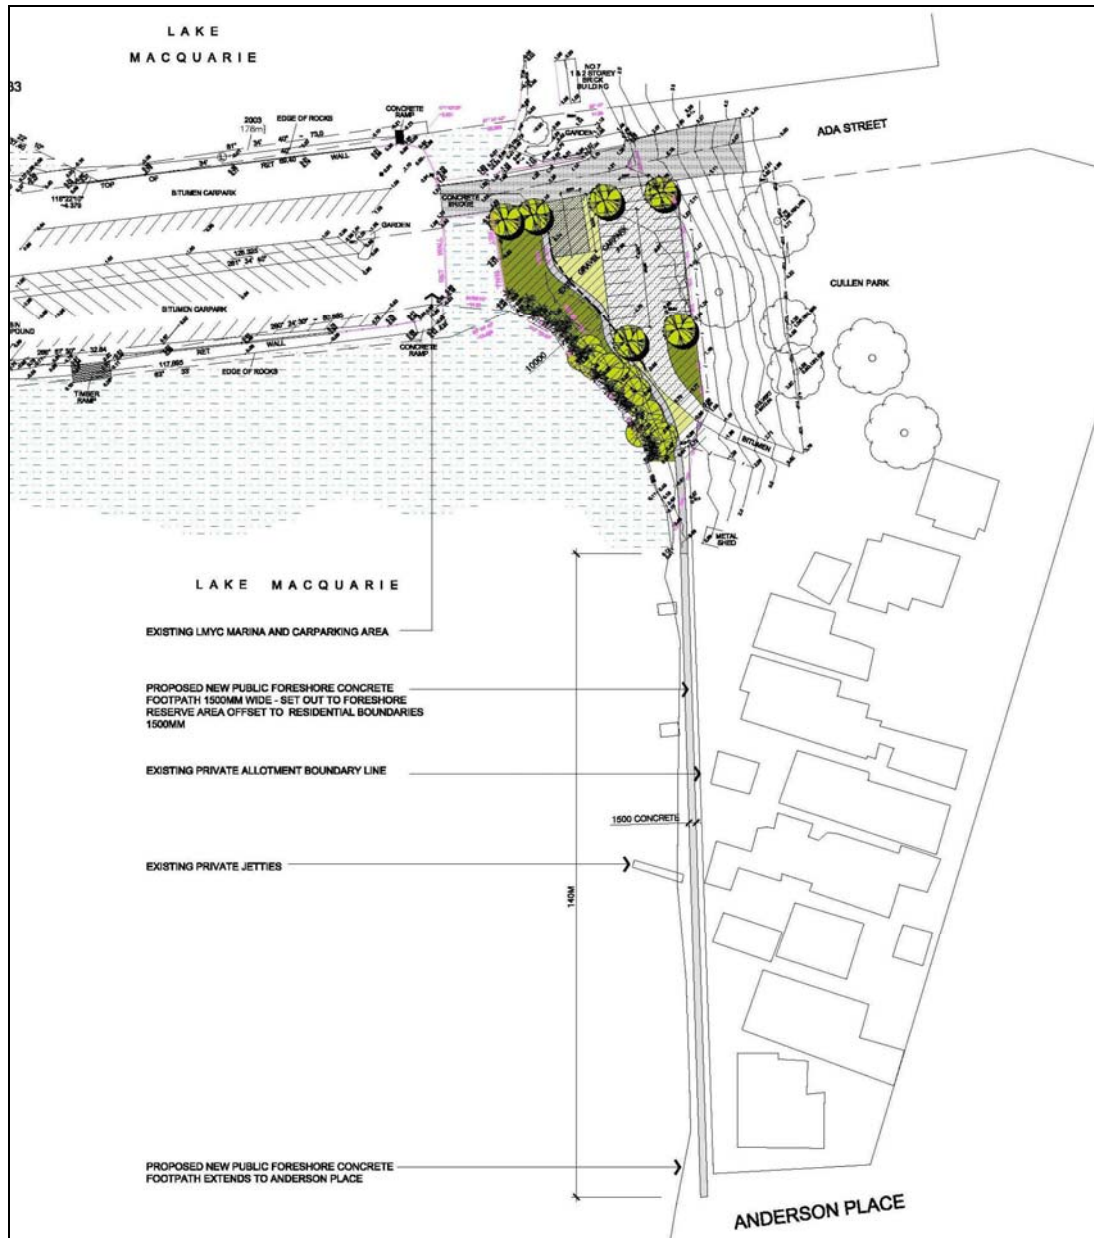
The potential cycle / pedestrian way will require minimal impact. Should the pathway be required it will be in the order of 125mm thick concrete over a 50mm thick sand base and is unlikely to impact on in-situ soil profiles.

**Figure 9 The proposed cycle / pedestrian path connecting the Yacht Club to Anderson Place. The path lies over a sewer main.**

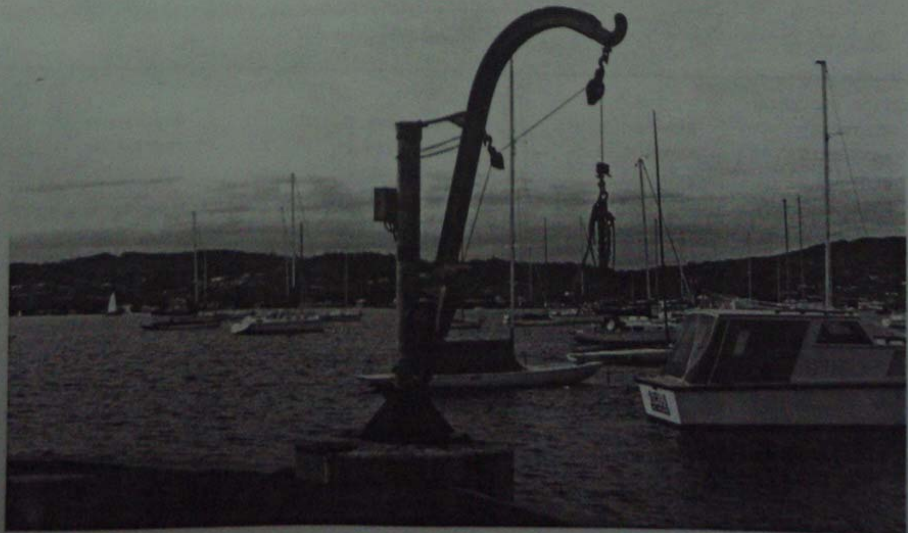
Doring Neg. 421-13

| PHOTOGRAPH &/OR SKETCH PLAN (and caption):<br>Electric Crane, Lake Macquarie Yacht Club, Ada Street, Belmont. | | |

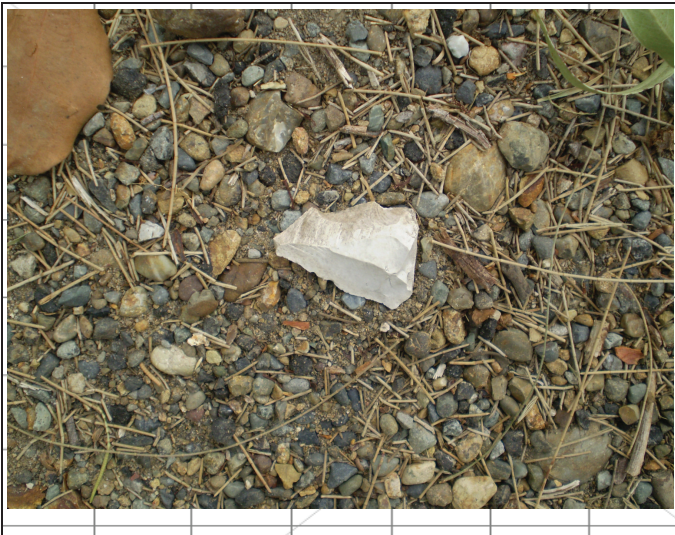
Description: tuff flake on road base on margins of unus
