Ardent Leisure Pty Ltd

# Geotechnical, Acid Sulfate Soil and Stage 2 Contamination Assessment: The Spit Marina, Mosman, NSW

P0701675JR02\_v2  
May 2010

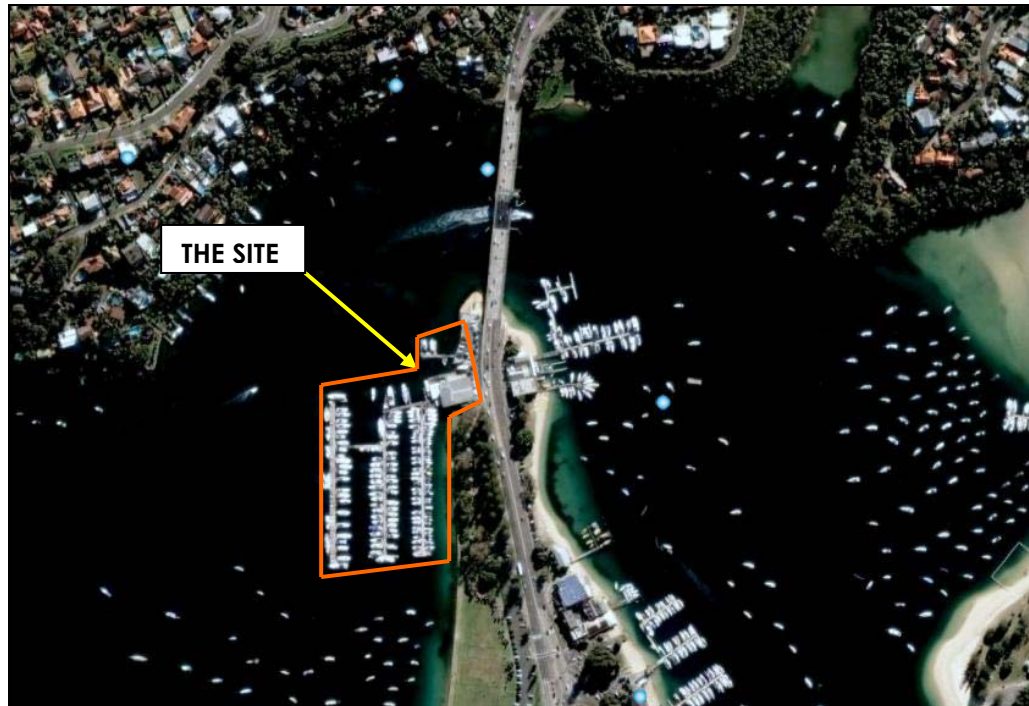
Figure 1: Aerial photo of The Spit, showing site location (land and lease area), (source: Google Maps, 2007).

Figure 1 shows a site aerial photo and approximate site boundaries.
