FINAL REPORT

National Biodiesel Production
Facility: Contamination
Assessment, Inner Harbour, Port
Kembla, NSW

PROJECT
NATIONAL BIODIESEL FACILITY SITE ASSESSMENT, INNER HARBOUR, PORT KEMBLA, N.S.W.

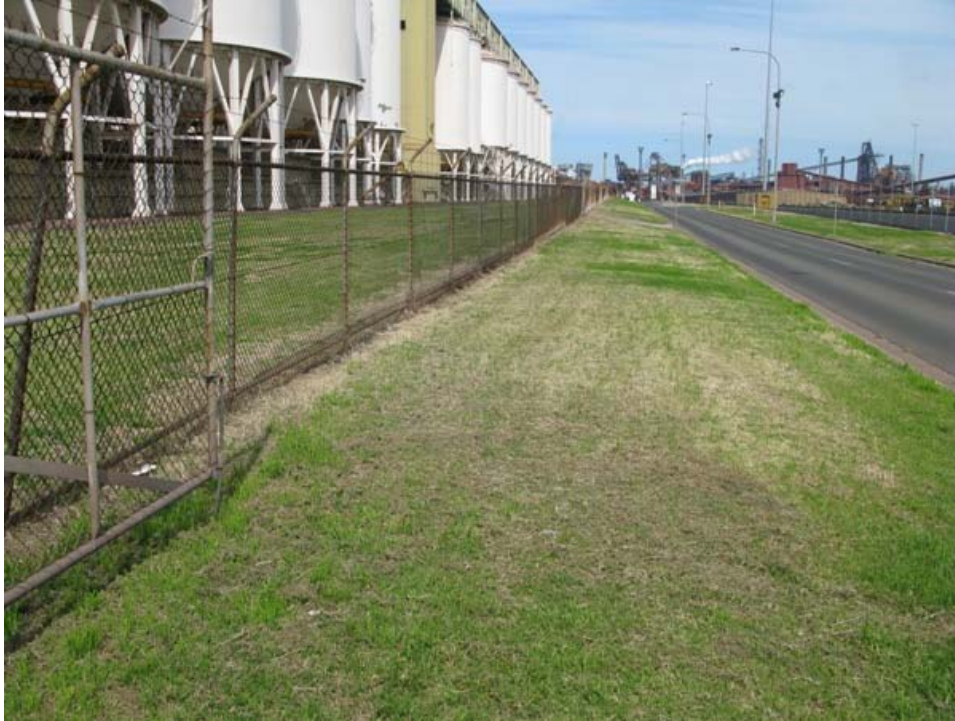
Plate 1. Allotment 1 looking south towards the Inner Harbour.

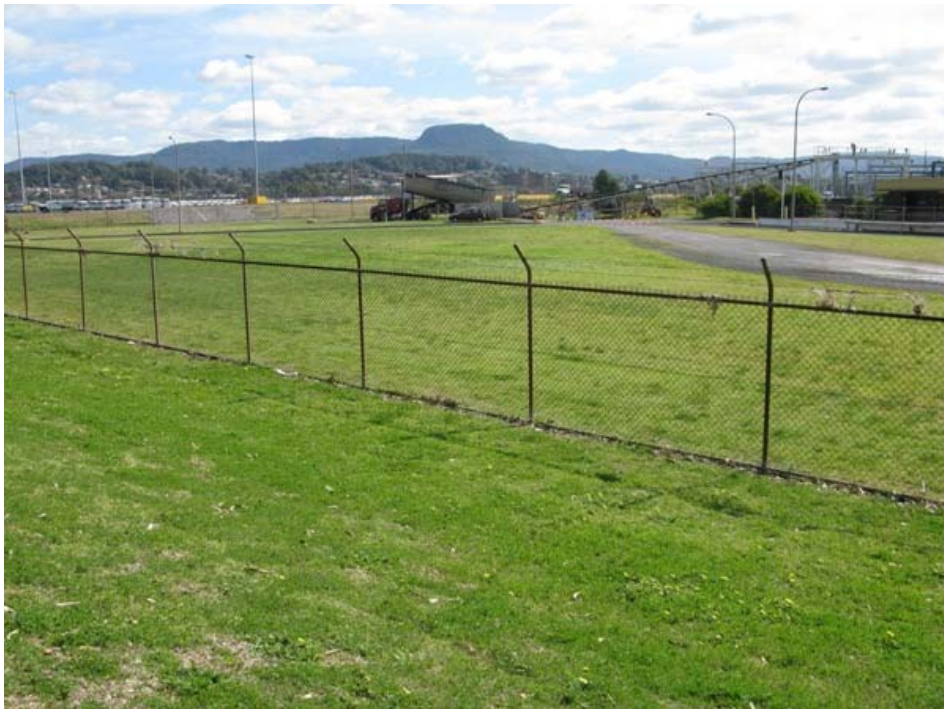
Plate 2. Allotment 3 looking northwest.

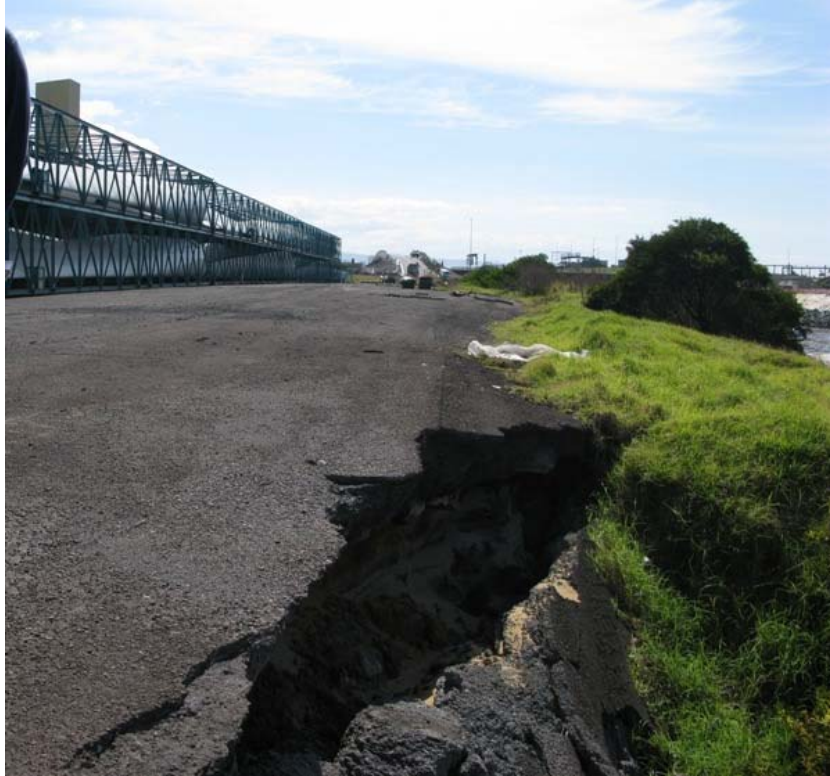
Plate 3. Allotment 5 looking north. Turbines are temporarily stored on this allotment to the west.

Allotment 5 is bounded by the Western Drain to the east, Morton Way and the Grain Terminal to the west, Tom Thumb Road to the north and the Eastern Basin/Inner Harbour to the south (**Plates 3, 4 and 5**). This allotment is relatively flat and is covered by a bitumen pavement with a narrow vegetative strip along the eastern boundary. On the southern end of the eastern boundary, a section of slag fill material has slumped towards the Western Drain, as a result of a broken subterranean pipeline (Maunsell 2008; **Plate 4**).

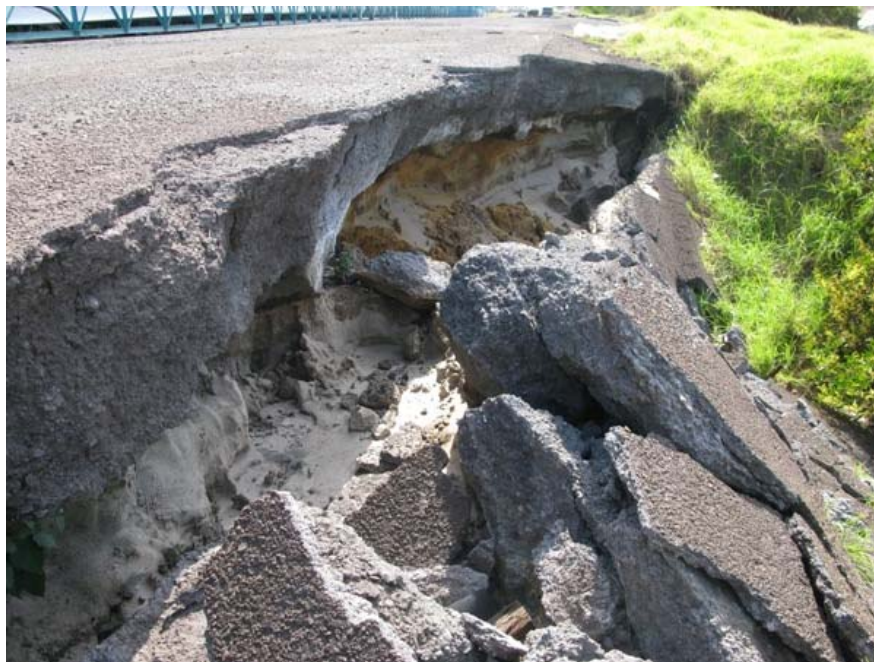
Plate 4. Allotment 5 slumping of fill material, looking north.

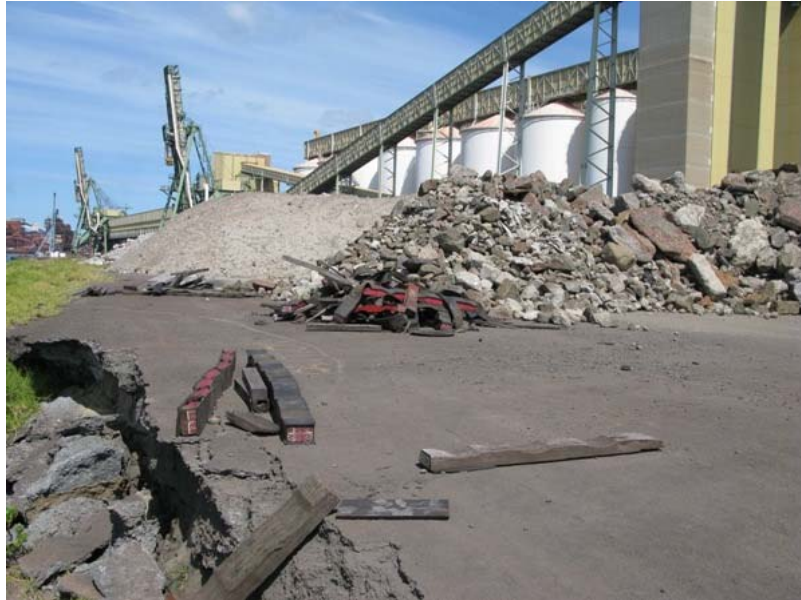
Plate 5. Allotment 5 looking south. Stockpiles of dredged material and gravel are temporarily stored on this allotment. The GrainCorp silos are to the southwest.

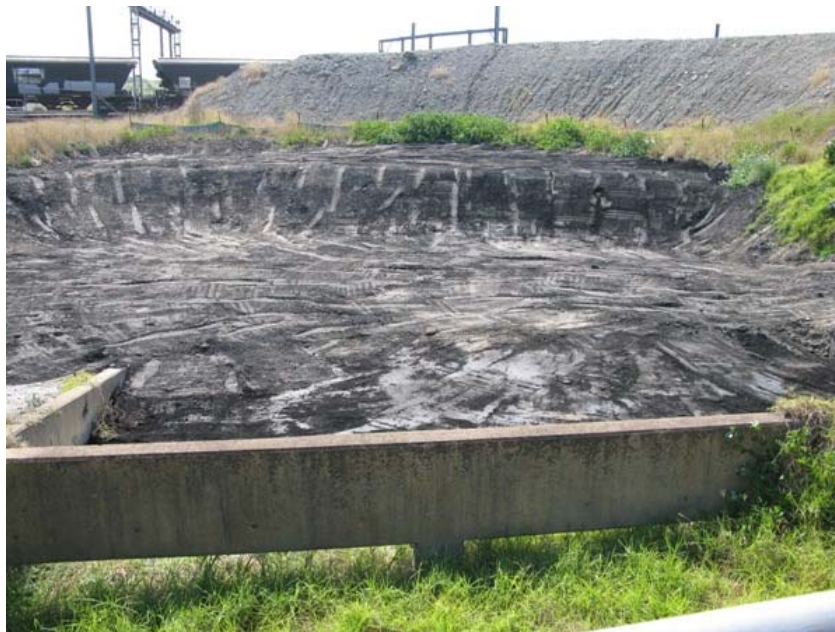
Plate 6. Allotment 6 facing north. The stormwater pit is in the foreground, and a large stockpile of gravel is present to the north.

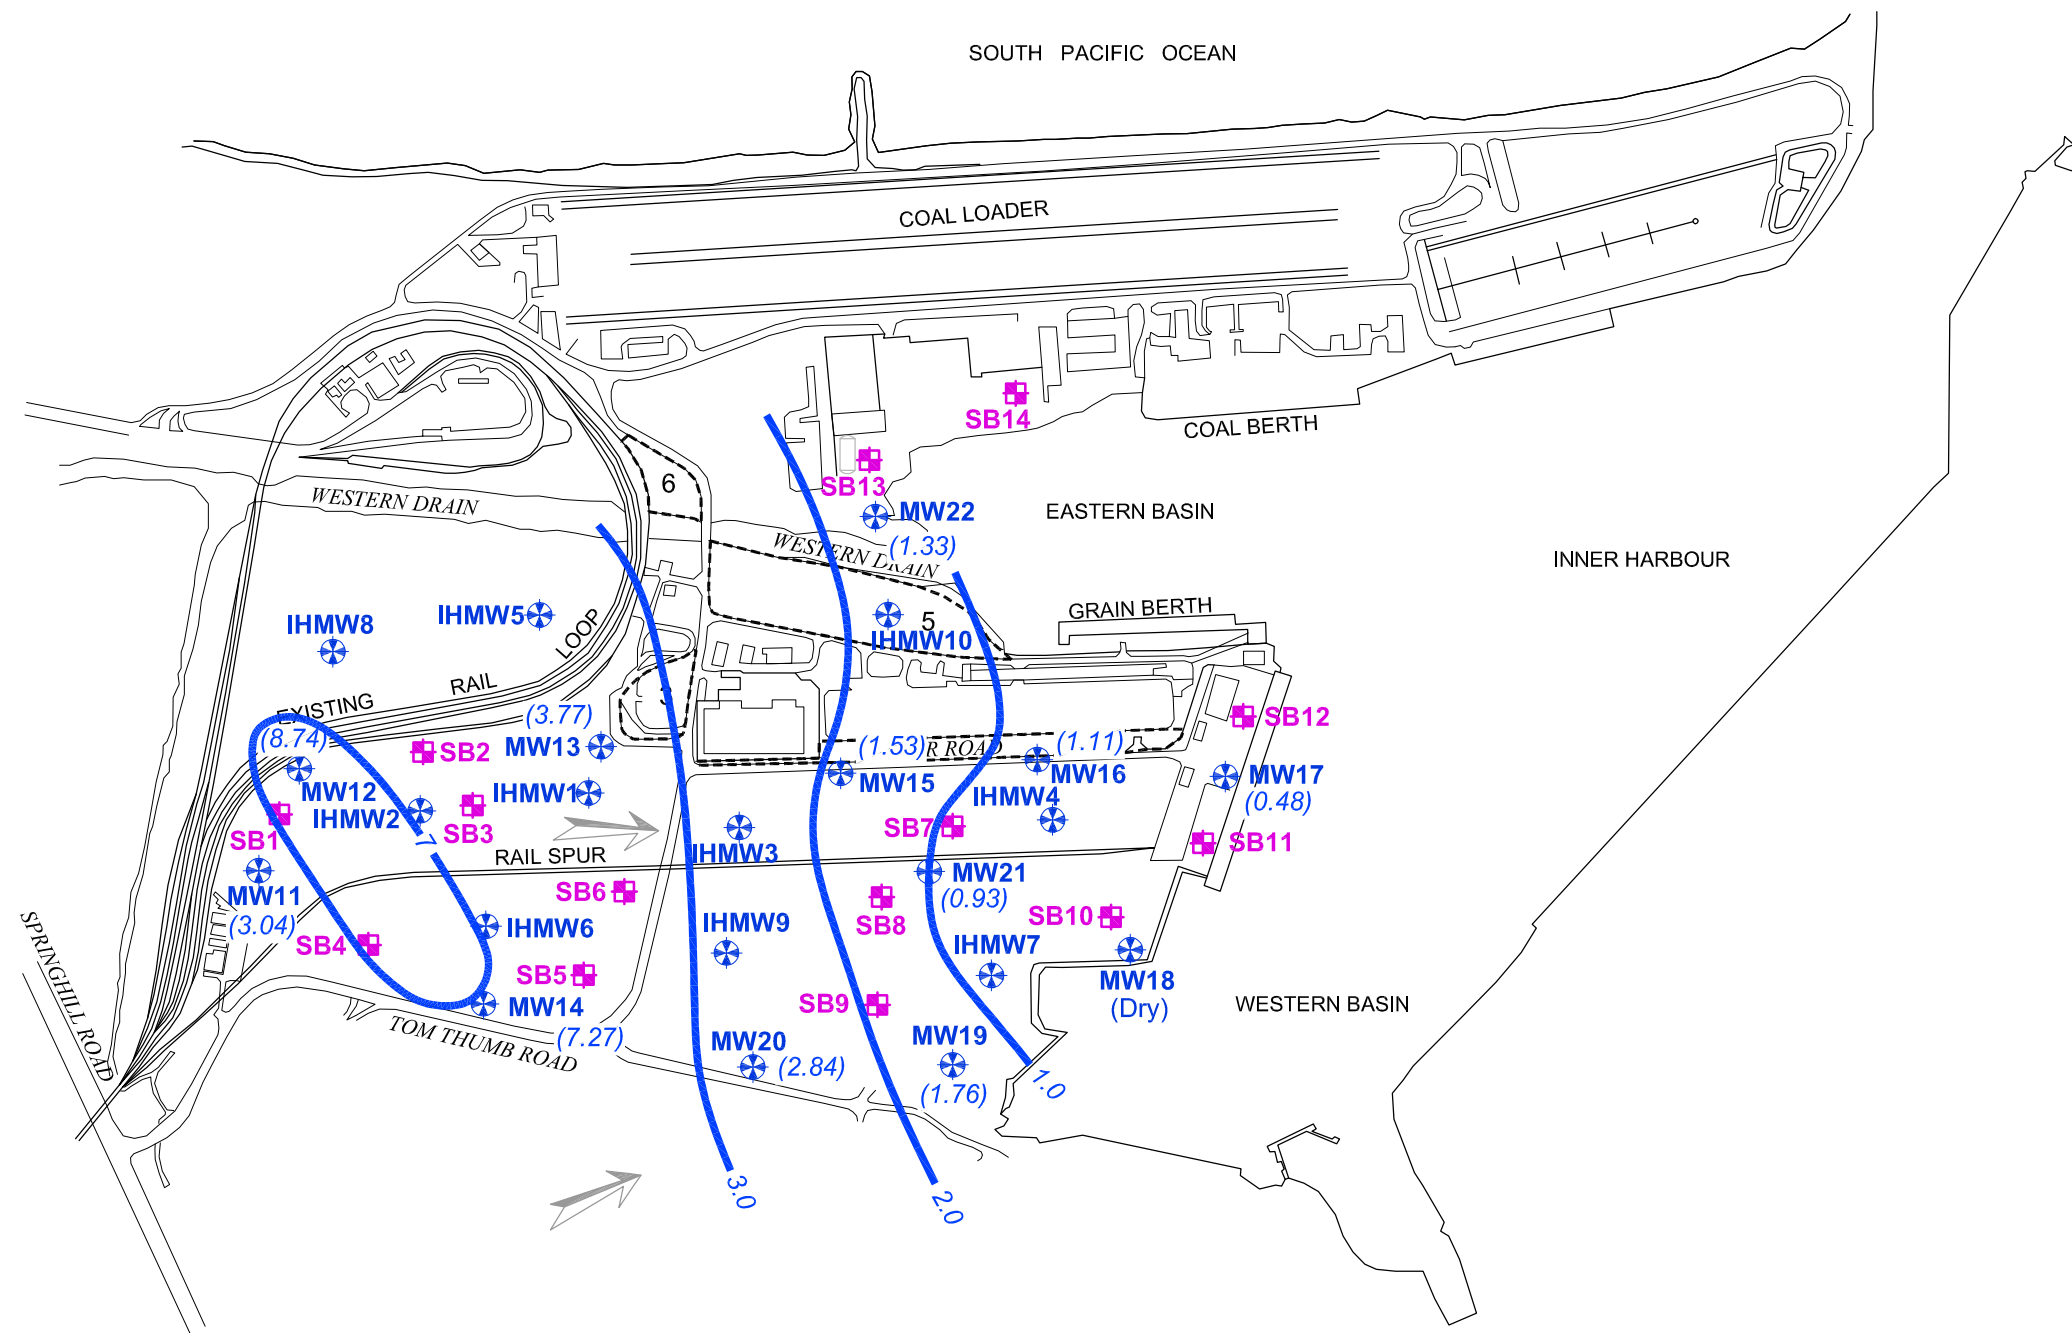
HYDROGEOLOGICAL INFORMATION:
HYDRAULIC CONDUCTIVITY: 5-10m/day
HYDRAULIC GRADIENT: 0.001-0.005
SEEPAGE VELOCITY: 12.17-73m/year

CLIENT	MAUNSELL / AECOM
PROJECT	NATIONAL BIODIESEL FACILITY SITE ASSESSMENT, INNER HARBOUR, PORT KEMBLA, N.S.W.
TITLE	HISTORICAL GROUNDWATER GRADIENT MAP
	A3
