# **Warrick Farm Printing Project Environmental Planning and Assessment - Soil**

Independent Print Media Group

August 2008

0086333R02V3 FINAL

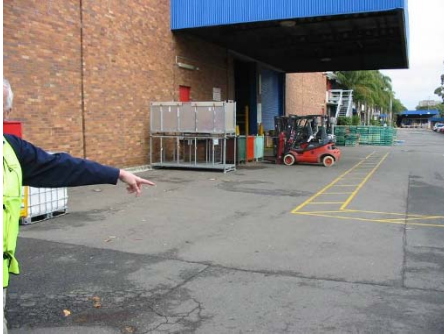
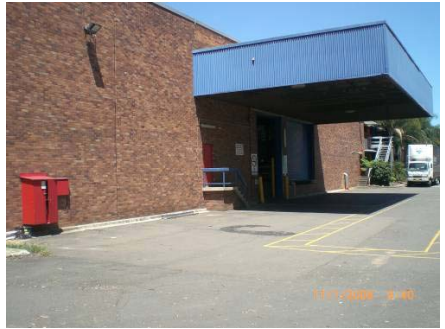
| Observations | June 06 | January 08 |
|---|---|---|
| <p>Previously investigated area of BH25-28 &amp; MW04. Previous Petrol UST Area.</p> <p><b>Jan 08</b> - No change - no new potential contamination sources or impact observed. MW04 still accessible.</p> | | |

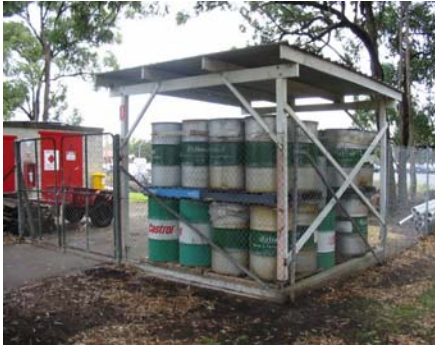
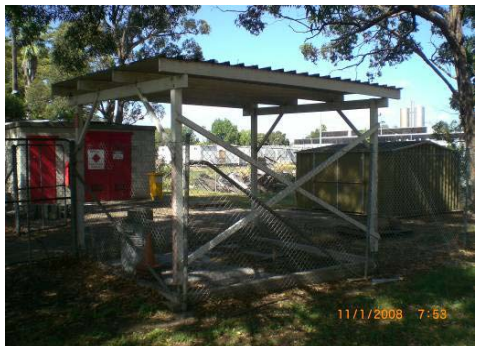
| Observations | June 06 | January 08 |
|---|---|---|
| <p>Previously investigated area of BH07, BH05 – Chemical store. 90% of drums in the Phase I assessment were disposed of by January 2007.</p> <p><b>Jan 08</b> - All drums in this area had been removed offsite. No new potential contamination sources or impact observed.</p> | | |

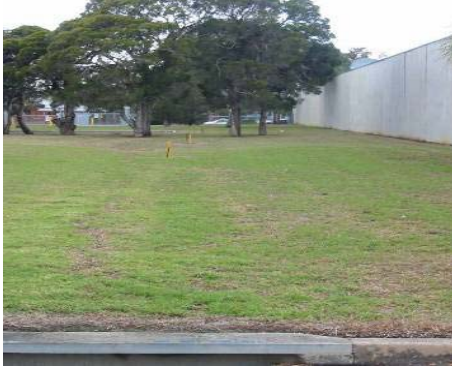
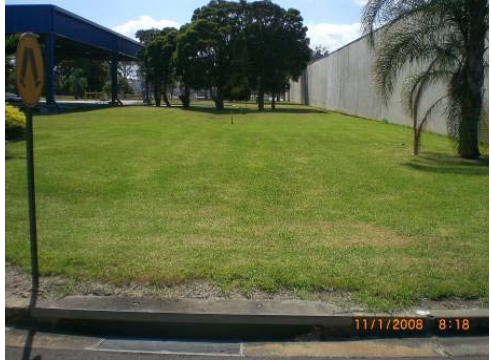
| Observations | June 06 | January 08 |
|---|---|---|
| <p>Previously investigated area of BH19,20,31, MW02 – former open unlined sewer.</p> <p><b>Jan 08</b> - Area along length of sewer is covered with good quality grass. No change - no new potential contamination sources or impact observed. MW02 still accessible.</p> | | |

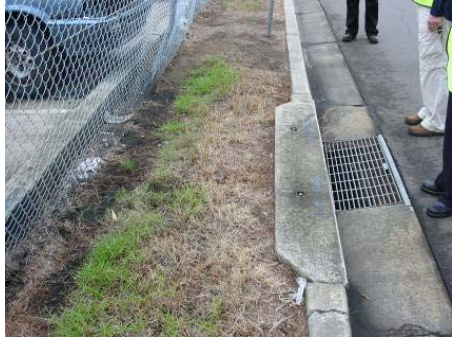
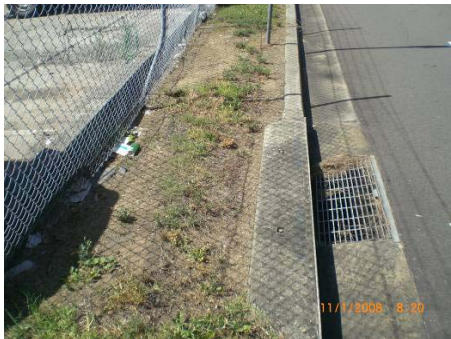
| Observations | June 06 | January 08 |
|---|---|---|
| <p>Previously investigated area of BH14 - Hydrocarbon staining was observed in June 2006. Impacted soil was removed by KCA in 2006.</p> <p><b>Jan 08</b> - No staining, otherwise no change - no new potential contamination sources or impact observed.</p> | | |

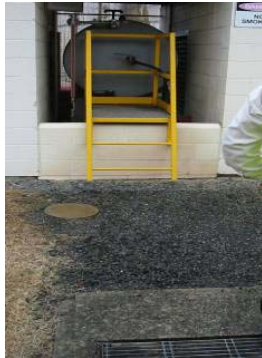
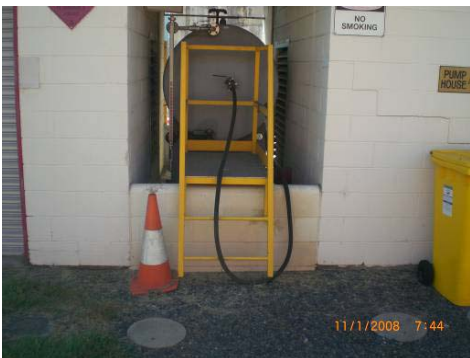
| Observations | June 06 | January 08 |
|---|---|---|
| <p><i>Previously investigated area near BH14 – 1500 litre diesel tank.</i></p> <p><b>Jan 08</b> – No change – tank observed to be in good condition and no significant staining observed. No new potential contamination sources or impact observed.</p> | | |

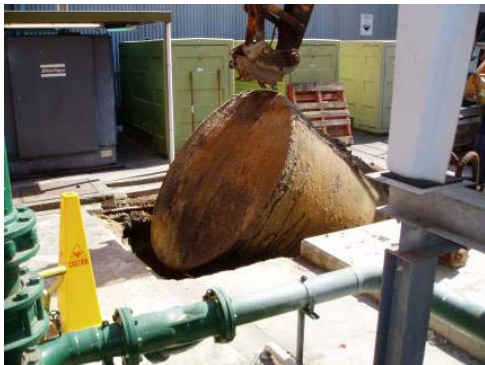
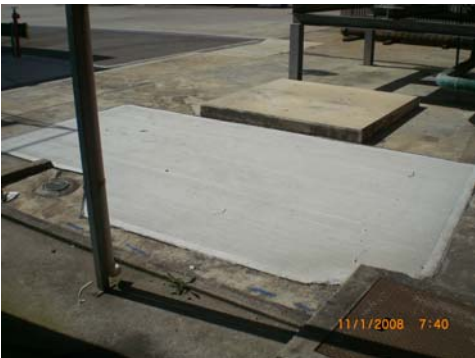
| Observations | June 06 | January 08 |
|---|---|---|
| <p><i>Previously investigated area near BH14, 19 - heavy fuel oil tank removed in late 2006. Validation tested and reported by third party consultant, after ERM issuing of Phase II investigation report. No significant soil impact was reportedly found during tank removal works.</i></p> <p><b>Jan 08</b> – Area has since been tested, validated and concreted over. No new potential contamination sources or impact observed.</p> | | |

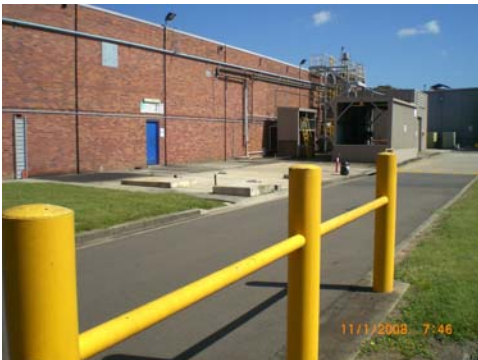
| Observations | June 06 | January 08 |
|---|---|---|
| <p><i>Previously investigated area near BH14, 19 – air handling equipment and washdown bay in background</i></p> <p><b>Jan 08</b> – All air handling equipment has been removed. No new potential contamination sources or impact observed.</p> | | |

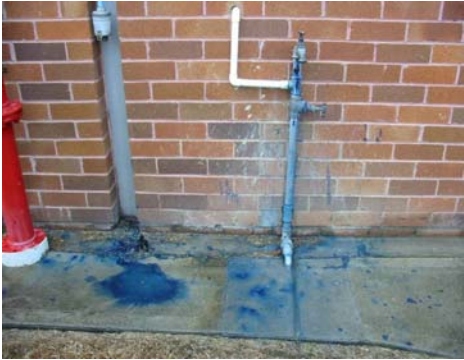
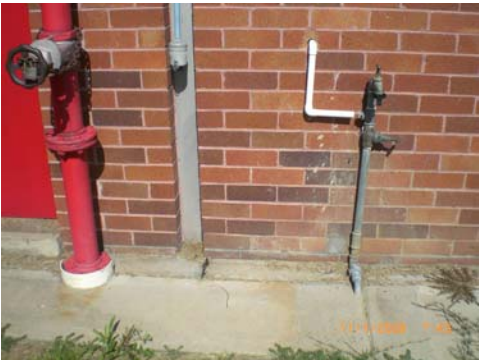
| Observations | June 06 | January 08 |
|---|---|---|
| <p><i>Previously investigated area BH14, 19- nearest – surficial dye staining was noted in 2006.</i></p> <p><b>Jan 08</b> – Localised cleanup of staining has been undertaken. No new potential contamination sources or impact observed.</p> | | |

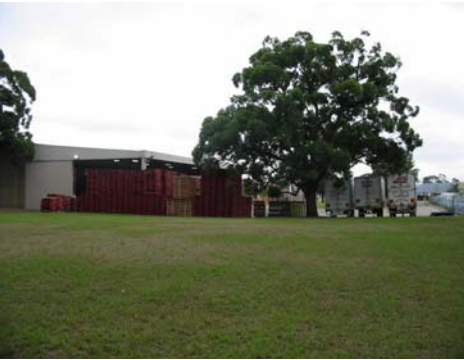
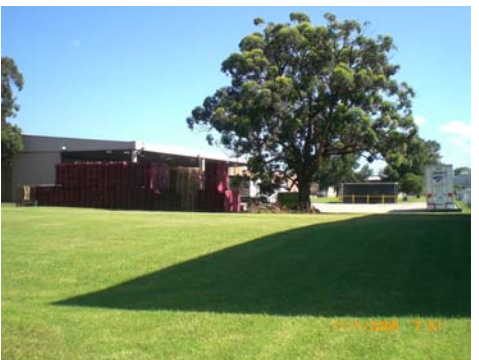
| Observations | June 06 | January 08 |
|---|---|---|
| <p><i>Previously investigated BH9-12, MW01 - former effluent spraying area.</i></p> <p><b>Jan 08</b> – Grass in good condition. No change - no new potential contamination sources or impact observed. MW01 still accessible.</p> | | |

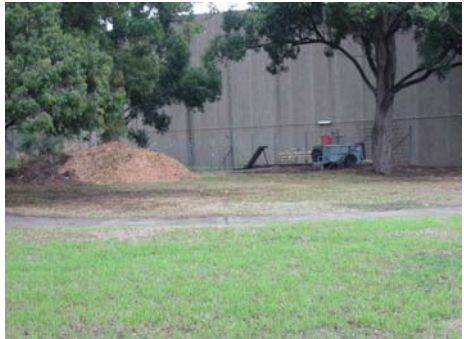
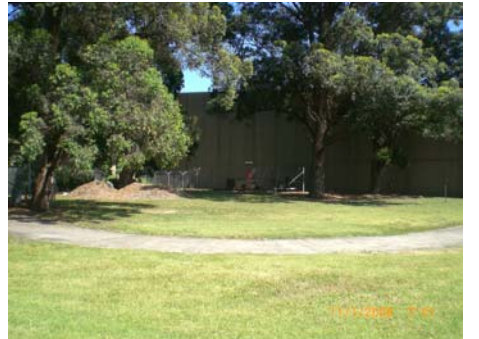
| Observations | June 06 | January 08 |
|---|---|---|
| <p><i>Previously investigated BH9-12, MW01 - former effluent settling tank area.</i></p> <p><b>Jan 08</b> – Grass in good condition. No change - no new potential contamination sources or impact observed. MW01 still accessible.</p> | | |

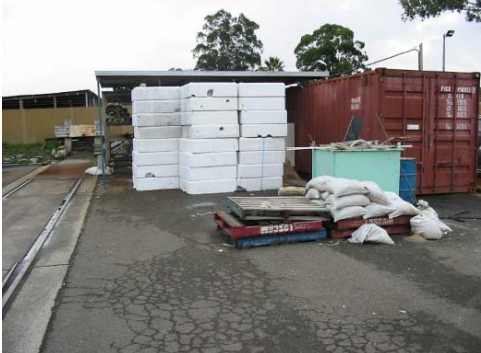
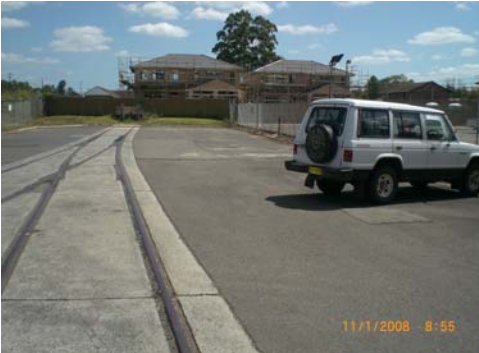
| Observations | June 06 | January 08 |
|---|---|---|
| <p><i>Previously investigated BH16 – former area used by water utility for storage of container during groundworks</i></p> <p><b>Jan 08</b> – All equipment removed, resurfaced. Houses under construction beyond boundary. No new potential contamination sources or impact observed.</p> | | |

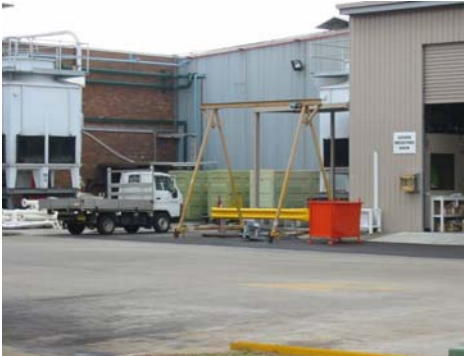
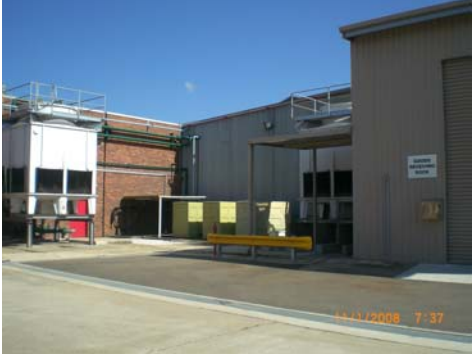
| Observations | June 06 | January 08 |
|---|---|---|
| <p><i>Previously investigated BH14, 19 – nearest – area of former heavy fuel oil UST in corner.</i></p> <p><b>Jan 08</b> – UST has since been removed, also air compressor unit. No new potential contamination sources or impact observed.</p> | | |

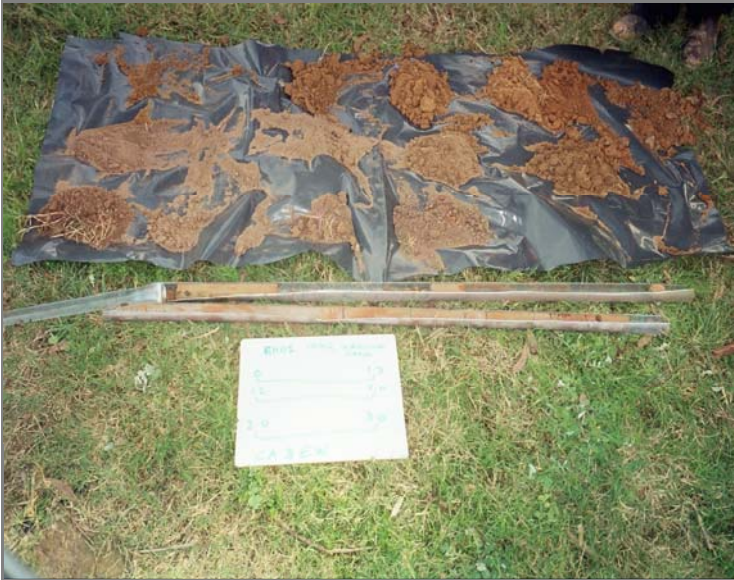
**Photograph 1**

BH01 Arising

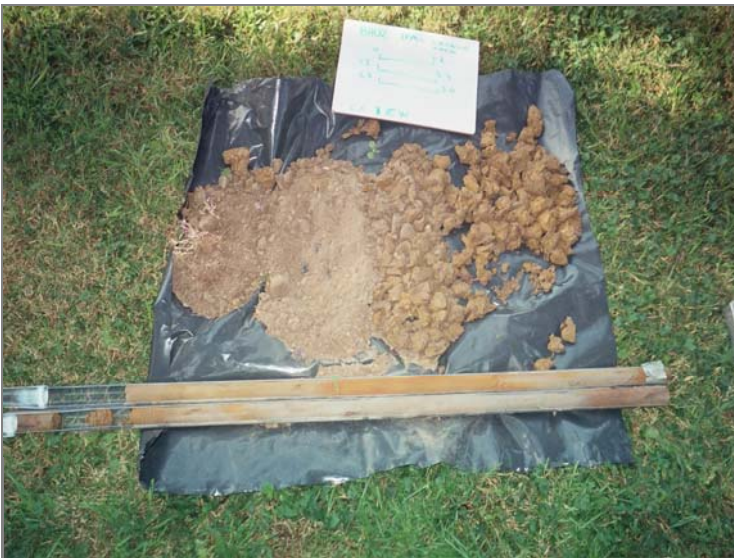
**Photograph 2**

BH02 Arising

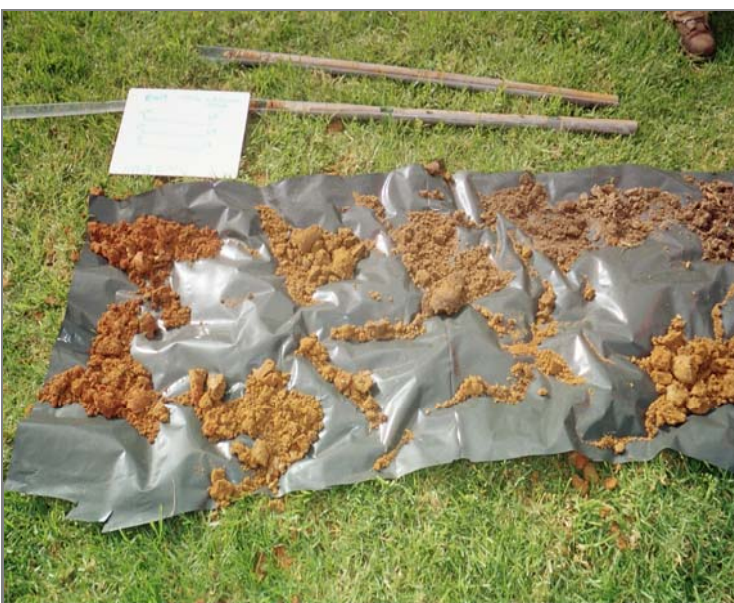
**Photograph 3**

BH03 Arising

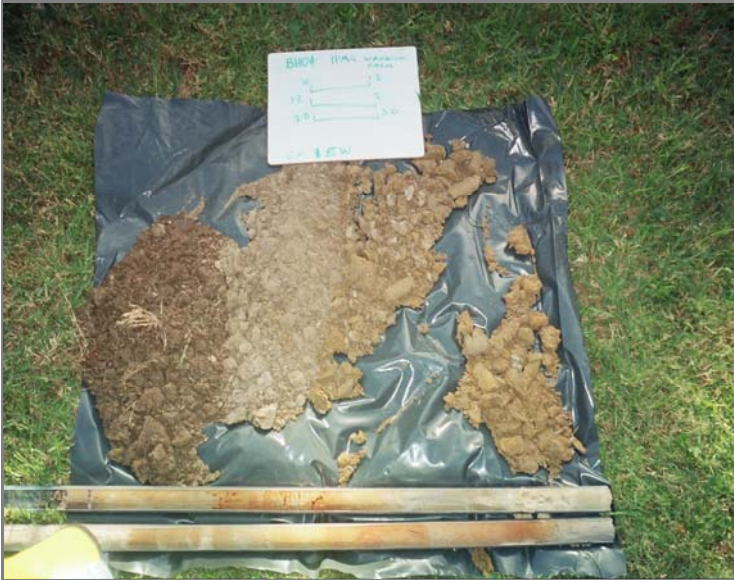
**Photograph 4**

BH04 Arising

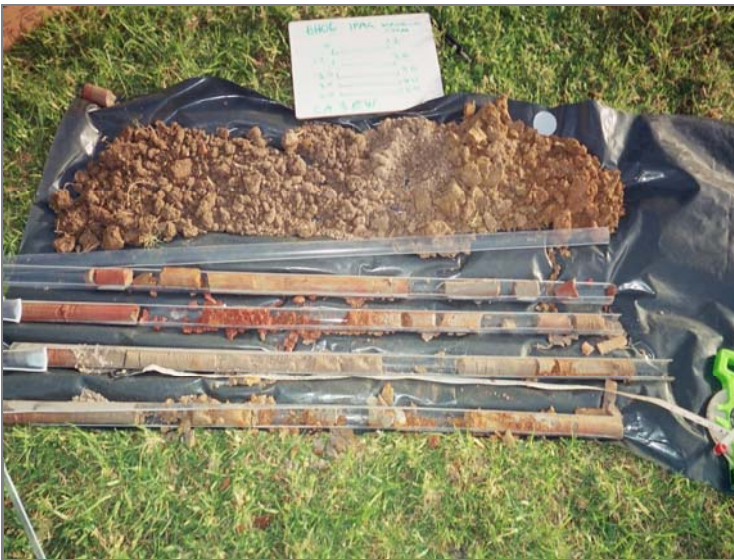
**Photograph 5**

BH06 Arising

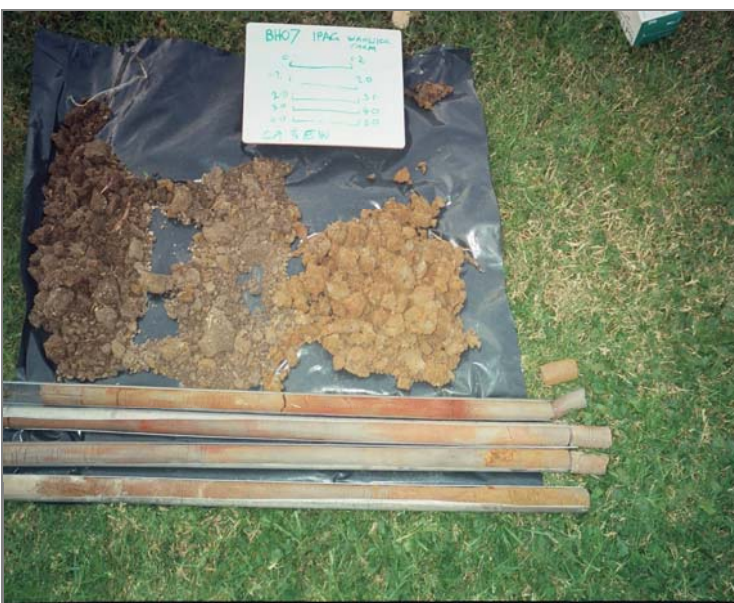
**Photograph 6**

BH07 Arising

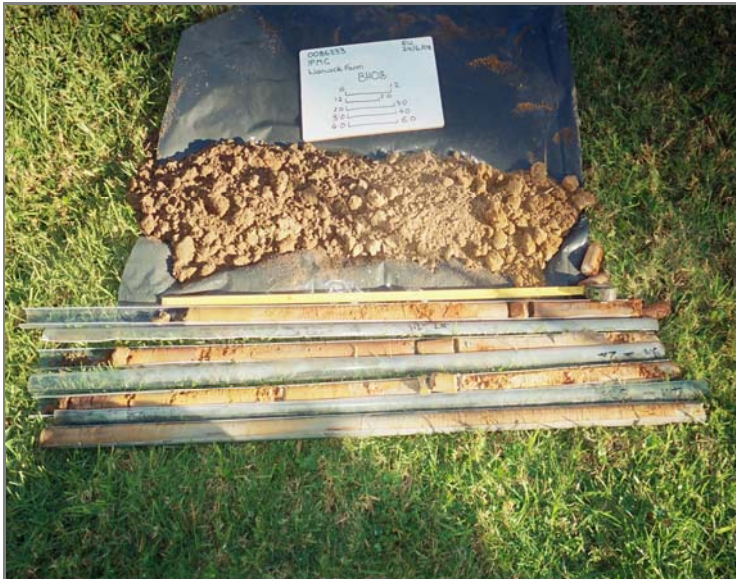
**Photograph 7**

BH08 Arising

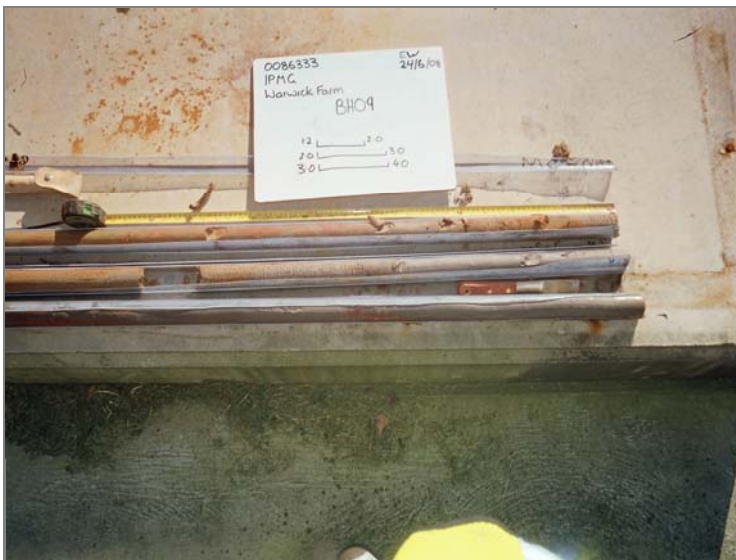
**Photograph 8**

BH09 Arising

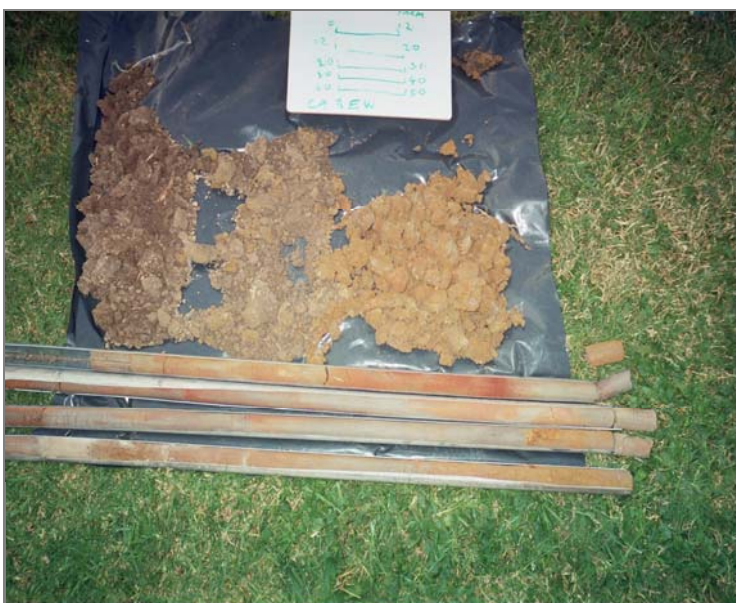
**Photograph 9**

- no hard pans or significant plant root system were noted in any of the boreholes; and
- no consistent groundwater body was encountered in any of the boreholes advanced across the site. A water strike was noted at 2.3m bgl in BH10 though water was not observed to be resting in the borehole. The water strike in BH10 is likely to be associated with perched water in the relatively permeable sand layer from 1.6m to 2.4m bgl.

BH10 Arising

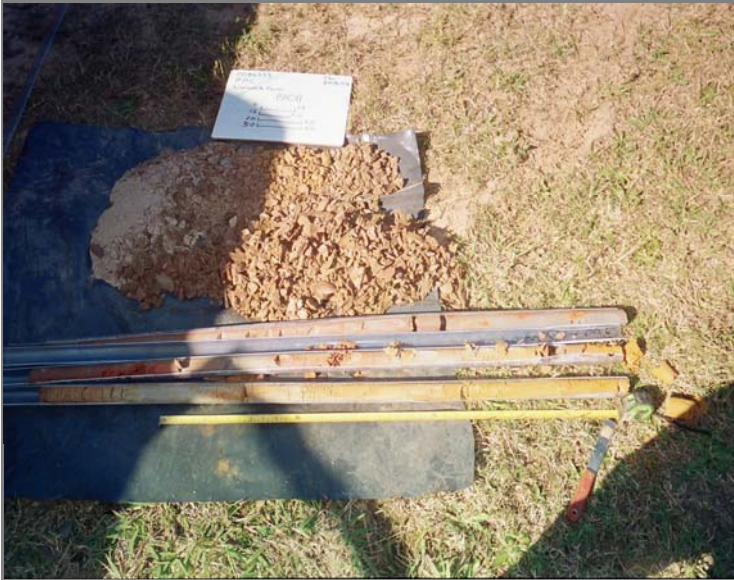
**Photograph 10**

BH011 Arising

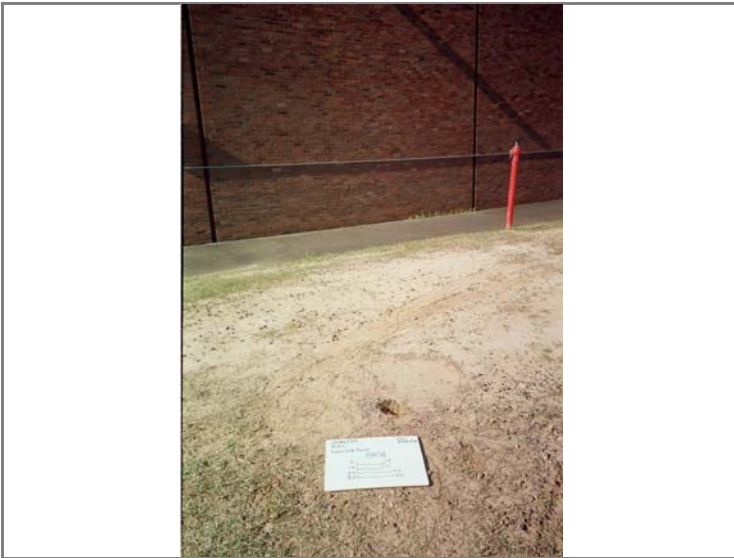
**Photograph 11**

BH011 Location

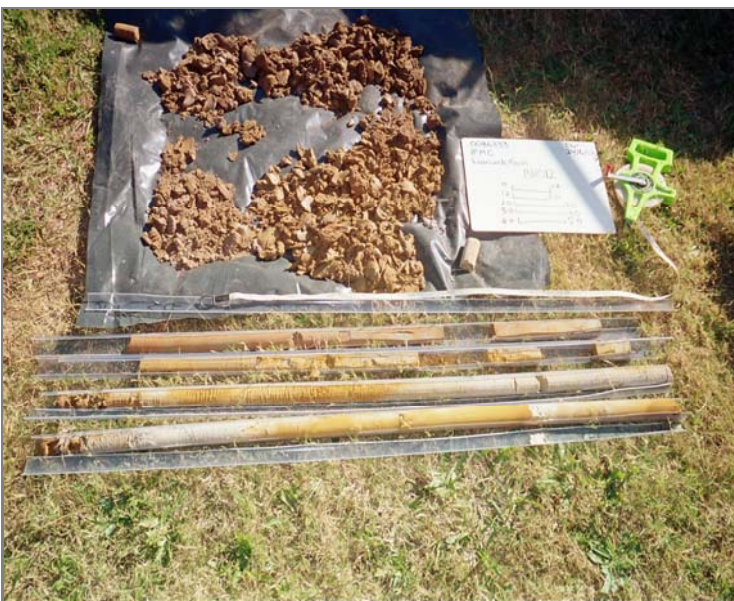
**Photograph 12**

BH12 Arising
