# **Offshore Artificial Reefs Project**

## ***Submerged Cultural Heritage Impact Assessment:***

### ***Desktop Review***

**December 2008**

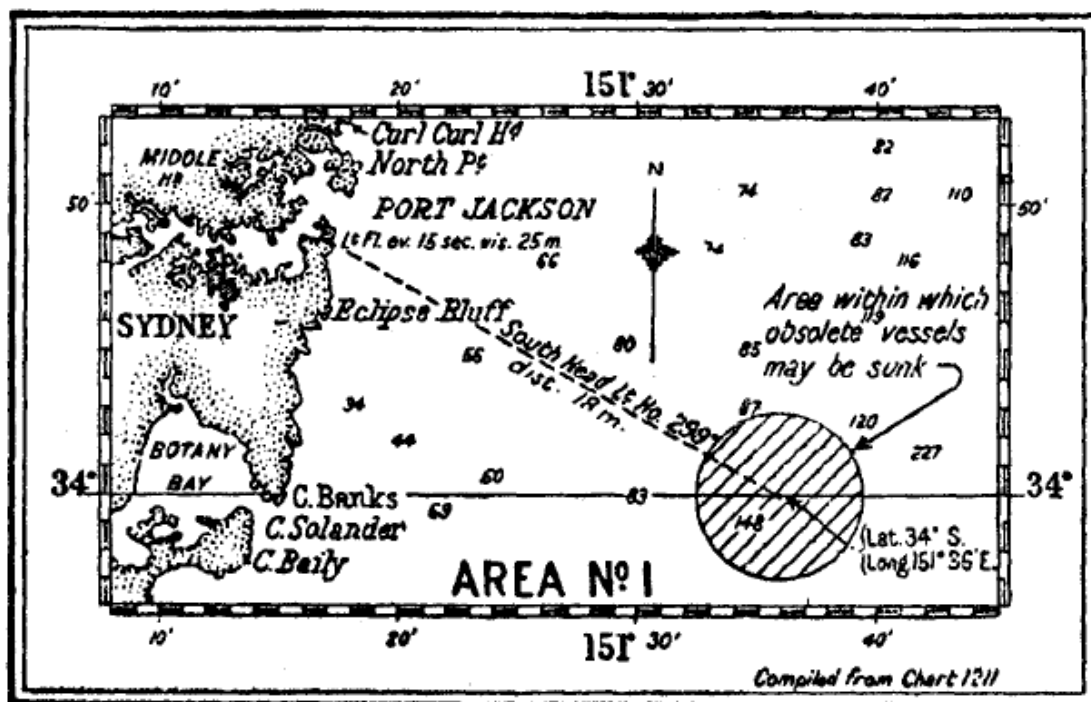
**Figure 1 Sydney Disposal Area** (Source: Department of the Environment <http://www.environment.gov.au/coasts/pollution/dumping/history/pubs/area-1.pdf>)

Outside the 100 fathom line within a circular area 5 miles in diameter with centre in latitude 34° 0' S., longitude 151° 36' E., with South Head Lighthouse bearing 200° distant 18 miles.

To the south east of Sydney is a formal vessel disposal area that has been in use for most of the 20<sup>th</sup> century (Figure 1). Though a considerable distance from the proposed Sydney AR site, vessels being towed to the disposal grounds passed over the area. It is well documented that vessels and other material were deposited outside the designated zone.

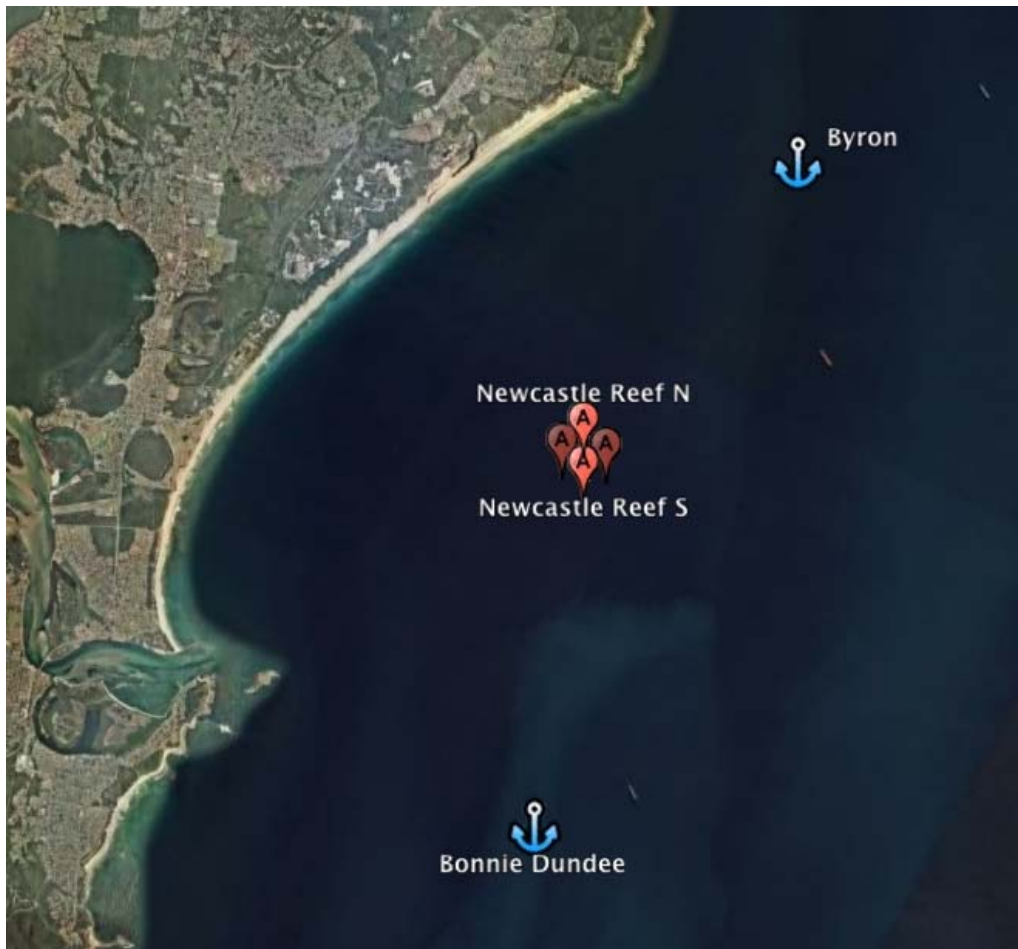
**Figure 2** The wrecks *Bonnie Dundee* and *Byron* in relation to the Newcastle AR location (©2007 Google™)

There are two known shipwreck sites located within 2.5 nm of the Newcastle study area. These are *Bonnie Dundee*, located to the south of the study area, and the *Byron*, located to the north-northeast of the study area (Figure 2 and Table 3). Both of these wrecks are considered to be well outside of the study area for this assessment.

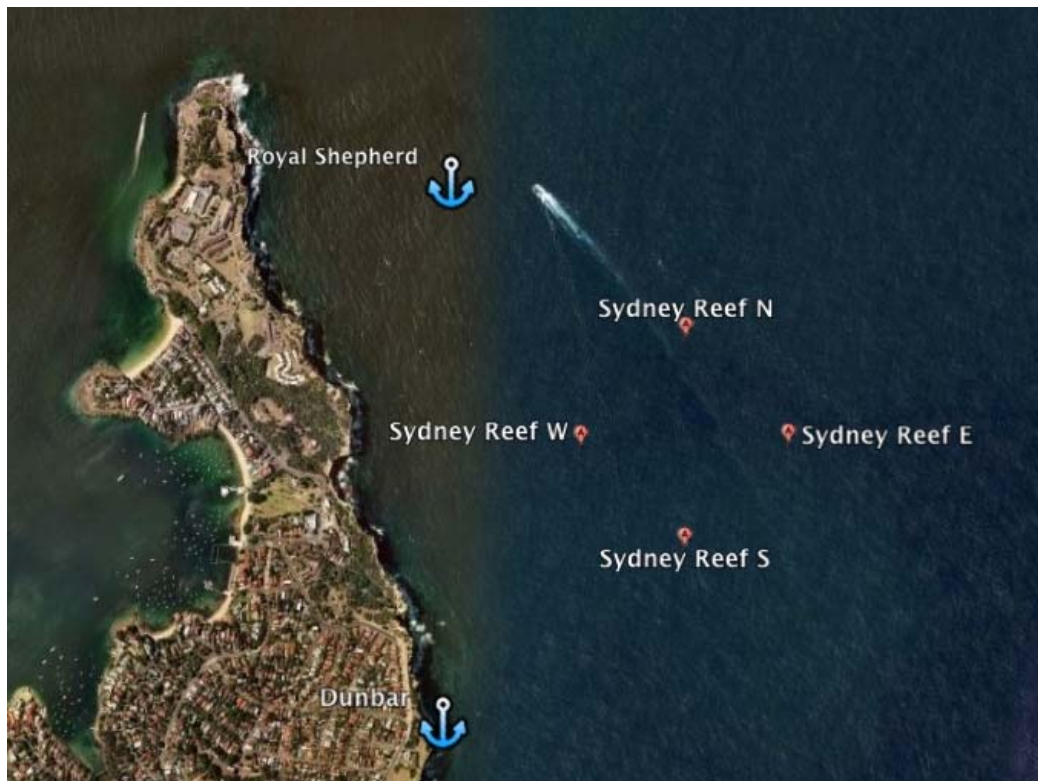
**Figure 3** The wrecks *Dunbar* and *Royal Shepherd* in relation to the Sydney AR location (©2007 Google™)

There are two known shipwrecks located within 0.5 nm of the proposed AR off Sydney. Approximately 0.4 nm WNW from the proposed location of the northern unit is the wreck of the *Royal Shepherd*; and approximately 0.48 nm southeast from the proposed locality of the southern structure is the wreck of the *Dunbar* (Figure 3 and Table 4).

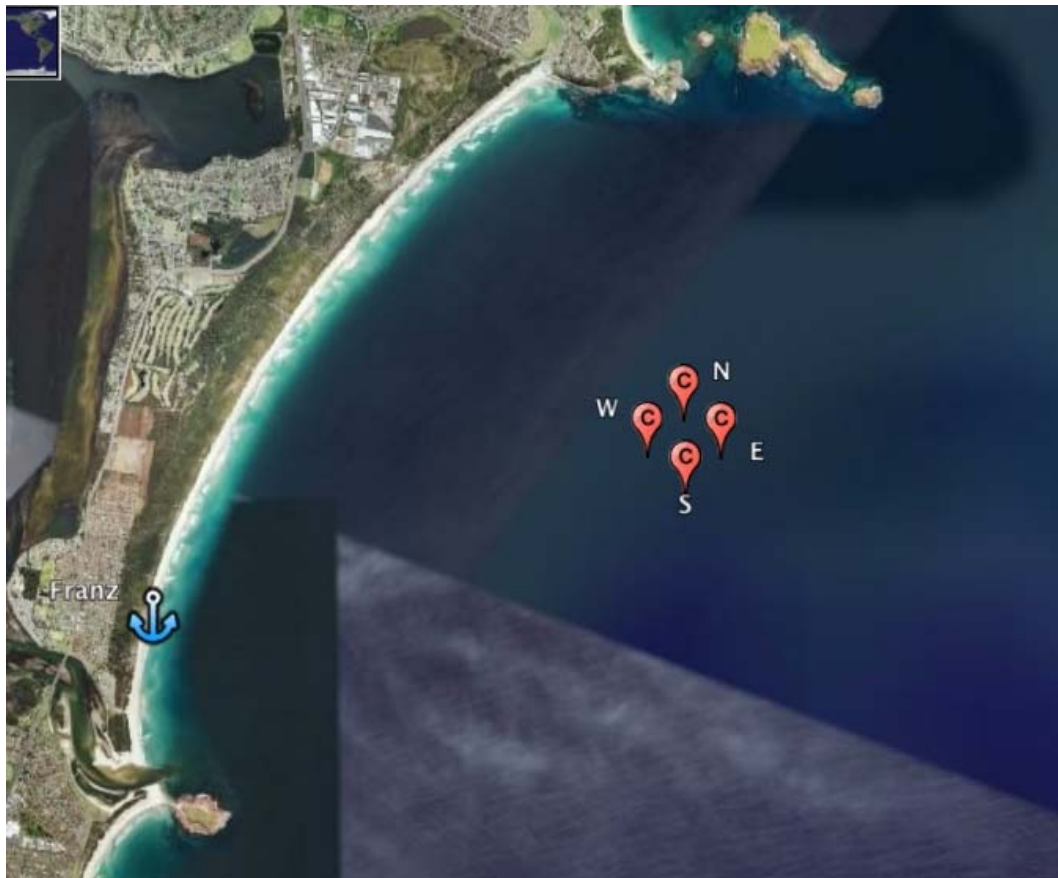
**Figure 4 The wreck Franz in relation to the Wollongong AR location**

There are no identified shipwrecks in the vicinity of the proposed location of the AR south of Wollongong. The closest known shipwreck is the wreck of the *Franz*, a wooden schooner wrecked in a gale at Windang, approximately 2.5 nm southwest from the proposed reef site (Figure 4 and Table 5). The shipwreck site is not considered in this assessment.
