# THE OFFICES OF THE SYDNEY ELECTRIC LIGHTING STATION

## CONSERVATION MANAGEMENT PLAN

19 FEBRUARY 2018  
PREPARED BY

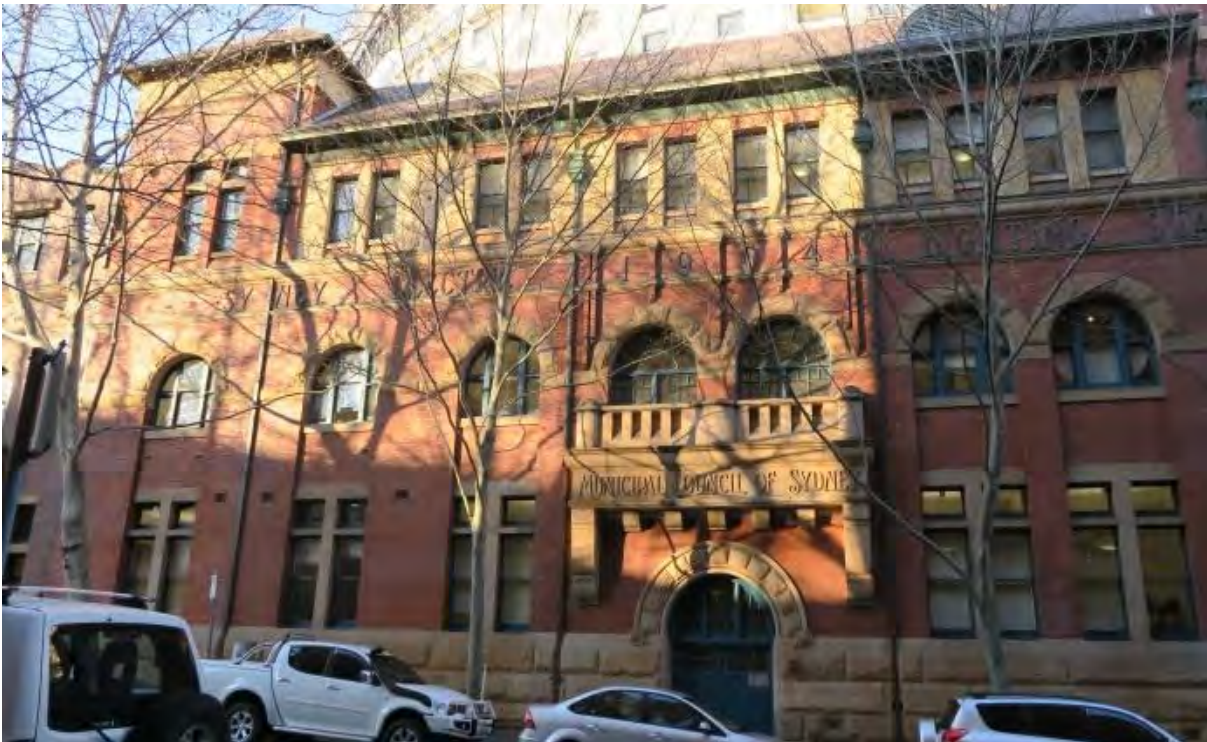
Figure 7 – External images of the primary (Western) Façade.

The masonry facade is primarily face red brick with strong sandstone detailing to the plinth courses, fenestration, cornices and string courses. The robust plinth courses of rusticated stone have smooth and chiselled margins. With the exception of the tower, the top-storey has pebble-dash render between the windows painted in pale yellow ochre to match the stonework below. The windows have expressed brick flat arches.

The main entrance has a prominent rusticated stone archway with a solid half glazed door and fanlight. Above the entrance is a prominent stone balconette with 'Municipal Council of Sydney' carved into the stone in large Art Nouveau lettering. The fenestration to the balconette lights the grand staircase within. This multi-paned glazing to the main entrance and stairwell features stained glass with Australian motifs. Other timber windows are typically paired and vertically proportioned within the facade. The second floor (Level 01) has arched windows with rusticated stone architraves. Most windows are double hung with single pane sashes.

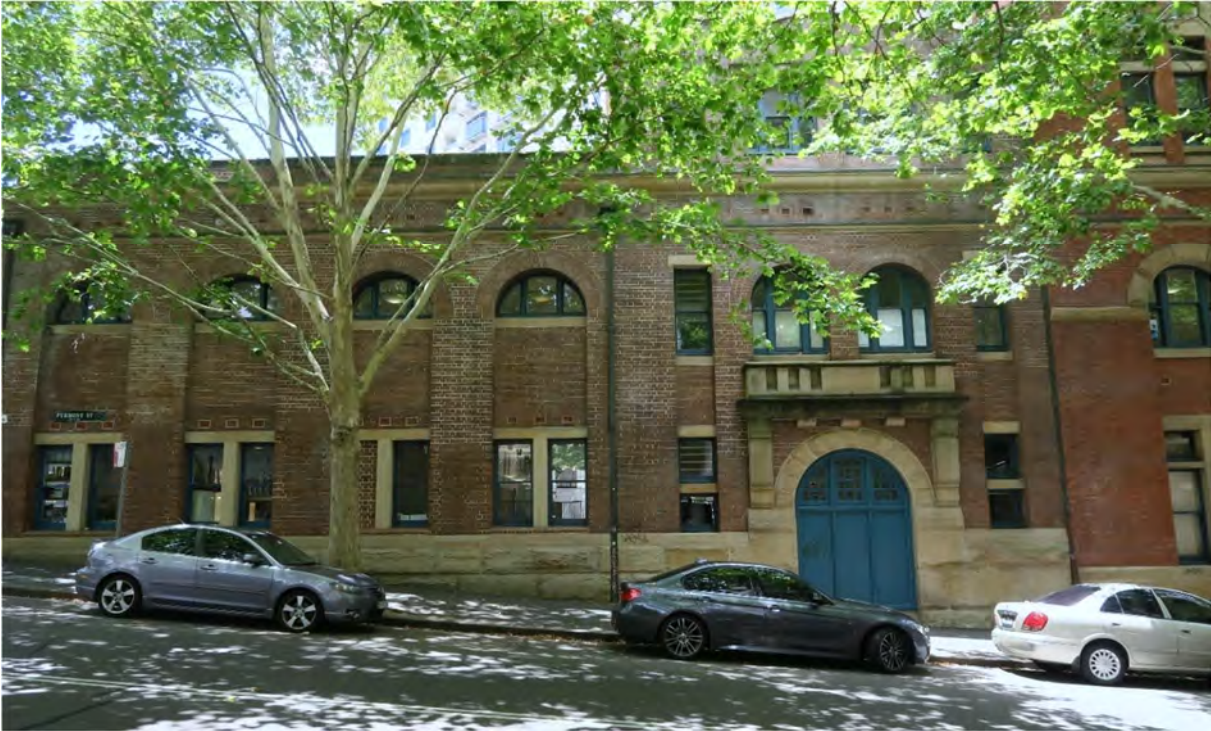
Picture 11 – Western principal façade of the SELS building (1904 portion).

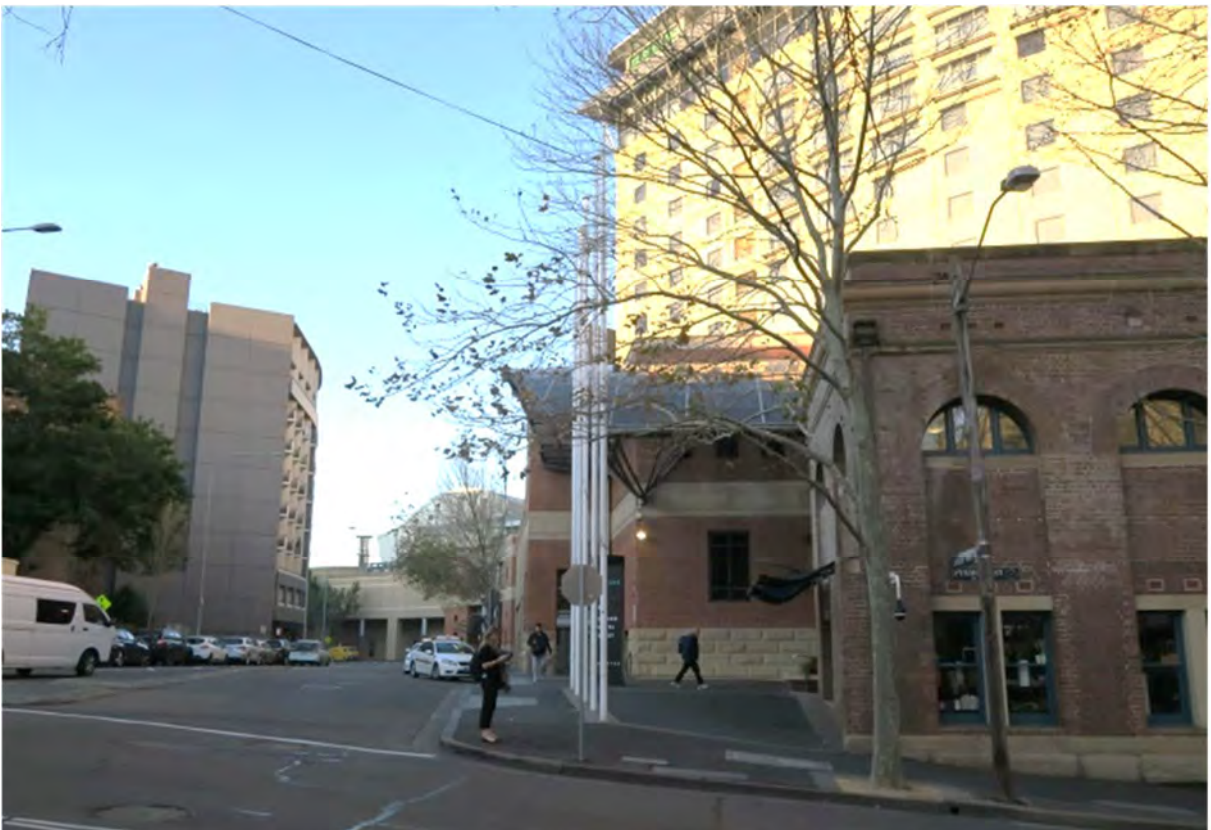
Picture 12 ĩ Western principal façade of the SELS building (1922 portion).

The mainly two-storey c1922 wing to the north is of a more restrained Federation character appropriate to an industrial building. The face brickwork is a softer brown colour typical of the Federation period with more expressed cream mortar joints. It has a masonry roof parapet and continues the sandstone plinth courses and dominant curved sandstone cornice of the 1908 building. On Pyrmont Street there is secondary entrance which mimics the 1904 main administration entry to the south with rusticated stone archway, stone balconette and a doorway with a multipaned fanlight. The paired ground floor windows have stone heads and mullions. The second-floor windows are high level arched windows with a tripartite timber sash arrangement. Terracotta wall vents have been inserted into the facade at first floor level.

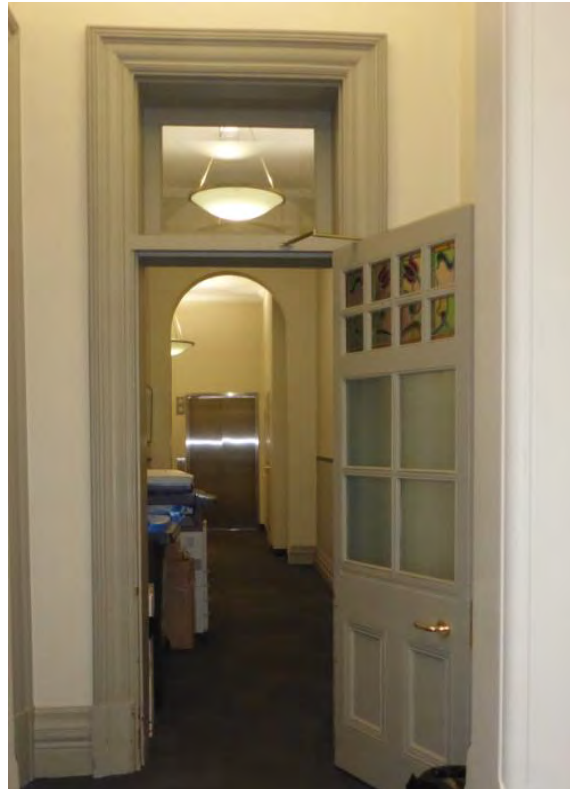
Picture 79 ĩ Typical glazed doorset with stained glass (1904).

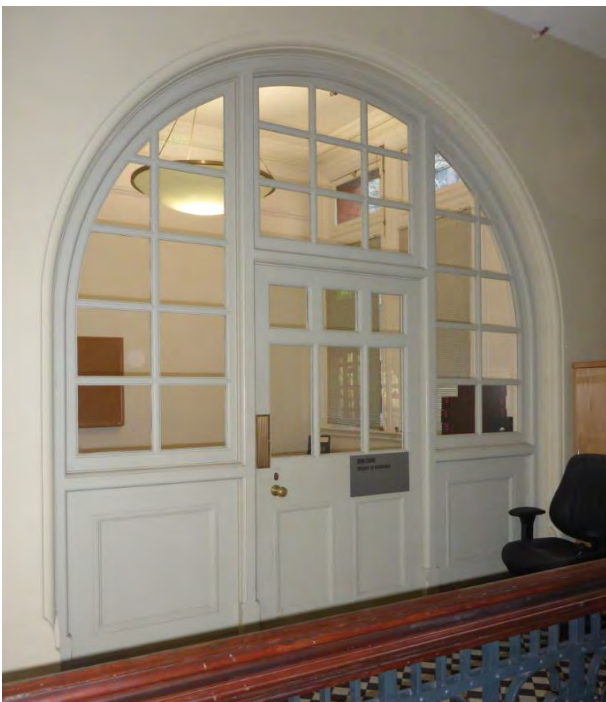
Picture 80 ĩ Door with half glazing and some leadlight to Corridor Level 00 (Ground) leading north from main stairwell.

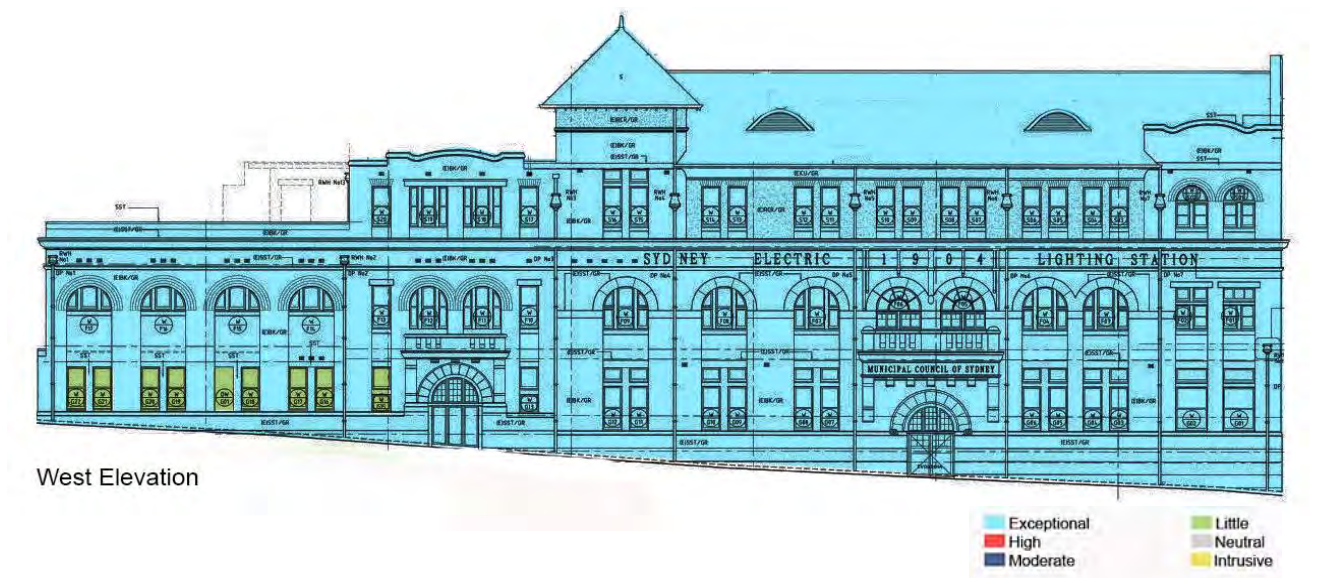
Figure 62 ĩ West Elevation (to Pyrmont Street).

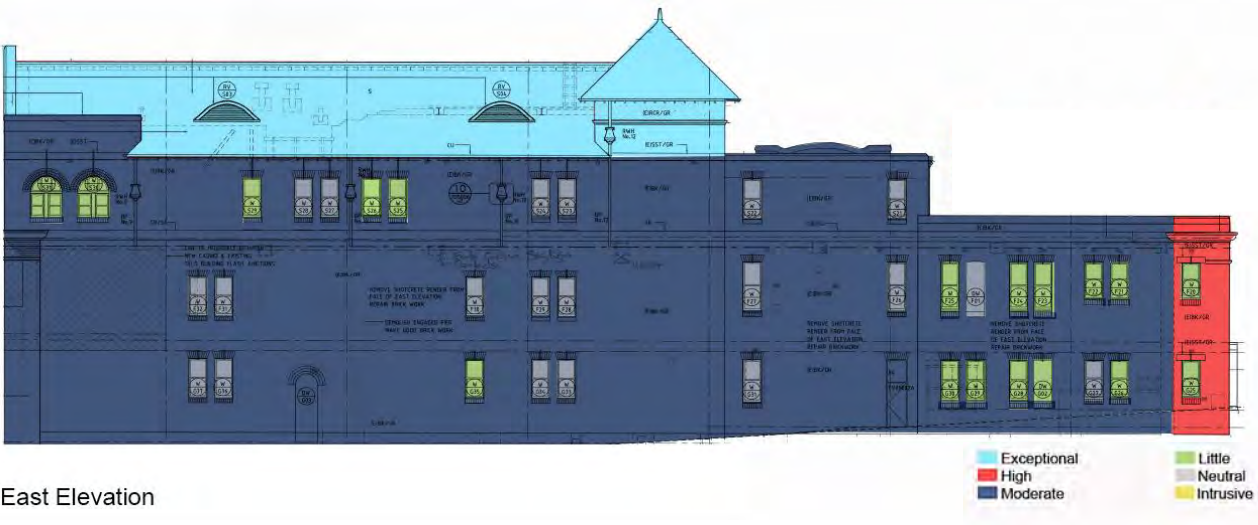
Figure 63 i East Elevation.

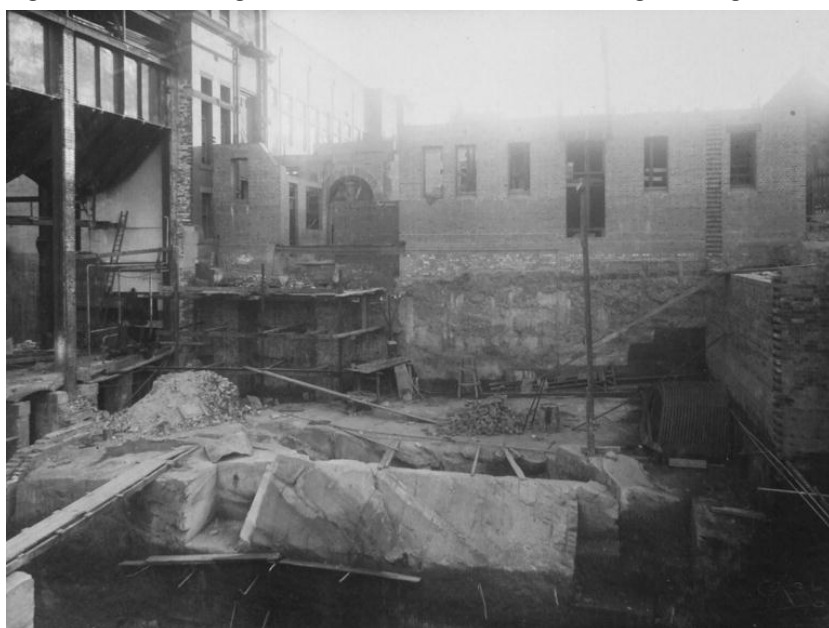
Figure 66 - c1903 Original Southern elevation of the building showing the abutting building to the rear (east).

The 1920 portion of the building is shown in historical images to sit immediately above sandstone bedrock, albeit with an apparently brick foundation. This means that there is very little potential for structural remains or occupational deposits associated with the former residential/commercial structure shown in the 1888 map (Figure 33) to have been retained on site beneath the 1920s building.

It is also noted that the construction of the Boiler House is shown in these same photos to have resulted in excavated into sandstone bedrock to a substantially greater depth than under the 1920s SELS building. This is highly likely to have removed evidence of deeper sub-surface features such as service lines, wells or cesspits, formerly located to the rear of the residential/commercial property.
