## **ABORIGINAL AND HISTORIC HERITAGE IMPACT ASSESSMENT**

### **LONGWALL EXTENSION MODIFICATION**

INTEGRA UNDERGROUND MINE

NOVEMBER 2017

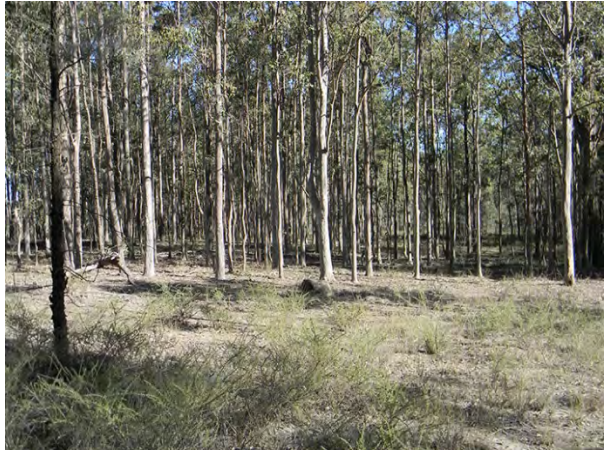
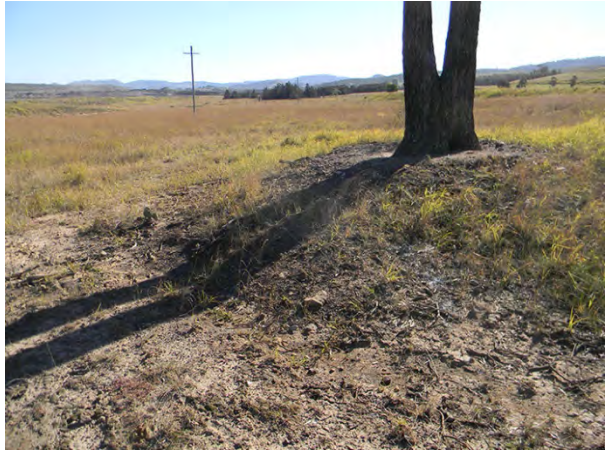
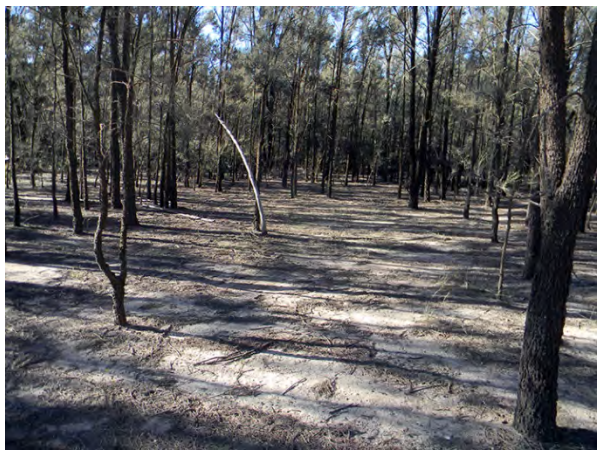
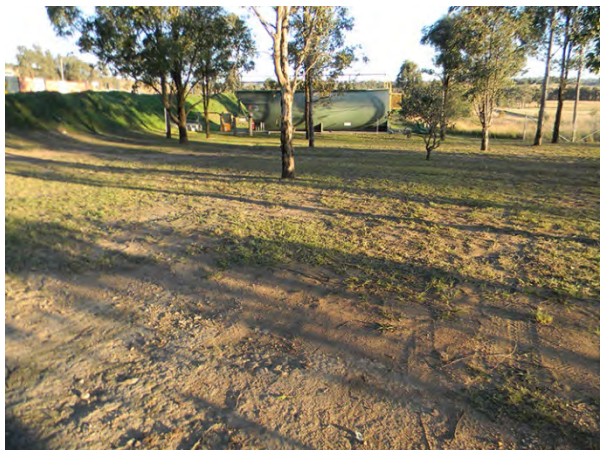
**Figure 1-6: Landforms within the Assessment Boundary.**

| <p>1. View of regenerating woodland in the east of the Underground Extraction Area within the Assessment Boundary.</p> | <p>2. View of modified landforms within the Mount Owen Rail Loop overlying the Underground Extraction Area within the Assessment Boundary.</p> |
| <p>1. View of regenerating woodland within the powerline corridor portion of the Assessment Boundary.</p> | <p>2. View of modified landforms surrounding the surface infrastructure amendments portion of the Assessment Boundary.</p> |
