# Austar Coal Mine Annual Review

July 2024 – June 2025

## ANNUAL REVIEW 2025

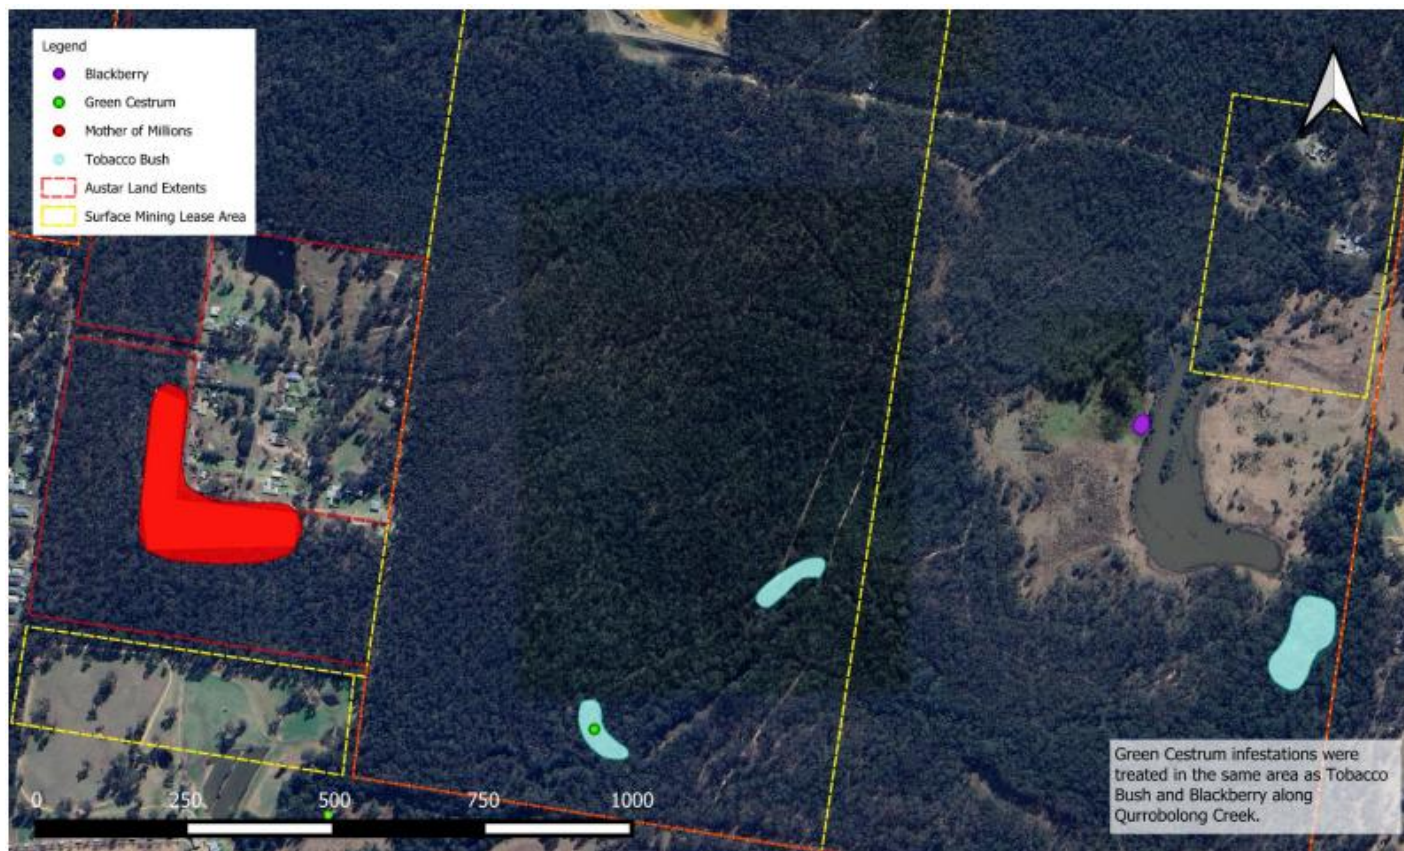
**FIGURE 6-8 KALINGO AND 3 SHAFT WEED TREATMENT (SOURCE: AUSTAR WEED WORKS COMPLETED JULY 2024 TO JUNE 2025)**
