Environmental Site Assessment – Stage 1 Investigation

## 7-9 Gibbons Street, Redfern NSW

24 August 2009

# **Stage 1 ESA - Gibbons Street, Redfern NSW**

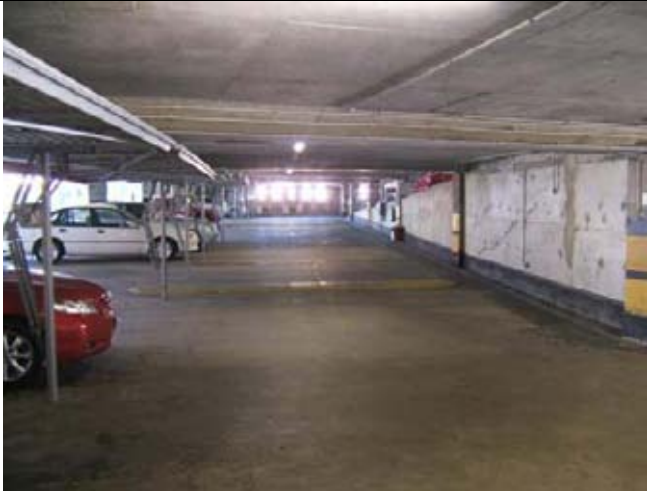
The car park surfaces, entirely concrete sealed, were observed in good conditions.

**Plate 1:** The car park area, above the secured premises.

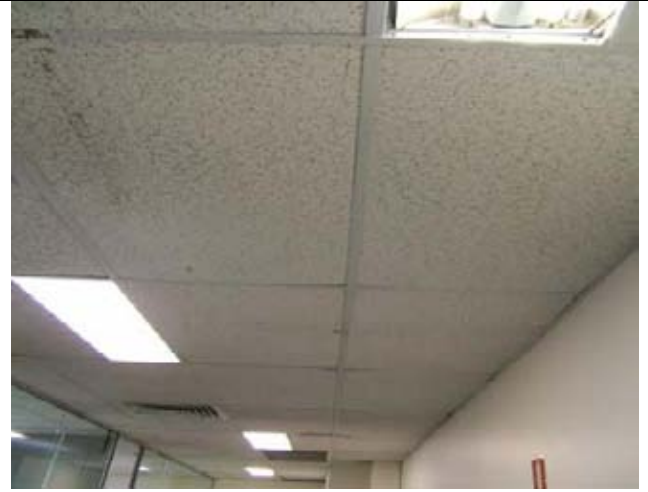
- Asbestos containing mustard-coloured brittle vinyl floor tiles were identified throughout the Armaguard depot (currently occupied by Travelex);
- Compressed SMF ceiling tiles were found at the Travelex area;
- PBC-containing capacitors were present in the single-tube fluorescent lights located throughout the Armaguard depot. Old style PBC-era, single tube fluorescent light fittings were identified in the TNT car park. These lights are likely to contain PBC but were not examined due to live power supply.

**Plate 2:** Ceiling panels in the office area at the Travelex site (secured facility).

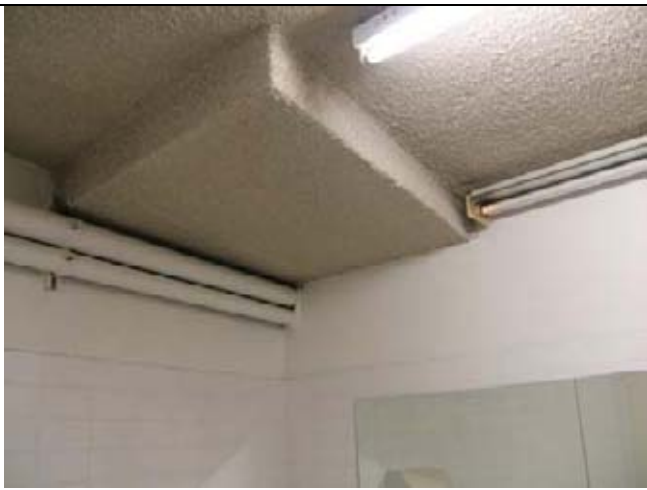
**Plate 3:** Sprayed fibro material in the toilet facility. The same material was noticed in several areas of the Travelex premises

8. If contamination is encountered, and following appropriate remediation, the site will be suitable for the proposed development; and
9. Hazardous material (hazmat) contained within the current structures would have to be managed adequately not to pose unacceptable risks to workers and the public during demolition.

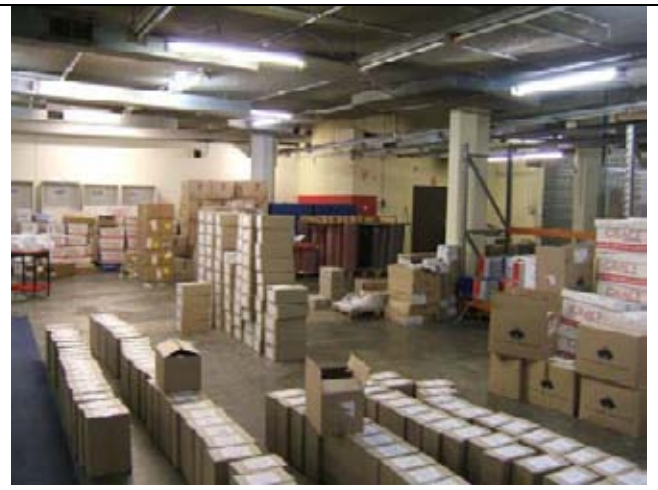
The basement is occupied by "Travelex", a money exchange company. It comprises a secured access walkway, several rooms for office use, various storage areas for paper and cardboard material, a kitchen and toilet facilities. The facility is entirely with concrete floors in good condition. The office rooms are paved with carpet and brittle vinyl floor tiles of mustard colour were noticed in several areas. The ceilings in the basement level are lined with sprayed fibro material showing signs of moisture staining and damaging in some corners. The lighting at the site is provided by single tube fluorescent lights, with non screwed ends and plastic cover casing.

**Plate 4:** The Travelex storage area. Fluorescent lights were used throughout the site.

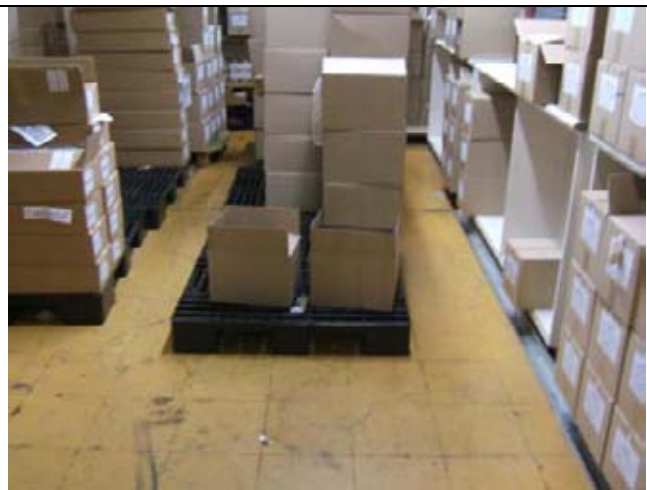
**Plate 5:** One of Travelex's storage room, paved with brittle vinyl floor tiles.

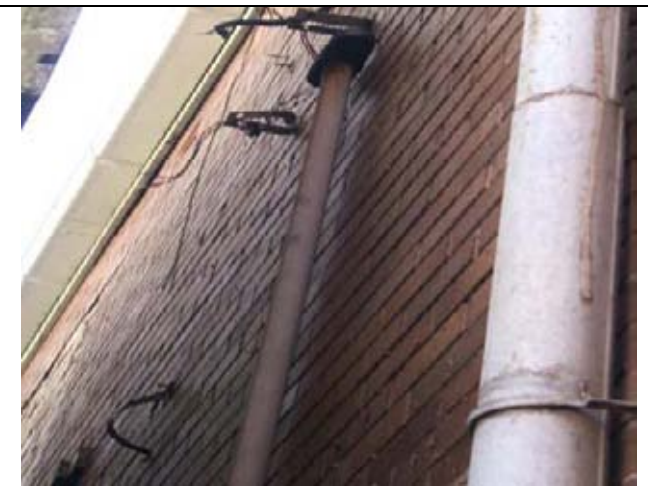
| Potential AECs | Potentially contaminating activity | CoC | Observations |
|---|---|---|---|
| Entire site (Up-gradient Section) | Contaminant migration from RSL UST | Metals, PAHs, TPH, BTEX | Contamination associated with the presence of a disused UST was found in the soil of the dwelling adjacent to the north boundary of the site. The site appears to be up-gradient from the study area and contaminants may have migrated on site and affected soil and groundwater. |

**Plate 6:** Vent pipe observed on the wall of the RSL site, adjacent to the north boundary of the study area. The pipe is presumably associated with the disused UST in the cellar of the RSL site.

1. Site investigations be conducted during the following stages of the development process to chemically characterise site conditions, and if required, determine suitable management procedures. The investigations should initially focus on potential contamination associated with the off-site UST, on-site UST, and potential fill. Following demolition, further testing may be required to characterise any shallow sub-slab fill and for waste classification purposes to determine off-site disposal options;
2. The site be considered suitable for the proposed development, under the assumption that some contamination management will be required, and subject to findings from future soil sampling and testing; and
3. The conclusions and recommendations are not considered without considering the remainder of the report.
