**PREPARED FOR  
KENMAR FARMS PTY LTD**

**ACID SULFATE SOIL ASSESSMENT**

LOT 4 in DP 876253  
WILLOW AVENUE, BOGANGAR

*Ref: BT 19135-A(2)*

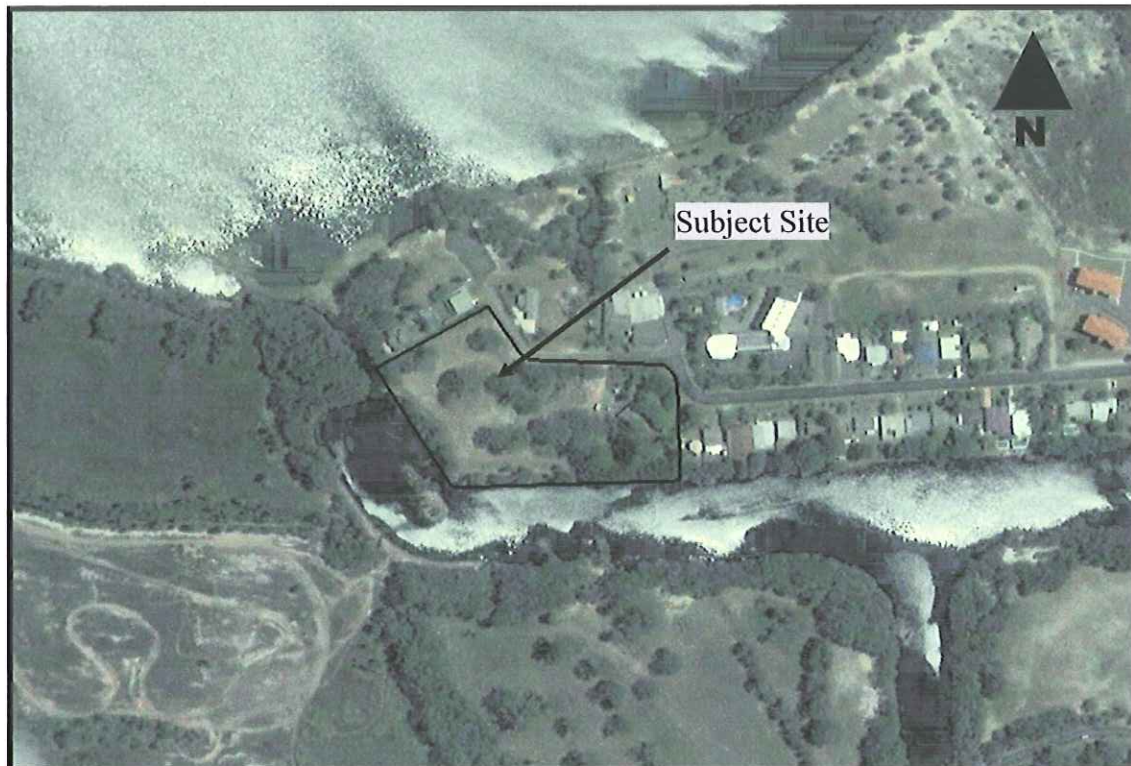
**Figure 1 – Approximate Location of Subject Site**

The subject site has an approximate area of 8400 m<sup>2</sup> located within Lot 4 DP 876253. The site has frontage to Willow Avenue Bogangar, with an existing drainage channel located at the rear of the block. Residential house blocks border the site along the eastern and north-western boundaries.

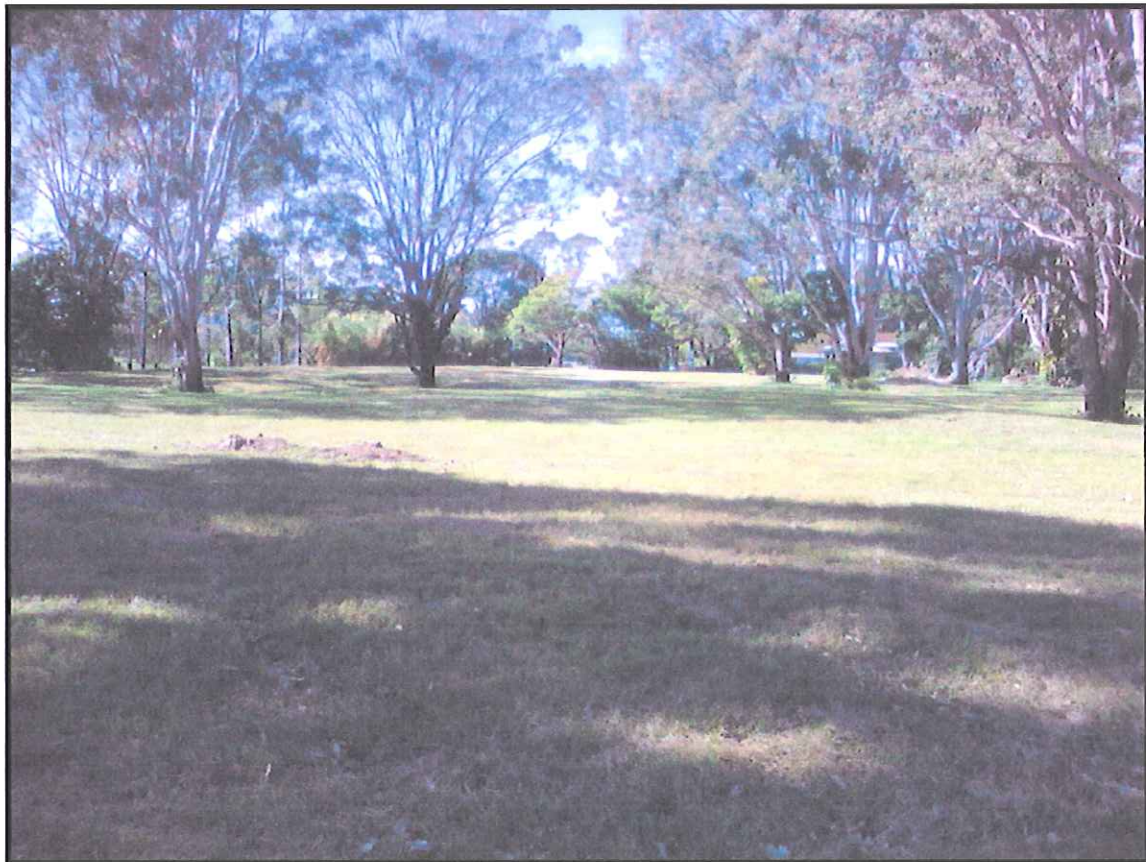
At the time of the site investigation the block was vegetated by mown grass and scattered large eucalypt trees. Site photos are presented as Figures 2 and 3 below.

*Figure 2 – View of Subject Site Looking East*

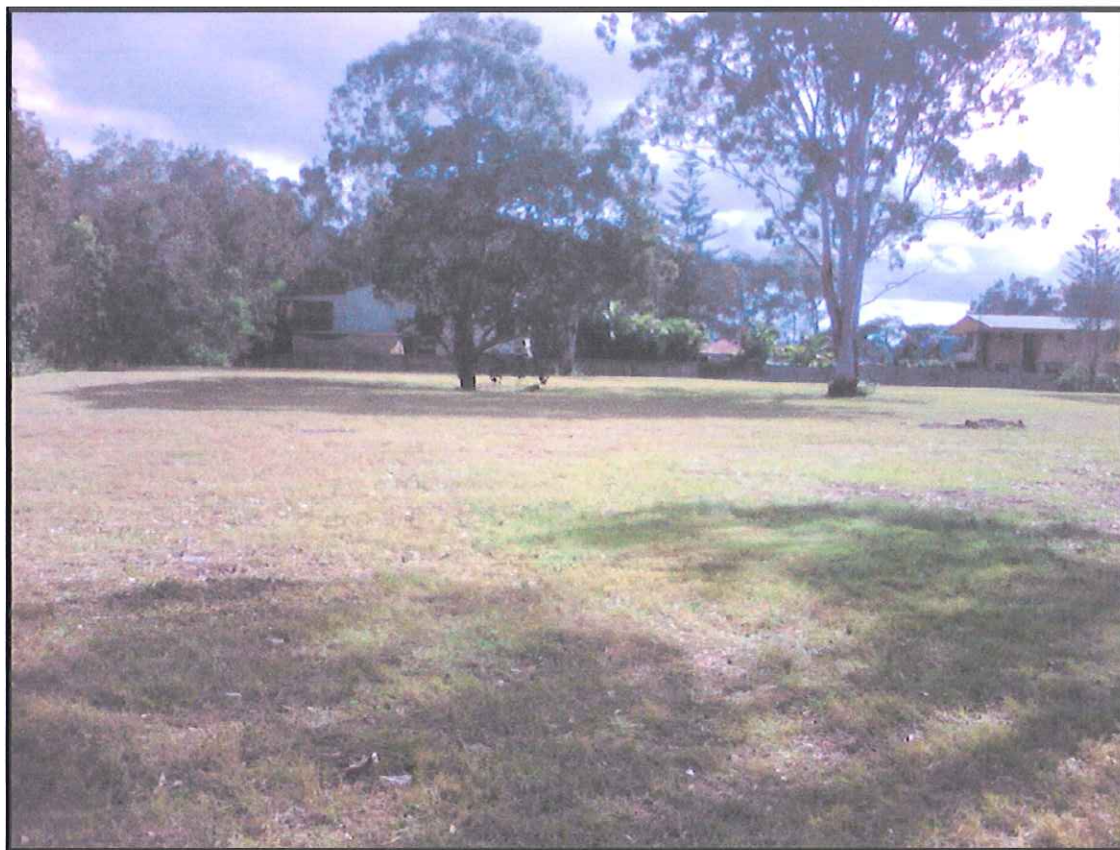
**Figure 3 – View of Subject Site Looking North**

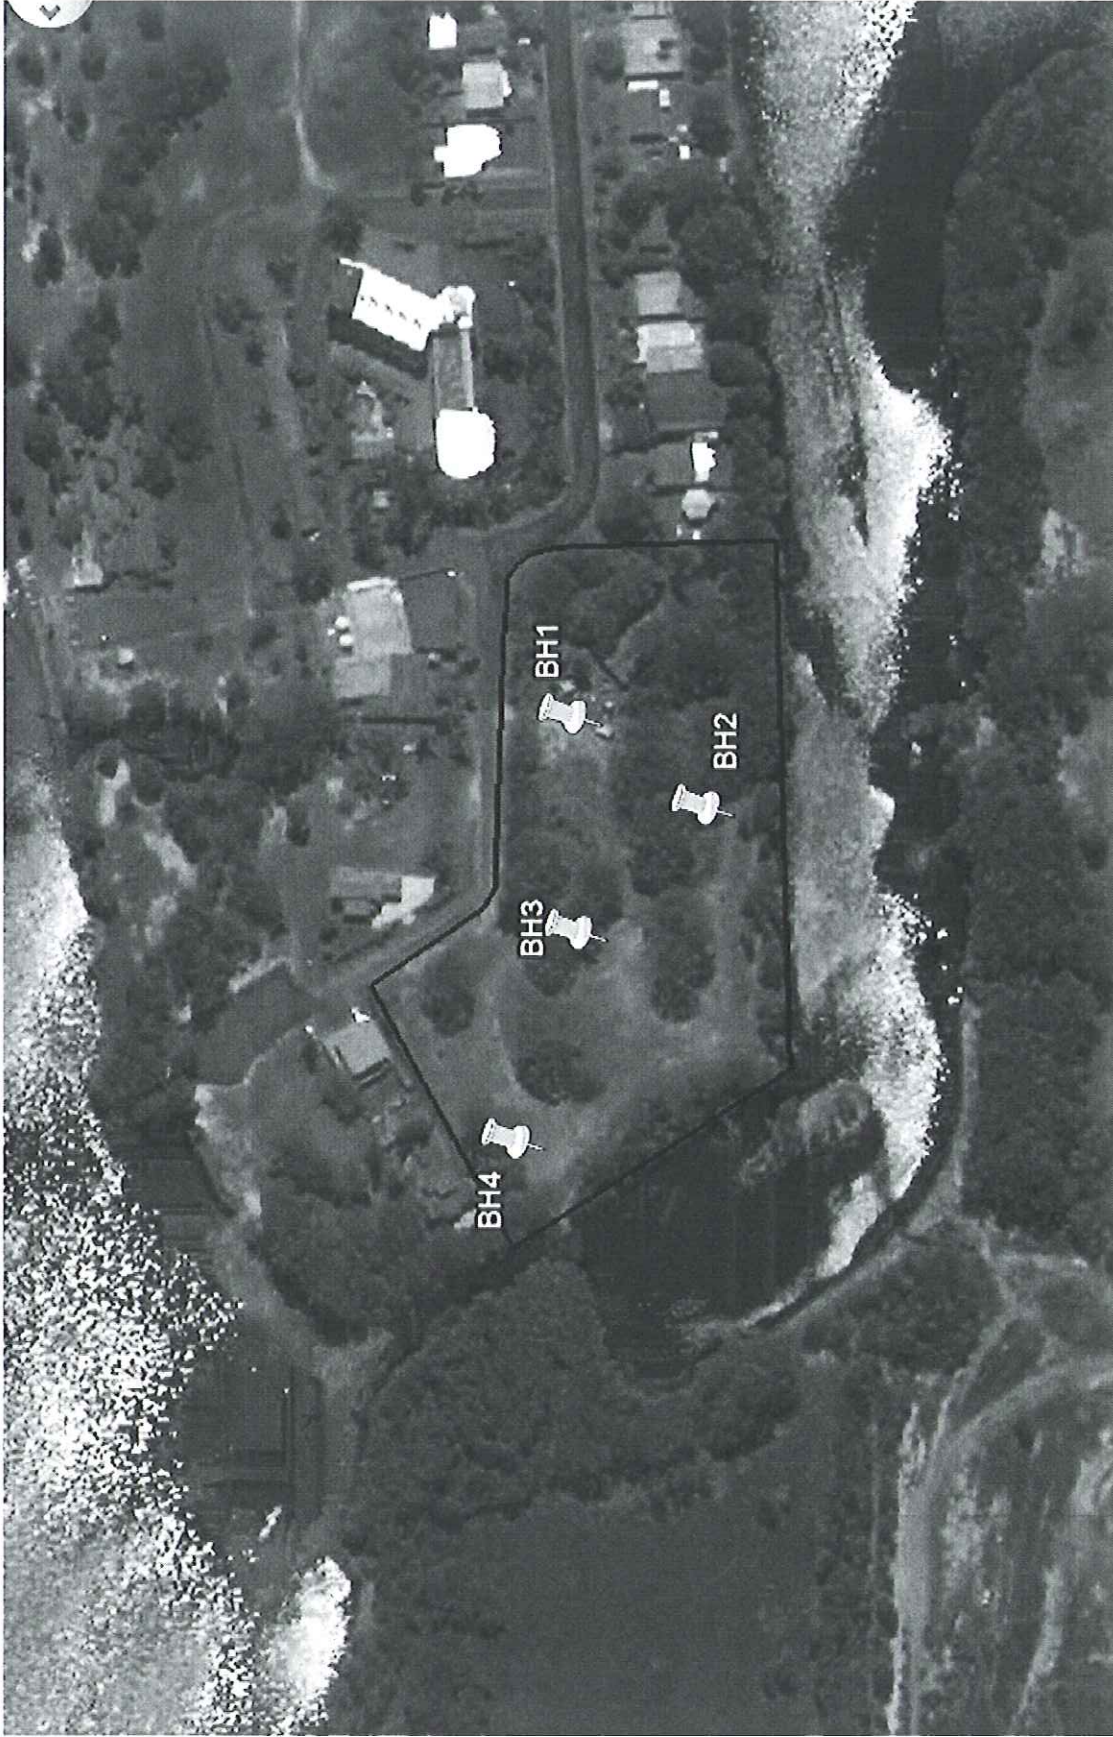
**SITE PLAN**

Border-Tech has received a consultant brief and preliminary conceptual drawings indicating the type of development proposed for the site. From this information it is understood that the project involves the creation of a 13 lot subdivision with residential lot sizes ranging from  $569 \text{ m}^2$  –  $1065 \text{ m}^2$  and a residue lot (Lot 13) of 11.37 hectares. The subject site (*see Figure 1 above*) is proposed to be divided into the 12 residential lots and has an area of approximately  $8400 \text{ m}^2$ . A site map showing the proposed layout is displayed in Appendix 1.

## PLAN OF PROPOSED SUBDIVISION

Of Lot 4 in DP876253
