Aboriginal Cultural Heritage Assessment Report
Moolarben Coal Complex UG2 Modification, Ulan NSW
Mid-Western Regional Council Local Government Area
Prepared for Moolarben Coal Operations Pty Ltd

Prepared by Niche Environment and Heritage Pty Ltd | 19 November 2021

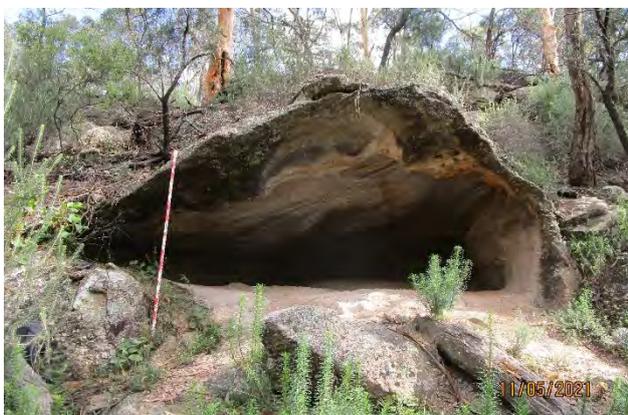
S2MC439 (AHIMS ID#36-3-3808), a rock shelter with PAD, was recorded on the upper slope of the ridge within the UG2 Approved Mining Area, approximately 140 m east-south east of S2MC438. The rock shelter interior has a sandy deposit approximately greater than 50 cm along the dripline and while no stone artefacts were identified, the rock shelter outlook, proximity to a potential stone resource and other stone artefact sites and depth of the deposit increases the likelihood of subsurface stone artefacts being present. The integrity of the deposit was affected by rabbit burrowing.

Plate 16: S2MC439 (AHIMS ID#36-3-3808), Rock Shelter with PAD, facing north-east.

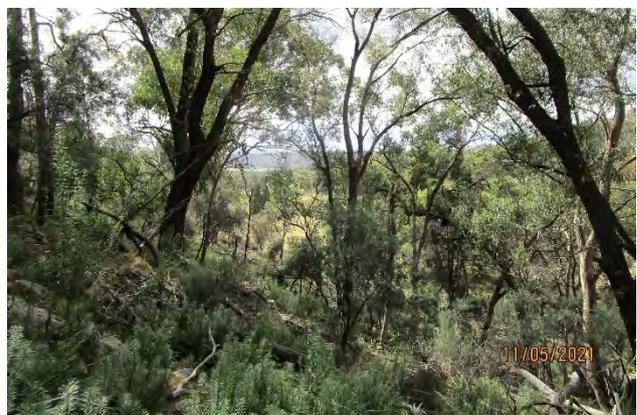
Plate 17: S2MC439 (AHIMS ID#36-3-3808), Rock Shelter with PAD, facing south.

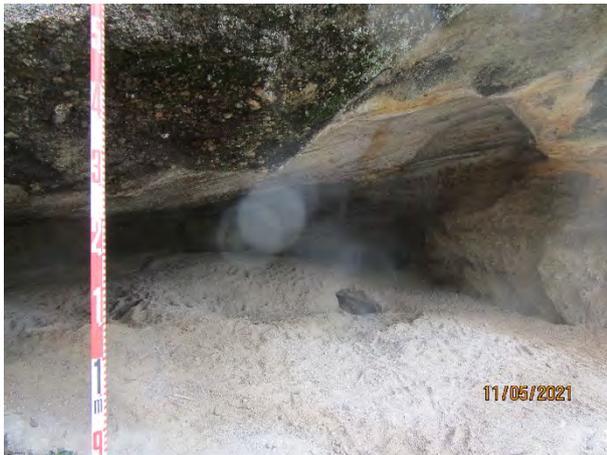
Plate 18: S2MC439 (AHIMS ID#36-3-3808), Rock Shelter with PAD, facing south.

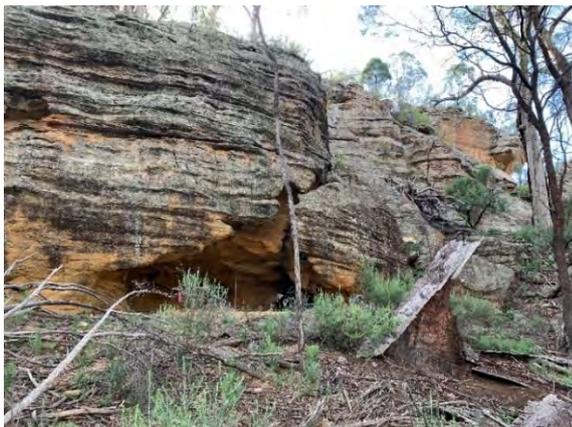
S2MC440 (AHIMS ID#36-3-3809), a rock shelter with Artefacts and PAD, located midslope along a continuous sandstone ridge within the UG2 Approved Mining Area, looking south-west across a gully. Vegetation at the front of the rock shelter is burnt. The rock shelter interior large habitable floor space and has a sandy deposit at least 30 cm deep in parts. Two stone artefacts were located within the drip line and interior of the rock shelter. The integrity of part of the deposit was impacted by wombat burrowing.

Plate 19: S2MC440 (AHIMS ID#36-3-3809), Rock Shelter with Artefact and PADs, general location, facing north-east.

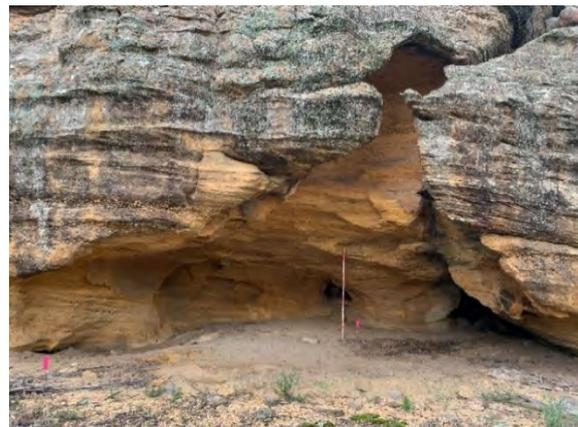
Plate 20: S2MC440 (AHIMS ID#36-3-3809), Rock Shelter with Artefact and PAD, facing north-east.

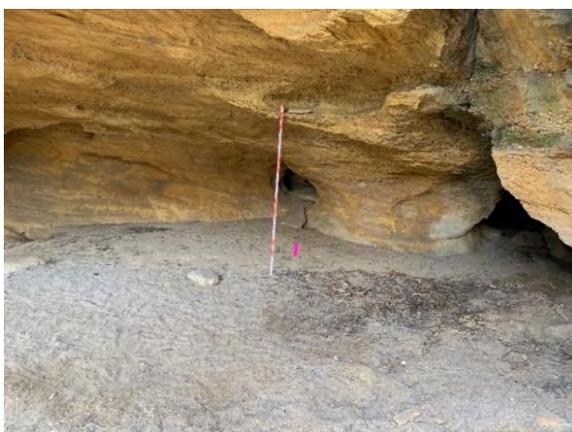
Plate 21: S2MC440 (AHIMS ID#36-3-3809), rock shelter detail with wombat burrowing at back of rock shelter.

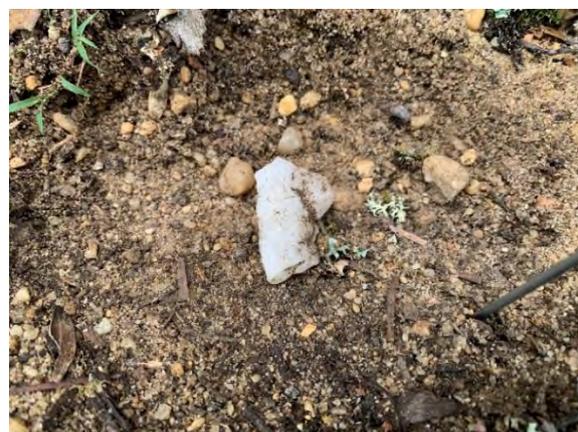
Plate 22: Quartz complete flake located at S2MC440 (AHIMS ID#36-3-3809).

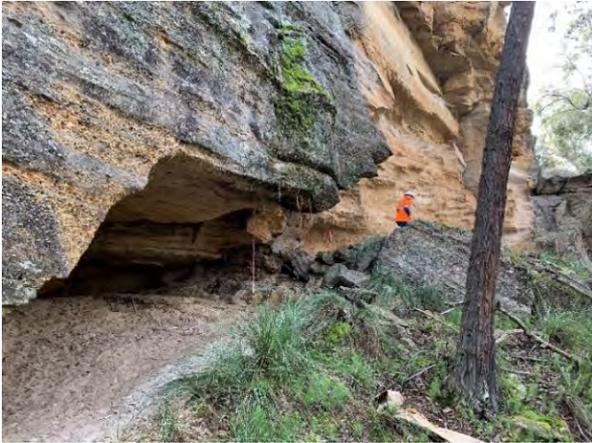
S2MC441 (AHIMS ID#36-3-3810), a Rock Shelter with Artefacts and PAD, was recorded mid slope along a continuous sandstone ridge running roughly east-west within the UG2 Extended Mining Area. The rock shelter consists of two adjoining overhangs, connected by a sandy deposit. The rock shelter interiors have a sandy deposit, disturbed in parts by wombat burrowing. Two quartz flakes were located within the dripline of the rock shelters.

Plate 23: S2MC441 (AHIMS ID#36-3-3810), Rock Shelter with Artefacts and PAD, facing south-east.

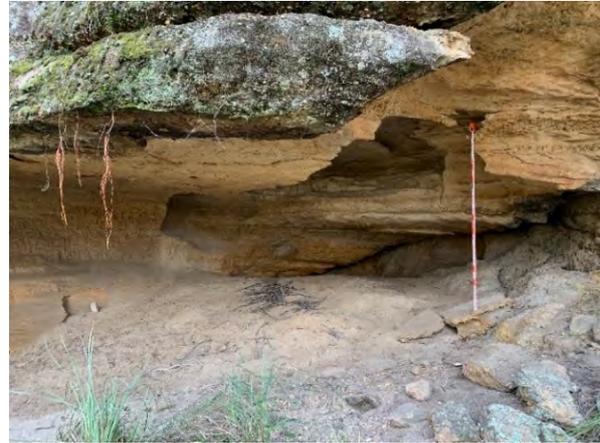
Plate 24: S2MC441 (AHIMS ID#36-3-3810), Rock Shelter with Artefacts and PAD, facing north-east.

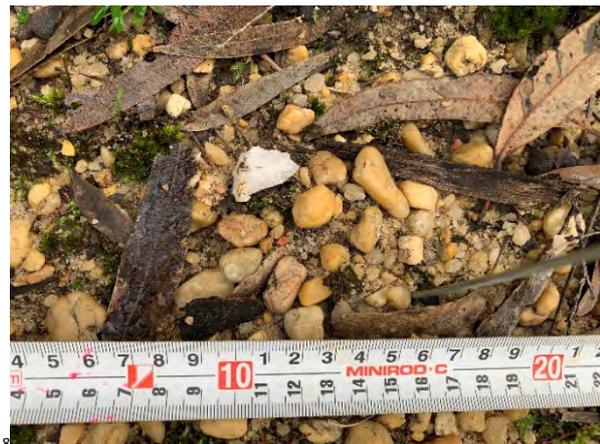
Plate 25: S2MC441 (AHIMS ID#36-3-3810), Rock Shelter with Artefacts and PAD, facing south-east.

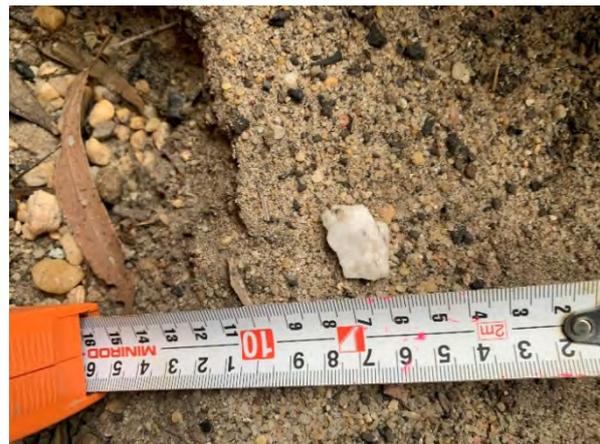
Plate 26: S2MC441 (AHIMS ID#36-3-3810), Rock Shelter with Artefacts and PAD, facing north-east.

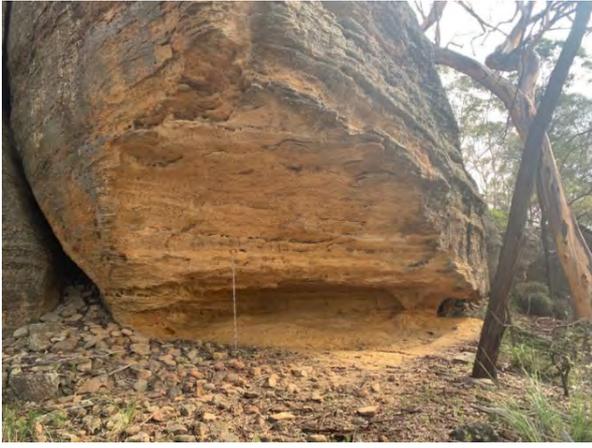
S2MC442 (AHIMS ID#36-3-3812), a Rock Shelter with PAD, is a large sandstone overhang located on the upper slope within the UG2 Extended Mining Area. The overhang has formed through chemical weathering, block fall and exfoliation and has been highly weathered. The overhang consists of banded conglomerate sandstone and fine-grained sandstone. The floor of the overhang is stone with 20 cm fine sandy deposit, however flat to gently inclined land continuous along the same contour line towards S2MC443. The rock shelter has been visited in the past during construction of a fenceline.

Plate 27: General photo S2MC442 (AHIMS ID#36-3-3812), facing north-west.

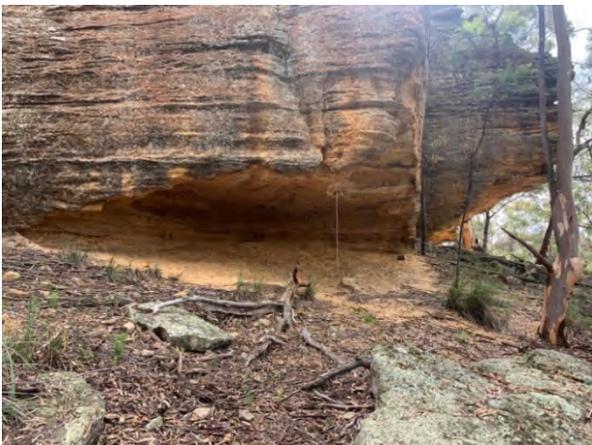
S2MC443 (AHIMS ID#36-3-3811), a Rock Shelter with PAD, was located along the same contour line as S2MC442 within the UG2 Extended Mining Area, separated by an old fence line. The large sandstone overhang has formed through chemical weathering, block fall and exfoliation and has been highly weathered. The overhang consists of banded conglomerate sandstone and provides a large habitable floor space with excellent views across the valley to the south east, east and north-east. The floor of the overhang is stone with 15 cm sandy deposit at dripline and at least 30 cm at rear of the rock shelter. S2MC443 (AHIMS ID#36-3-3811) is directly adjacent to S2MC442 (AHIMS ID#36-3-3812). Overhangs are separated by fence line. While no Aboriginal objects were visible at the time of the survey, the outlook, scale of the rock shelter, estimate deposit depth and blockfall at the front of the rock shelter increases the likelihood for Aboriginal objects to be present.

Plate 29: S2MC443 (AHIMS ID#36-3-3811), facing east.

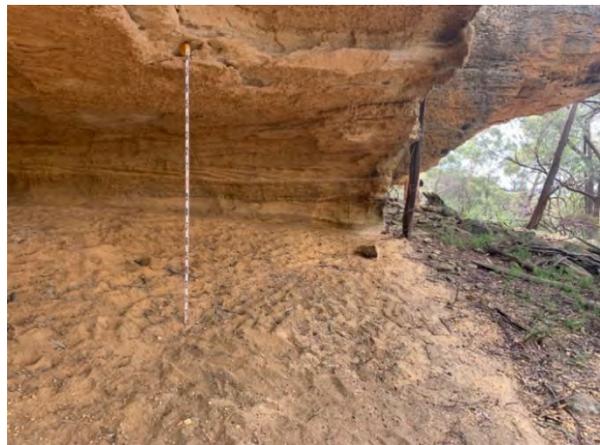
Plate 30: Rock shelter detail S2MC443 (AHIMS ID#36-3-3811).

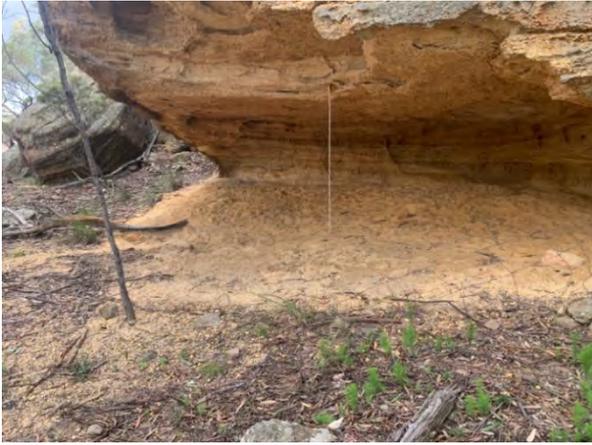
Plate 31: General photo of S2MC443 (AHIMS ID#36-3-3811), facing north-west.

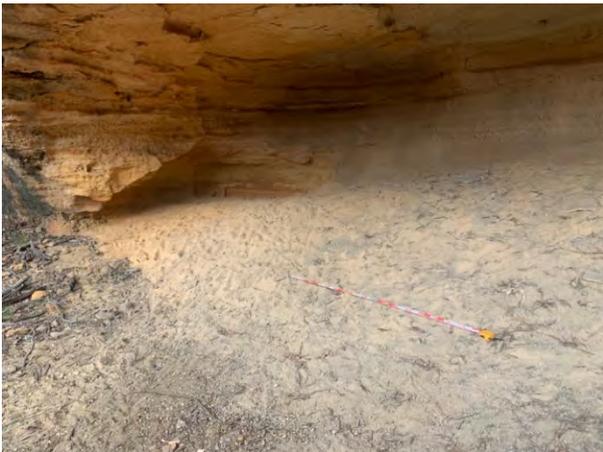
S2MC444 (AHIMS ID#36-3-3813), a Rock Shelter with PAD, consists of large sandstone overhang along a continuous sandstone ridge, located mid-slope withing the UG2 Approved Mining Area, with a pleasant outlook across the gully. The rock shelter contains an approximately 30 cm deep sandy deposit with evidence of animal burrowing and wasp nests throughout the rock shelter. Animal burrowing is likely to have reduced the integrity of the deposit.

Plate 33: S2MC444 (AHIMS ID#36-3-3813), Rock Shelter with PAD, facing south-east.

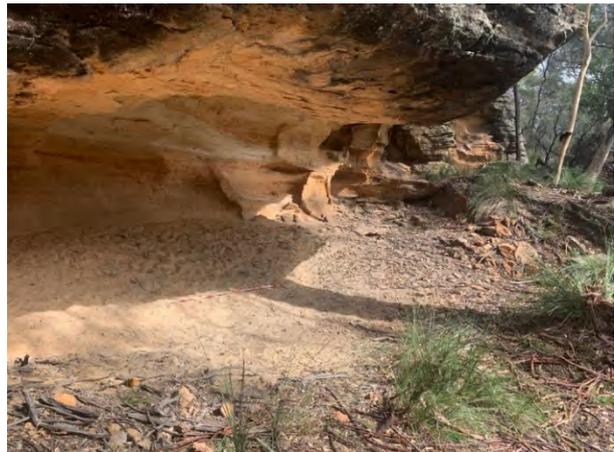
Plate 34: S2MC444 (AHIMS ID#36-3-3813), Rock Shelter with PAD, facing south-west.

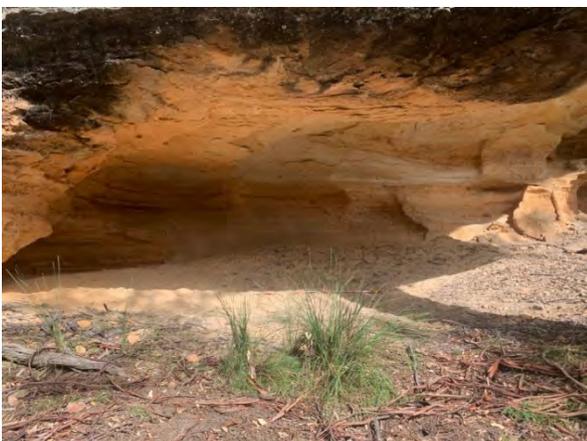
Plate 35: S2MC444 (AHIMS ID#36-3-3813), Rock Shelter with PAD, facing south-west.

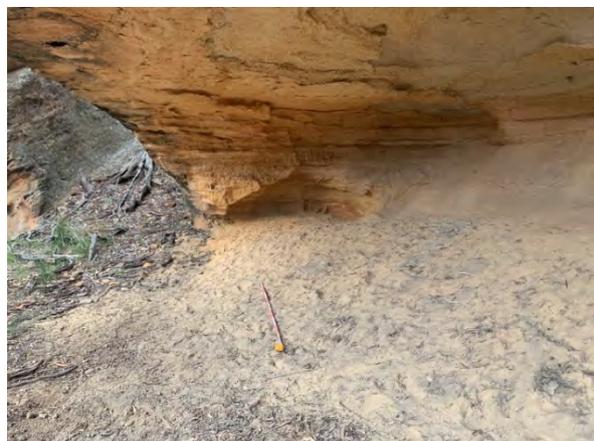
Plate 36: S2MC444 (AHIMS ID#36-3-3813), Rock Shelter with PAD, facing south-east.

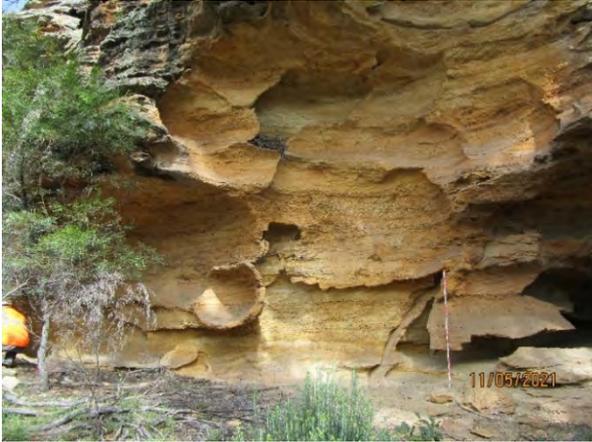
Site S2MC445 (AHIMS ID#36-3-3817), a Rock Shelter with PAD, comprises of a large sandstone overhang located within a continuous sandstone outcrop along the midline of steep hills within the UG2 Approved Mining Area. The interior of the rock shelter consists of conglomerate sandstone banding and contains wasps and birds nests within the rock shelter. The rock shelter has a grey sandy deposit on top of a sandstone floor. PAD located within the eastern end of the rock shelter, approximately 4 m from the dripline.

Plate 37: S2MC445 (AHIMS ID#36-3-3817), Rock Shelter with PAD, facing south-west.

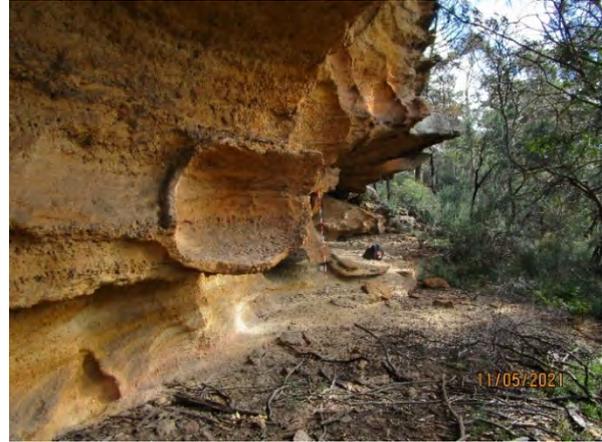
Plate 38: S2MC445 (AHIMS ID#36-3-3817), Rock Shelter with PAD, facing west.

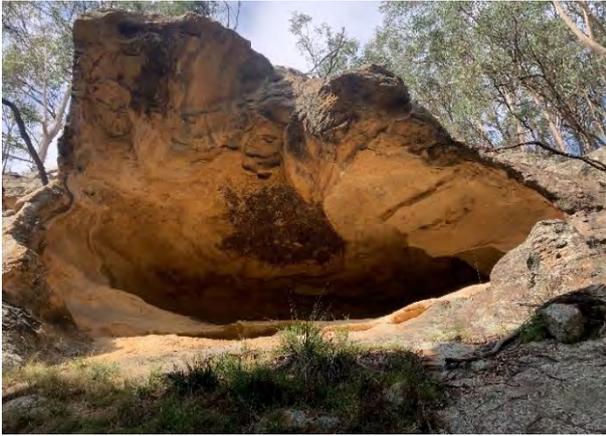
S2MC446 (AHIMS ID#36-3-3814) is a large sandstone shelter and overhang with PAD and artefacts located within a sandstone outcrop along the mid slope of moderately inclined hills within the UG2 Extended Mining Area, overlooking a gully. The rock shelter interior consists of a sloped stone floor that levels out towards the back of the rock shelter. The stone floor has a built-up sandy deposit, approximately 30 cm to 40 cm deep along the dripline. The rock shelter contains wasp nests and is actively being used by animals. A chert backed flake was located in the eroding downslope of the rock shelter. While further stone artefacts are likely within the deposit, the area of PAD is relatively small and the deposit is moderately sloped. Downslope sediment movement and the impact of animal use is also likely to have impacted the integrity of the deposit.

Plate 41: S2MC446 (AHIMS ID#36-3-3814), Rock Shelter with Artefact and PADs, facing south, artefact located in foreground.

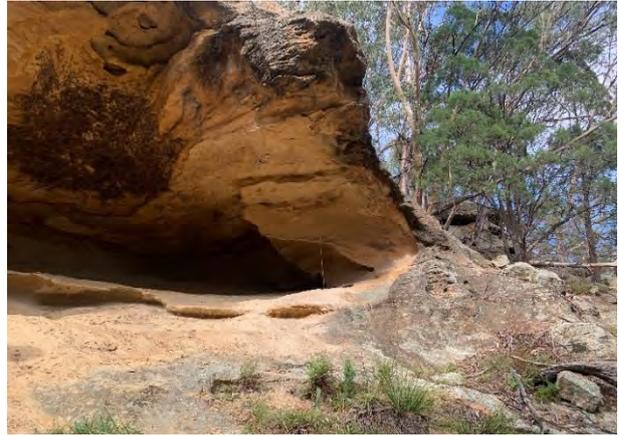
Plate 42: S2MC446 (AHIMS ID#36-3-3814), Rock Shelter with Artefact and PAD, facing south-west.

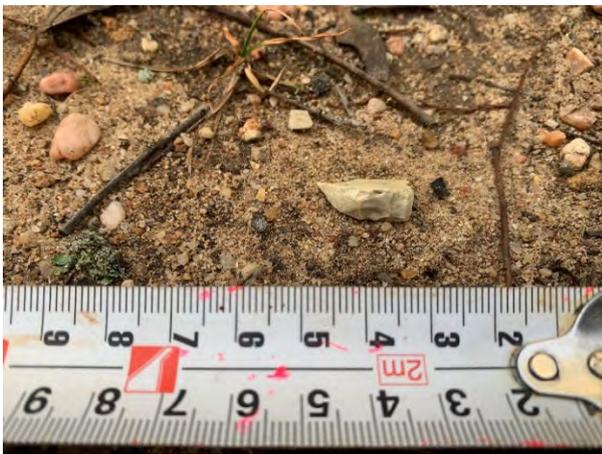
Plate 43: S2MC446 (AHIMS ID#36-3-3814), backed chert flake.

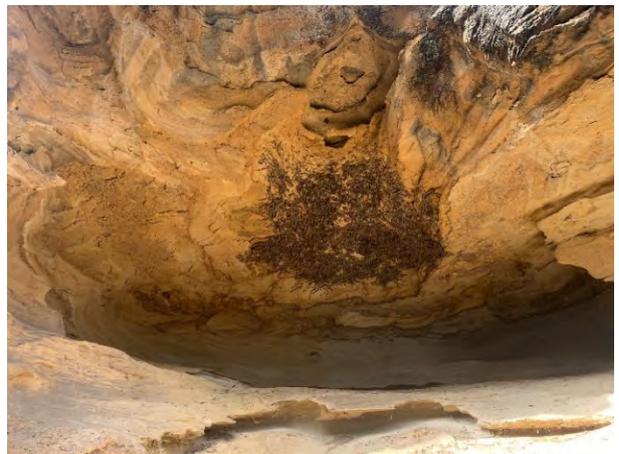
Plate 44: S2MC446 (AHIMS ID#36-3-3814), Rock Shelter with Artefact and PAD, interior detail, facing south.

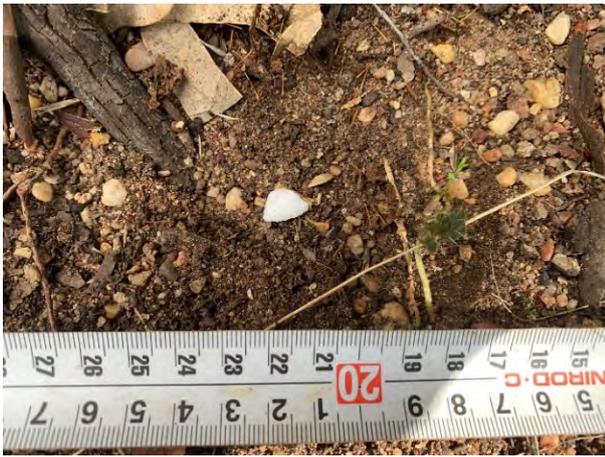
Plate 47: Quartz flake located at site S2MC447 (AHIMS ID#36-3-3815).

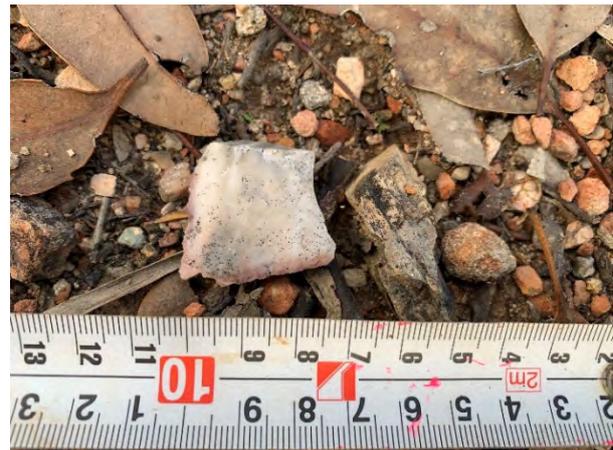
S2MC448 (AHIMS ID#36-3-3816) consists of an isolated chert scraper located on a slate-covered lower slope in open depression outside of the Subject Area. Visibility due to leaf and slate cover was poor but it is likely further surface artefacts are present.

Plate 50: S2MC448 (AHIMS ID#36-3-3816), chert scraper, ventral surface.

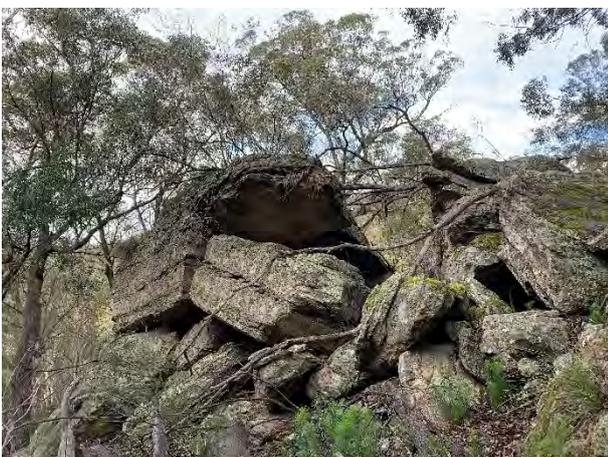
Plate 51: Example of natural blockfall and collapse that has occurred within UG2.

For rock shelters, the types of changes will be similar or identical to those that would be expected due to natural weathering processes, but exacerbated by subsidence. For example, a naturally weathering block which will have detached and fallen at some point in time may be detached and fall sooner due to differential movements of the rock strata induced by subsidence (Biosis Research and The Ecology Lab 2007: 29).

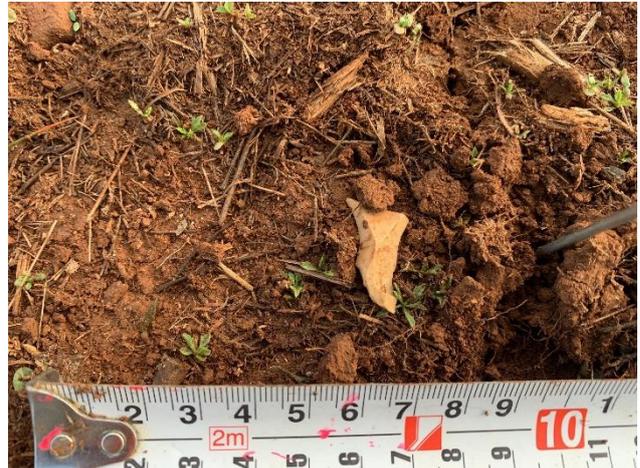
A chert retouched flake was located on a dirt track on a cleared ridge crest within the UG2 approved longwall mining extent, approximately 130 m north-east of S2MC420, an artefact scatter of six stone artefacts identified during surveys for an exploration drilling program. The landform offered views across Murragamba Creek valley and OC4. Cobbles and outcrops of basalt were exposed across the ridge crest.

Plate 2: S2MC438 (AHIMS ID# 36-3-3807), chert flake.

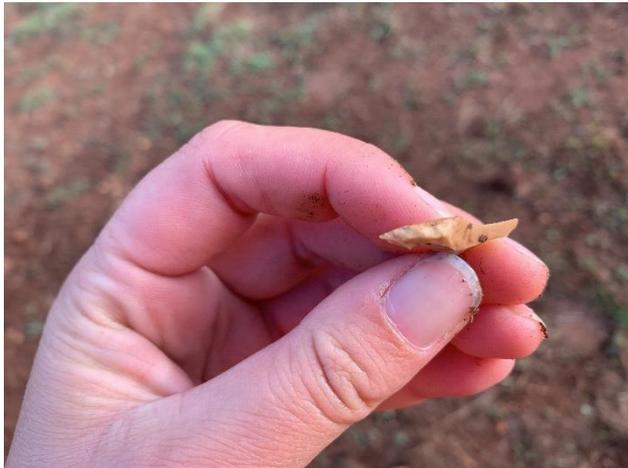
Plate 3: S2MC438 (AHIMS ID# 36-3-3807), chert flake.

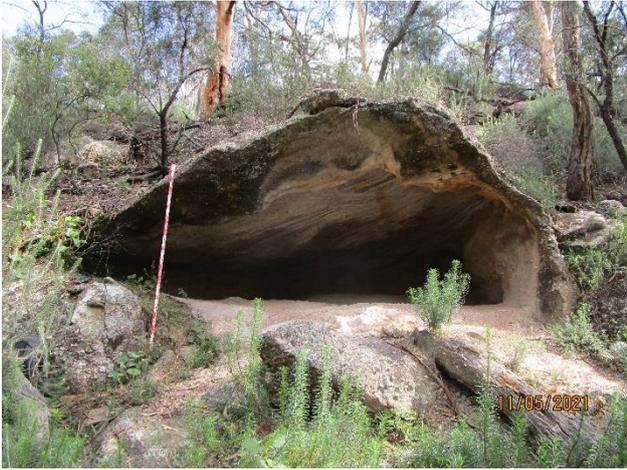
Plate 5: S2MC439 (AHIMS ID# 36-3-3808) Shelter with PAD, facing north-east.

Visible artefacts?	No	Where?	N/A	How many?	N/A
Notes:	The shelter interior has a sandy deposit approximately greater than 50 cm along the dripline and while no stone artefacts were identified, the shelter outlook, proximity to a potential stone resource and other stone artefact sites and depth of the deposit increases the likelihood of subsurface stone artefacts being present. The integrity of the deposit however was impacted from rabbit burrowing.				
Panel / Platform					
Art surfaces	N/A		Grooves	N/A	
Environmental Factors					
Waterwash	Y	Graffiti	N	Macro vegetals	N
Animals	Y	Salt/granular loss	N	Fissuring	N
Insects	N	Spalling/Exfoliation	Y	Other	
Fire	N	Block fall	N

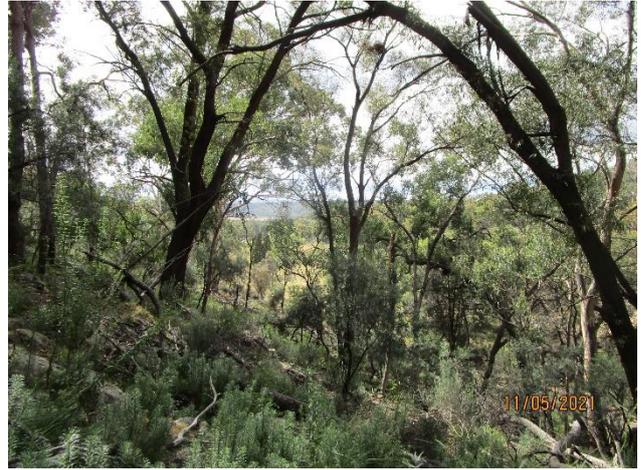
Plate 6: S2MC439 (AHIMS ID# 36-3-3808) Shelter with PAD, facing south.

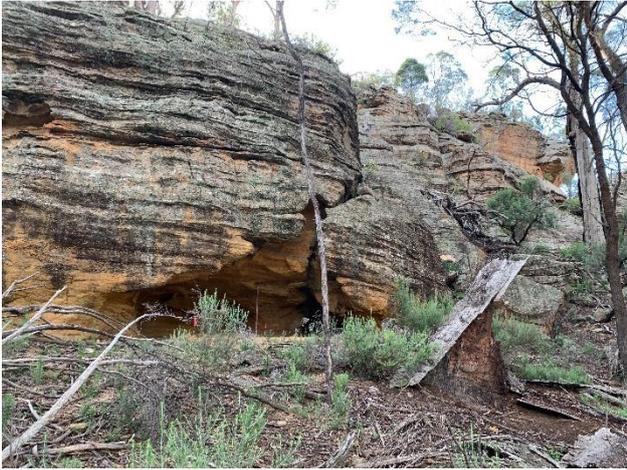
Plate 8: S2MC440 (AHIMS ID# 36-3-3809) Shelter with Artefact and PADs, general location, facing north-east.

Visible artefacts?	Yes	Where?	Along dripline and shelter interior.	How many?	2
Notes:	Further stone artefacts are likely within the shelter, however the integrity of the deposit may be reduced as a result of wombat burrowing.				
Panel / Platform					
Art surfaces	N/A		Grooves	N/A	
Waterwash	N	Graffiti	N	Macro vegetals	Y
Animals	Y	Salt/granular loss	Y	Fissuring	N
Insects	Y	Spalling/Exfoliation	Y	Other	Lateral movement of planes
Fire	Y	Block fall	N

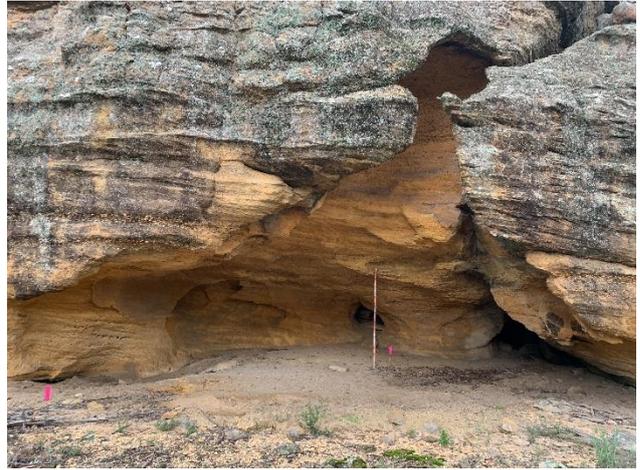
Plate 9: S2MC440 (AHIMS ID# 36-3-3809) Shelter with Artefact and PAD, facing north-east.

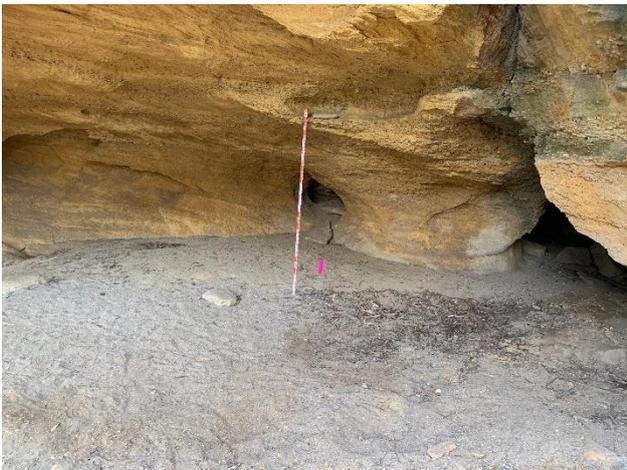
Plate 10: S2MC440 (AHIMS ID# 36-3-3809), shelter detail with wombat burrowing at back of shelter.

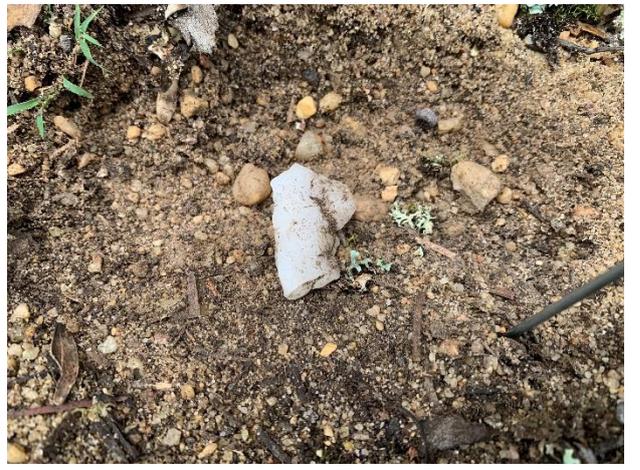
Plate 11: Quartz complete flake located at S2MC440 (AHIMS ID# 36-3-3809).

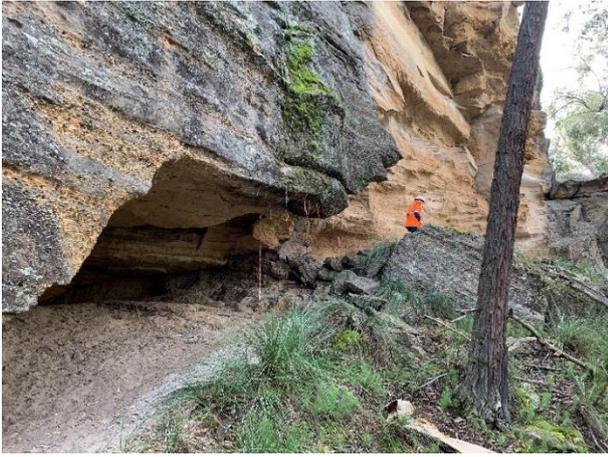
Notes:	Two quartz flakes are located along the dripline among quartzose gravels. One quartz flake was located between the two overhangs				
Panel / Platform					
Art surfaces	N/A		Grooves	N/A	
Environmental Factors					
Waterwash	N	Graffiti	N	Macro vegetals	N
Animals	Y	Salt/granular loss	Y	Fissuring	N
Insects	N	Spalling/Exfoliation	Y	Other	
Fire	N	Block fall	N

Plate 12: S2MC441 (AHIMS ID#36-3-3810), Shelter with Artefacts and PAD, facing south-east.

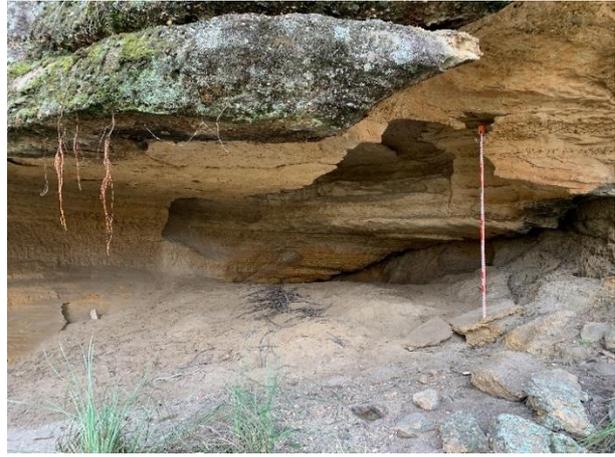
Plate 13: S2MC441 (AHIMS ID#36-3-3810), Shelter with Artefacts and PAD, facing north-east.

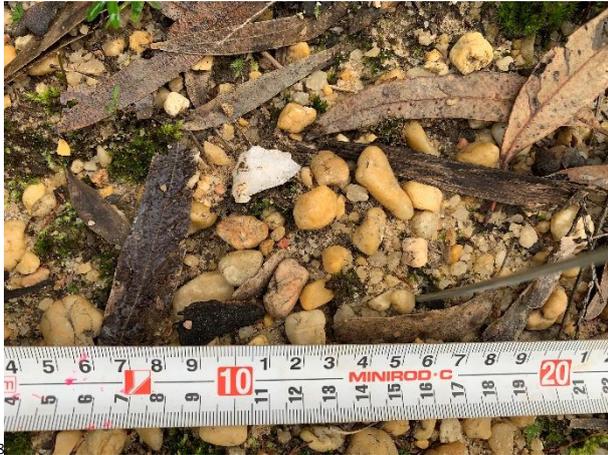
Plate 14: S2MC441 (AHIMS ID#36-3-3810), Shelter with Artefacts and PAD, facing south-east.

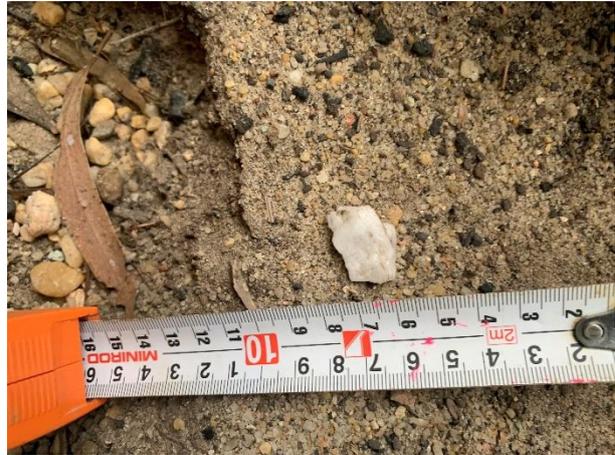
Plate 15: S2MC441 (AHIMS ID#36-3-3810), Shelter with Artefacts and PAD, facing north-east.

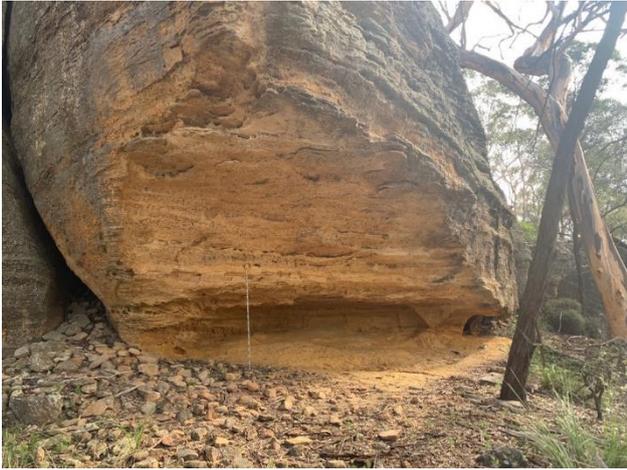
Notes:	Shelter directly adjacent to S2MC443. Fence line running through the two shelters, separating the deposits.				
Panel / Platform					
Art surfaces	N/A		Grooves	N/A	
Environmental Data					
Waterwash	Y	Graffiti	N	Macro vegetals	Y
Animals	Y	Salt/granular loss	Y	Fissuring	N
Insects	Y	Spalling/Exfoliation	Y	Other	
Fire	N	Block fall	Y

Plate 16: General photo S2MC442 (AHIMS ID# 36-3-3812), facing north-west.

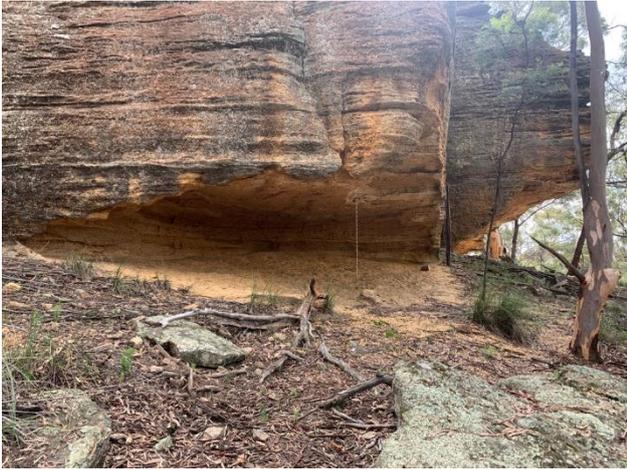
Notes:	Shelter directly adjacent to S2MC442. Fence line running through the two shelters, separating the deposits.				
Panel / Platform					
Art surfaces	N/A		Grooves	N/A	
Environmental Factors					
Waterwash	Y	Graffiti	N	Macro vegetals	Y
Animals	Y	Salt/granular loss	Y	Fissuring	N
Insects	Y	Spalling/Exfoliation	Y	Other	
Fire	Y	Block fall	Y

Plate 18: S2MC443 (AHIMS ID#36-3-3811), facing east.

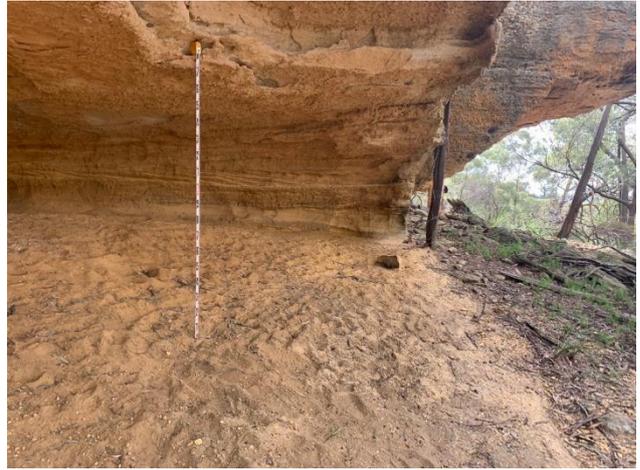
Plate 19: Shelter detail, S2MC443 (AHIMS ID#36-3-3811), facing east.

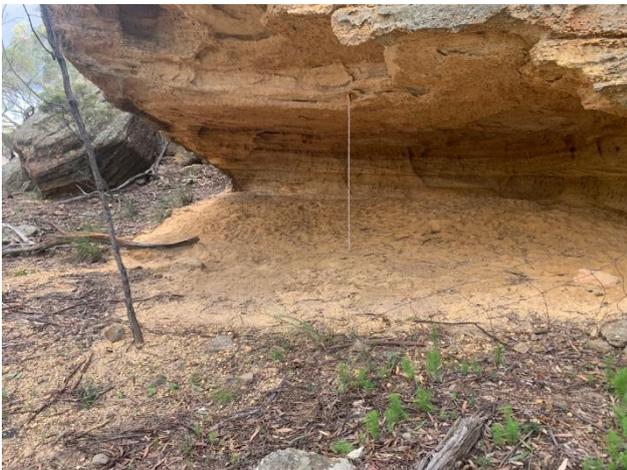
Plate 20: General photo of S2MC443 (AHIMS ID#36-3-3811), facing north-west.

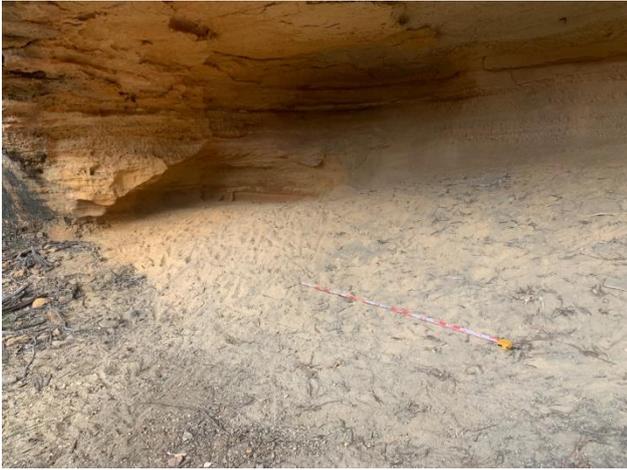
Visible artefacts?	No	Where?	N/A	How many?	N/A
Notes:	The shelter has a large habitable floor with at least 30 cm of deposit. Animal burrowing is likely to have reduced the integrity of the deposit.				
Panel / Platform					
Art surfaces	N/A		Grooves	N/A	
Waterwash	N	Graffiti	Y	Macro vegetals	Y
Animals	Y	Salt/granular loss	Y	Fissuring	Y- Horizontal cracking
Insects	Y	Spalling/Exfoliation	Y	Other	
Fire	N	Block fall	Y

Plate 22: S2MC444 (AHIMS ID#36-3-3813) Shelter with PAD, facing south-east.

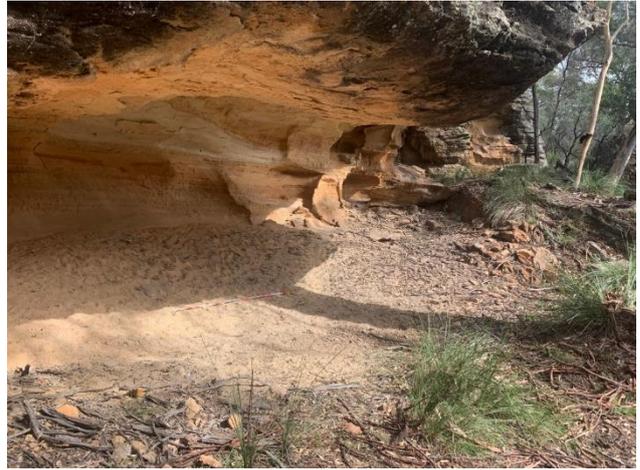
Plate 23: S2MC444 (AHIMS ID#36-3-3813) Shelter with PAD, facing south-west.

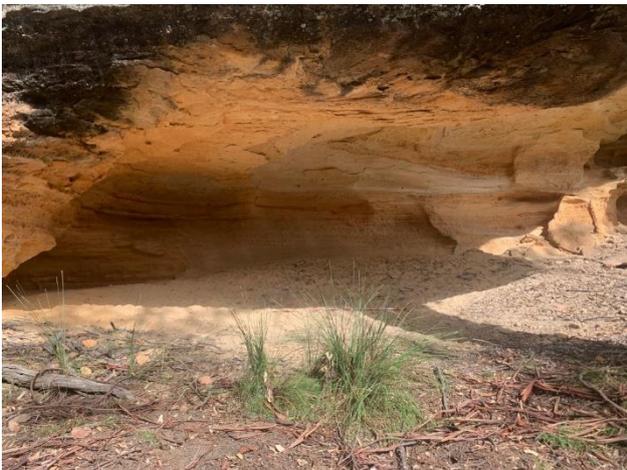
Plate 24: S2MC444 (AHIMS ID#36-3-3813) Shelter with PAD, facing south-west.

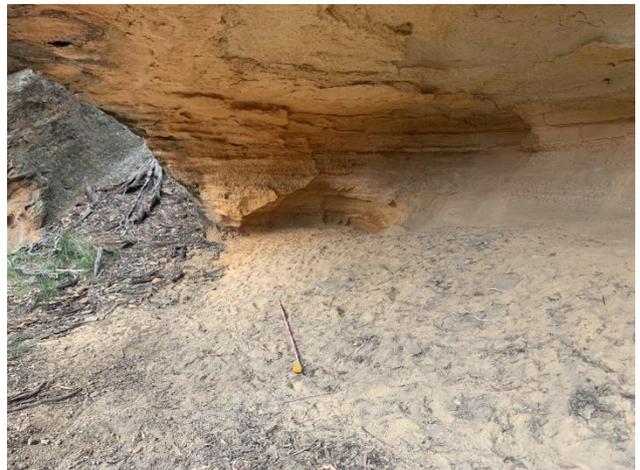
Plate 25: S2MC444 (AHIMS ID#36-3-3813) Shelter with PAD, facing south-east.

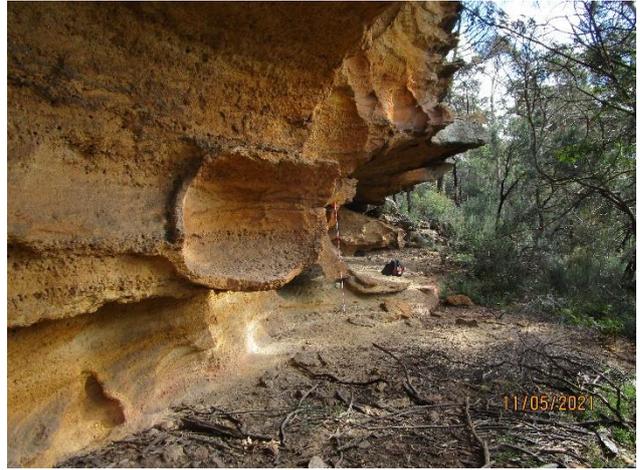
Plate 27: S2MC445 (AHIMS ID#36-3-3817) Rock shelter with PAD, facing west.

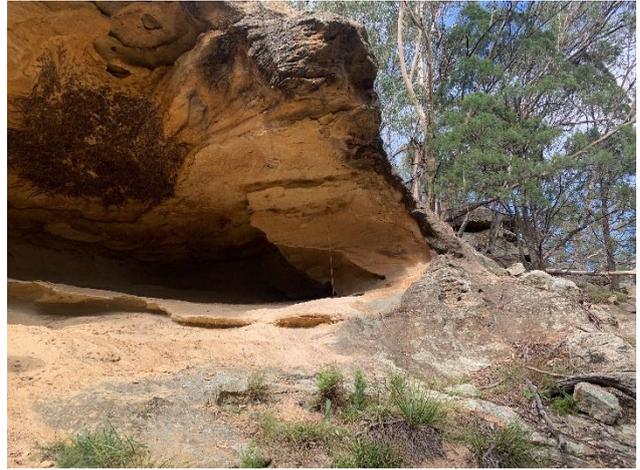
Plate 31: S2MC446 (AHIMS ID#36-3-3814) Shelter with Artefact and PAD, facing south-west.

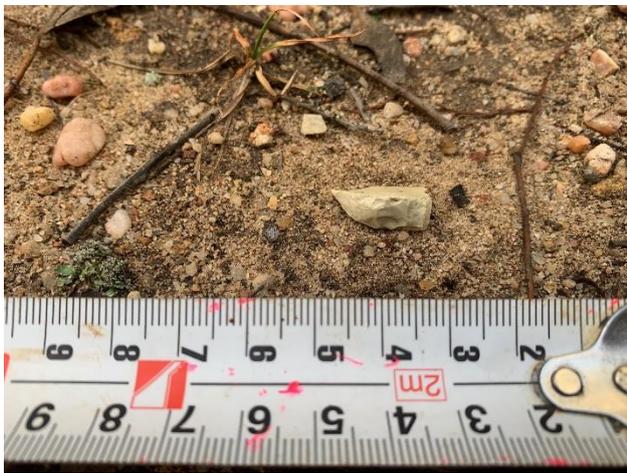
Plate 32: S2MC446 (AHIMS ID#36-3-3814) backed chert flake..

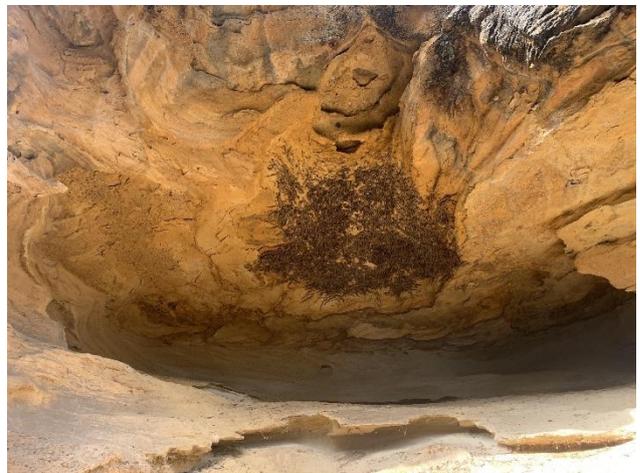
Plate 33: S2MC446 (AHIMS ID#36-3-3814) Shelter with Artefact and PAD, interior detail, facing south.

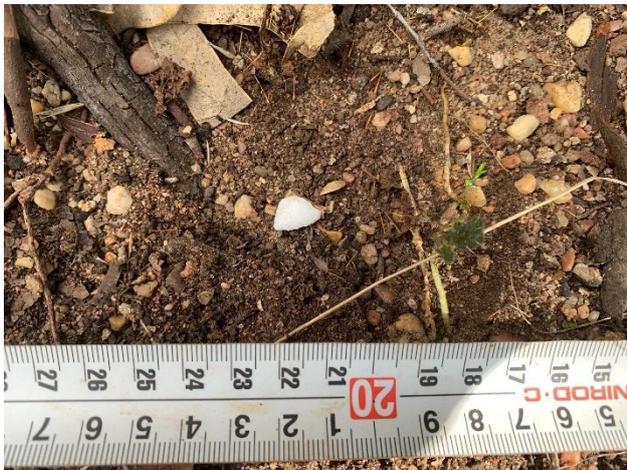
Plate 36: Quartz flake located at site S2MC447 (AHIMS ID#36-3-3815).

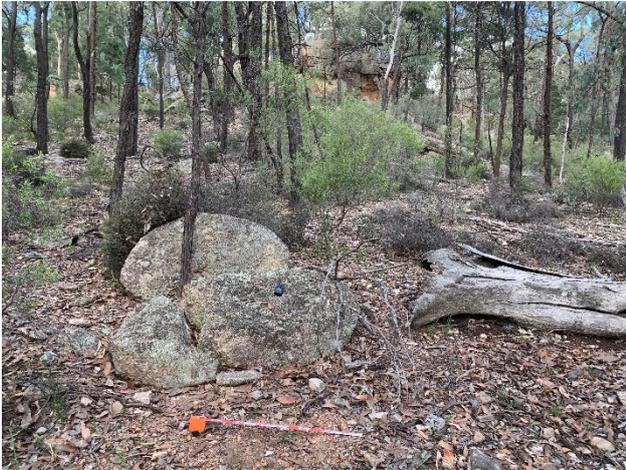
S2MC448 consists of an isolated chert scraper located on a slate-covered lower slope in open depression. Visibility due to leaf and slate cover was poor but it is likely further surface artefacts are present.

Plate 38: S2MC448 (AHIMS ID#36-3-3816), general location.

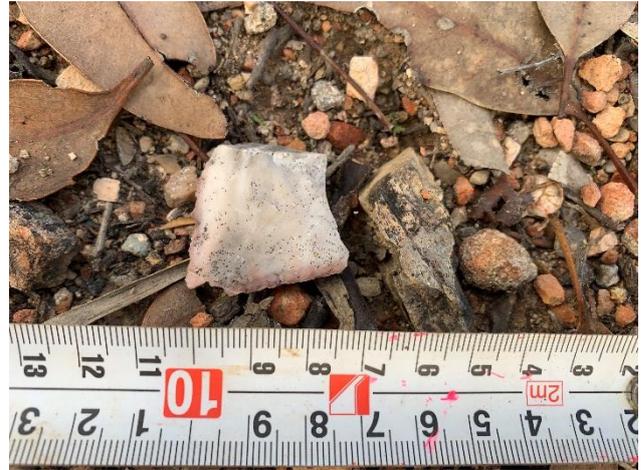
Plate 39: S2MC 448 (AHIMS ID#36-3-3816), chert scraper, ventral surface.

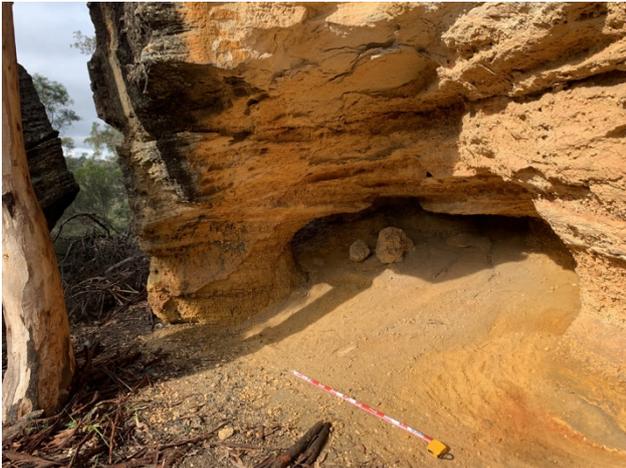
RS CDF1 is a low overhang that has been highly weathered, with small opening formed in the back corner of the shelter due to weathering. The overhang comprised of conglomerate sandstone. The shelter floor contained a fine sandy layer formed through erosion of sandstone. No Aboriginal objects or Potential Archaeological Deposit identified.

Plate 1: General photo RS CDF1, facing south.

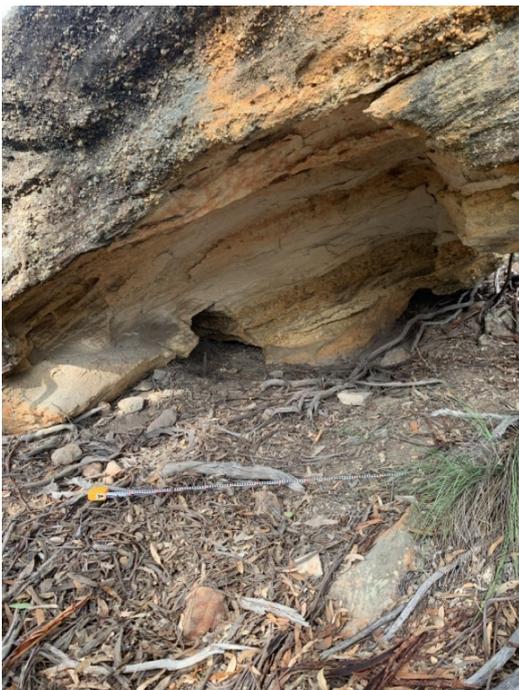
Plate 3: General photo RS CDF2, facing south.

RS CDF2 is a low overhang that has formed through block fall and exfoliation and consists of conglomerate sandstone banded with fine grained sandstone. The overhang floor contained high amounts of leaf litter, with evidence of animal burrowing. No Aboriginal objects or Potential Archaeological Deposit was identified.

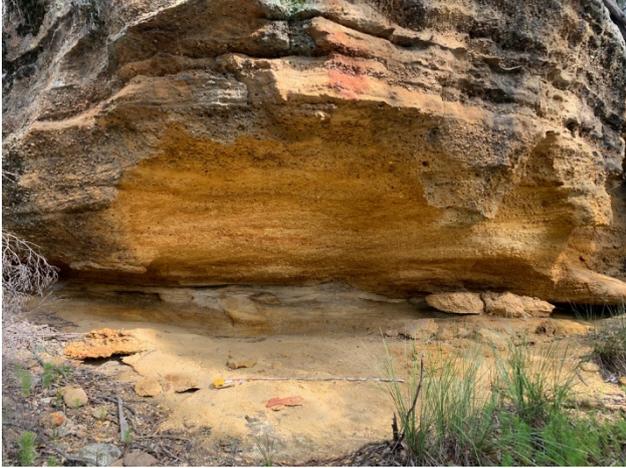
RS CDF3 is an overhang that has formed through chemical weathering, block fall and exfoliation and consists of exfoliated banded conglomerate sandstone. The floor of the overhang is stone with 15 cm sandy deposit. No Aboriginal objects or Potential Archaeological Deposit.

Plate 5: General photo RS CDF3, facing south.

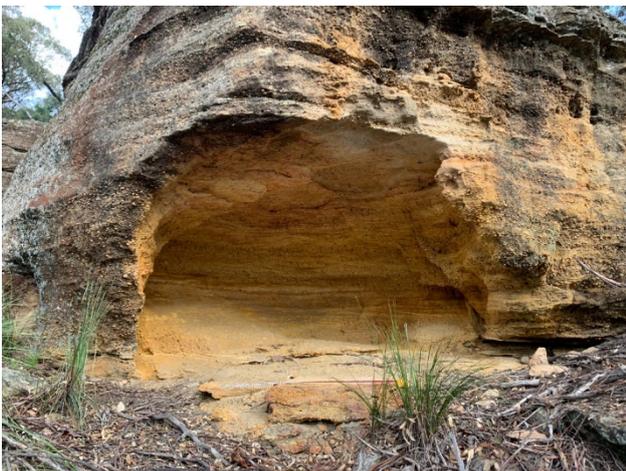
Plate 7: General photo RS CDF4, facing south-west.

RS CDF4 is a low overhang that has formed through chemical weathering and exfoliation and has been highly weathered. The overhang consists of banded conglomerate sandstone with vertical fissuring running through the northern wall of the overhang. The floor of the overhang is stone with 2 cm fine sandy deposit. No Aboriginal objects or Potential Archaeological Deposit.

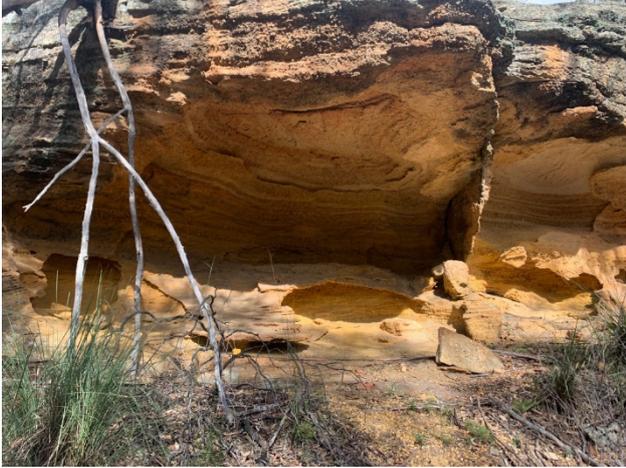
RS CDF7 is a large overhang that has formed through chemical weathering, block fall and exfoliation. The overhang consists of banded conglomerate sandstone. The floor of the overhang is eroded sandstone with a sandy deposit that has piled in a section of the overhang floor. No Aboriginal objects or Potential Archaeological Deposit.

Plate 9: General photo RS CDF7, facing south.

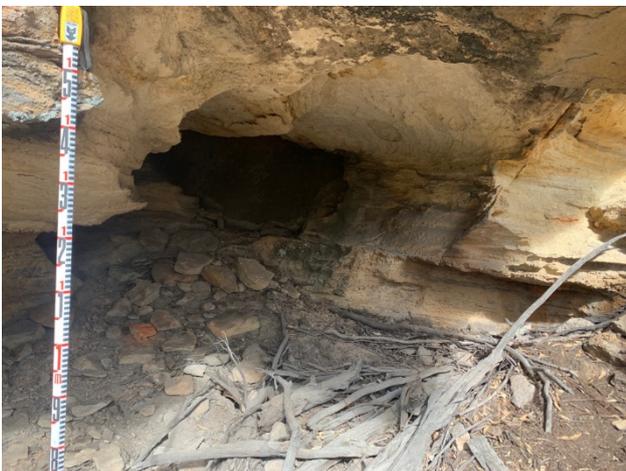
RS CDF8 is a low overhang that has formed through chemical weathering, block fall and exfoliation and consists of conglomerate sandstone with horizontal fissuring. The overhang floor contained high amounts of leaf litter and rock fall, with a fallen tree blocking the entrance of the overhang. No Aboriginal objects or Potential Archaeological Deposit.

Plate 11: General photo RS CDF8, facing south.

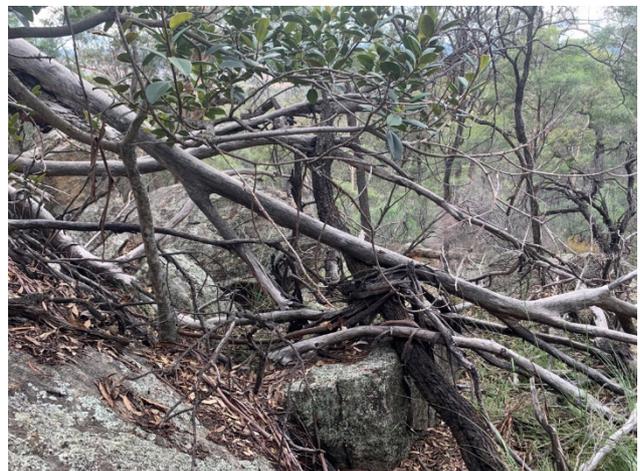
Plate 12: General photo of trees and block fall blocking the entranceway of RS CDF8, facing north-east.

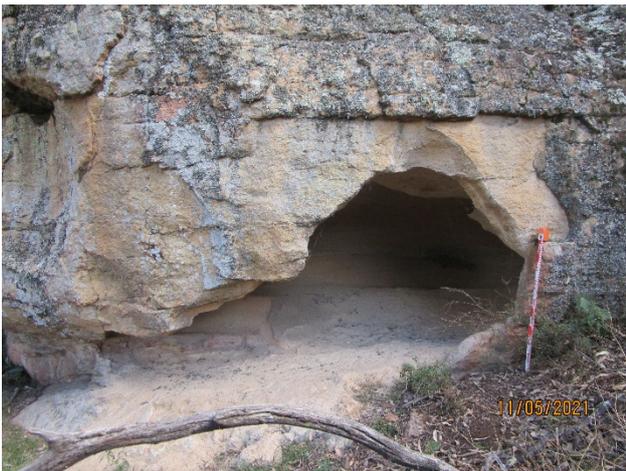
RS CDF18 is an overhang that has formed through cavernous weathering and consists of conglomerate sandstone. The overhang floor contains a stone floor and evidence of seepage with micro vegetals growing. No Aboriginal objects or Potential Archaeological Deposit.

Plate 15: General photo RS CDF18, facing south.
