Aboriginal Cultural Heritage Assessment Report
Moolarben Coal Complex UG2 Modification, Ulan NSW
Mid-Western Regional Council Local Government Area
Prepared for Moolarben Coal Operations Pty Ltd

Prepared by Niche Environment and Heritage Pty Ltd | 19 November 2021

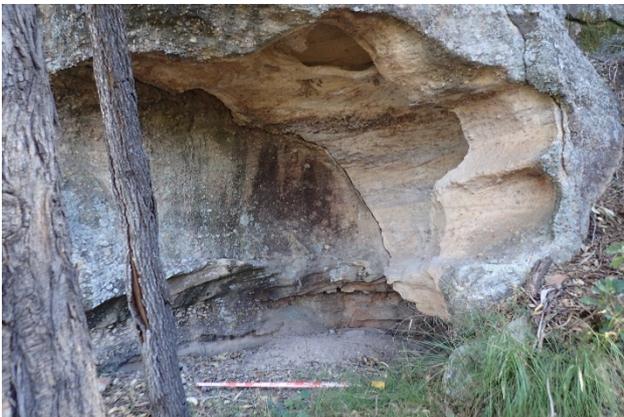
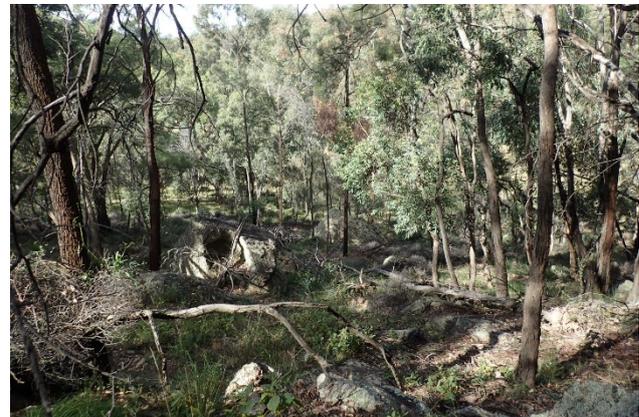
Plate 19: General photo RS CDF20, facing south-west.

RS CDF20 is a small overhang that has formed through block fall and cavernous weathering with sandy deposit cover in leaf litter. The deposit has been dug out by animals (wombats) and has been undermined at the rear of the overhang. The overhang consists of conglomerate sandstone with vertical fissuring evident through backwall and into the ceiling. No Aboriginal objects or Potential Archaeological Deposit.

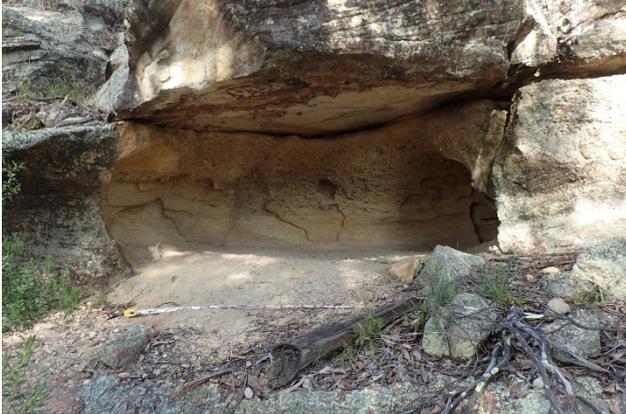
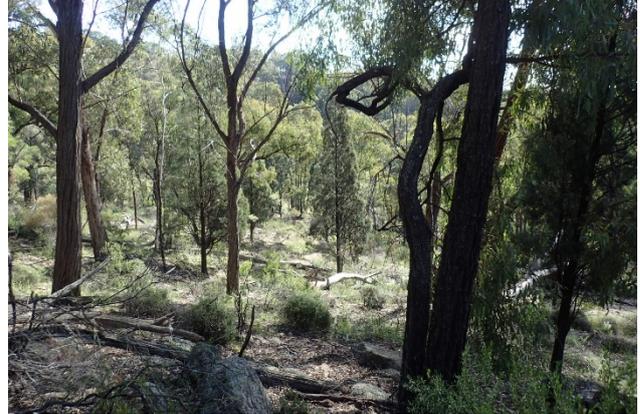
Plate 21: General photo RS CDF21, facing south-east.

RS CDF21 is a small overhang that has formed through block fall and cavernous weathering with a sandy deposit over a stone floor. The overhang contains banded conglomerate sandstone with erosion along horizontal bedding. Wasps nest and cobwebs are evident throughout the overhang. No Aboriginal objects or Potential Archaeological Deposit.

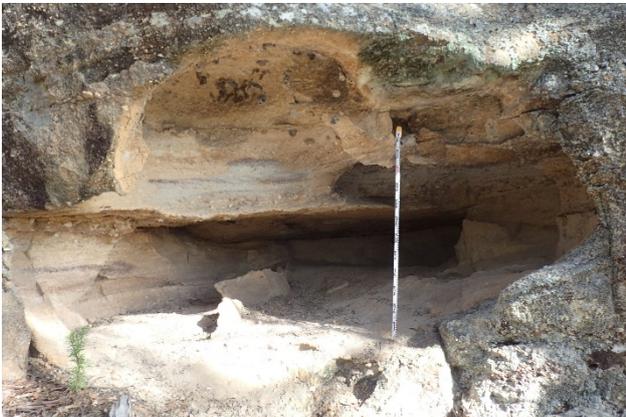
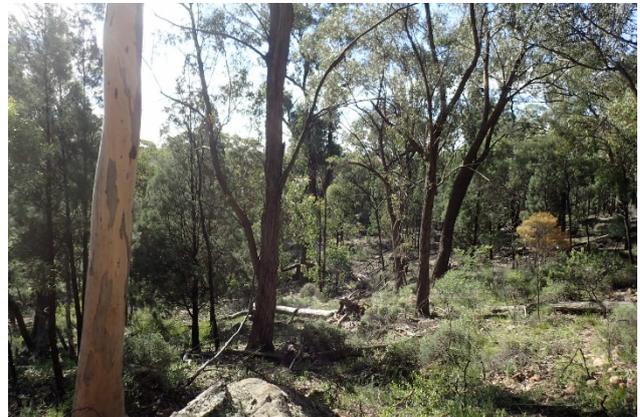
Plate 23: General photo RS CDF22, facing south-south-west.

RS CDF22 is a small overhang that has formed through block fall and cavernous weathering with a sandy deposit over a stone floor. The overhang contains exfoliated banded conglomerate sandstone, with the ceiling covered by wasps nests. Vertical cracking is evident along the backwall of the overhang. No Aboriginal objects or Potential Archaeological Deposit.

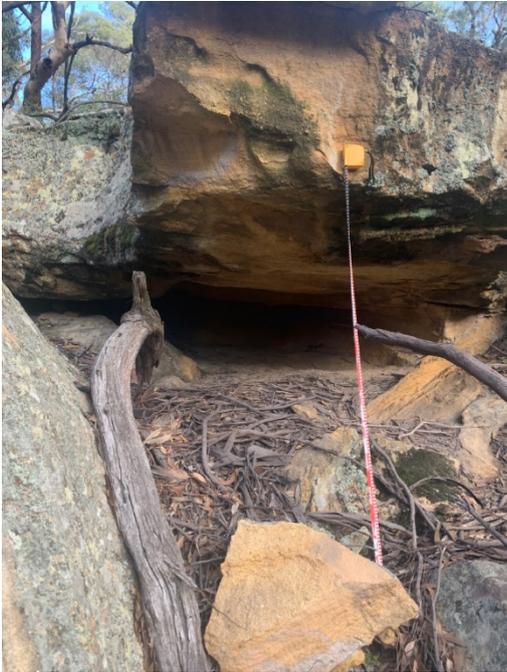
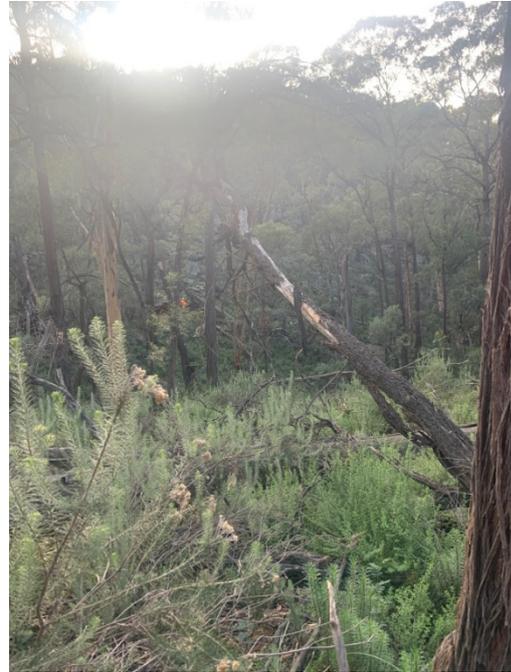
Plate 25: General photo RS CDF23, facing west.

RS CDF23 is a low overhang that has formed primarily through block fall and has been subjected to chemical weathering and exfoliation. The overhang floor is stone, with a sandy layer from weathered sandstone, leaf litter throughout. A dead tree Infront of the overhang was evident. No Aboriginal objects or Potential Archaeological Deposit.

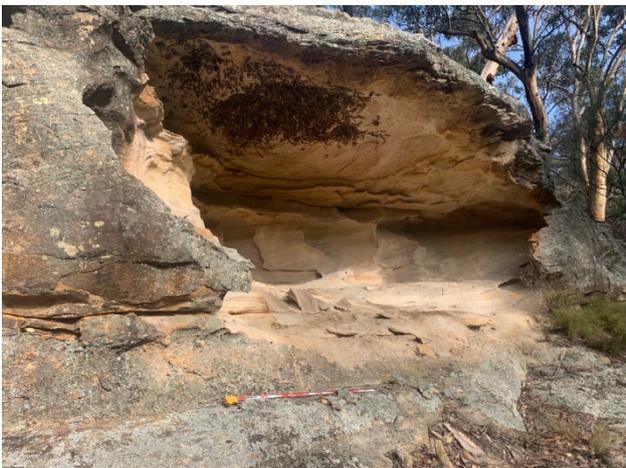
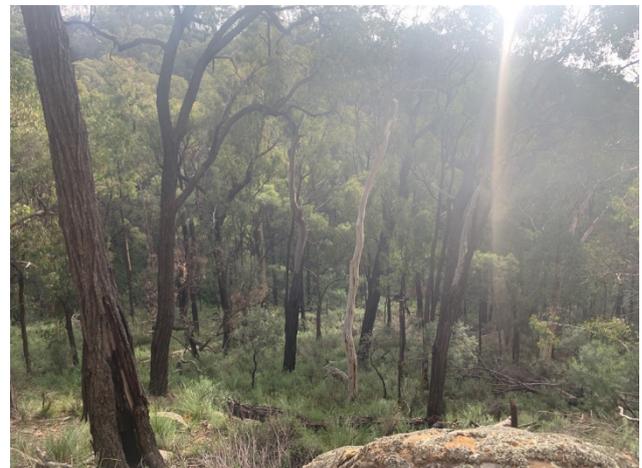
Plate 27: General photo RS CDF24, facing north-west.

RS CDF24 is a low and wide overhang that has formed through chemical weathering, block fall and exfoliation. Th overhang interior contained a stone floor with rock fall, vertical and horizontal cracking along the walls and wasp nests through the overhang. No Aboriginal objects or Potential Archaeological Deposit.

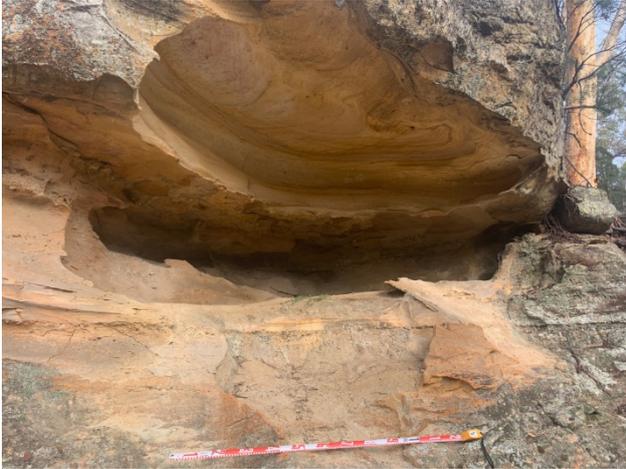
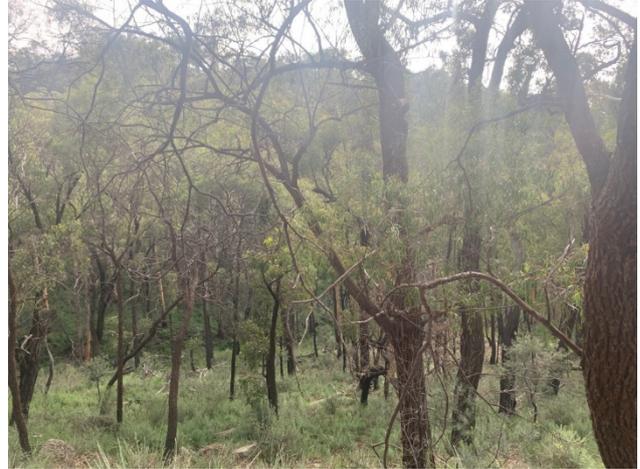
Plate 29: General photo RS CDF25, facing west.

RS CDF25 is an overhang that has formed through chemical weathering, block fall and exfoliation and is located atop of a steeply sloped sandstone platform. The overhang floor consists of a steeply sloped rock floor with large amounts of rockfall. No Aboriginal objects or Potential Archaeological Deposit.

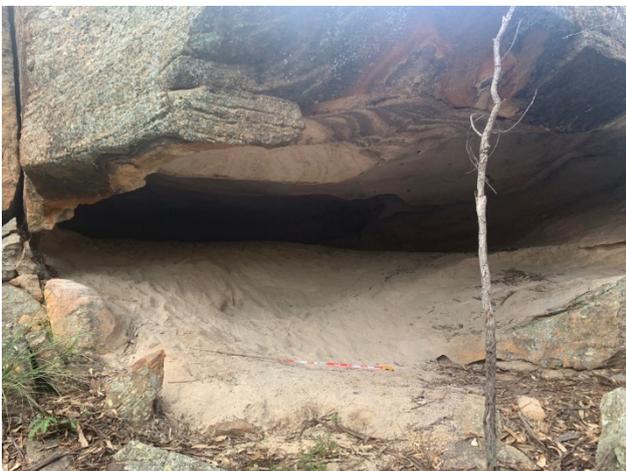
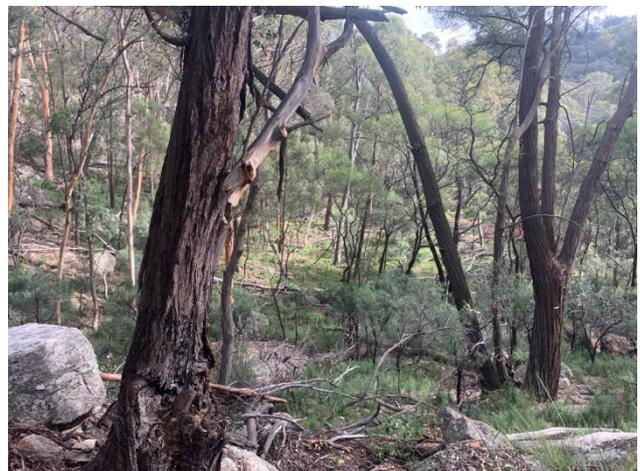
Plate 31: General photo RS CDF26, facing south-east.

RS CDF26 is an isolated overhang that has a steeply inclined stone floor that levels out approximately 4m deep into the overhang. A sandy deposit approximately 10 cm deep has formed on the level portion of the stone floor. Evidence of animal burrowing is present at the rear of the overhang. The exterior has been heat effected, with cracking exfoliation due to fire continuing into the shelter for 4m. No Aboriginal objects or Potential Archaeological Deposit.

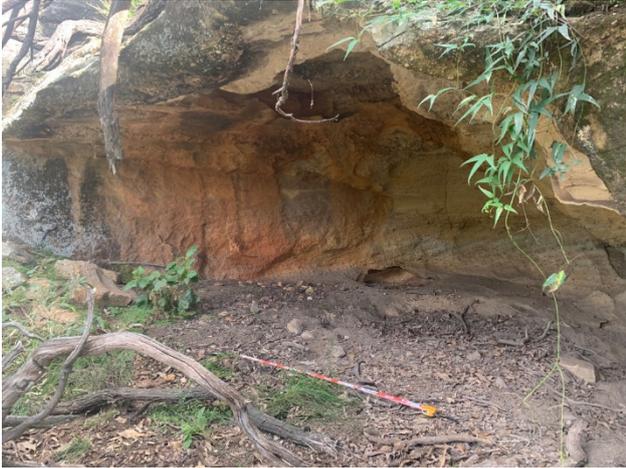
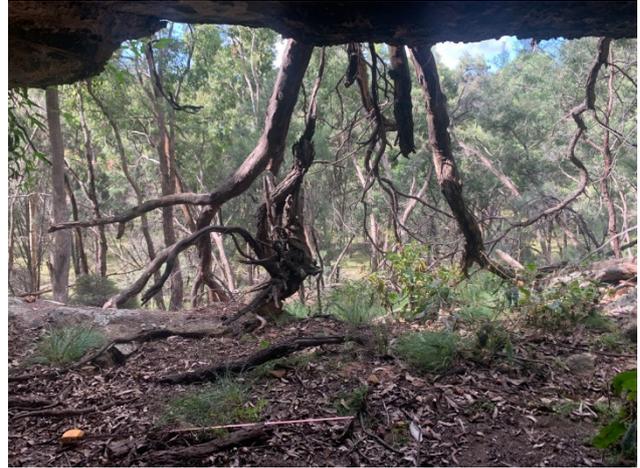
Plate 37: General photo RS CDF29, facing south-west.

RS CDF29 is an overhang that has formed through chemical weathering, exfoliation, and cavernous weathering. The overhang consists of banded conglomerate sandstone with bands of fine-grained sandstone. The floor of the overhang is stone with a sandy deposit formed through exfoliation of sandstone. The entrance of the overhang is covered by leaf litter, a fallen tree and block fall, partially blocking entrance into the overhang. Vertical cracking is evident along the rear wall and continuing into the ceiling of the overhang. No Aboriginal objects or Potential Archaeological Deposit.

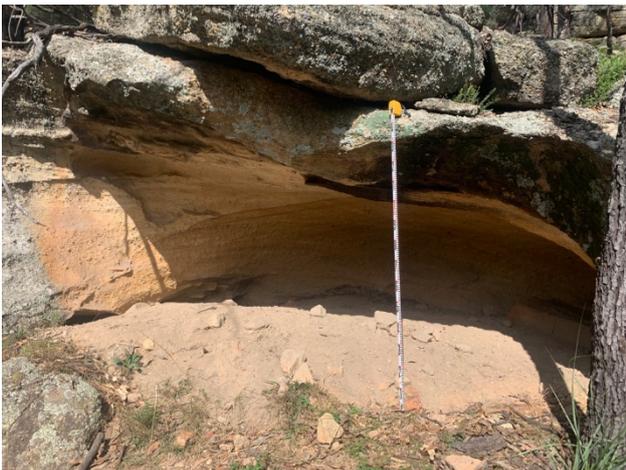
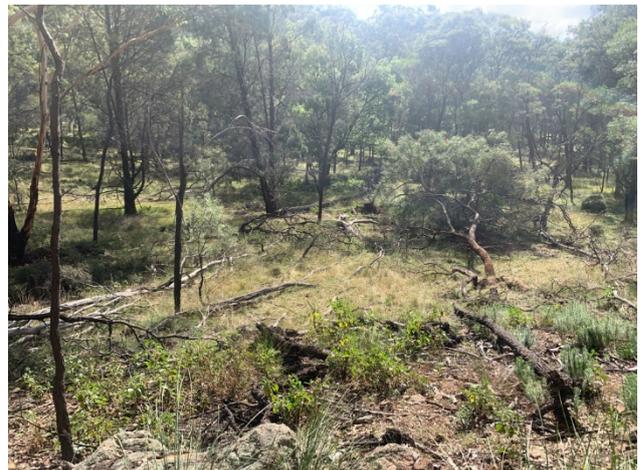
Plate 39: General photo RS CDF30, facing south.

RS CDF30 is a low overhang that has formed through chemical weathering, block fall and exfoliation. The overhang floor consists of a sandy deposit approximately 15 cm deep that has formed through exfoliated sandstone and internal rockfall. The overhang consists of banding of fine-grained orange sandstone. No Aboriginal objects or Potential Archaeological Deposit.

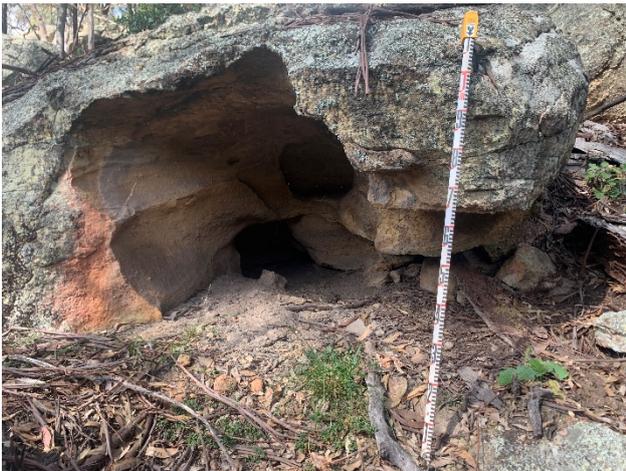
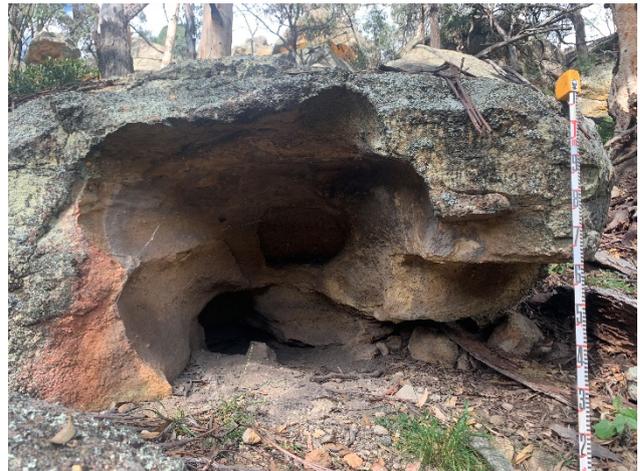
Plate 41: General photo RS CDF31, facing north-east.

RS CDF31 is a small weathered boulder. No Aboriginal objects or Potential Archaeological Deposit.

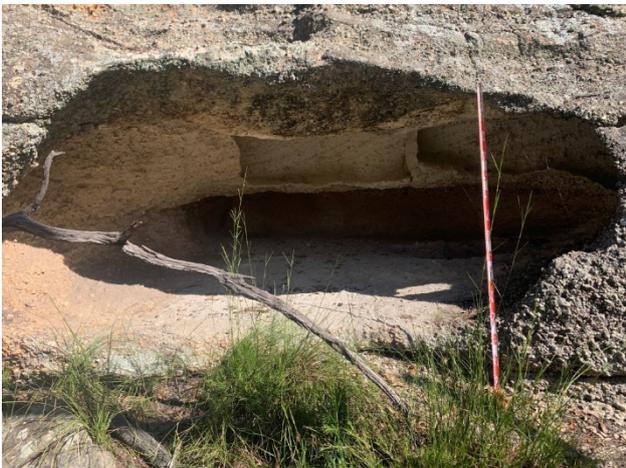
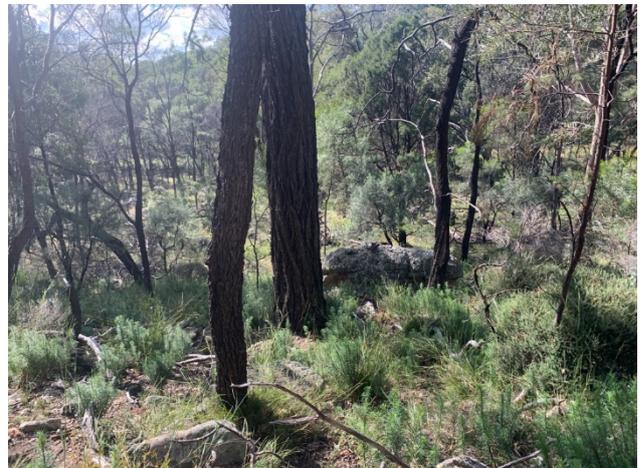
Plate 43: General photo RS CDF32, facing south-west.

RS CDF32 is a low overhang that has formed through chemical weathering and exfoliation. The overhang consists of a flat stone floor with an exfoliated sandstone sandy layer with evidence of animal faeces and leaf litter. The interior of the overhang consists of conglomerated sandstone with a vertical cracking occurring along the eastern wall near the entrance of the overhang. No Aboriginal objects or Potential Archaeological Deposit.

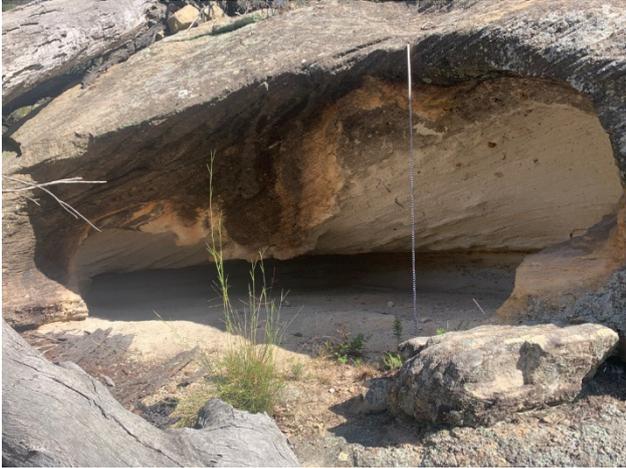
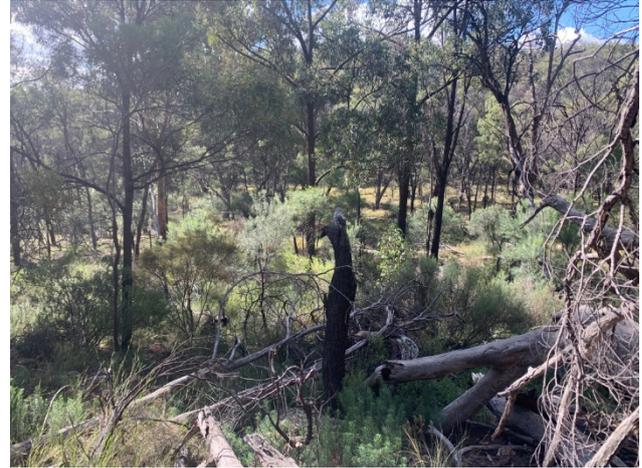
Plate 45: General photo RS CDF33, facing south-west.

RS CDF33 is a low overhang that has formed through chemical weathering and exfoliation. The overhang floor consists of a strong floor with a sandy deposit of exfoliated sandstone. The overhang has a width of 3.4m at the entrance but expands to a width of 5.2m internally. Internally the overhang consists of fine-grained pale sandstone banded with orange conglomerate sandstone. Effects of burning are evident on the exterior and within the interior of the overhang, with small horizontal cracking occurring along the back wall of the overhang. No Aboriginal objects or Potential Archaeological Deposit.

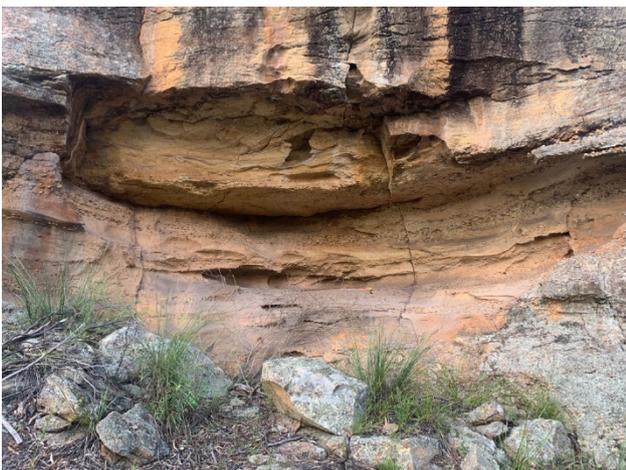
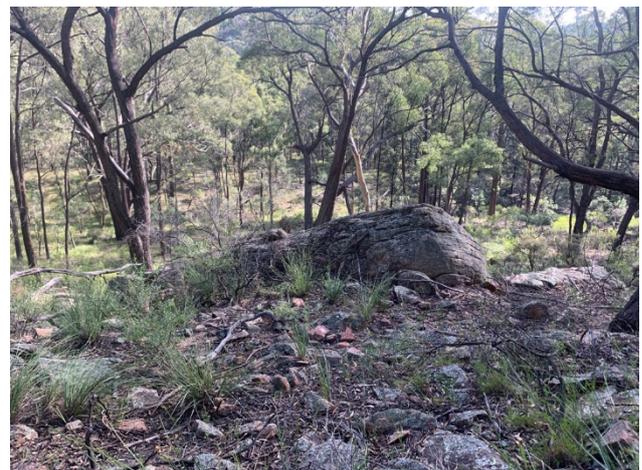
Plate 47: General photo RS CDF34, facing east.

RS CDF34 consists of a high overhang that has formed through chemical weathering and exfoliation. The overhang consists of conglomerate sandstone with ironstone veining, with vertical, horizontal, and diagonal cracking occurring along the side and rear walls and into the ceiling. The overhang floor is a steeply sloped stone floor. No Aboriginal objects or Potential Archaeological Deposit.

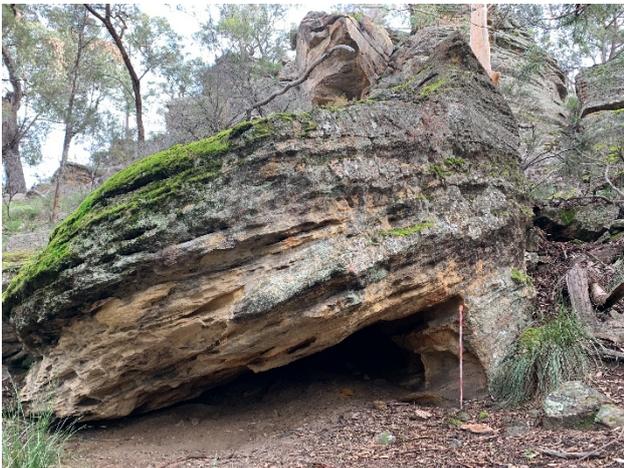
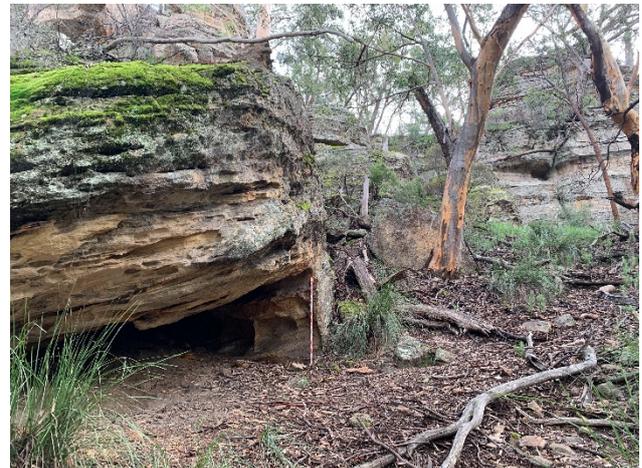
Plate 50: General photo RS A8_A6, facing north.

RS A8_A6 is a low overhang located that has formed through chemical weathering block fall and exfoliations. Evidence of animal and insect use of the overhang. No Aboriginal objects or Potential Archaeological Deposits.

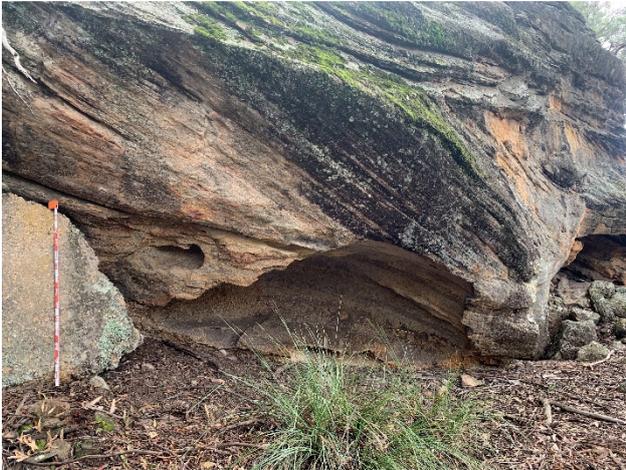
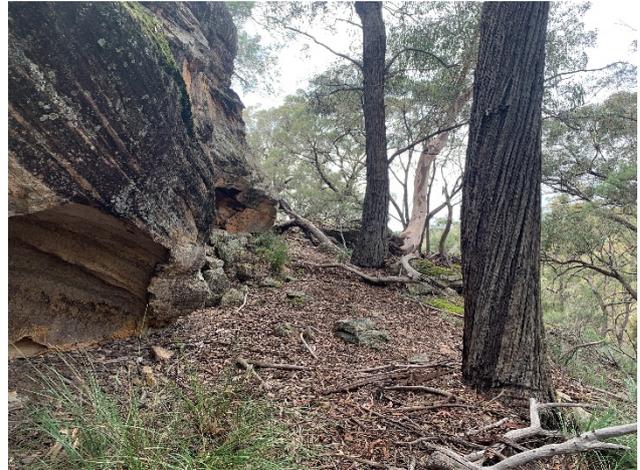
Plate 52: General photo RS A9, facing north-east.

RS A9 is a low overhang that has formed through chemical weathering and block fall and contains a sandy stone floor. No Aboriginal objects or Potential Archaeological Deposit.

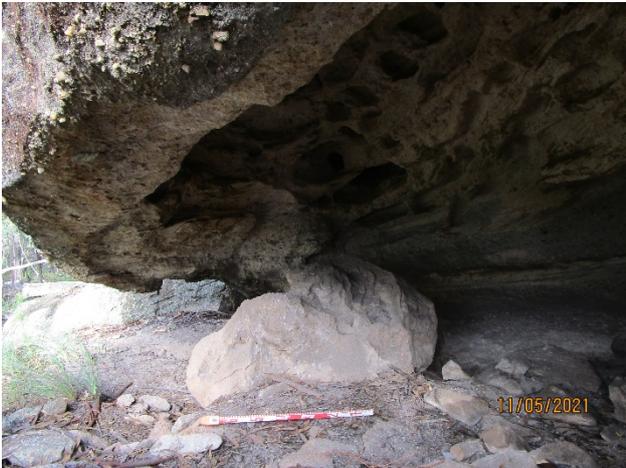
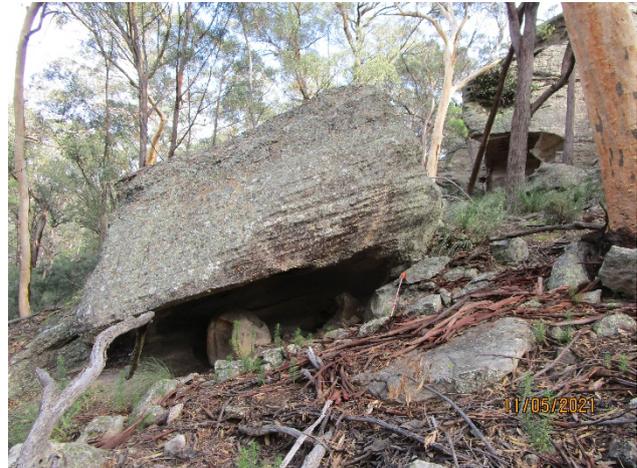
Plate 56: General photo RS A12, facing east.

RS A12 is a small sandstone overhang formed from cavernous weathering and block fall, downslope of RS A11. There is enough space to sit with a view down to the drainage line. Animal burrowing is present. No Aboriginal objects or Potential Archaeological Deposit.

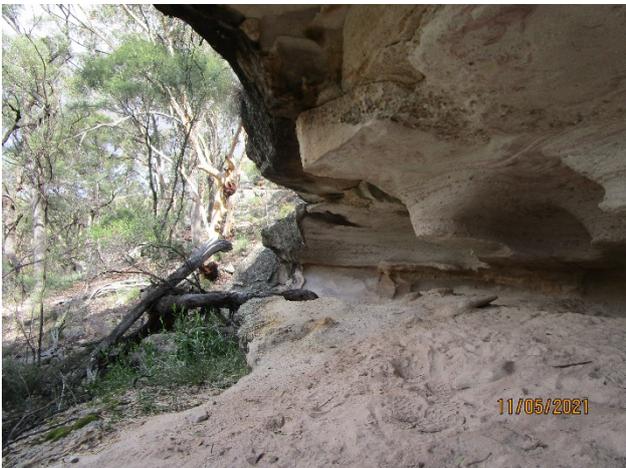
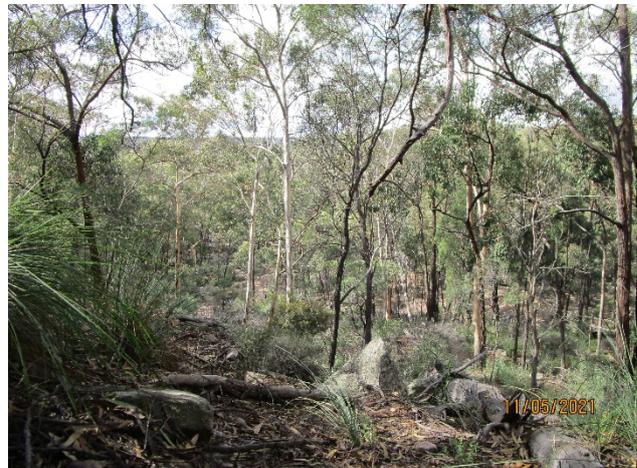
Plate 58: General photo RS A13, facing north-east.

RS A13 is an overhang that has formed from block fall with a sloped floor and approximately 20 cm of rocky and sandy floor overlying block fall. It looks down towards earthworks associated with slate deposits. No Aboriginal objects or Potential Archaeological Deposit.

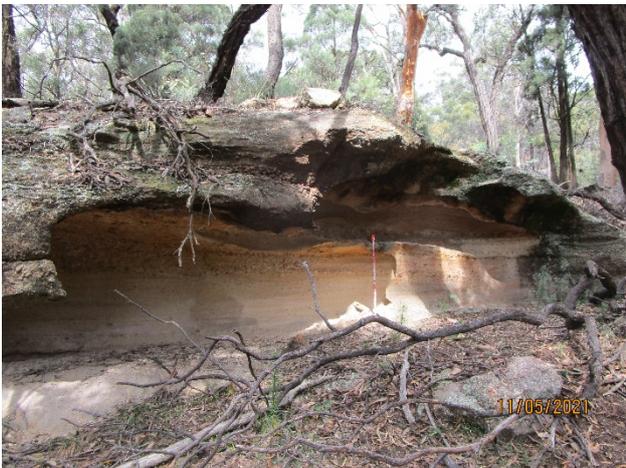
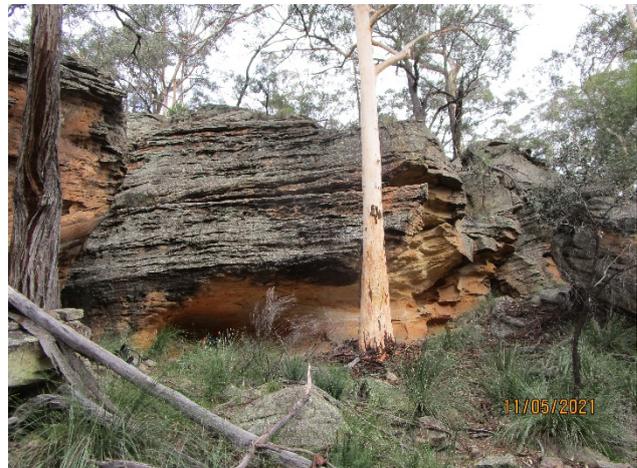
Plate 62: General photo RS A15.

RS A15 is a conglomerate sandstone overhang located on the mid slope. The sloped sandstone floor has a build-up of exfoliated sediment approximately 20 cm deep at the dripline. No Aboriginal objects or Potential Archaeological Deposit.

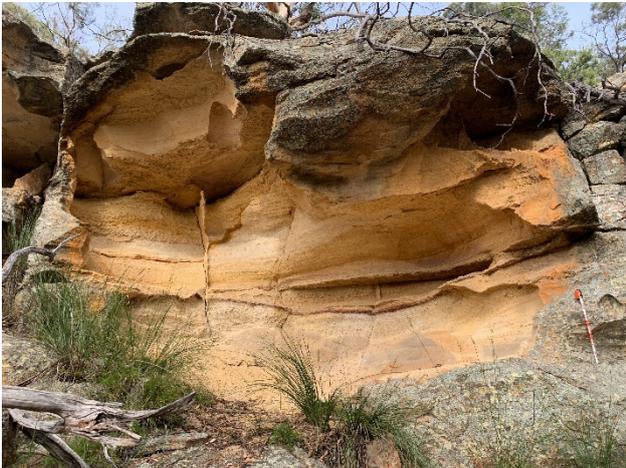
Plate 64: General photo RS CA8, facing south-west.

RS CA8 is a large overhang that has formed through chemical weathering. The overhang is steeply sloped and rocky and contains vertical and horizontal cracking. No Aboriginal objects or Potential Archaeological Deposit.

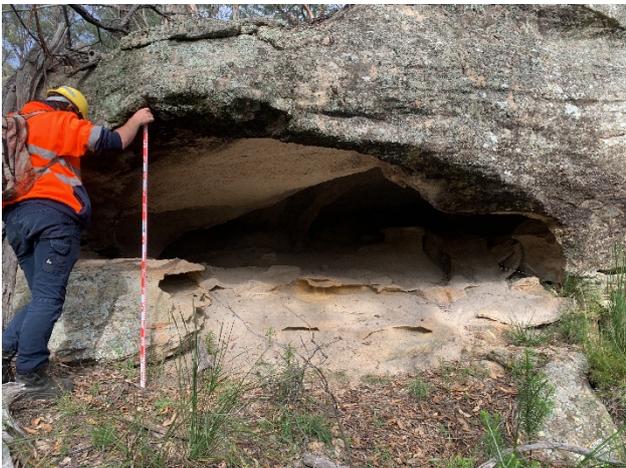
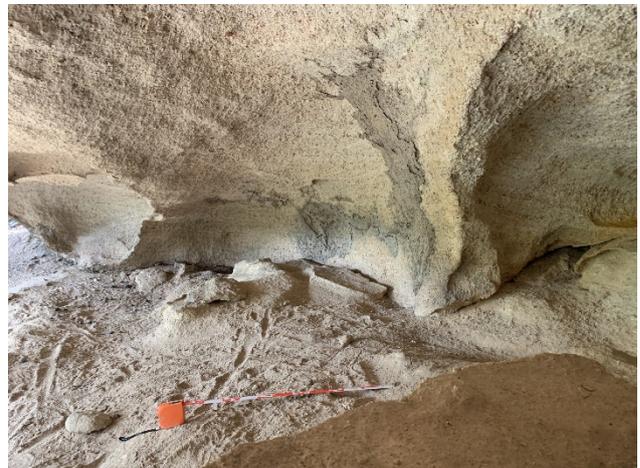
Plate 66: General photo RS CA9, facing west.

RS CA9 is low overhang facing east towards gully with burnt exterior and quartz gravel exfoliated sandstone floor thinly across stone floor. No Aboriginal objects or Potential Archaeological Deposit. Ants/termite nest running up back wall.

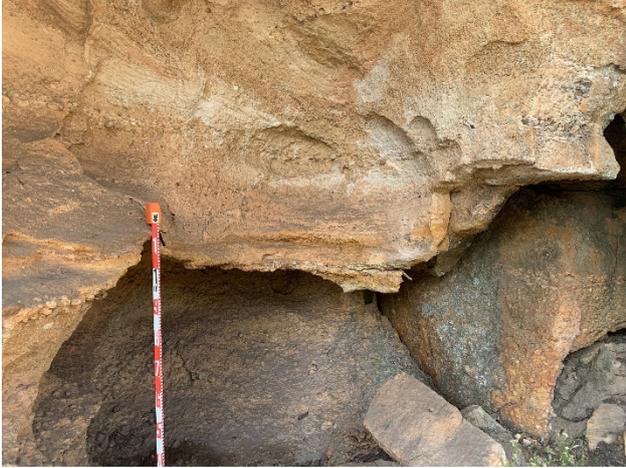
Plate 68: General photo RS CA10, facing south-west.

RS 10 is a large overhang situated mid slope overlooking hilly, a larger shelter is located south east with artefacts. the overhang contains sloped floor with block fall and silty brown soils with conglomerate sandstone pebbles. No Aboriginal objects or Potential Archaeological Deposit. Animals and birds have nested in the overhang.

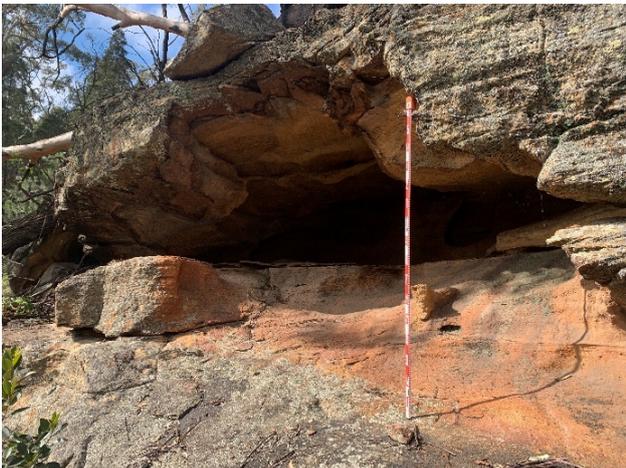
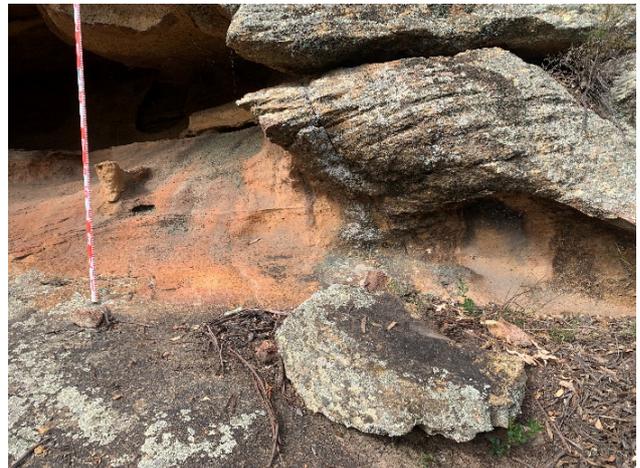
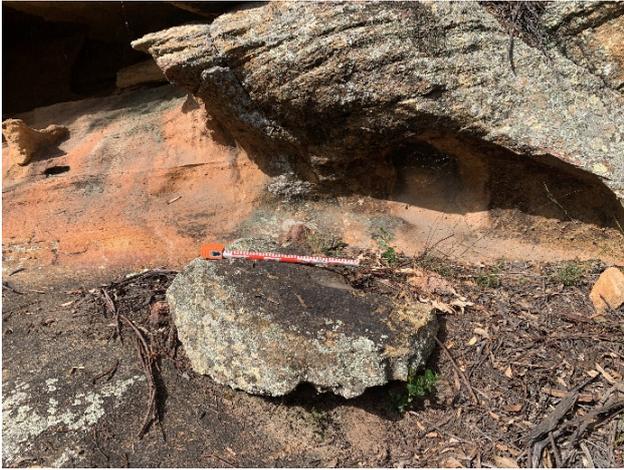
Plate 70: General photo RS CA12, facing south.

RS CA12 is an overhang that was requested to be recorded due to the presence of multiple grooves on blockfall at western end of shelter outside drip line. The grooves are following the ridges of sandstone in a similar weathering pattern to other parts of the shelter, are not internally smooth due to conglomerate inclusions and are exposed to rainfall. The dimensions of the grooves are not typical of cultural grooves. The grooves have most likely formed through natural processes.

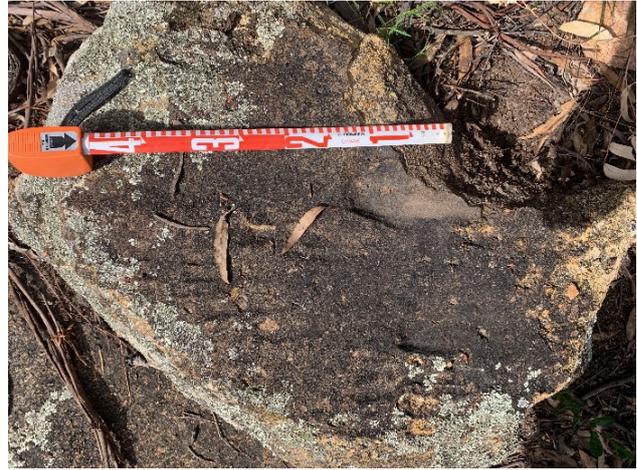
Plate 73: Grooves located at RSCA12.

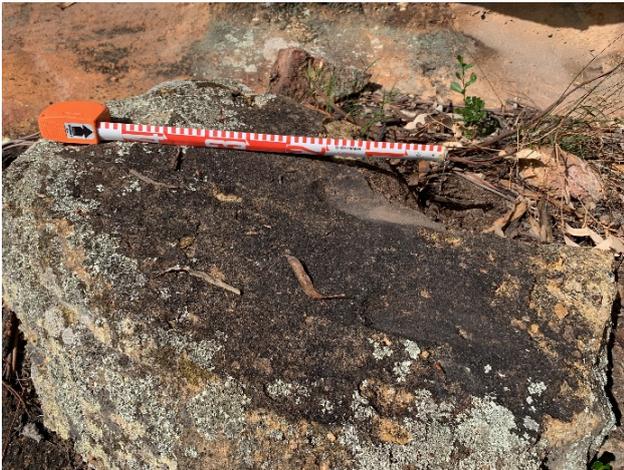
Plate 74: Grooves located at RSCA12.

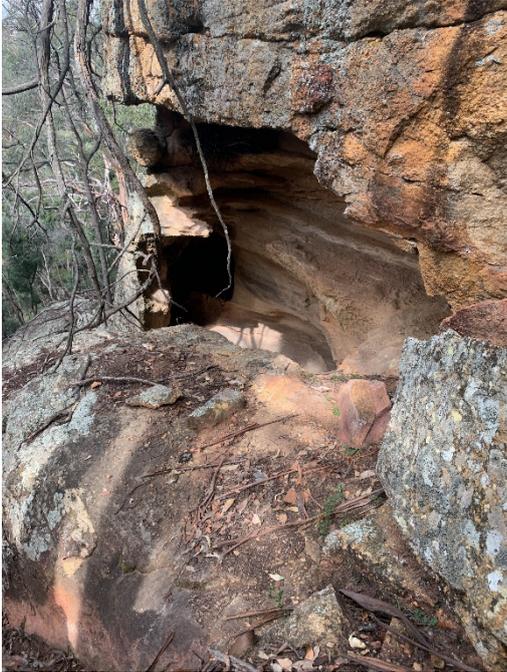
Plate 77: General photo RS CA8_CA8.

RS CA8_CA8 is a shallow overhang that has formed through chemical weathering and exfoliation. The overhang is being used as a bird habitat with two nests present within the overhang. No Aboriginal objects or Potential Archaeological Deposit.

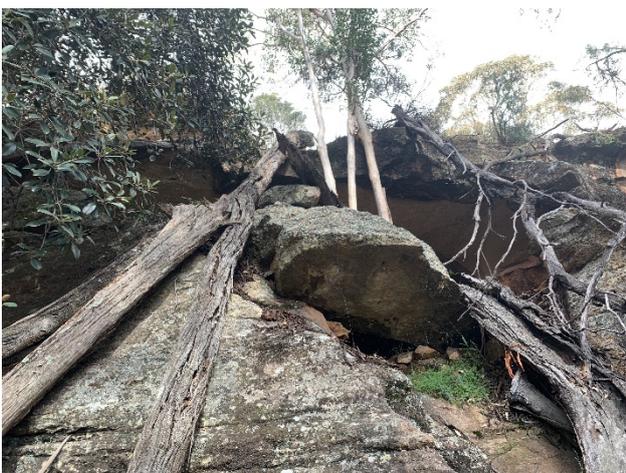
Plate 78: General photo RS CA16, facing south-west.

RS CA16 is a large overhang that is obscured by debris blocking the entrance. The overhang contained a stone floor with block fall and debris. The shelter was not entered due to blockage. No Aboriginal objects or Potential Archaeological Deposit.

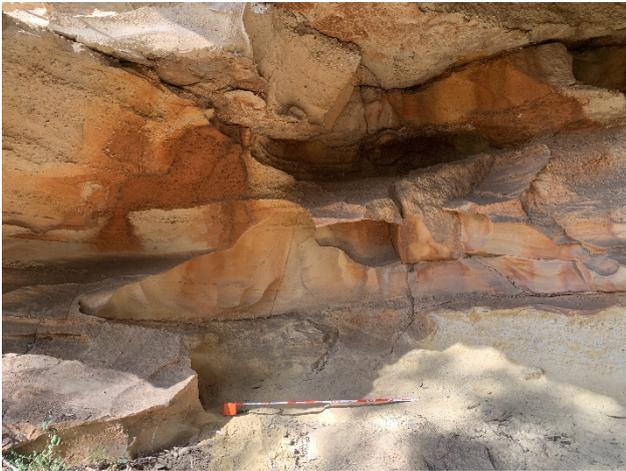
Plate 79: General photo RS CA17, facing south-west.

RS CA17 is a large overhang with a large vertical crack running from bedding plane and up through rear of shelter and across ceiling. Two graffiti panels scratched into iron oxide stained chemically weathered sandstone reading "H B A R 1934" and "A.G". No Aboriginal objects or Potential Archaeological Deposit.

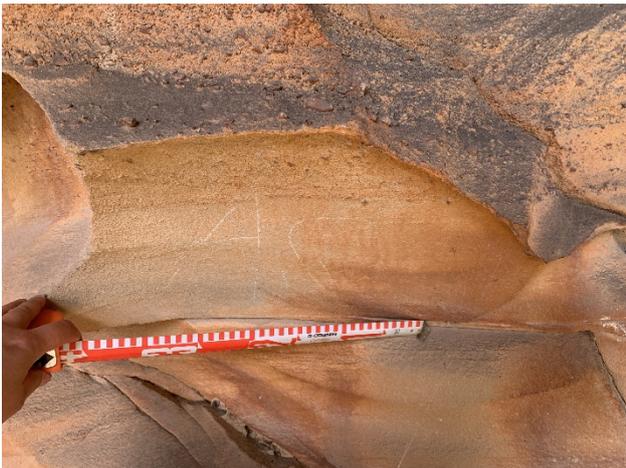
Plate 81: RS CA17 graffiti showing "A.G".

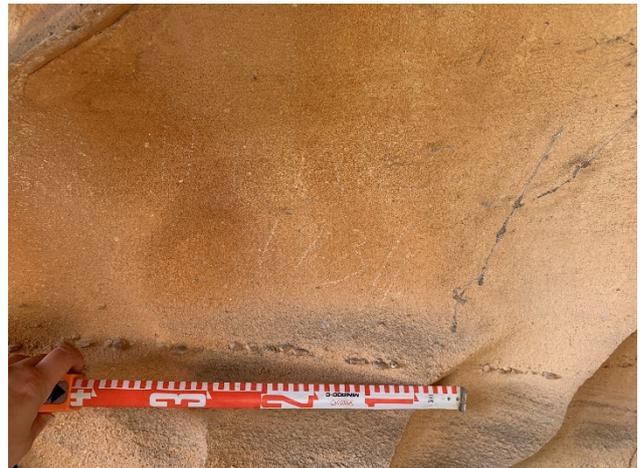
Plate 82: RS CA17 graffiti showing "H B A R 1934".

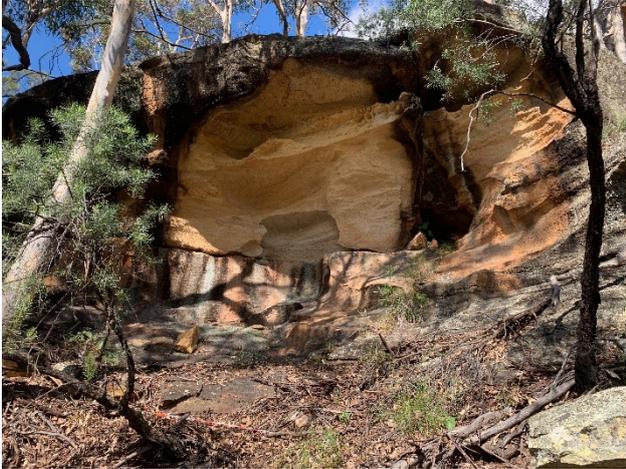
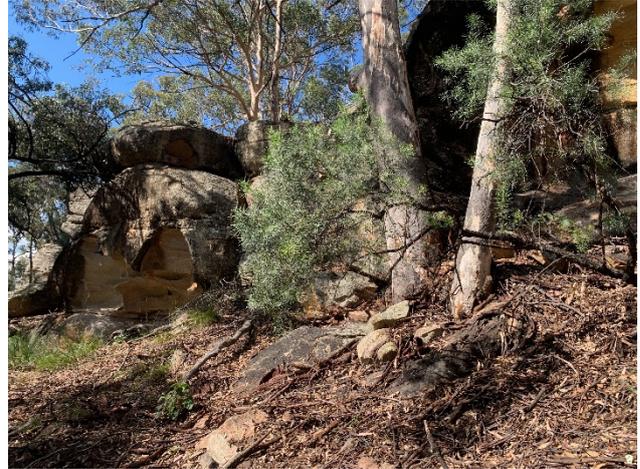
Plate 83: General photo RS CA18, facing south-west.

RS CA18 overhang that forms part of a continuous ridgeline. Wash is visible across most surfaces; the overhang is actively weathering and exfoliating. The overhang has a steep sloped stone floor. No Aboriginal objects or Potential Archaeological Deposit.

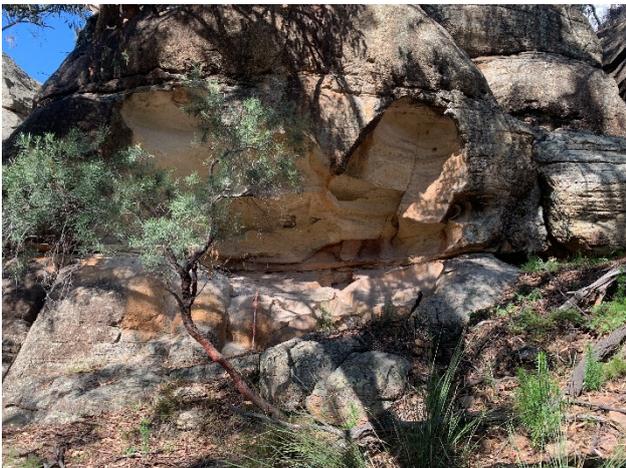
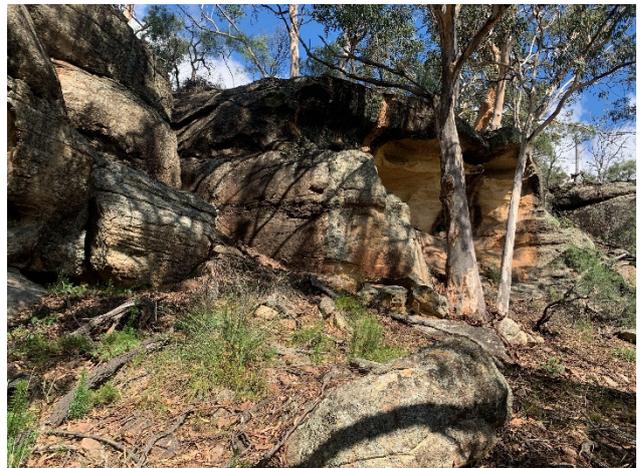
Plate 85: General photo RS CA19, facing south-west.

RS CA19 consists of a sandstone overhang located in the mid slope of steeply inclined hills. The overhang has formed through chemical weathering and exfoliation. The overhang has diagonal cracking, seepage and has been affected by fire. The overhang has a sloped stone floor with steep slope below dripline

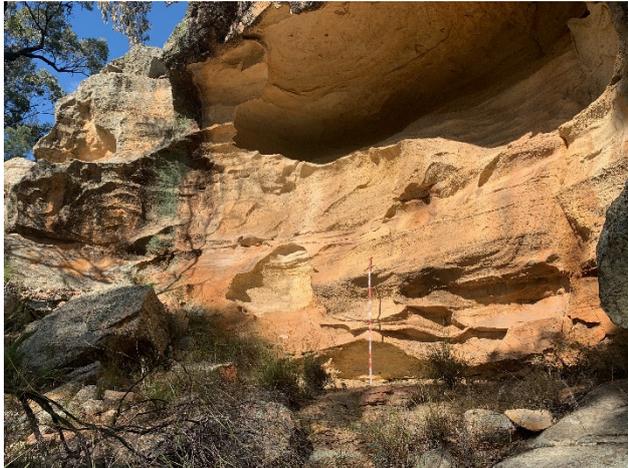
Plate 87: General photo RS CA20, facing south-west.

RS CA20 is a large sandstone overhang that has formed through chemical weathering and exfoliation. No Aboriginal objects or Potential Archaeological Deposit.

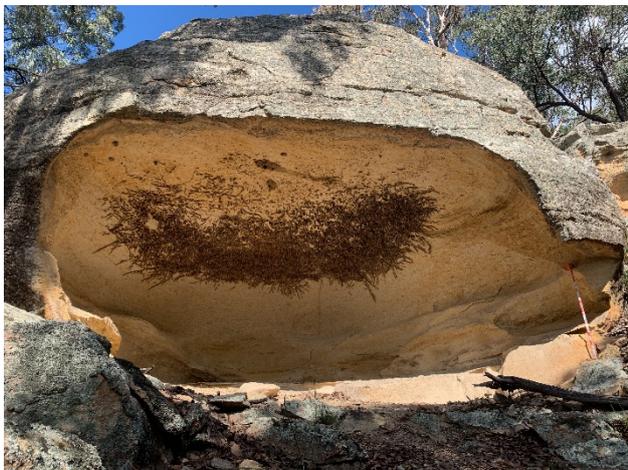
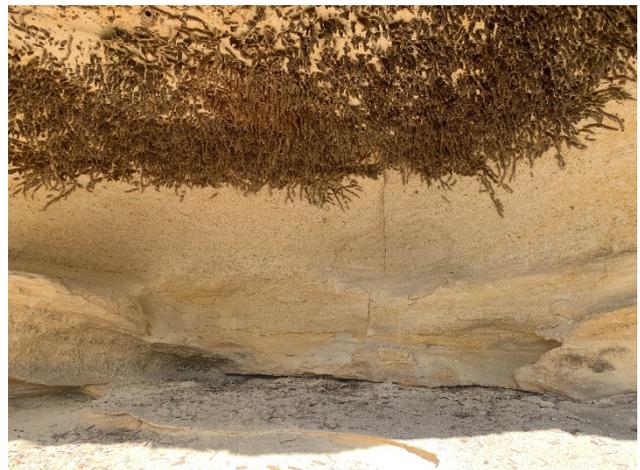
Plate 89: General photo RS CA21, facing north-west.

RS CA21 is a large overhang that contains a stone floor with a build-up of exfoliated sandstone at the dripline. A large non active wasp nest on was located on the ceiling of the overhang. No Aboriginal objects or Potential Archaeological Deposit.

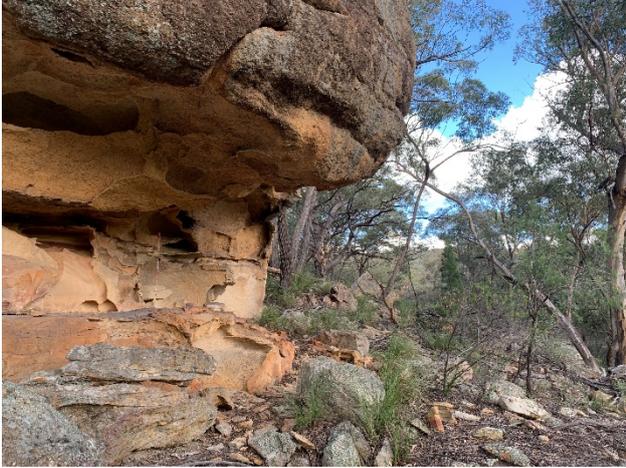
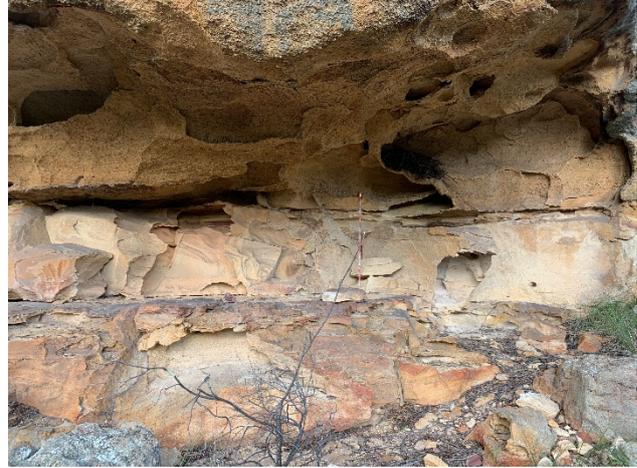
Plate 91: General photo RS CA22 within the landscape, facing north-west.

RS CA22 is a large overhang that contains a stone with small build-up of exfoliated sandstone conglomerate beneath the dripline. The overhang is actively weathering in a mid-slope position with a bird's nest present. Bushfire has affected the dripline and exterior of shelter. Macrovegetals visible similar erosion along patterns on block fall. No Aboriginal objects or Potential Archaeological Deposit.
