Aboriginal Cultural Heritage Assessment Report
Moolarben Coal Complex UG2 Modification, Ulan NSW
Mid-Western Regional Council Local Government Area
Prepared for Moolarben Coal Operations Pty Ltd

Prepared by Niche Environment and Heritage Pty Ltd | 19 November 2021

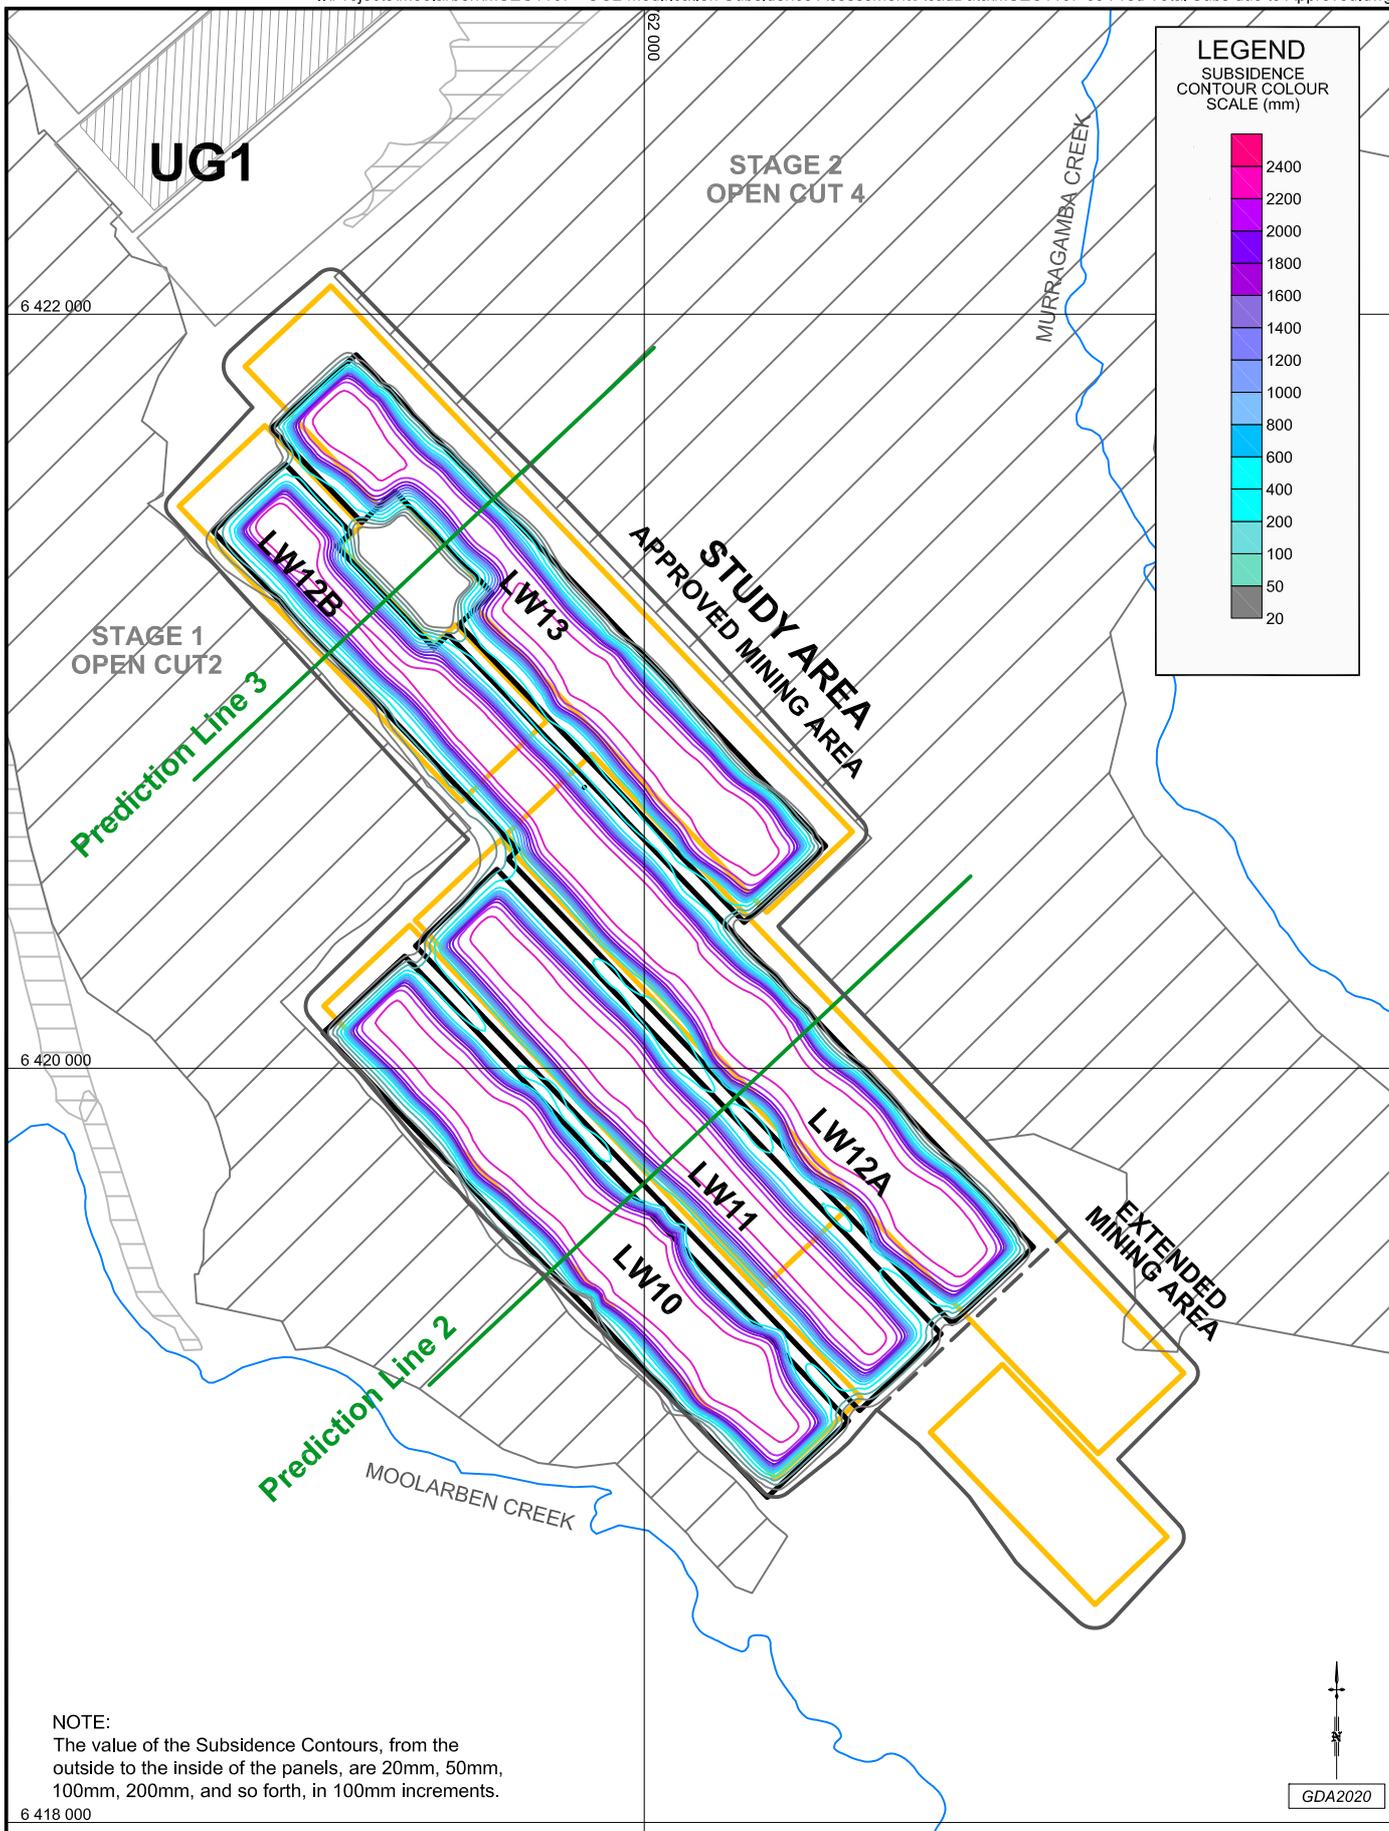
NOTE:
The value of the Subsidence Contours, from the outside to the inside of the panels, are 20mm, 50mm, 100mm, 200mm, and so forth, in 100mm increments.

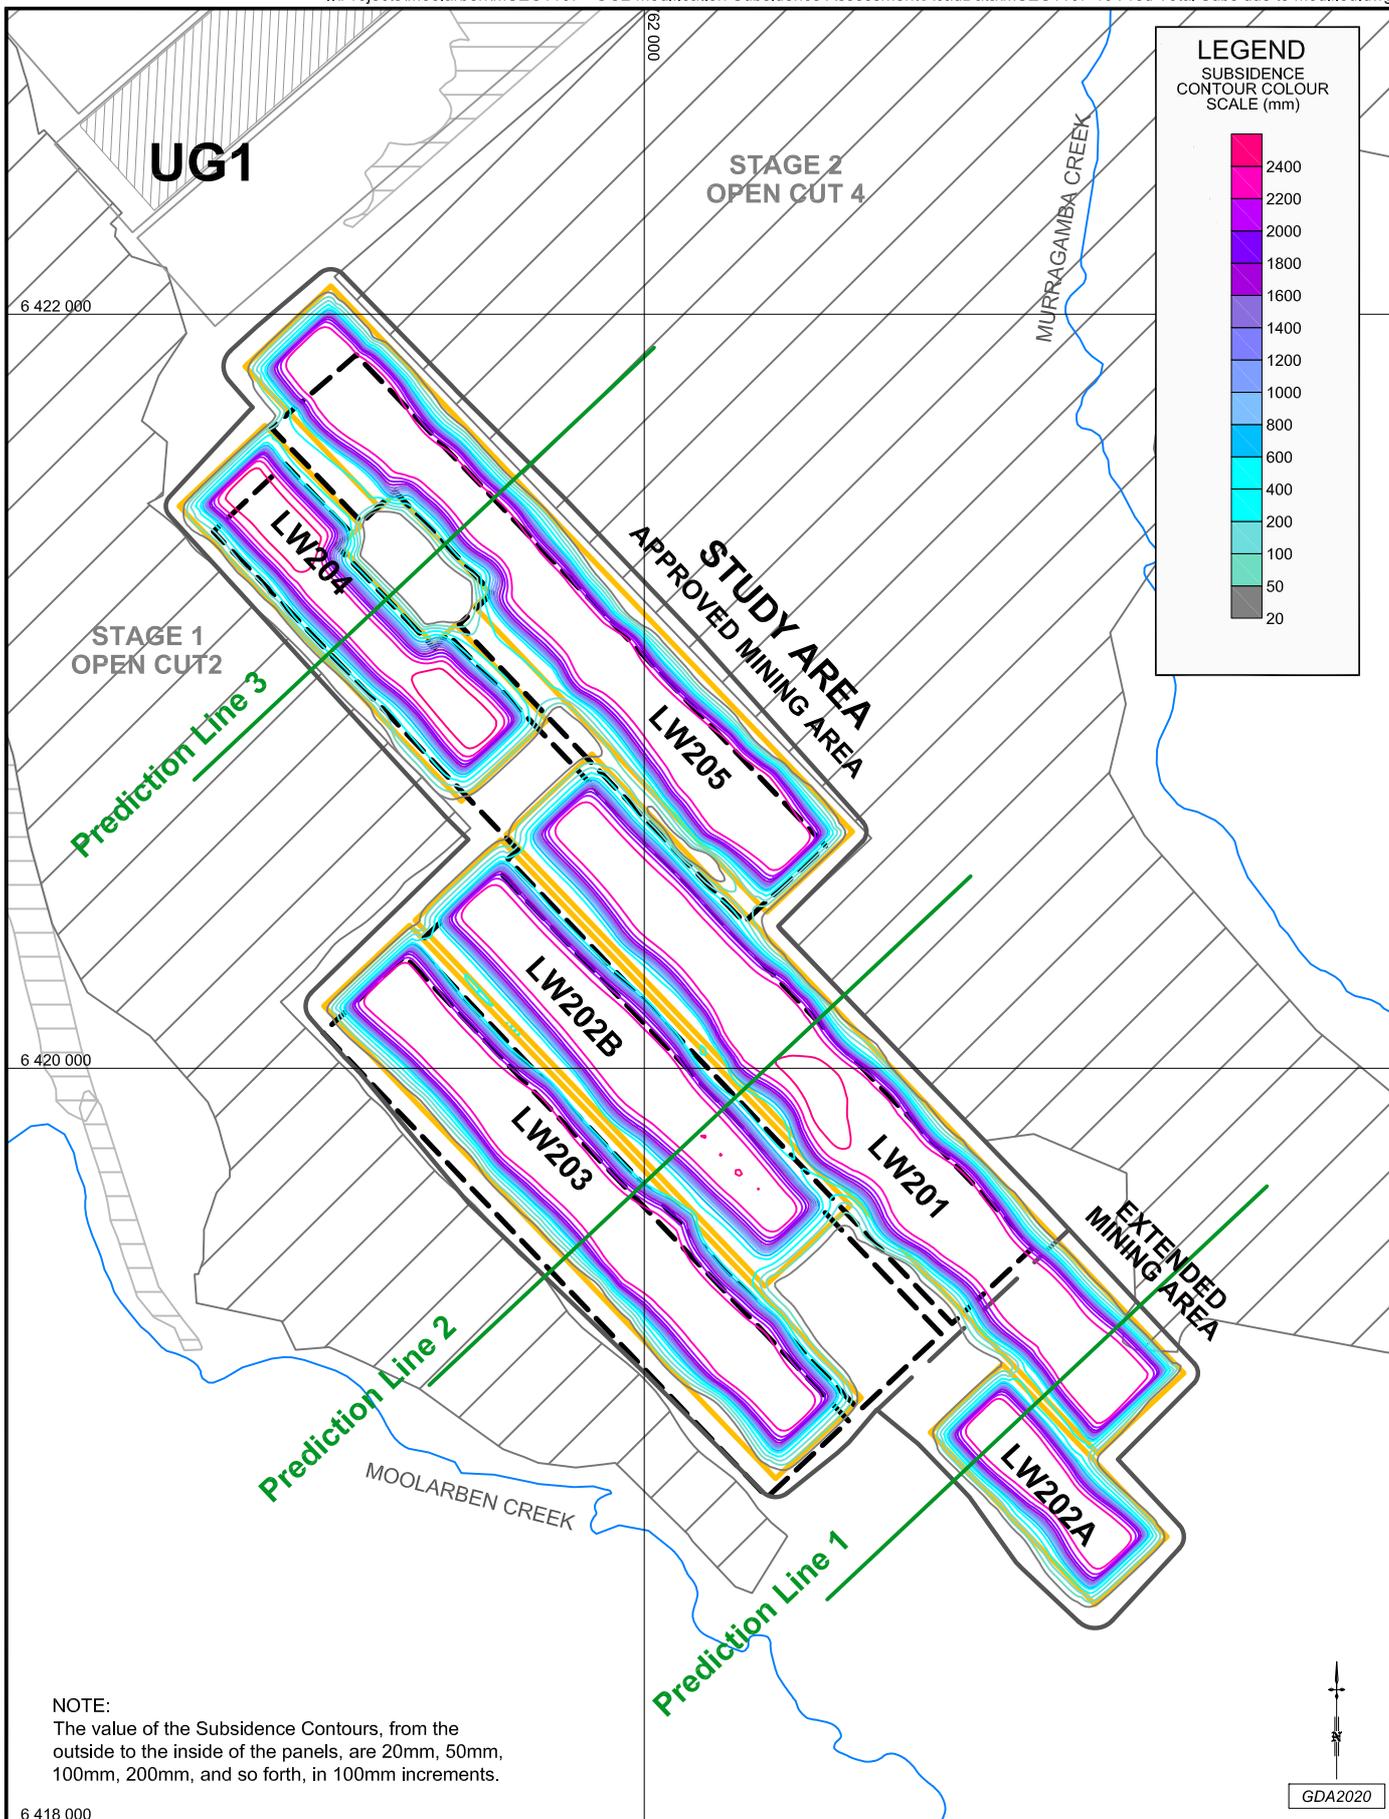
NOTE:
The value of the Subsidence Contours, from the outside to the inside of the panels, are 20mm, 50mm, 100mm, 200mm, and so forth, in 100mm increments.
