## Moolarben Coal Operations

### UG1 Longwalls 101 - 103

#### Monitoring of Aboriginal Heritage Site PAD 3

23 April 2020

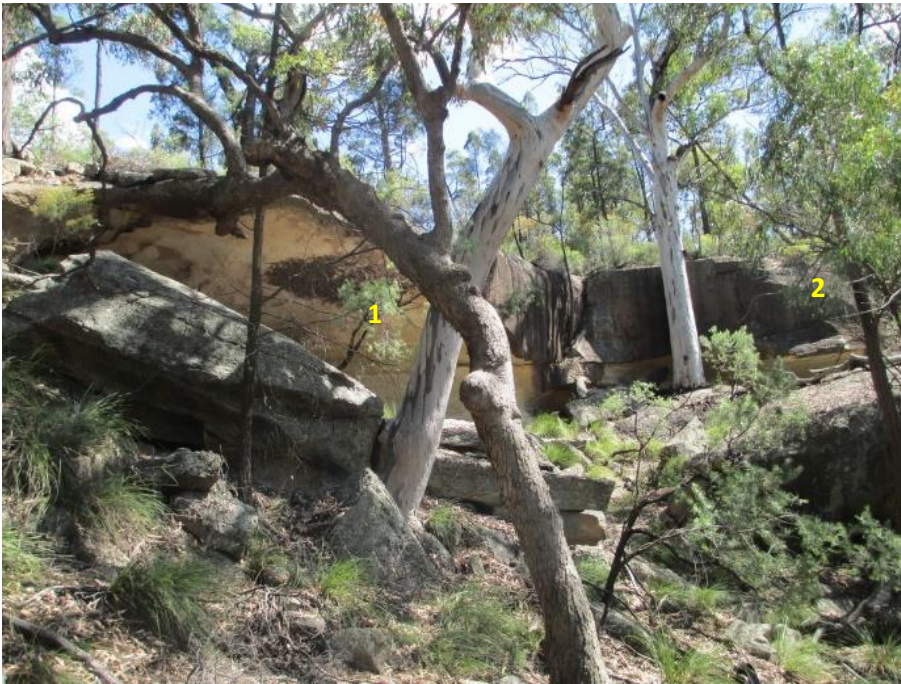
**Plate 1. PAD 3 (36-3-0839) 20 December 2016 (pre-extraction). Aspect: south.**

Observation points:

1. PAD 3 shelter ceiling (rock visible in this photo is inside of shelter) – eastern cavern
2. PAD 3 overhang – western cavern

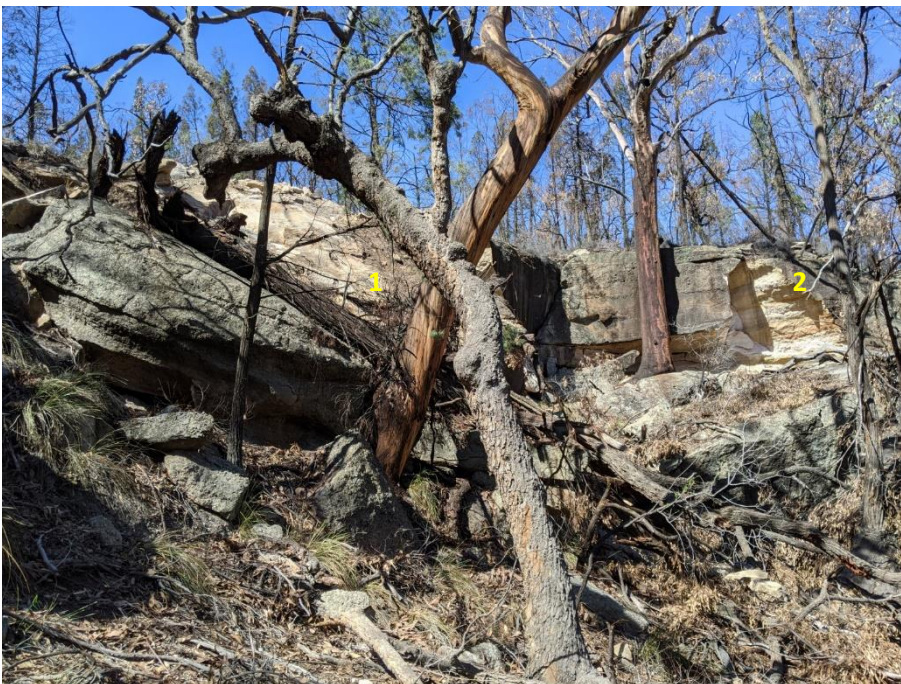
**Plate 2. PAD 3 (36-3-0839) 20 February 2020 (post-extraction). Aspect: south.**

Observation points:

1. Overhang collapse (rock visible is the former roof of the shelter)
2. Rock fall due to mechanical failure of rock matrix and movement along existing joints

The site was subject to subsidence effects resulting from the extraction of LW103. The subsidence impacts at the site included mass movement consisting of overhang collapse and rock falls. The subsidence impacts have resulted in the single artefact present at PAD 3 being covered by an overhang collapse, and most of the PAD present at site PAD 3 being also covered by debris from rock fall.

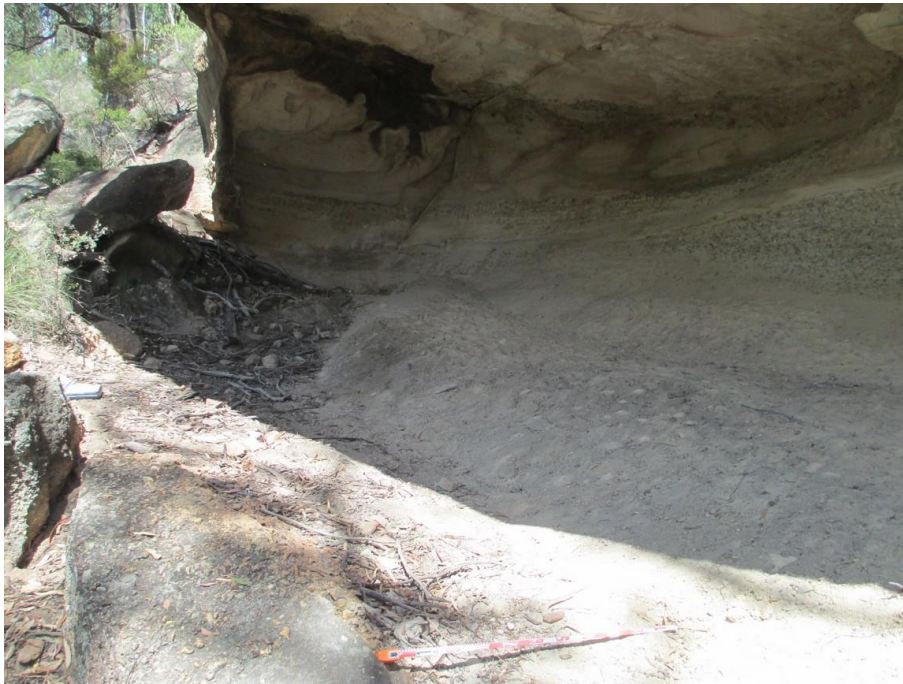
**Plate 3. PAD 3 (36-3-0839) 20 December 2016 (pre-extraction). Aspect: east.**

Observation notes:

Eastern cave of site PAD 3 with the identified single artefact located at the scale.

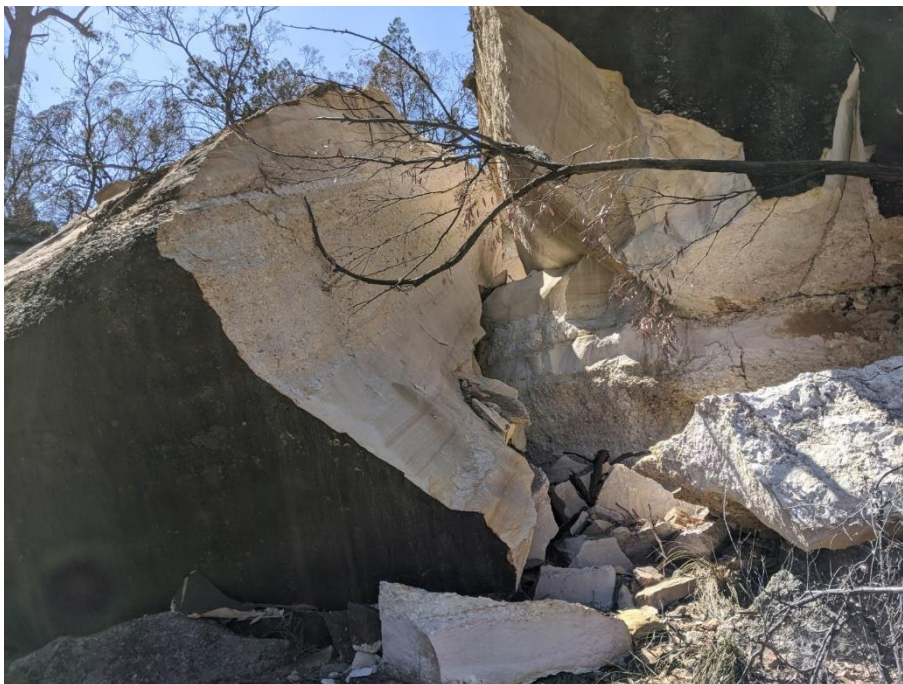
**Plate 4. PAD 3 (36-3-0839) 20 February 2020 (post-extraction). Aspect: east.**

Observation notes:

Eastern cave of site PAD 3 showing overhang rock collapse post-extraction. The artefact location and PAD is under the large fallen block.

Example of vertical cracking of rock matrix and horizontal movement along bedding planes present at right.

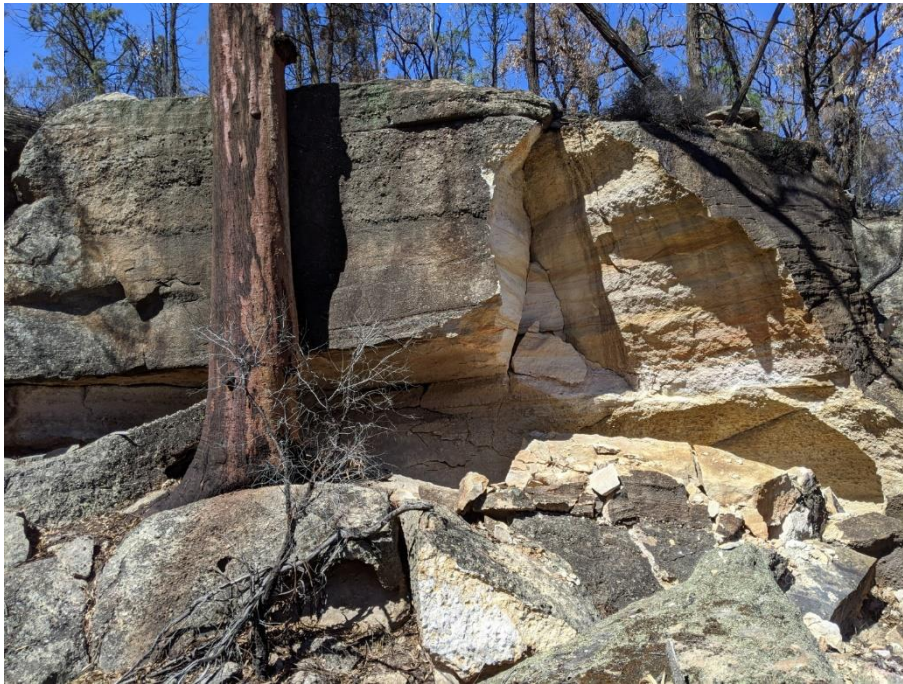
Plate 5. PAD 3 (36-3-0839) 20 February 2020 (post-extraction). Aspect: south.

Observation notes:

Western cave of site PAD 3 post-extraction. A section of the overhang had partially fallen. Cracking, separation of joints and deformation/cracking of softer sandstone below the overhang are visible.

Part of the area identified as PAD is under the rock fall, a small part of the PAD surface remains visible at left.

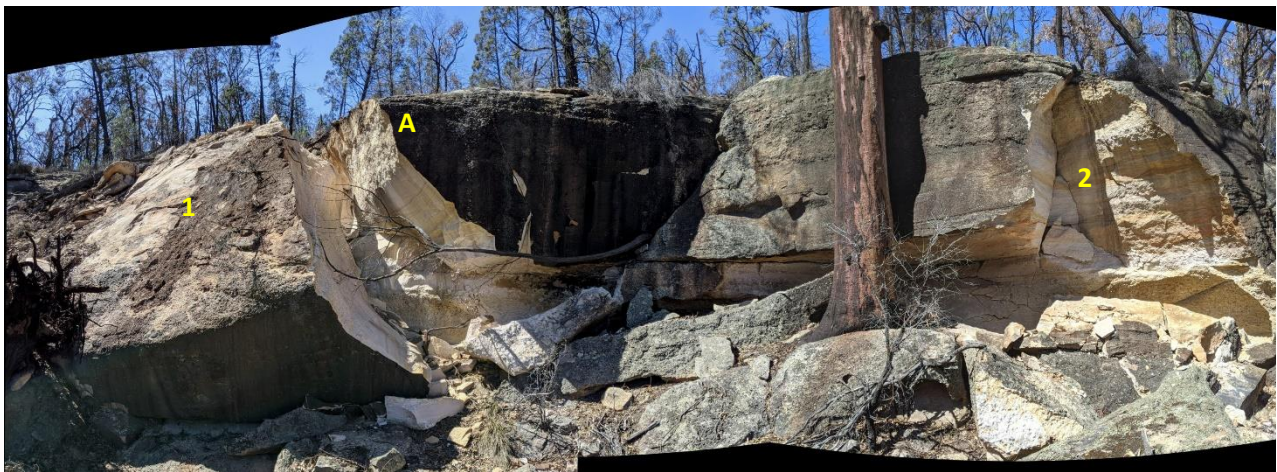
Plate 6. PAD 3 (36-3-0839) 20 February 2020 (post-extraction). Aspect: south-west. Panorama showing collapsed eastern cavern (left) and partially fallen western cavern (right).

Observation points:

1. Overhang collapse of eastern cavern. A pre-existing fissure has failed and the fallen block (that was the suspended overhang of the eastern cavern) has dropped down and collapsed forward.
2. Detachment and fall of rock from the outcrop above the western cavern.
- A. Original shape of the eastern cavern overhang can be seen in profile here
