Hume Highway Upgrade

# Holbrook bypass

Technical Paper 2 – Aboriginal Heritage

**HUME HIGHWAY TOWN BYPASS: HOLBROOK  
ABORIGINAL CULTURAL HERITAGE  
Cultural Heritage Assessment Report**

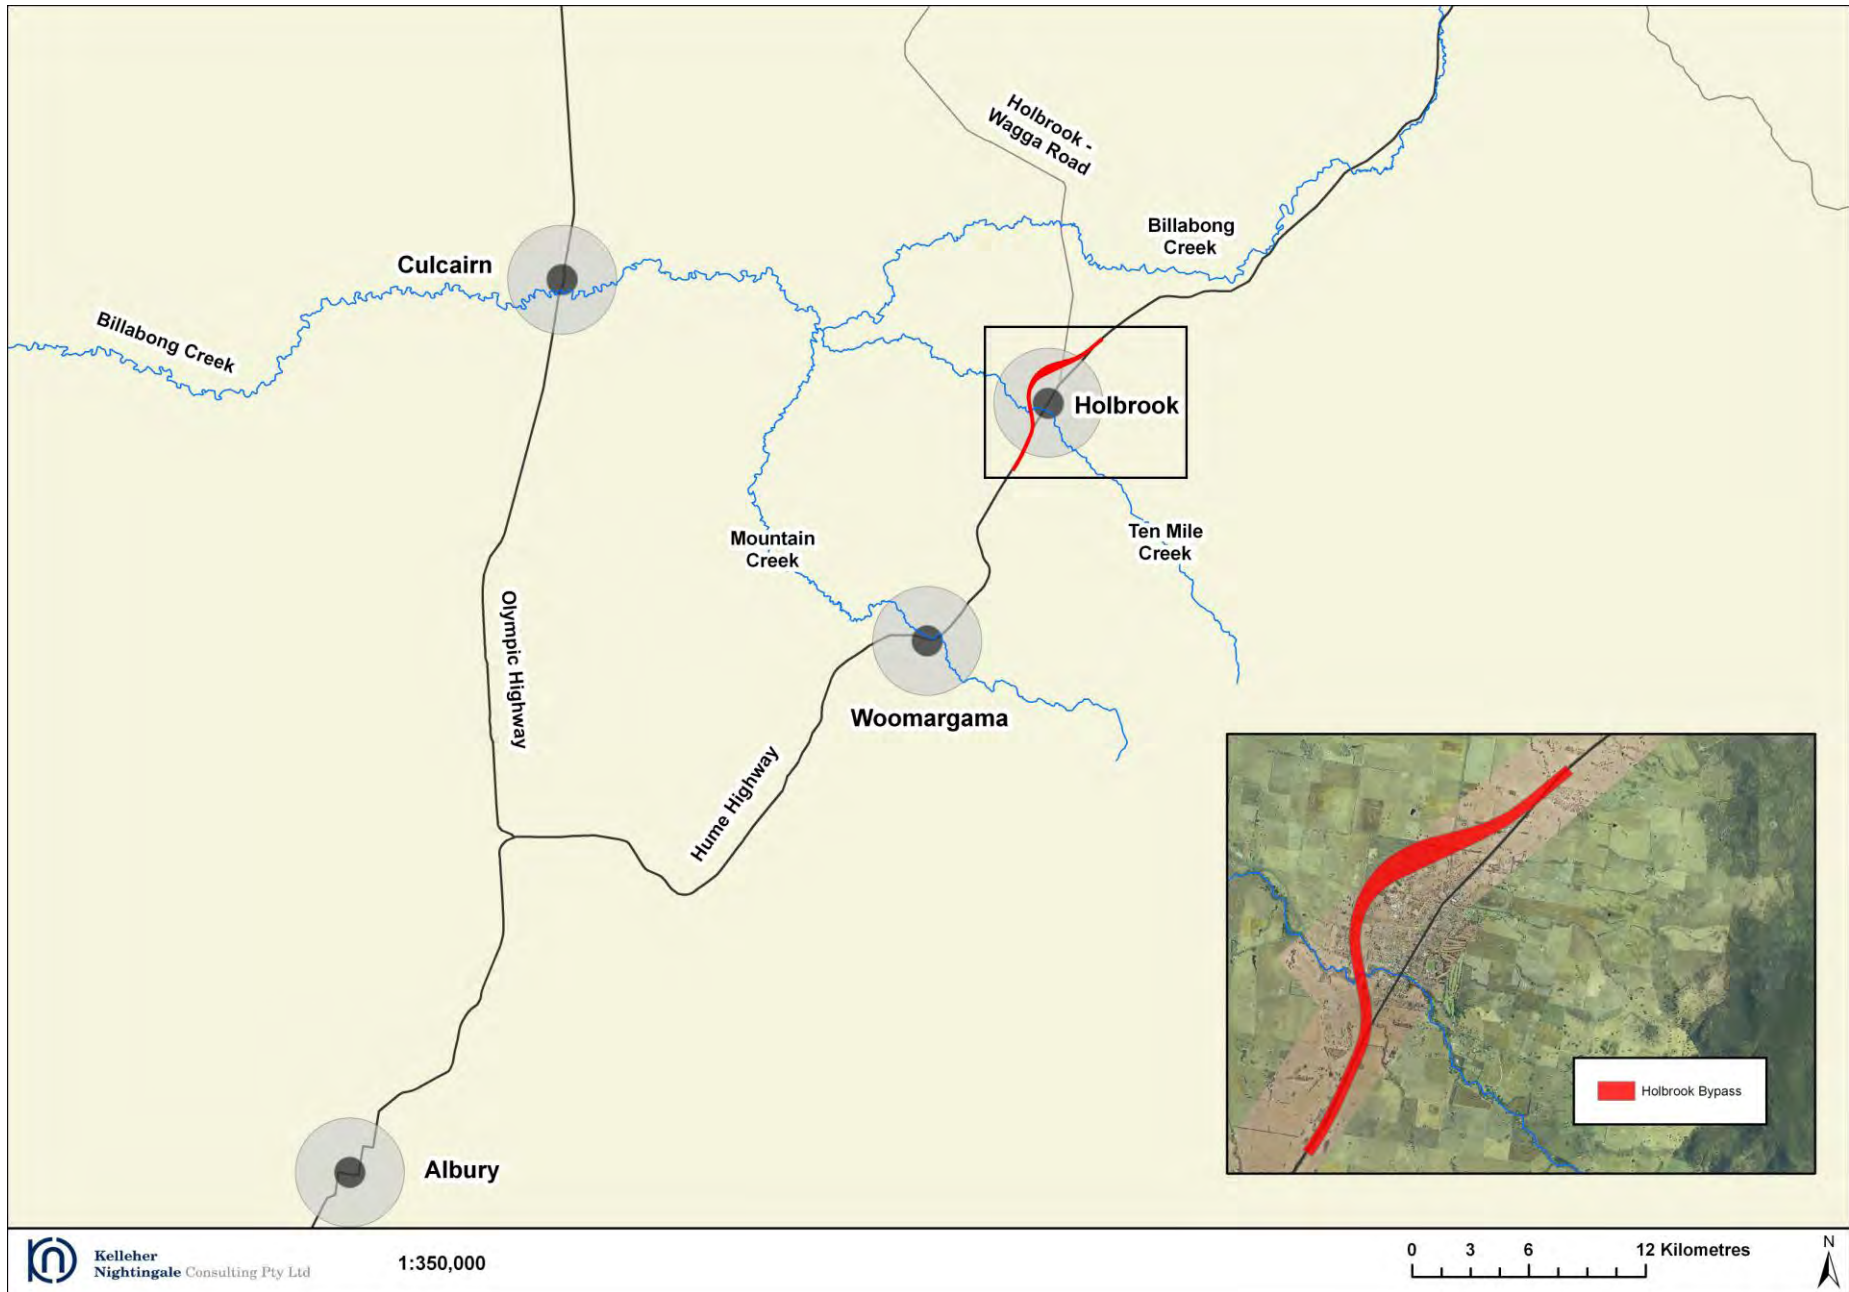
Figure 1. Study area location and bypass corridor

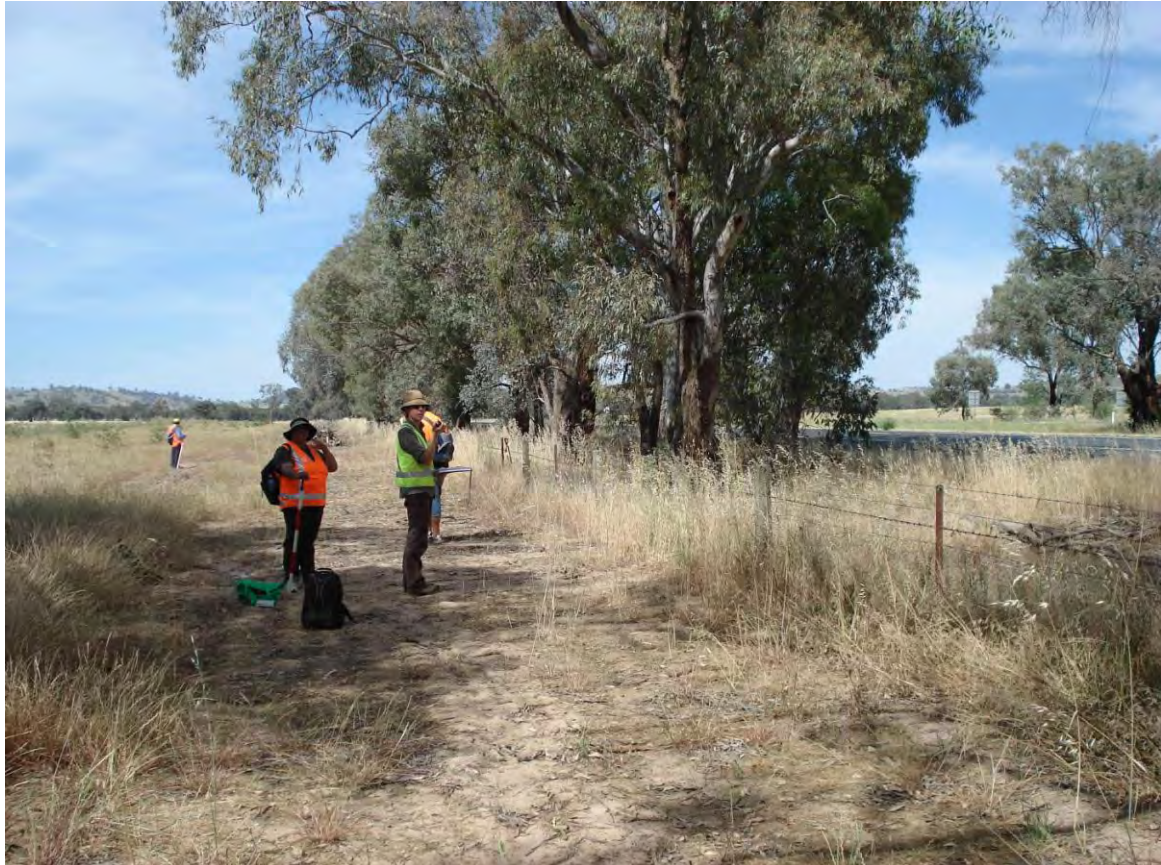
Plate 1. Exposure of HB2 with HB1 in the distance

Site HB2 was located across a broad, gently sloping terrace landform. The surrounding area was generally flat, with occasional well incised ephemeral drainage lines leading north/northeast towards Ten Mile Creek. The stable terrace landforms across the area are likely to exhibit an increased probability of archaeological deposit integrity, with relatively high survivability of artefacts. Site HB1 was located immediately to the south of HB2, whilst site HB3 was located immediately north of HB2. Sites HB1 and HB2 were intersected by a first order drainage line. Sites HB2 and HB3 are separated by a slight elevation change – HB2 was situated on a slightly higher level of the terrace.

Site HB2 consisted of a scatter of artefacts spread over a large area. The main surface visibility in the area was a tree planting easement along the eastern side of the Hume Highway. The relatively high surface visibility within the easement was a result of telecommunication cable installations and a vehicle access track. Site HB1 covered an area of approximately 650 m north-south and 150 m east-west (c.100,000m<sup>2</sup>). Within this area, a total of 15 artefacts were identified.

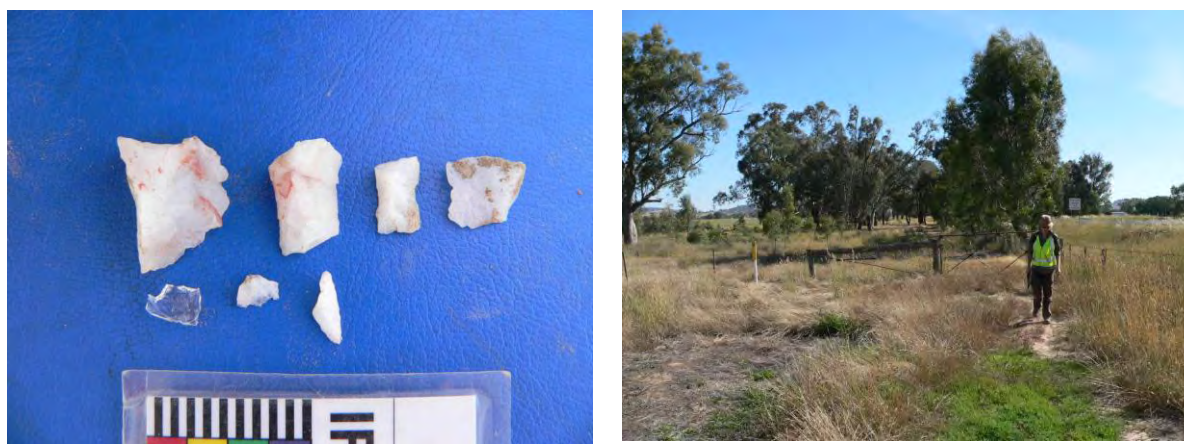
**Plate 2. Artefacts from HB2 and general location of HB3 north of the drainage channel**

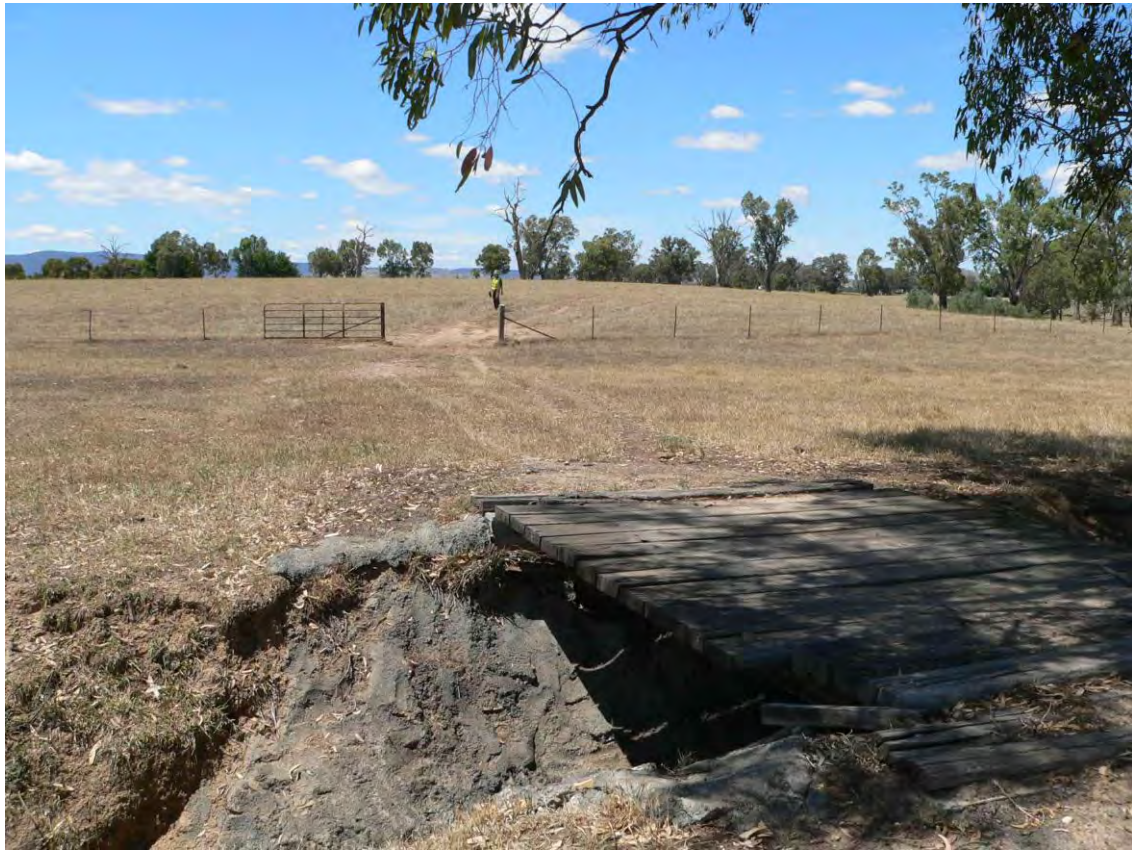
**Plate 3. HB4 facing south from the drainage channel looking towards the raised landform that is the site**

Site HB4 consisted of a scatter of artefacts over a large area. Their main surface visibility was at the break of slope in the northwestern portion of the site bordering the 3<sup>rd</sup> order tributary. Surface visibility over the remainder of the site was around 30%. The site covered an area of approximately 400m north-south and 200m east-west (c.80,000m<sup>2</sup>). Within this area a total of eight artefacts were identified. Subsequent test excavation identified significant quantities of artefacts.

The site is of particular archaeological significance because of the relationship with the swamp. It is a rare opportunity along the Hume to investigate the relationship between Aboriginal occupation and swamp based resources.

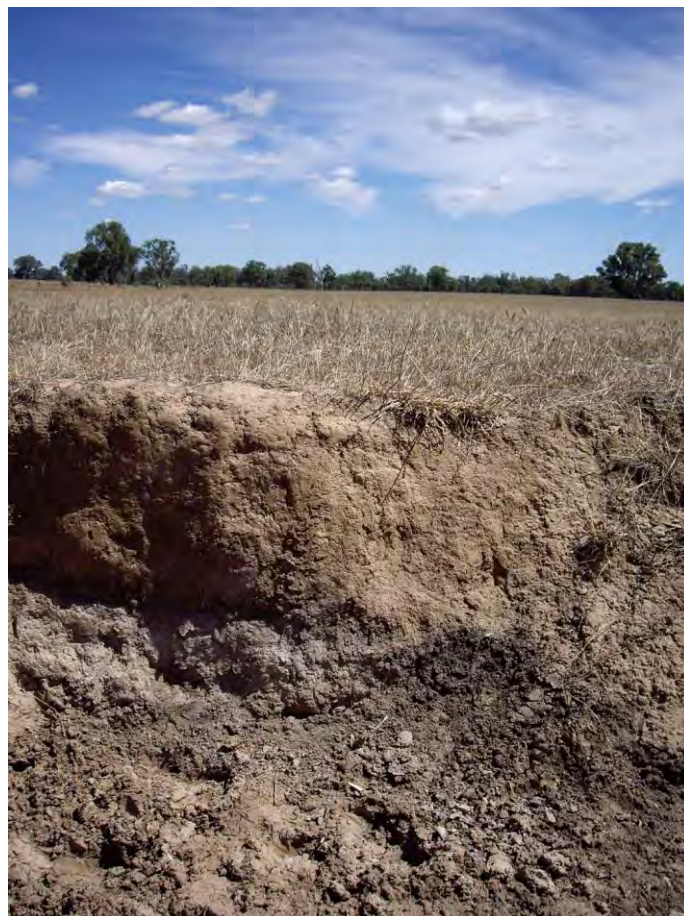
**Plate 4. Subsurface cutting north of HB4 showing homogenised alluvial deposit**

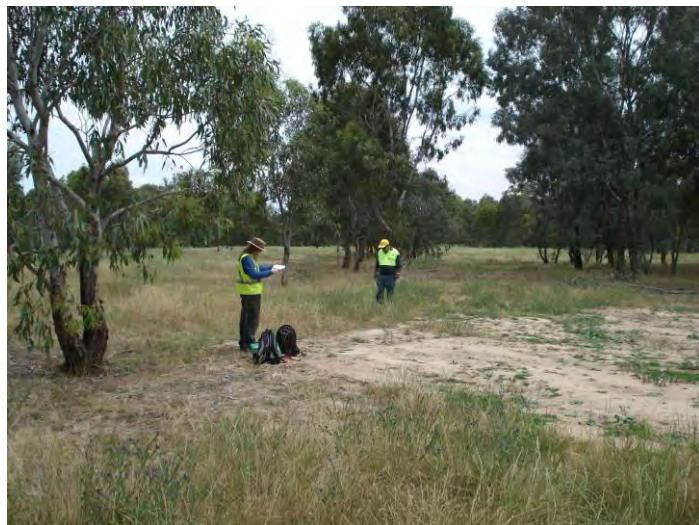
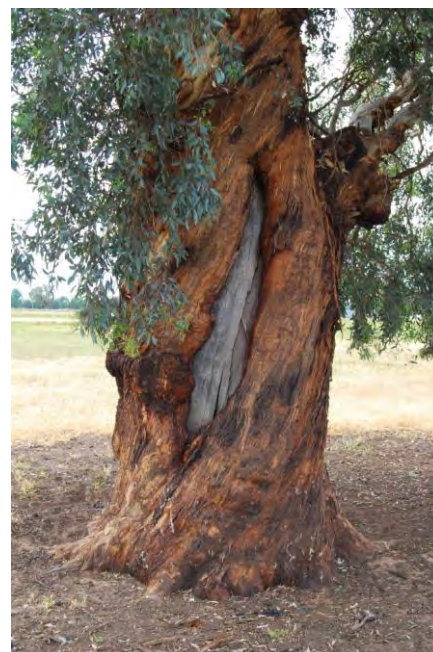
**Plate 5. Exposure located at HB5 (above) and scarred tree HB6 (right)**

Site HB5 covered an area of approximately 140m north-south and 80m east-west (c. 11,000m<sup>2</sup>). A scatter of artefacts was identified over an exposure in the northeastern corner of the site. The exposure was a heavily disturbed area that appeared to consist of dumped material forming a slightly raised area above the surrounding grass cover. Despite the evident impact to surface of the site the subsurface (alluvial sodosols) of HB5 appeared to be relatively undisturbed, and representative of a prominent position above Ten Mile Creek. A total of six artefacts were identified across the disturbed exposure at site HB5.

Site HB6 was a south facing scar on a Yellow Box tree located approximately 8 m north of [REDACTED]. The tree was in relatively good condition and approximately 25 m high. The scar was an elongate shape, measuring 1.30 m long, 40 cm wide and 20 cm thick.

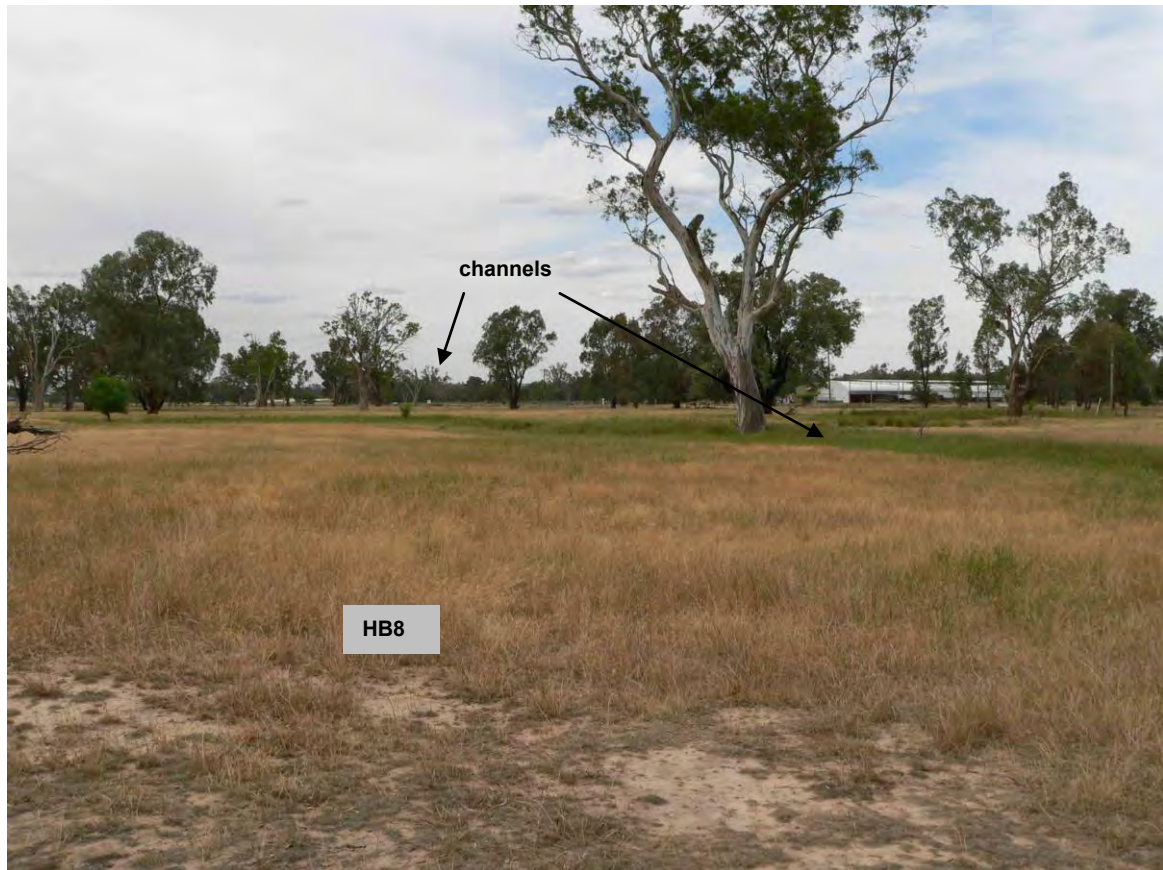
Plate 6. HB8 showing the raised surfaces (exposures) separated by drainage channels (dark green)

This site is located west of the road leading to the Holbrook tip and just south of the disused railway line opposite [REDACTED]. A collection of artefacts was found on a series of low level mounds in association with a drainage channel/springs flowing into Ten Mile Creek. This landform represents a smaller scale version of the landform associated with HB4. Both HB8 and HB4 offer an opportunity to investigate relatively well watered areas (swamp and springs) which have been little explored by previous archaeological investigations. Subsequent test excavation confirmed a significant but dispersed collection of artefacts associated with the billabong creek/channel. The site is in good condition with an alluvial soil displaying little degradation. The site has high archaeological significance.

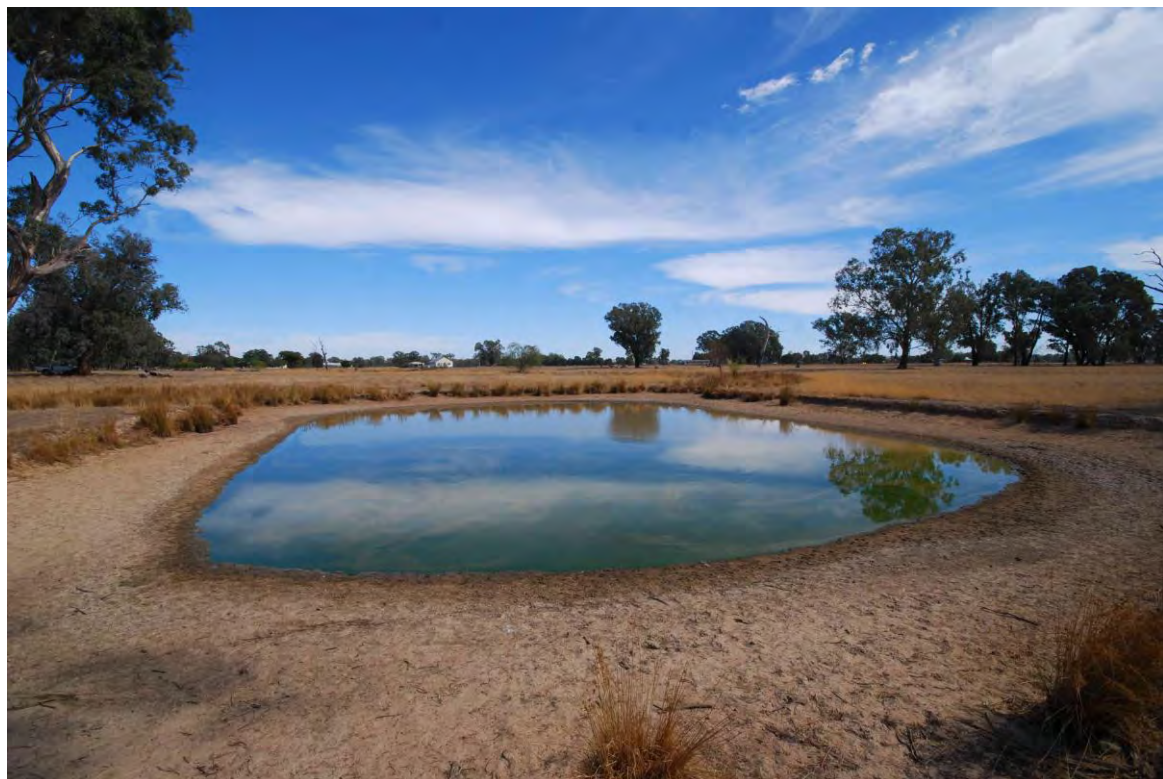
Plate 7. Billabong as part of the drainage system of HB8

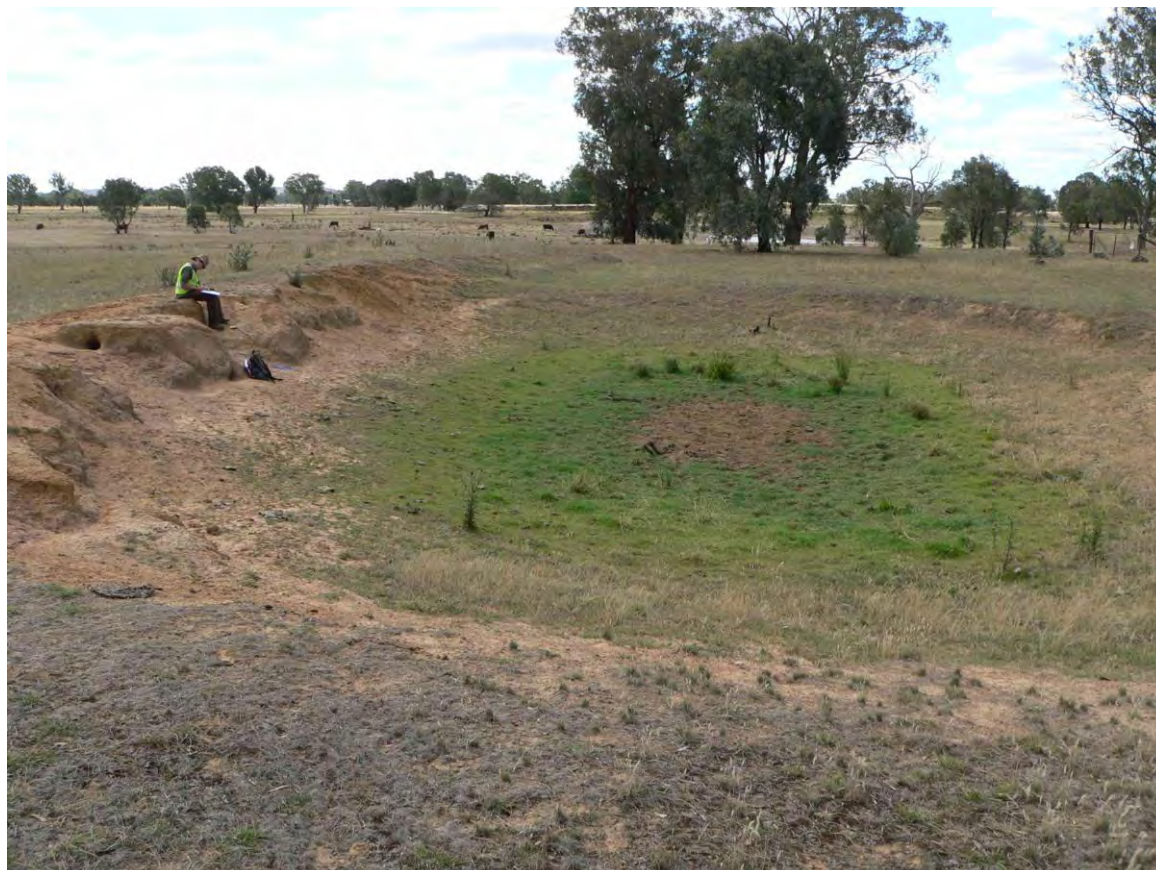
**Plate 8. Dry dam associated with HB9. Artefacts eroding from the southern (left) wall**

This site is located west of the Holbrook sewerage treatment tank. Site HB9 comprises a scatter of 10 quartz artefacts found over a 7m x 2m area the south wall of a small dry dam. The dam has been cut into lower hillslope overlooking a drainage basin, possibly a former wetland. Visibility along the south-west edges of the 40m x 20m dam was up to 80%. A cutting on the opposite (eastern) side of the dam exposed the natural soil profile of the slope, a pale grey brown loam over yellow clayey subsoil. Yellow clay from the excavation of the dam has been dumped on the opposite side to create the southern dam wall. This wall has inverted soil profile, with yellow clay over topsoil.

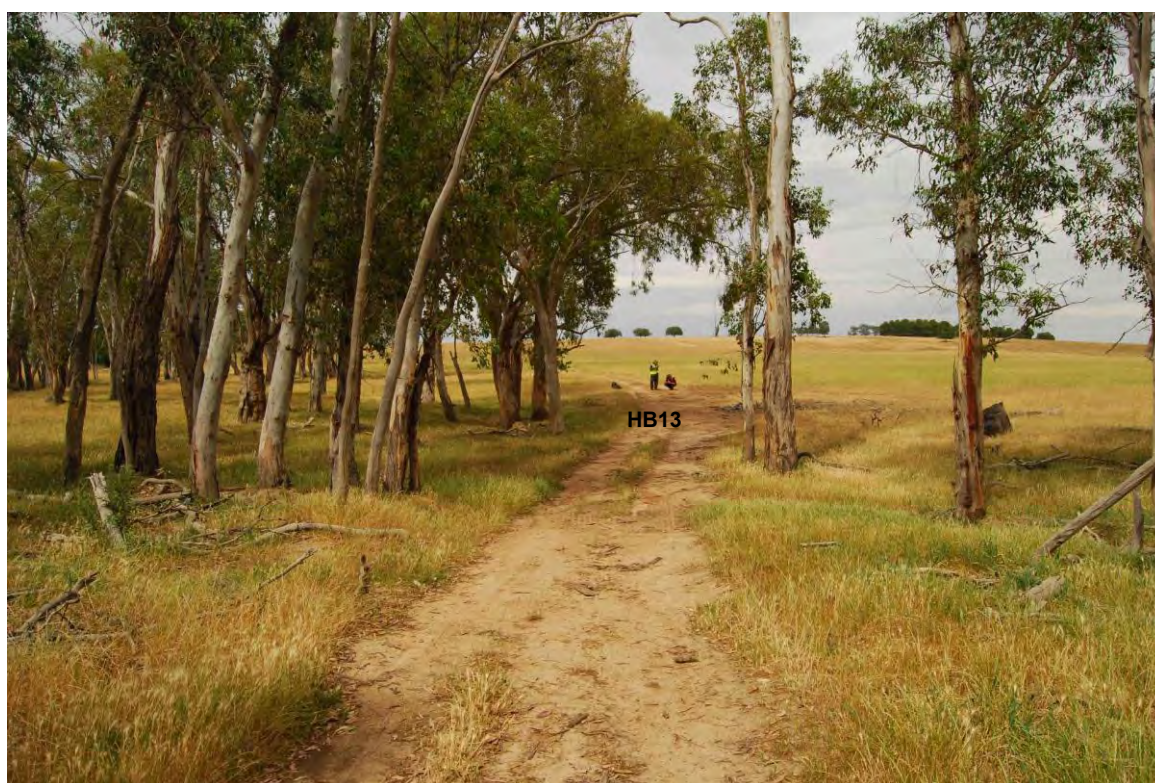
Plate 9. HB13 facing south towards Hillview. Artefacts were recorded along the track bisecting terrace/banks

This artefact scatter is approximately 1.5km north of Holbrook along a westerly flowing drainage channel associated with Billabong Creek. Artefacts were found on the low slopes (fans) and raised mounds associated with the channel. Site HB13 comprises a small scatter of three quartz artefacts on a 3m wide vehicle track (two wheel tracks each 1m wide, and central strip). Length of exposure was c.100m with the overall site covering an area of approximately 20,000m<sup>2</sup>. Two artefacts were within 1m<sup>2</sup>, and another artefact two metres further north. This is within 50m of the confluence of two dry ephemeral creek gullies. Exposure off the track was 0-10% due to grass cover. The soils in this area are transferral with gently inclined footslopes and fans which tend to suffer from erosion and have localised waterlogging. Archeologically these soils are unsuited to artefact survivability, but the slightly raised surfaces near the channel indicate marginally better conditions as expressed by the identified artefact scatter. Subsequent test excavation of the site identified a low density scatter of artefacts which have been impacted by colluvial and erosional forces. Based on these findings the significance of the site was determined to be low.

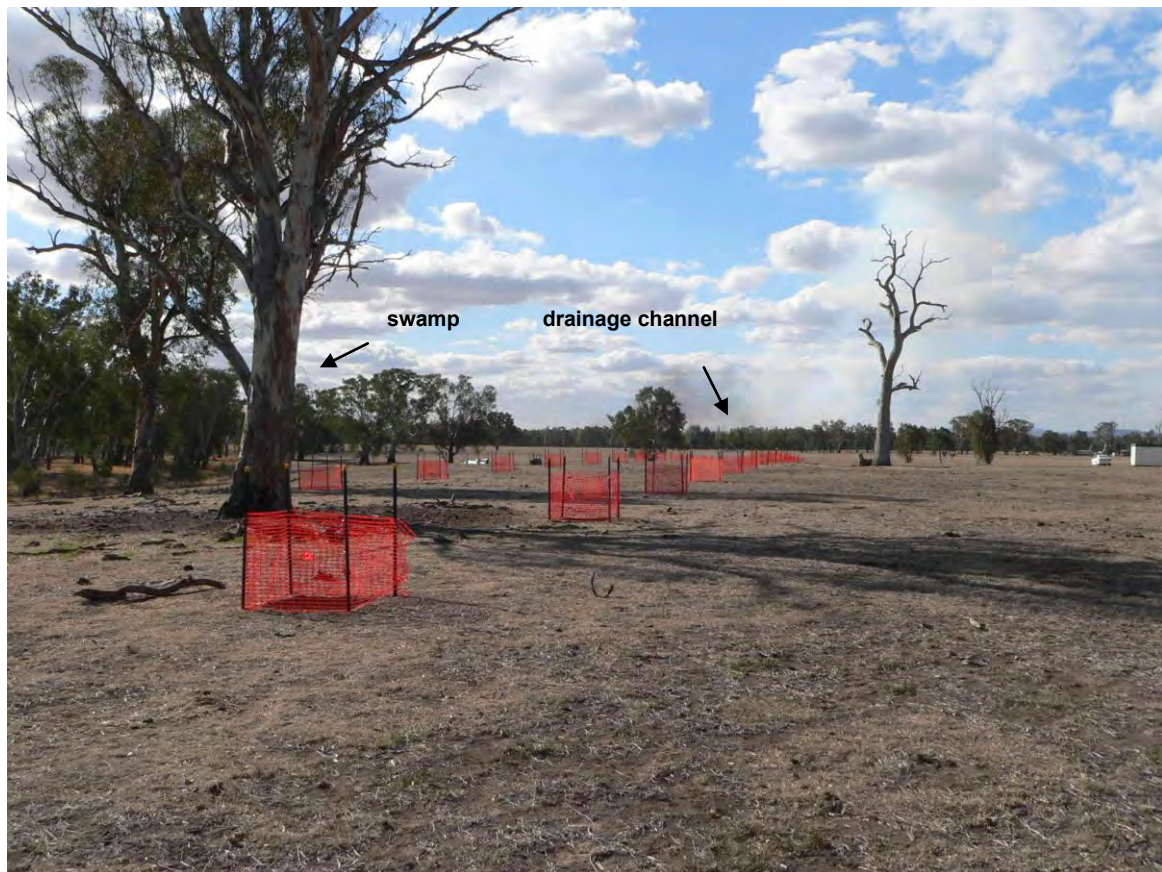
**Plate 10. TA18 (HB4) test area with Doodle Coomer Swamp on the right and highway left**

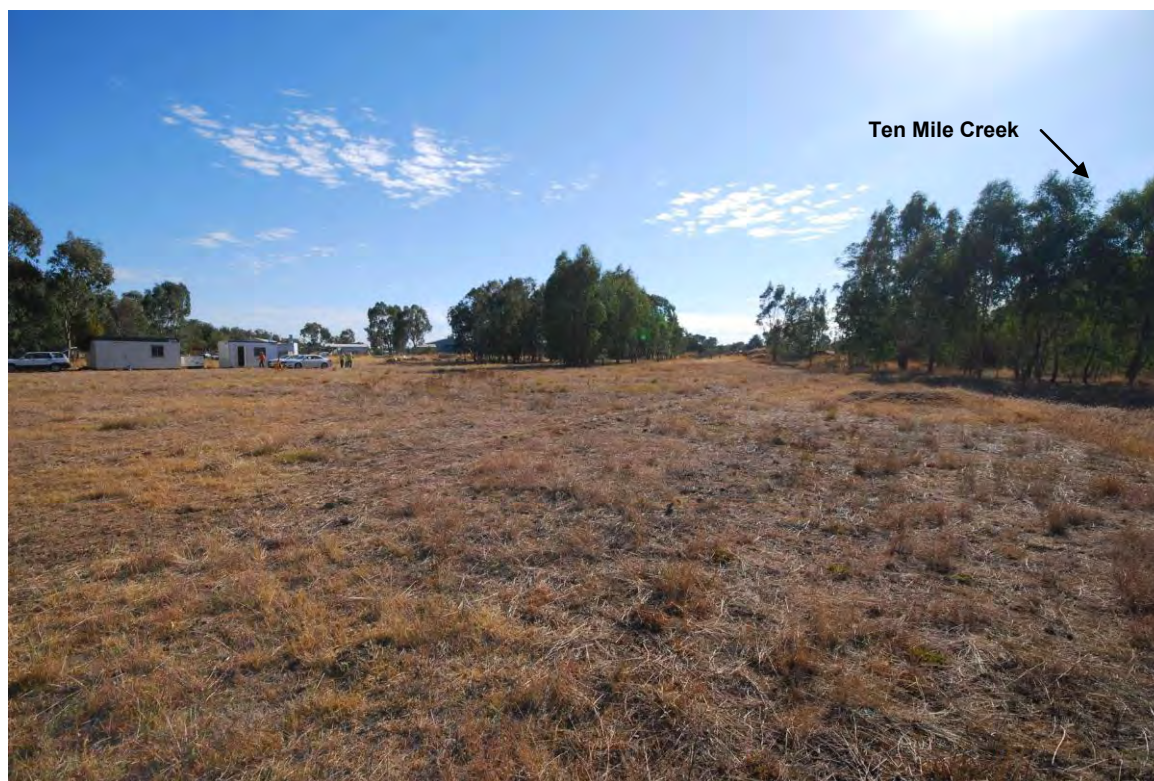
**Plate 13. View of TA19 (HB5) facing north with the bend in Ten Mile Creek on the right marked by trees**

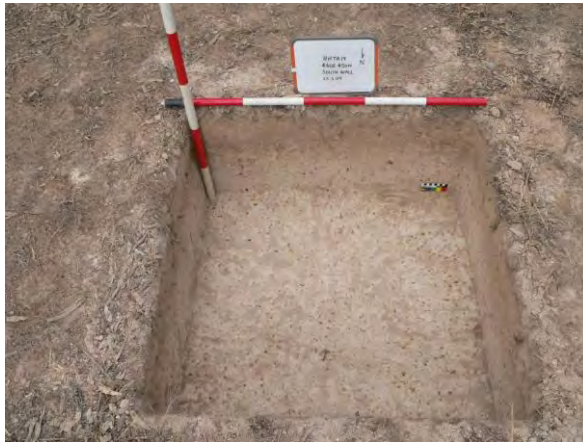
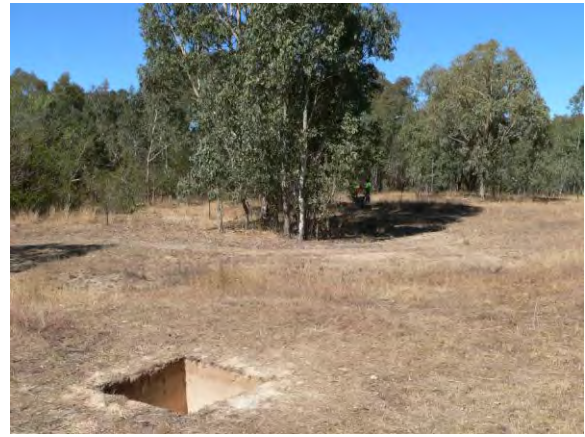
**Plate 14. Test squares at TA19 showing the less disturbed bleached soils above the bend in the creek**

Soil depths to non-artefact bearing clay ranged from 24cm in the northern half, to up to 84cm in the south, with an average depth of 40cm. Variable topsoil disturbance ranged from 10 to 20cm, although deposit below this was more intact than surface manifestations suggested. Profiles were typically two units comprising an upper mid brown unit (A1- 0 to 10/15cm) grading to a bleached unit with orange-brown ferro-manganese nodules (A2). Deeper deposit with more intact profiles was encountered on the edge of a large depression at the southern end of the tested area (465E 420N & 475E 430N). Test pit 475E 430N reached 60cm depth to clay, and pit 465E 420N had largely intact soils to 84cm depth. There were little or no natural soil inclusions except for ferro-manganese nodules at around 20-25cm depth. There was little or no charcoal found that could be dated.

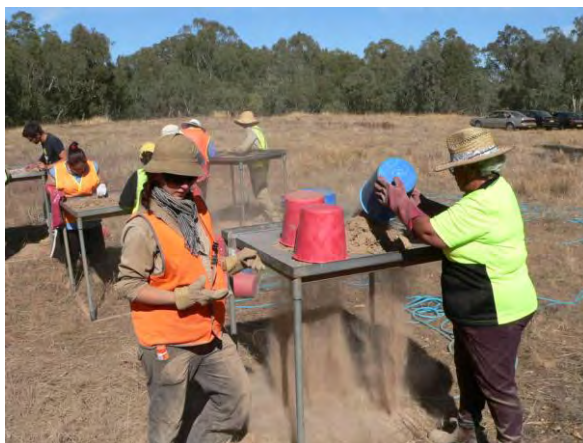
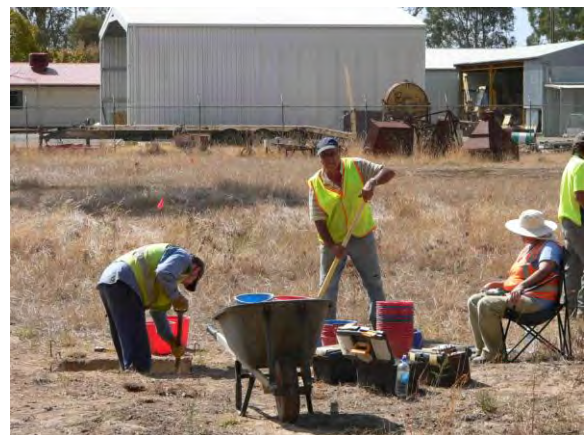
**Plate 15. Processing the deposit and hand excavation at TA19**

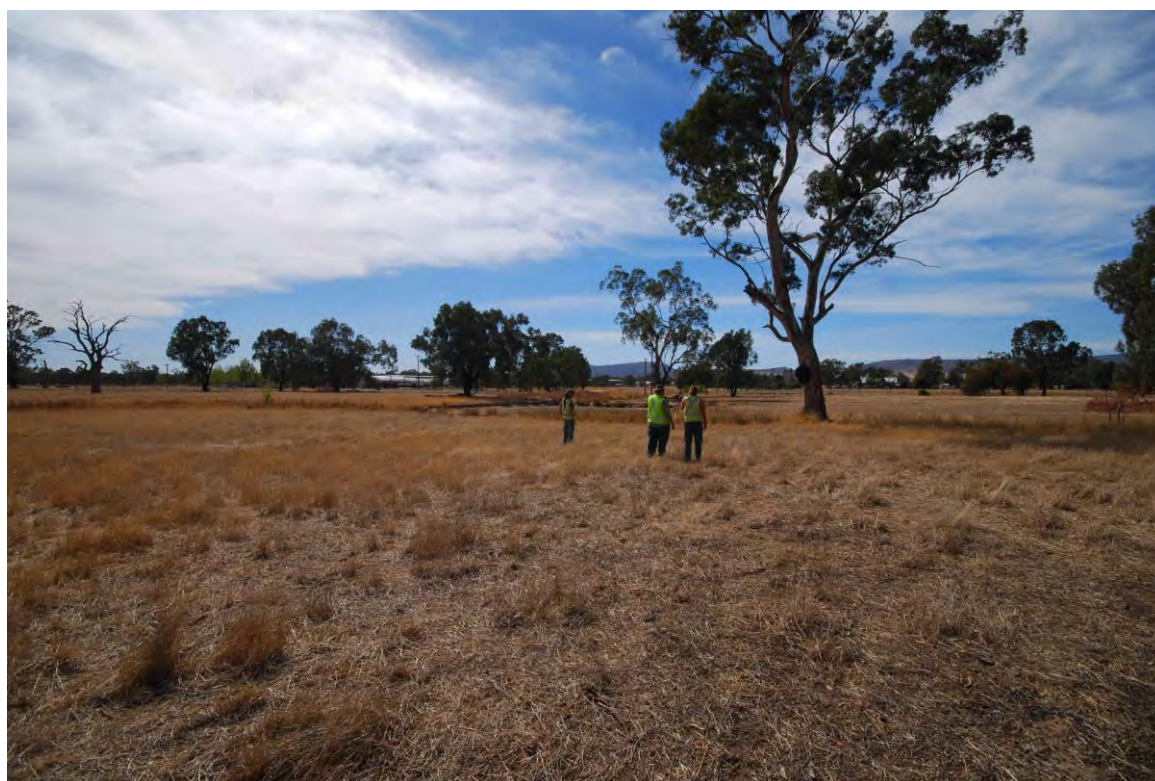
Plate 16. TA20 facing northeast towards Holbrook

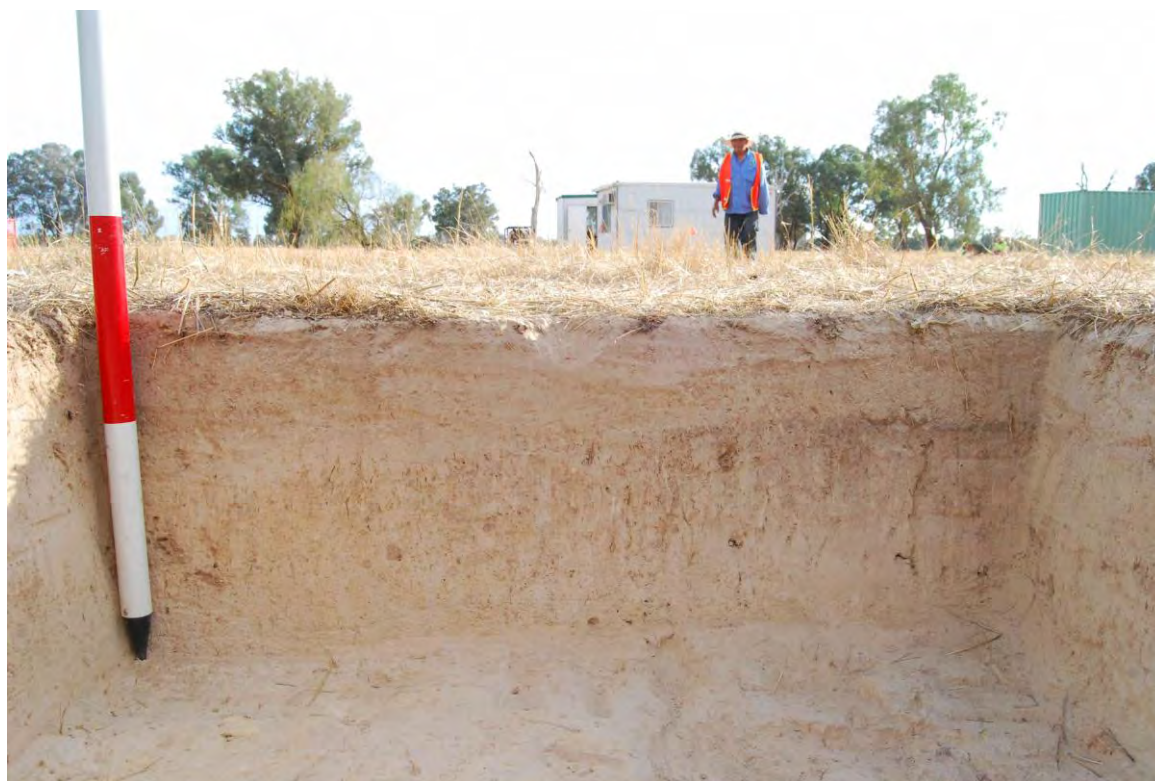
**Plate 17. Soloths displaying a high level of stability within the (relatively young) yellow dermosols**

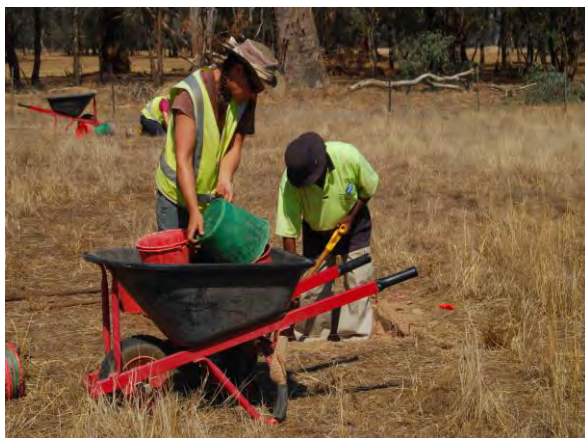
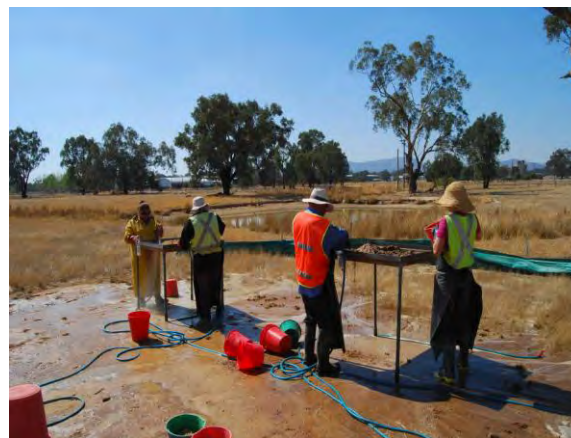
**Plate 18. TA20 excavations and sieving area**

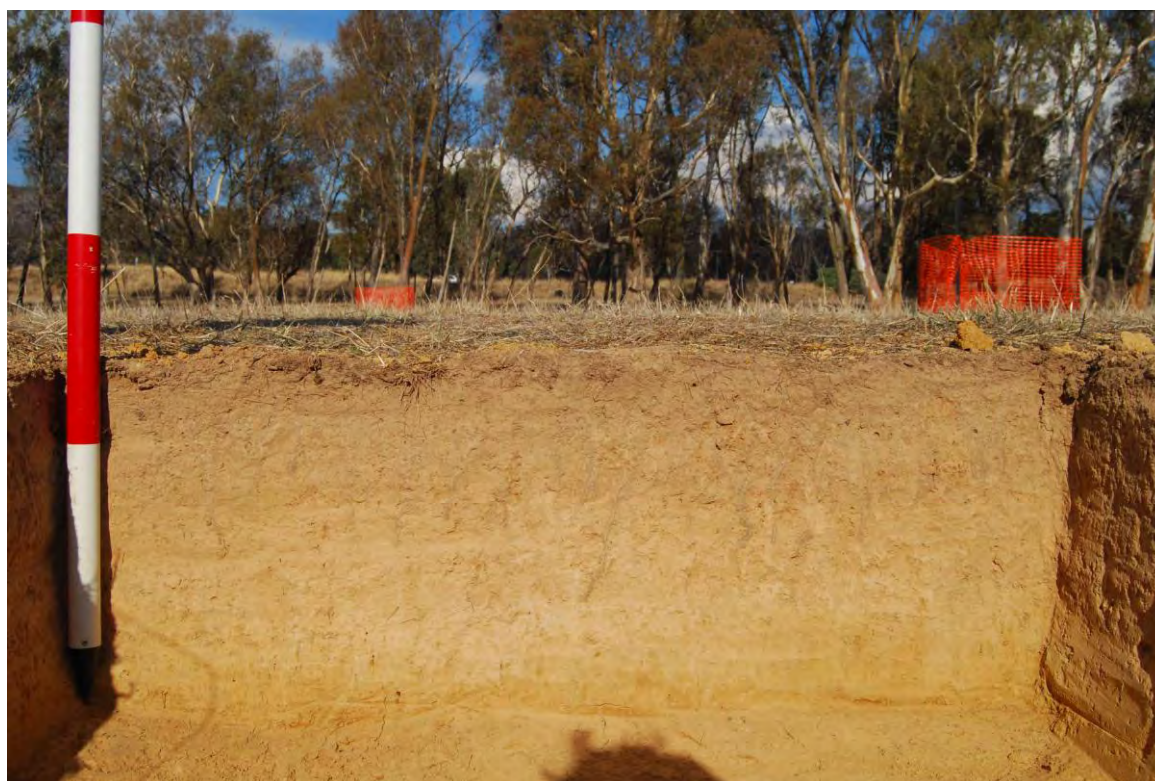
**Plate 20. Section from TA21 showing erosional deposit from the terraces above the channel banks**

Soil deposits on the floodplain were heavily bleached and compacted with very little stratigraphy visible. It is likely that the lower slope and the floodplain have been exposed to moderate to heavy erosion, with only minimal deposition along the floodplain in recent history. The terrace appears to contain a more intact soil profile.

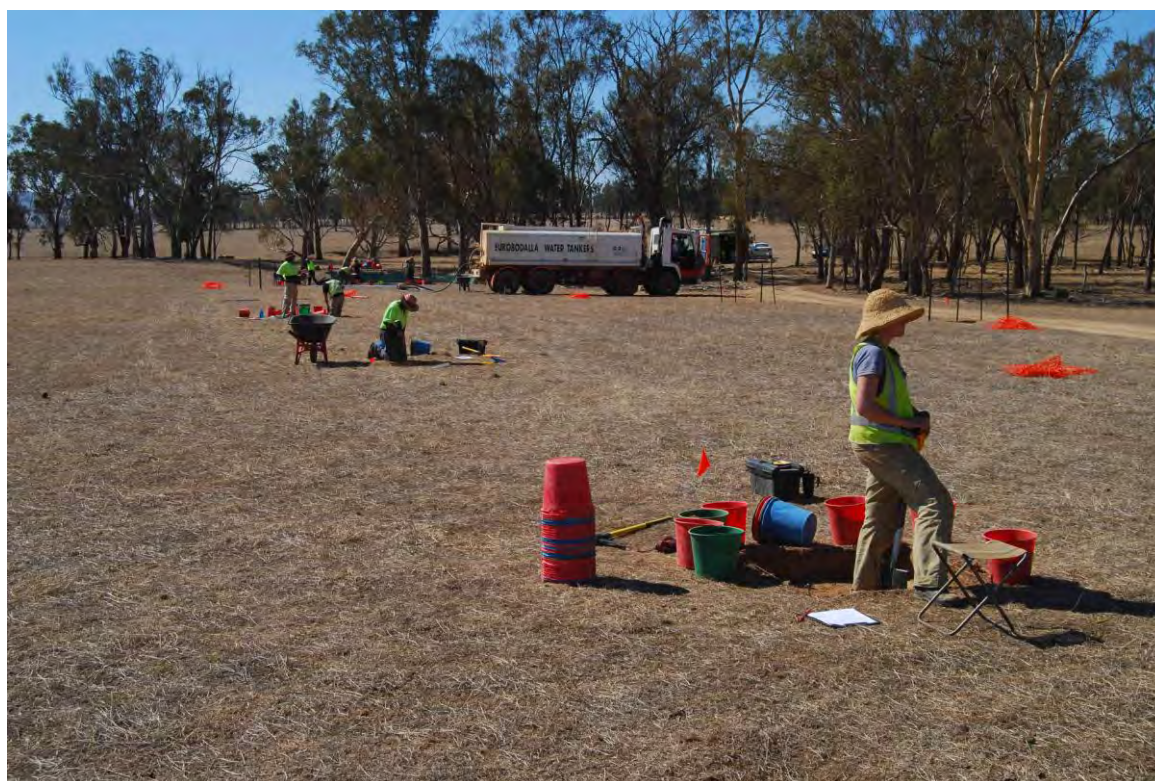
**Plate 21. Excavation of the southern terrace at TA21**

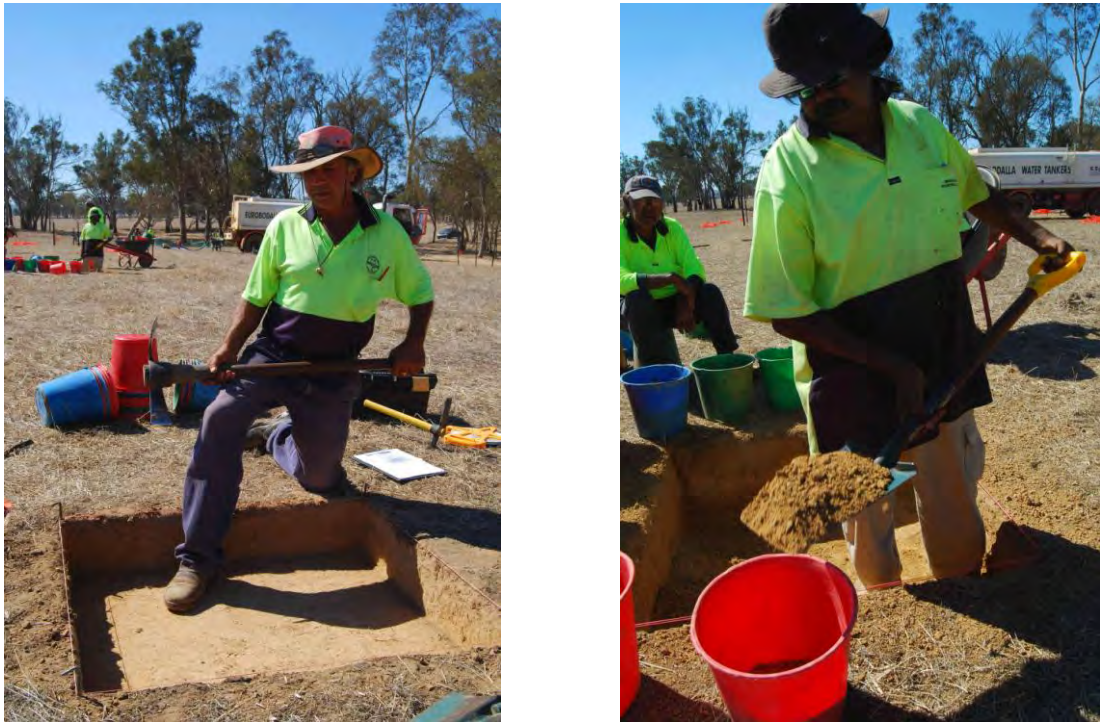
**Plate 22. Precision excavation of the alluvial deposit at TA21**
