# Stage 1 Contamination Assessment: Hanson's Bass Point Quarry Project

P0902486JR02V01  
June 2010

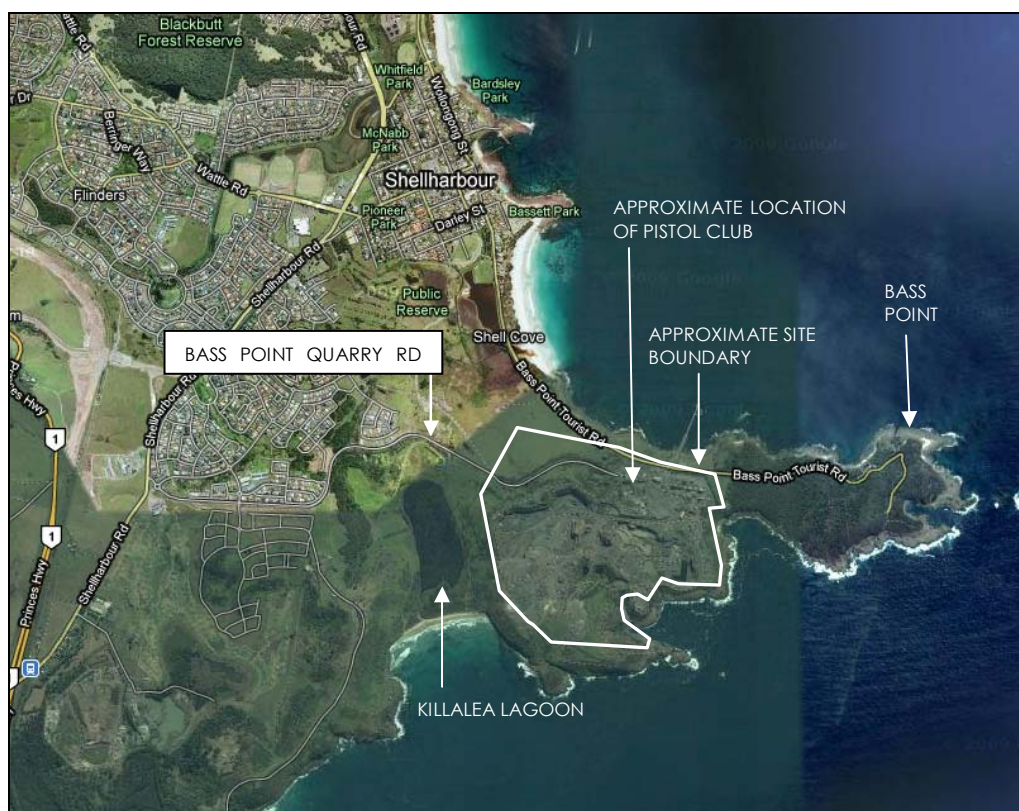
Figure 1: Aerial photograph of the site and surrounding environment (Google Earth, 2006).

The site (Lot 22 DP1010797) is located at Bass Point Quarry Road, Shellharbour, NSW and is within the Shellharbour Local Government Area. The site is located approximately 8 km north north east of Kiama and 2 km south east of Shellharbour on Bass Point. The site is border by Bass Point Reserve to the east, Killalea State Park to the west, the ocean to the south and Shell Cove (residential subdivision and boat harbour precinct) to the north (Figure 1).

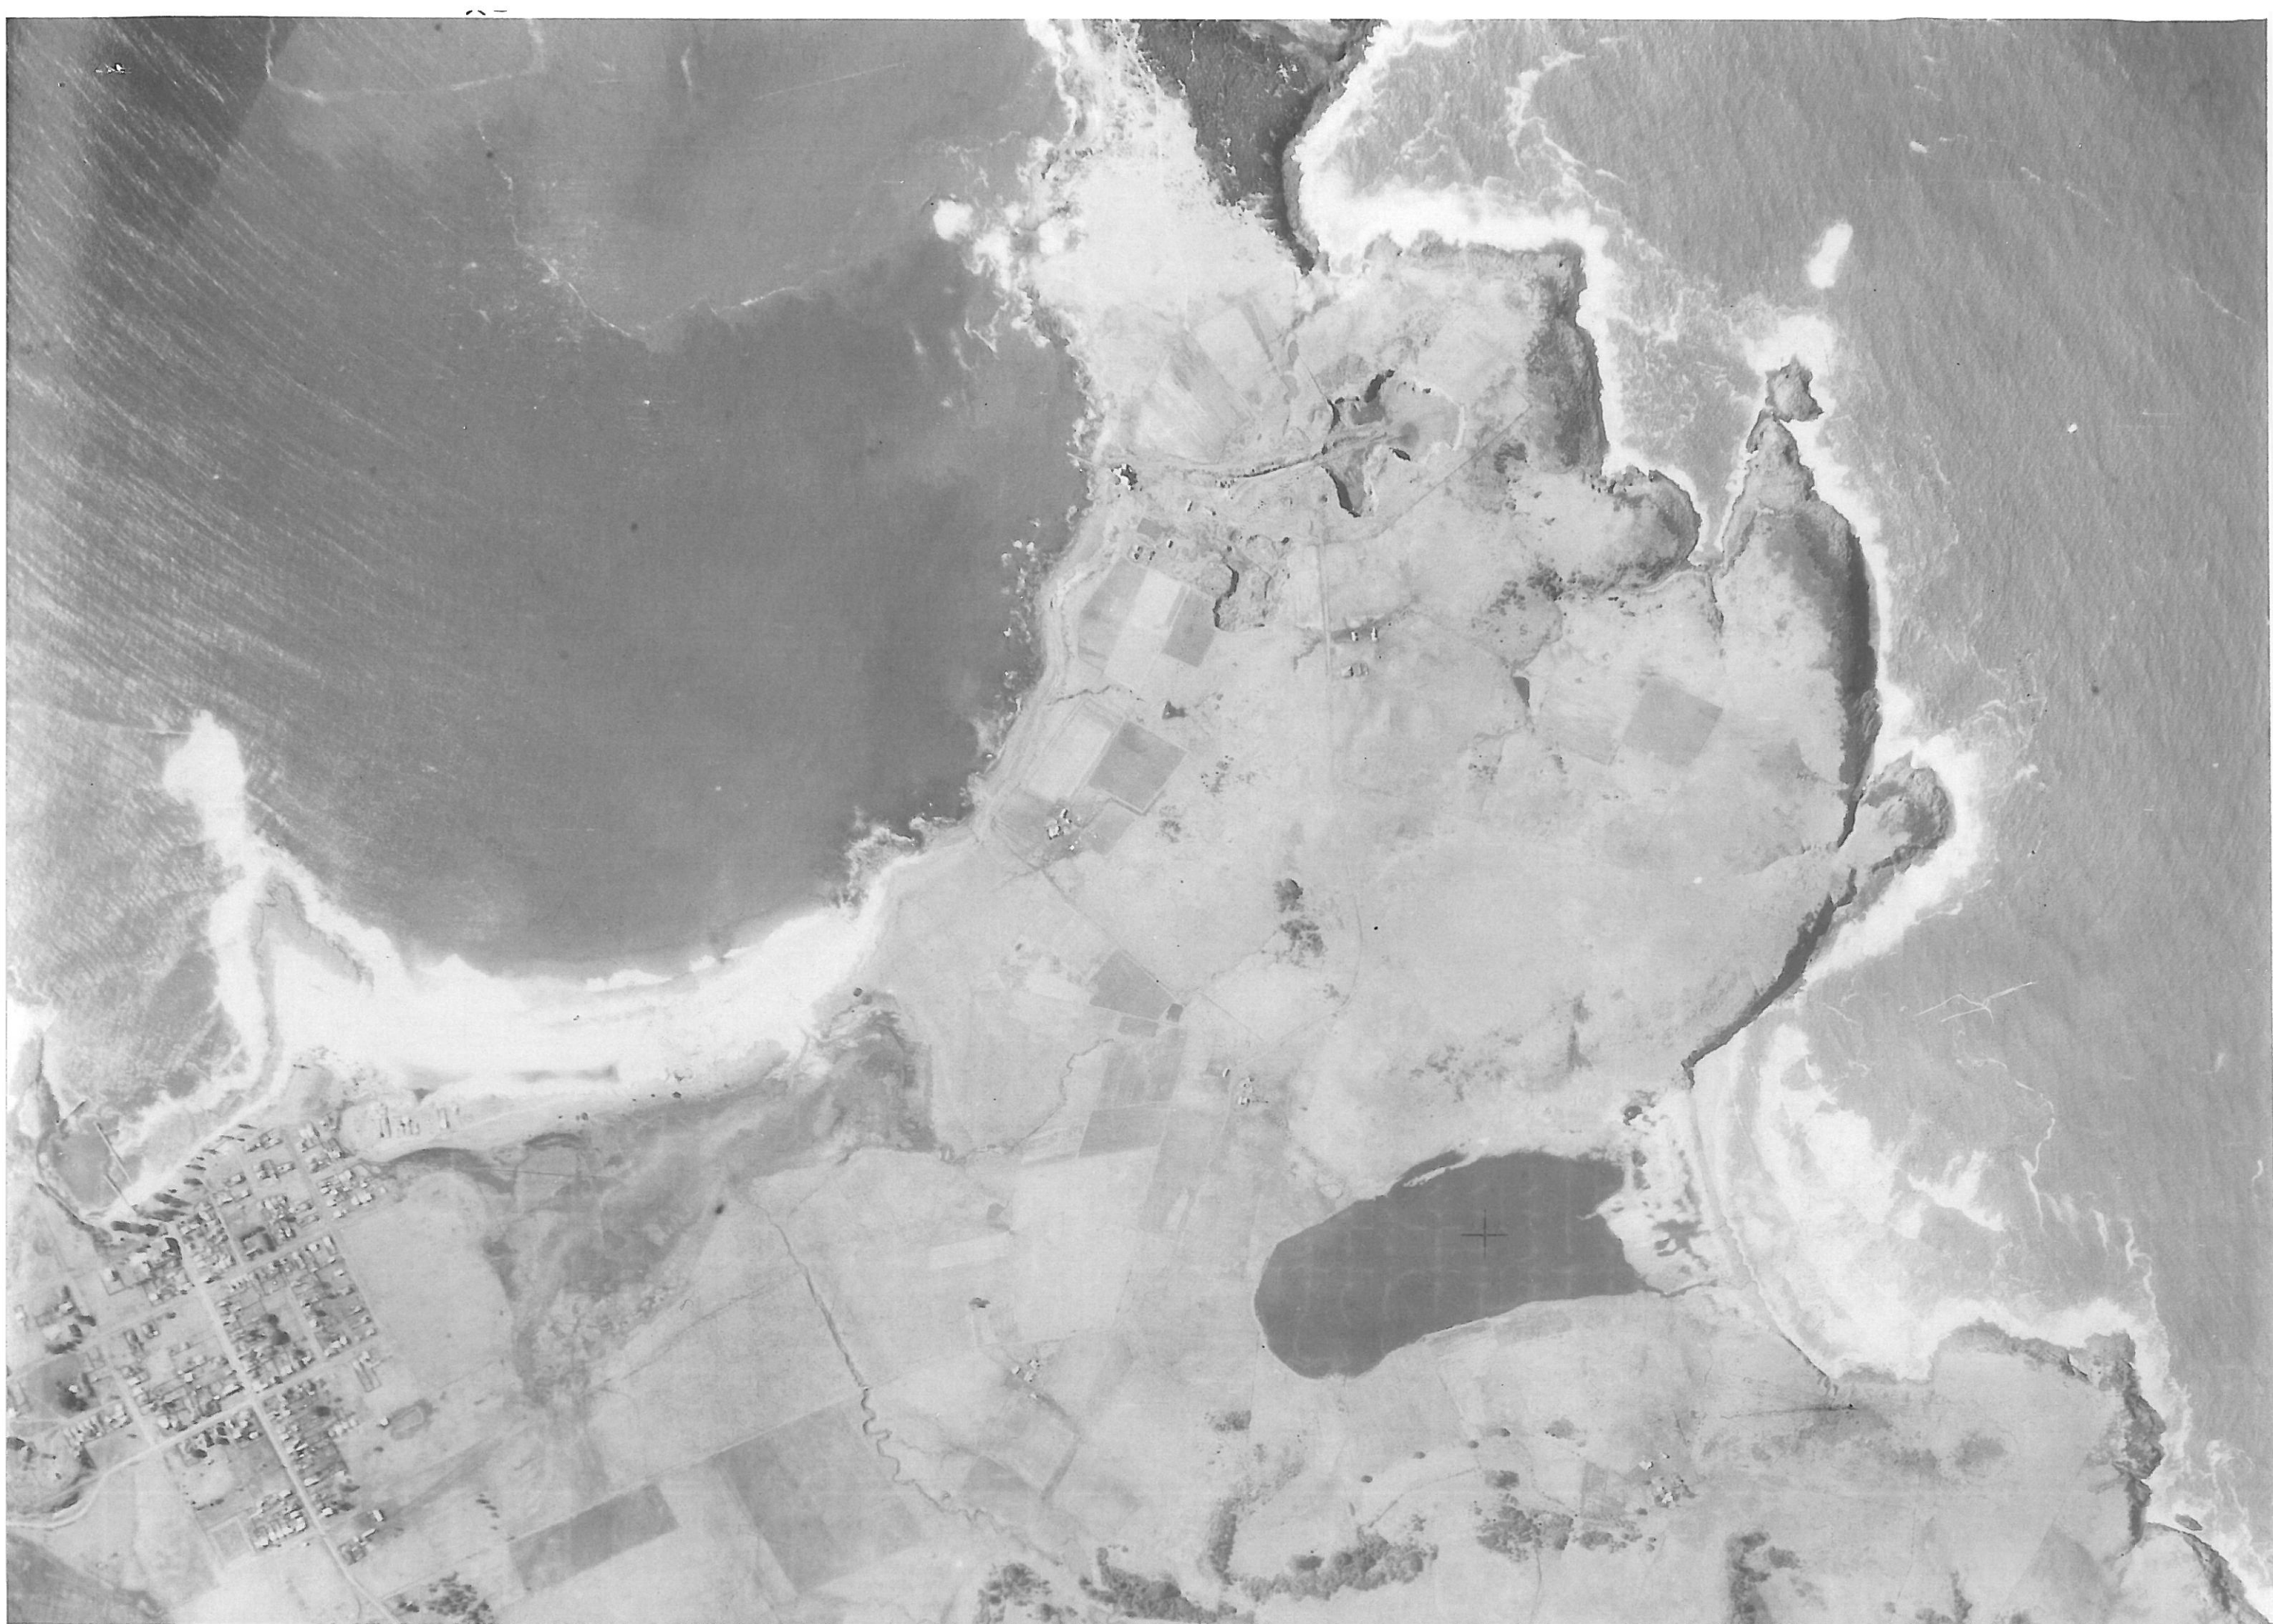
The 1949 aerial photo shows a single visible extraction area to the south and north of a road/track that appears to follow a similar general alignment to the current Bass Point Quarry Road. The remainder of the site appears to be cleared. An area with three or four structures exists in the approximate area of the current concrete plant.

| Year | Description |
|---|---|
| 1949 | Three to four visible structures on site. Two distinct extraction areas are visible. The majority of site land is cleared. Residential development is visible in the far west of photo. |

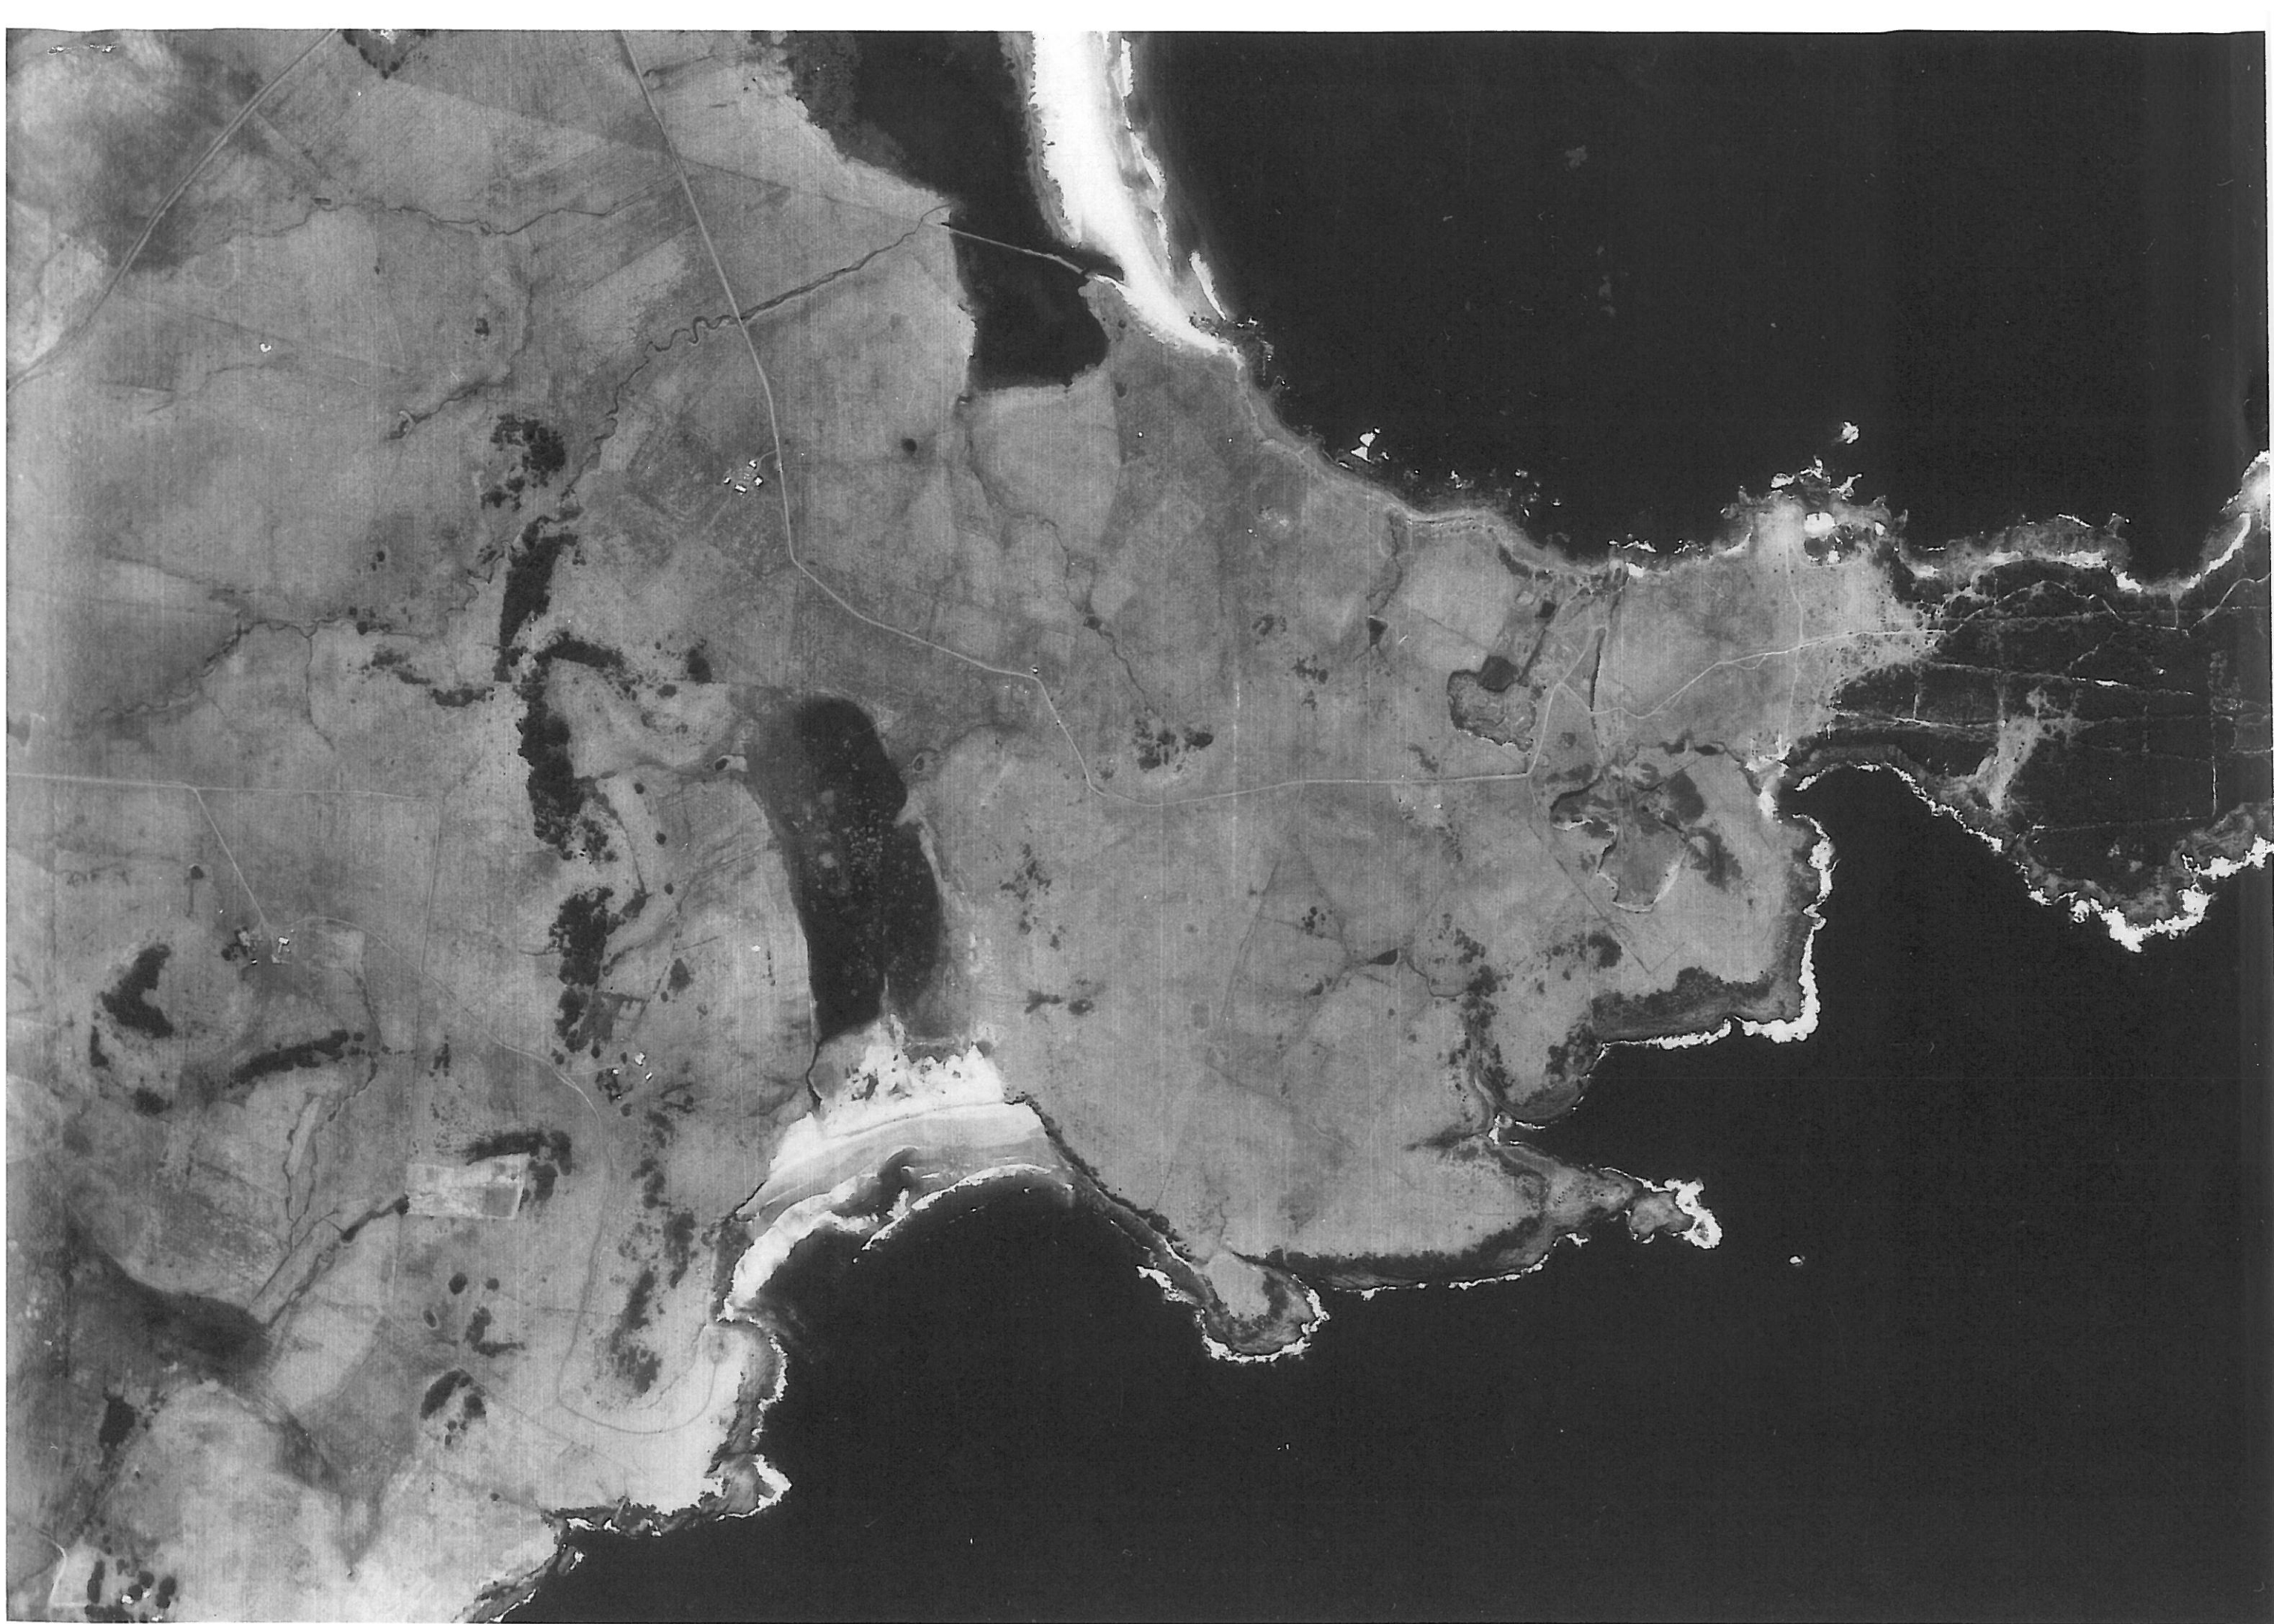
The 1963 aerial photo shows minor change when compared to the 1949 photo. Residential development near Shellharbour is not visible in this photograph (due to photo scale).

| Year | Description |
|---|---|
| 1963 | As above but no residential development is visible (1949 photo has different coverage to 1963 photo). |

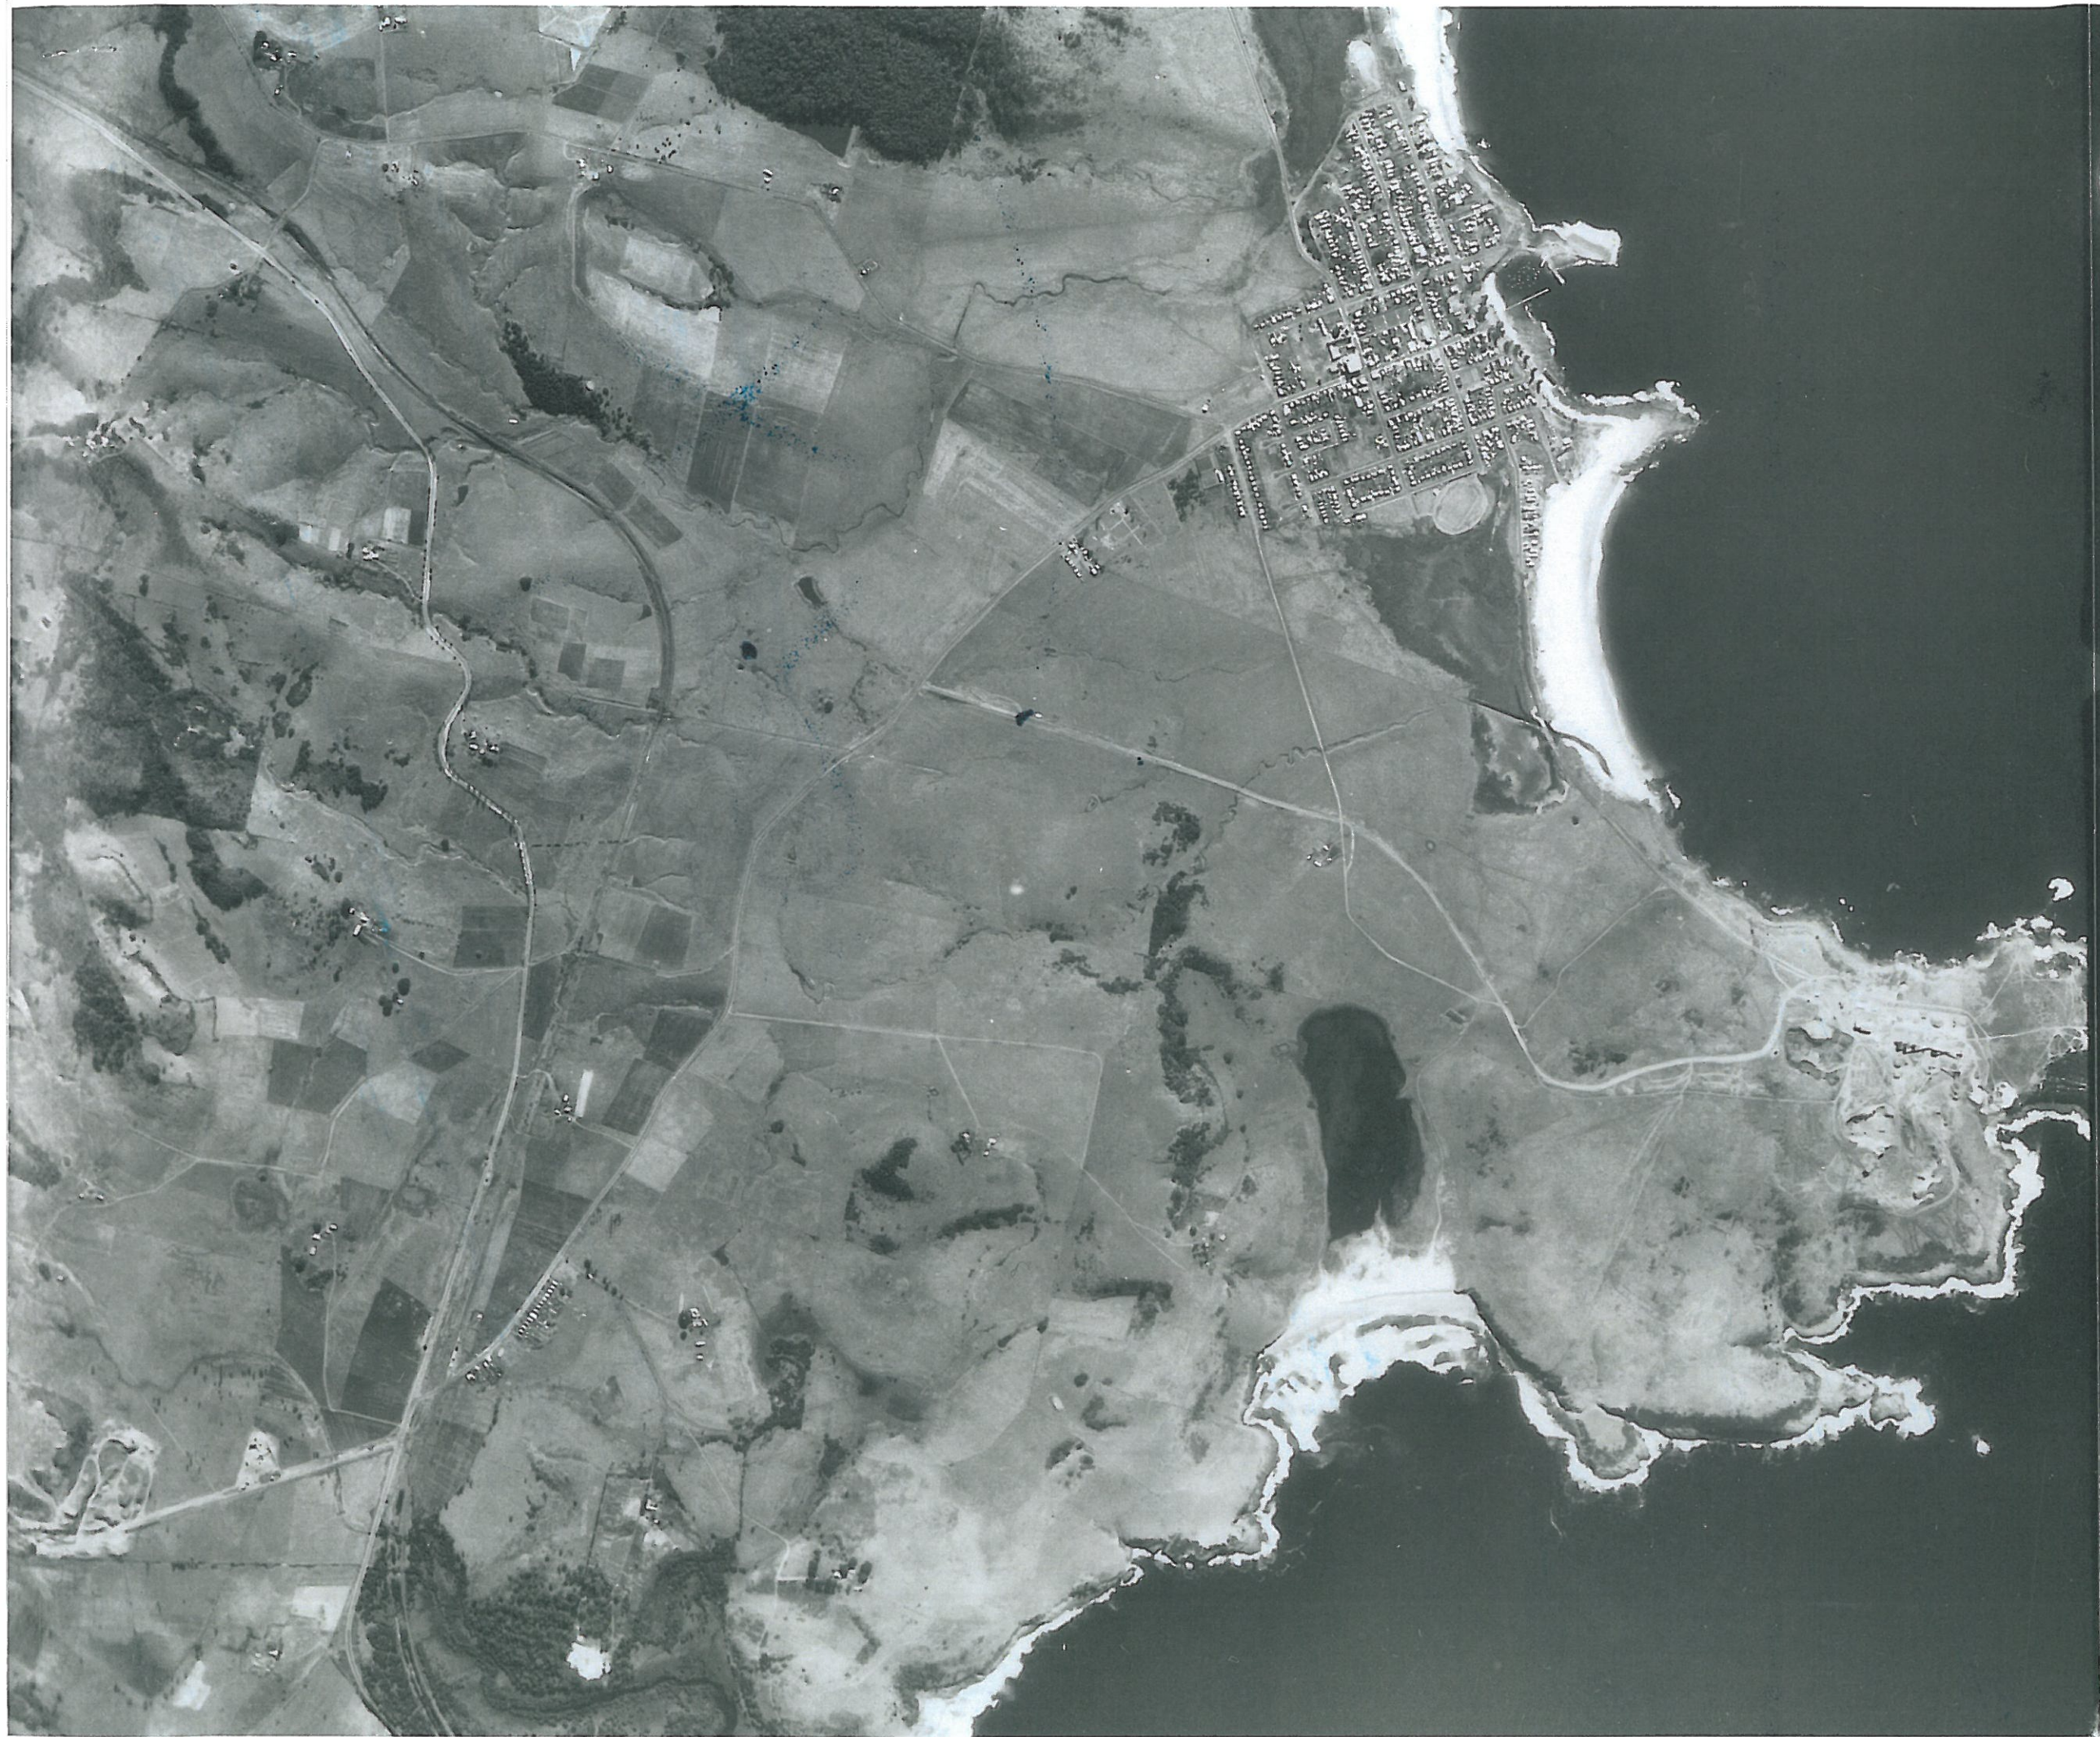
RUN 4  
23:5:70

The 1970 aerial is similar to the 1963 aerial. However, stockpiles and possible quarry plant are noticeable. A new road becomes visible that resembles the current alignment of Bass Point Quarry Road. Extraction

| Year | Description |
|---|---|
| 1970 | Stockpiles and possible quarry plant becomes visible. Road appears that follows alignment of the current Bass Point Quarry Road. Extraction operations appear to have expanded to an area south of the south extraction area that is visible in the 1963 photo. |

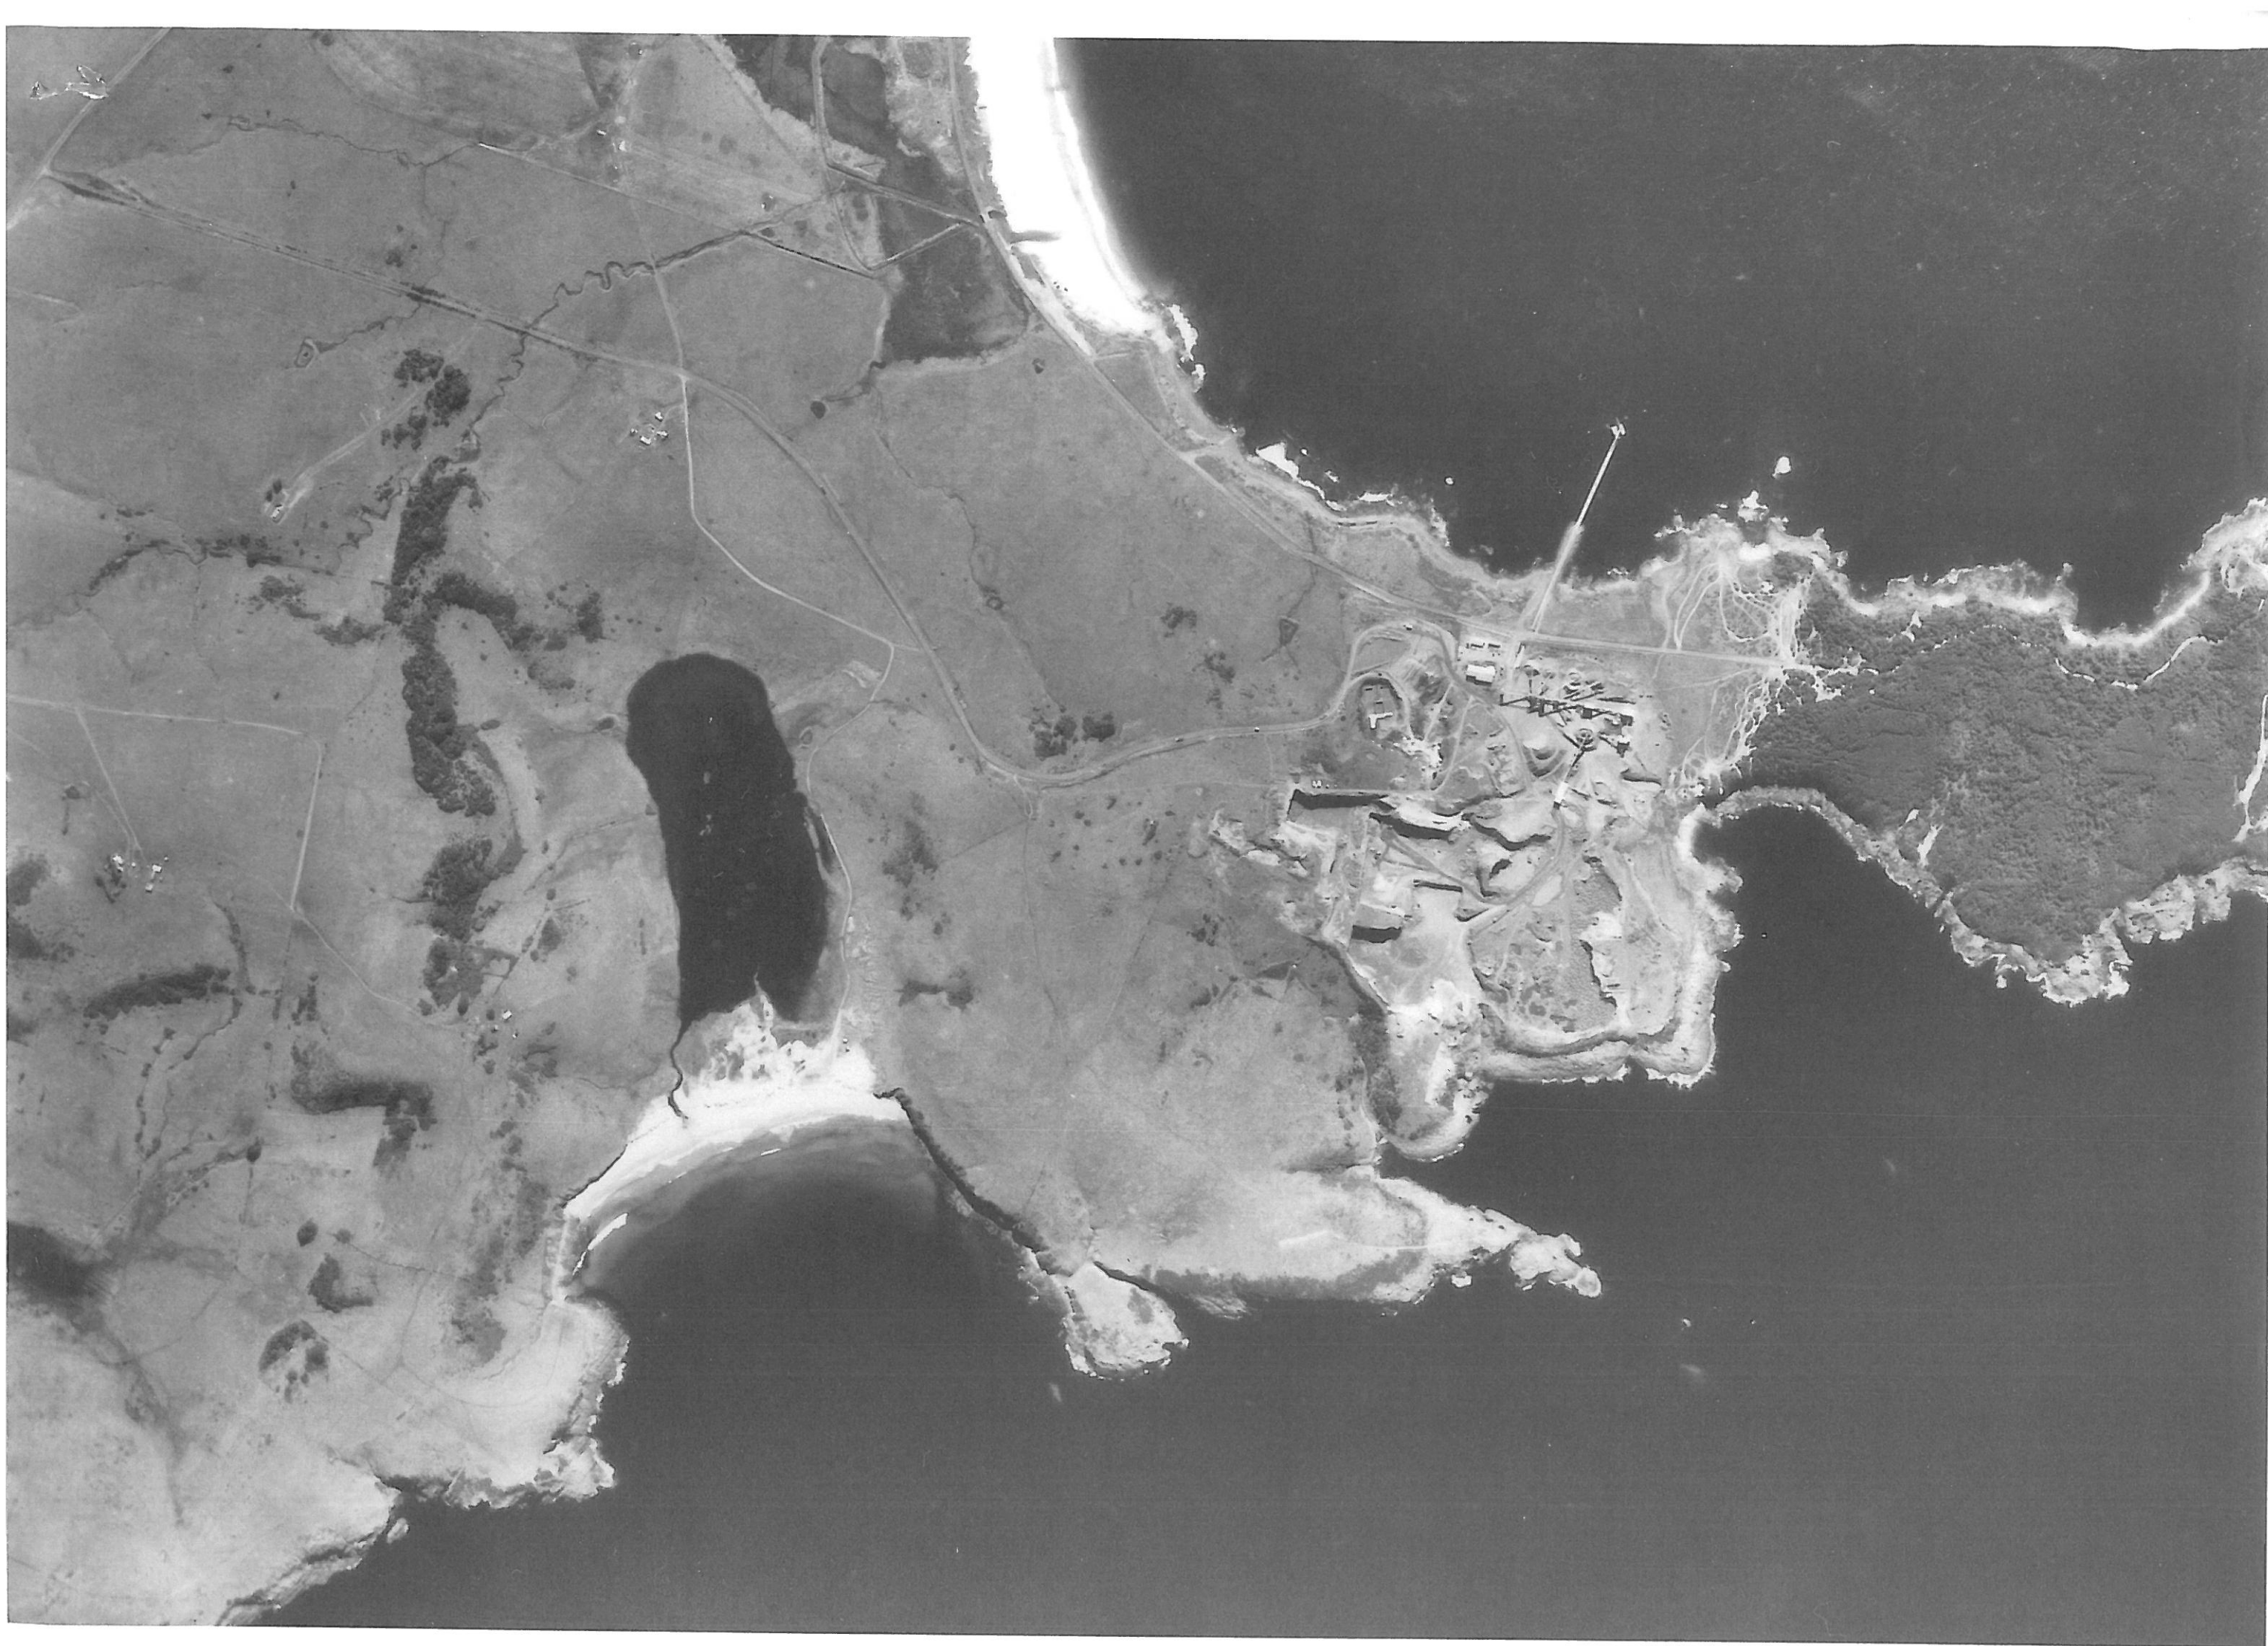
The 1979 aerial shows the coal loader, quarry processing plant, increased extraction and structures which may represent site offices or storage areas.

| Year | Description |
|---|---|
| 1979 | Coal loader is visible. Quarry plant and stockpiles are visible. Structures in area of current site office and south west of current site office become visible. |

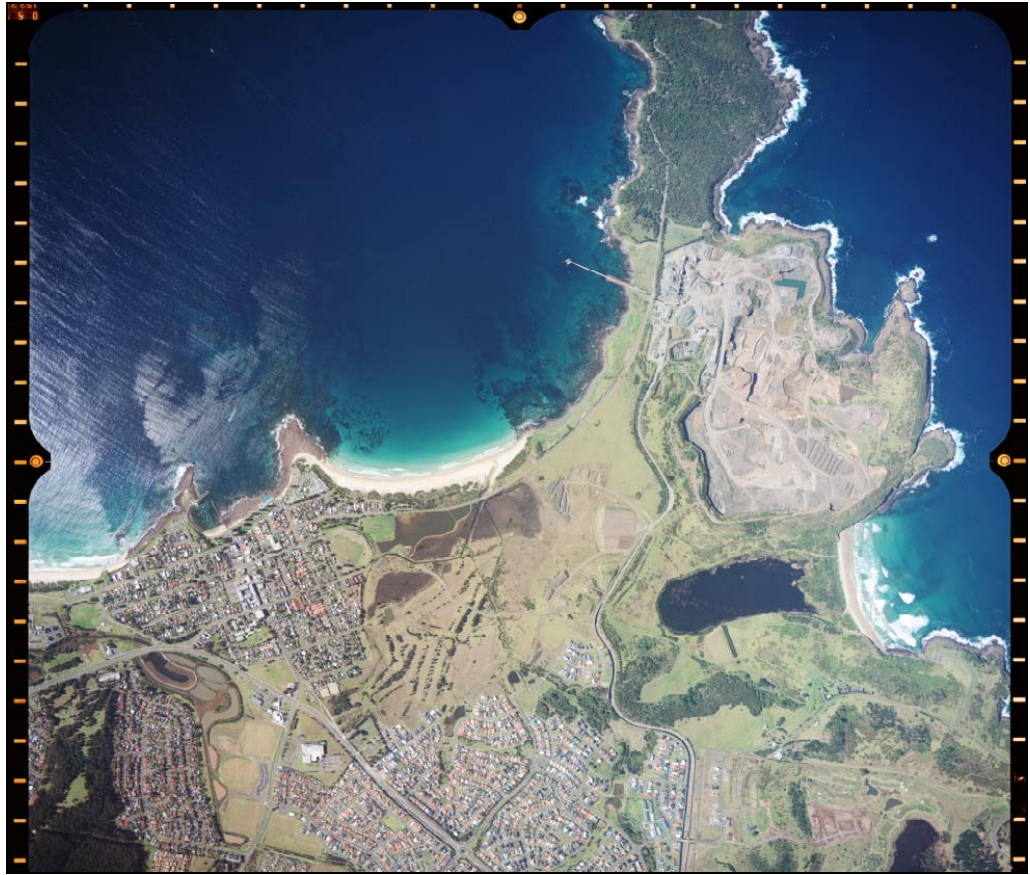
Figure 2: 1990.

The 1990, 1997 and 2005 aerials show increased extraction area/depth along with increased residential development. Interestingly, a cut that is filled with water and shaped like a backwards L is easily visible in the 1990 and 2005 photos but absent in the 1997 photo.

| Year | Description |
|---|---|
| 1990 | As above but with increased extraction areas/depth. Backwards L cut that is filled with water is visible. |

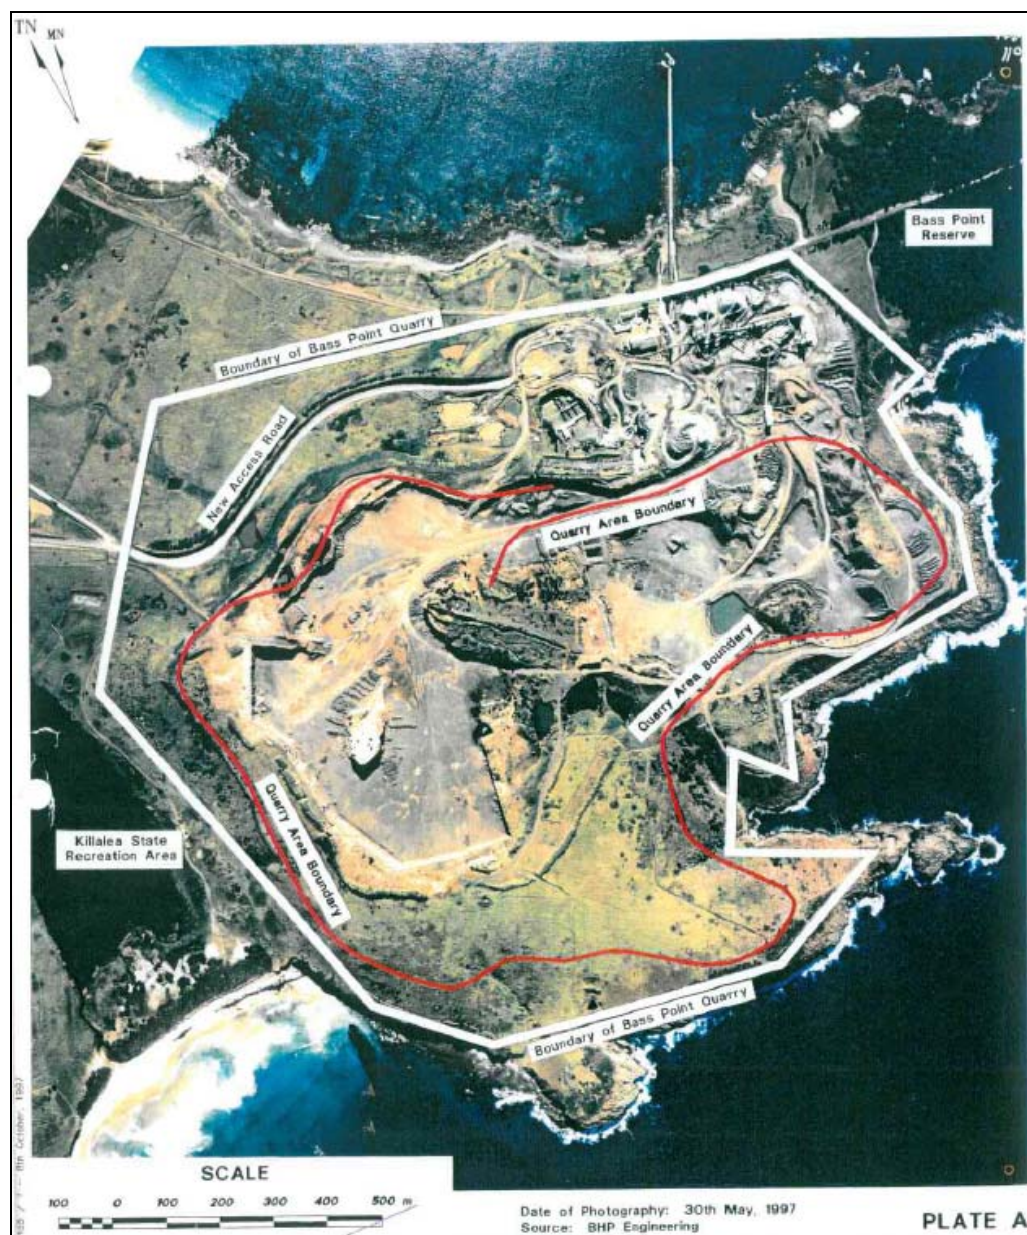
Figure 3: 1997.

| Year | Description |
|---|---|
| 1997 | As above but backwards L cut that is filled with water is not visible. |

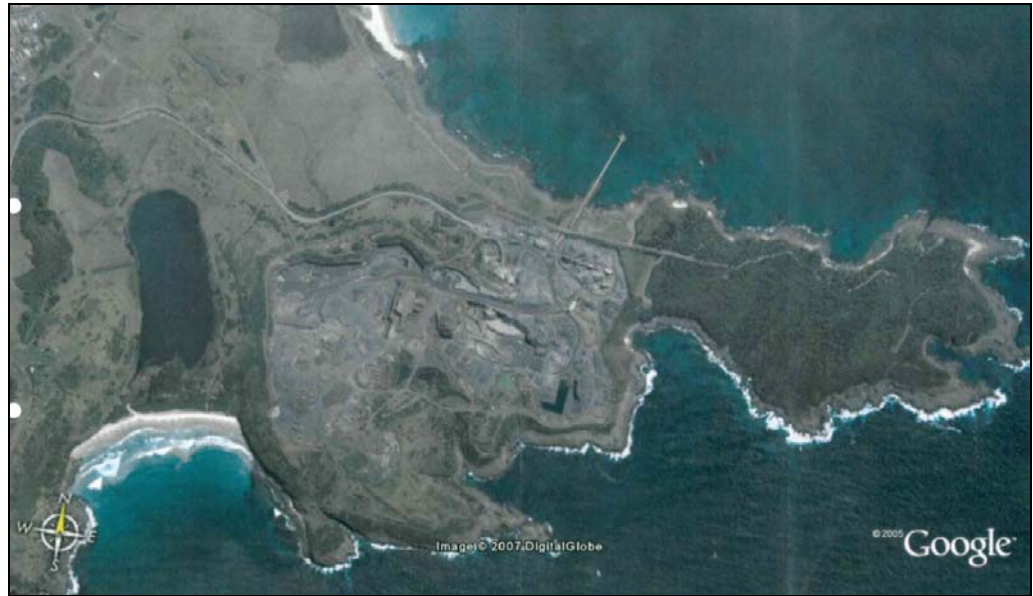
**Figure 4: 2005.**

| Year | Description |
|---|---|
| 2005 | As above but with increased extraction areas/depth. Backwards L cut that is filled with water is visible. |
