Wastewater Assessment:

Hanson's Bass Point Quarry Project

P0902486JR03V02  
January 2010

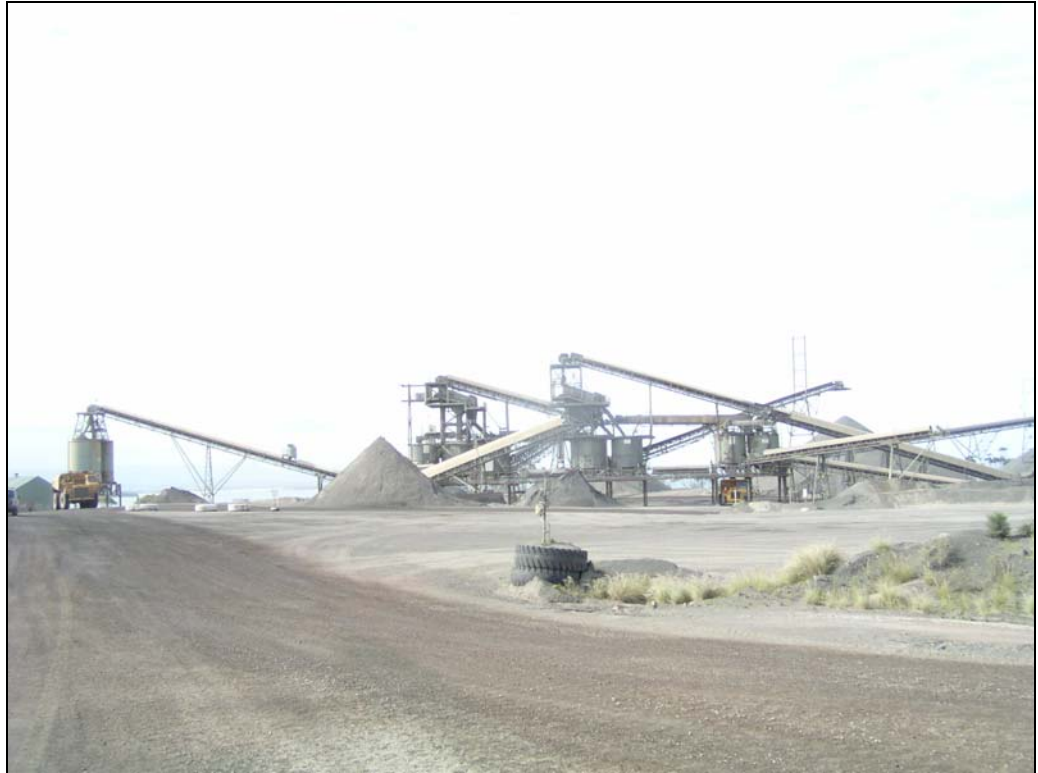
Given this areas current usage and the high level of disturbance, there is little to no soil for effluent disposal (Figure 2). The future use of this area for effluent disposal therefore will necessitate suitable soil material to be imported.

Figure 2: Photograph of the existing processing plant area to be rehabilitated and used for effluent disposal (24/11/2009).

Assessment indicates that, provided suitable soil material is brought into this area, the proposed effluent irrigation field would have minor limiting factors and therefore be considered to be suitable.
