The site history, conditions and results of the sampling and analysis for the site are summarised in the previous reports which should be read in conjunction with this RAP.

- i. To remediate the known heavy metal hotspots, by removing the contaminated soil to an appropriately licensed landfill and validate the excavations;
- ii. To remove the UST and associated pipework;
- iii. To remediate the known TPH hotspots, associated with the UST and former sheds, to a condition which does not pose a risk to current and future site users and/or the general public and are suitable for residential land use;

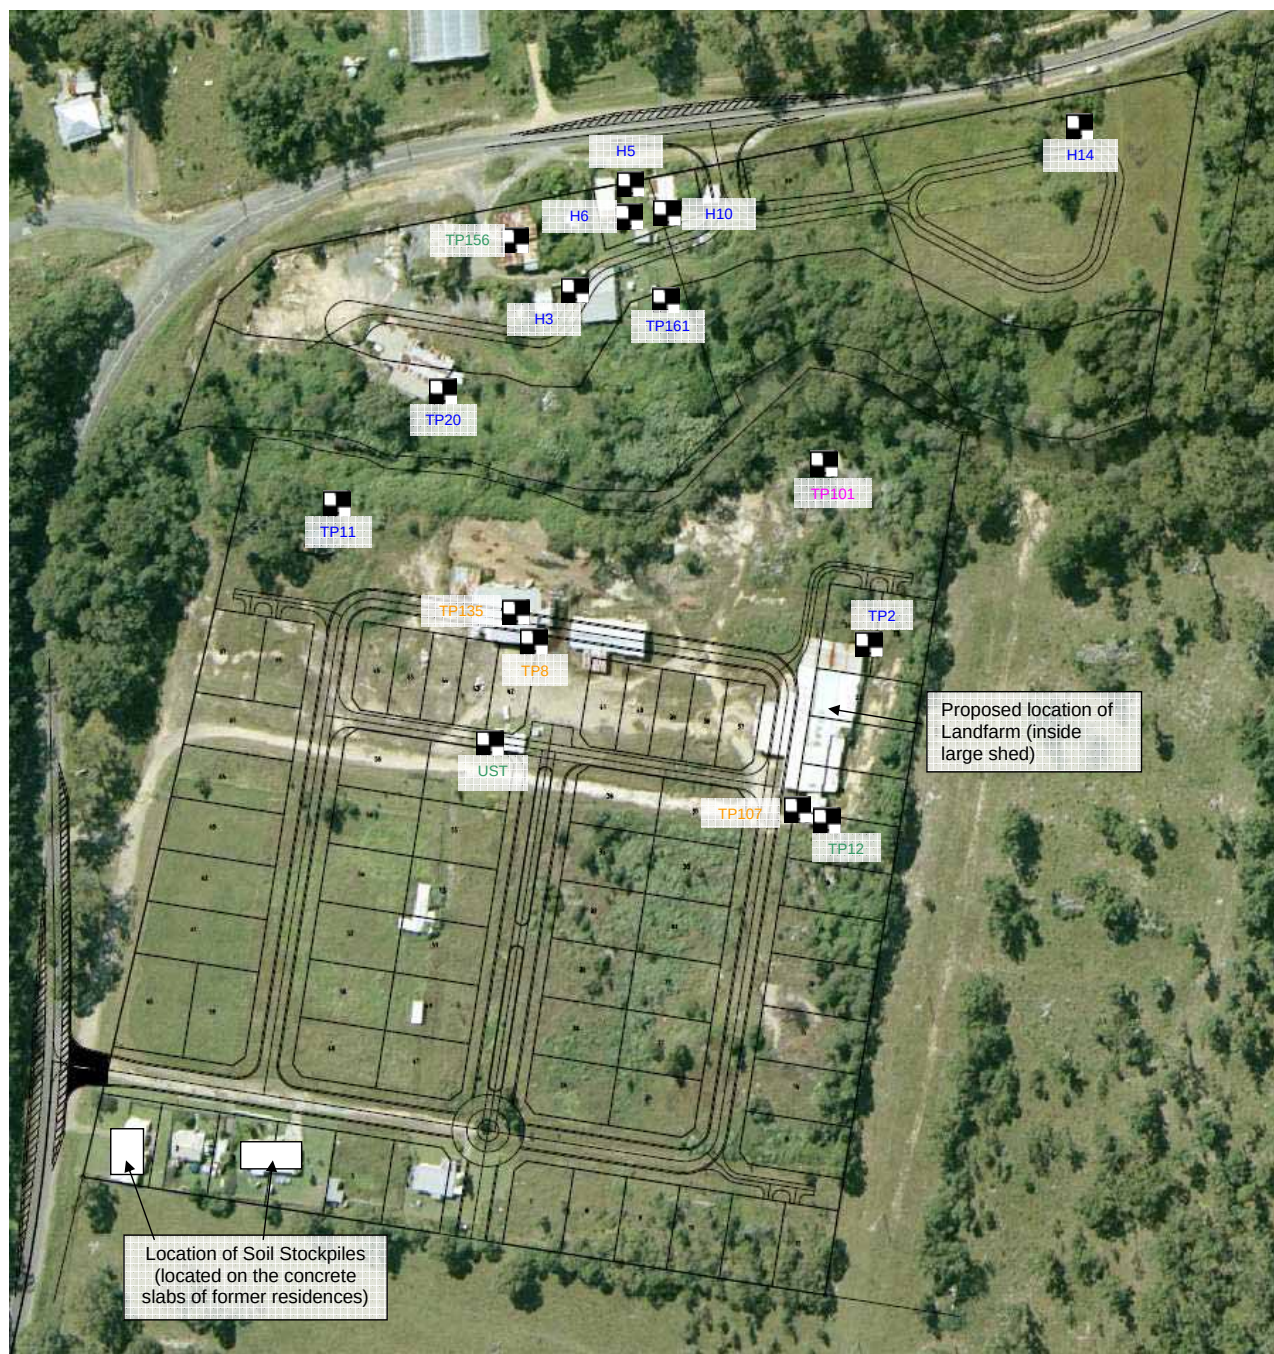
| scale | ~1:2000 | | project no: | GEOTCOFH01296AC-AE | figure no: FIGURE 1 |

It should be noted that six of the heavy metal hotspots have already been excavated and stockpiled, and validation samples collected. The locations of the heavy metal excavations were confirmed by Coffey personnel during the validation sampling. The laboratory results of the waste classification and validation samples were pending at the time of issue of this RAP. The heavy metal hotspots, the PAH hotspot, and the location of the stockpiled soils are shown on Figure 1.

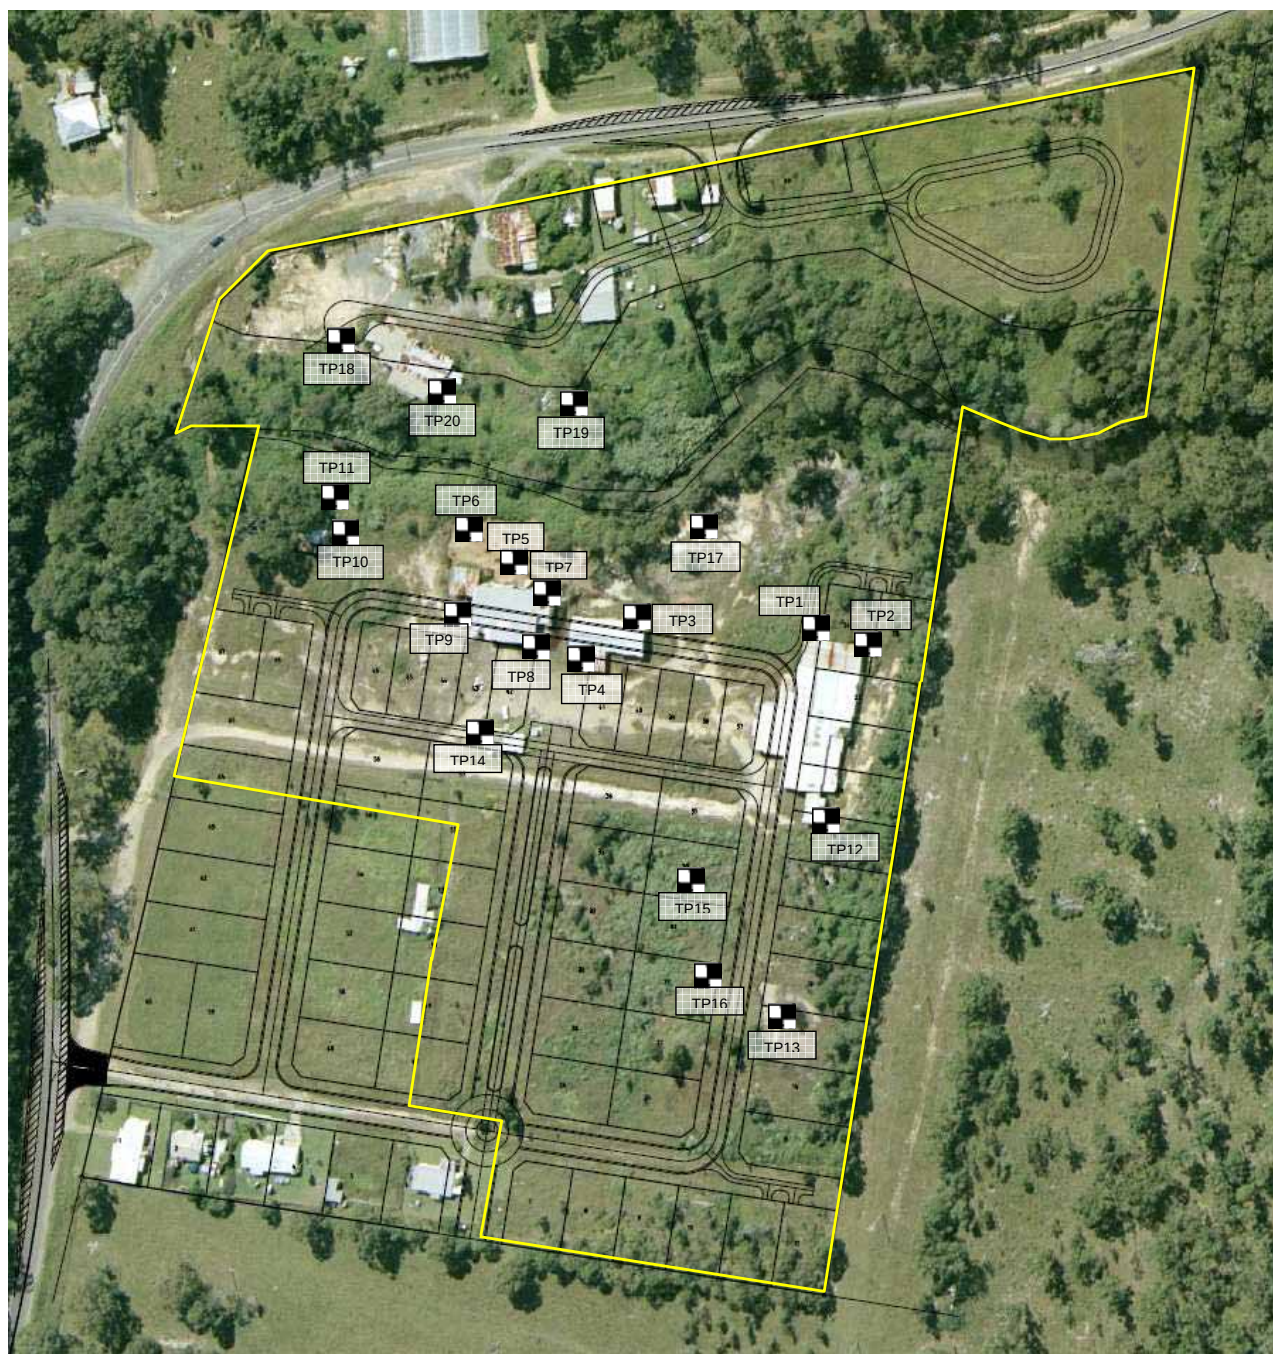
Figure 1: Location of Known Contamination Hotspots & Stockpiles

Six TPH hotspots are known to be present on the site. One is associated with a former shed, which is located in the north-east portion of Lot 1, two are associated with a former shed on Lot 260, which was located in roughly the centre of the northern area of the lot, one is associated with the UST located immediately west of the former office building on Lot 260, and a further two are located at the southern end of an existing shed located on Lot 260. The location of the known TPH contaminated soils and UST is shown on Figure 1.

Thirteen heavy metal hotspots and one PAH hotspot were identified to be present on the site. Many of these relate to zinc exceeding the phytotoxicity criteria. For the purposes of this RAP, a heavy metal hotspot is defined as a sample which has concentrations of heavy metals exceeding the phytotoxicity criteria by 2.5 times, except for lead where the human health criteria is lower than the phytotoxicity criteria. Each other contaminant type is a hotspot if it exceeds the human health criteria for residential sites. Six of the heavy metal hotspots were excavated and the soil stockpiled after discussions with the client, prior to the issuing of this RAP. The location of the heavy metal and PAH hotspots and the excavated soil stockpile locations are shown on Figure 1.

The TPH hotspots and UST locations are shown on Figure 1.

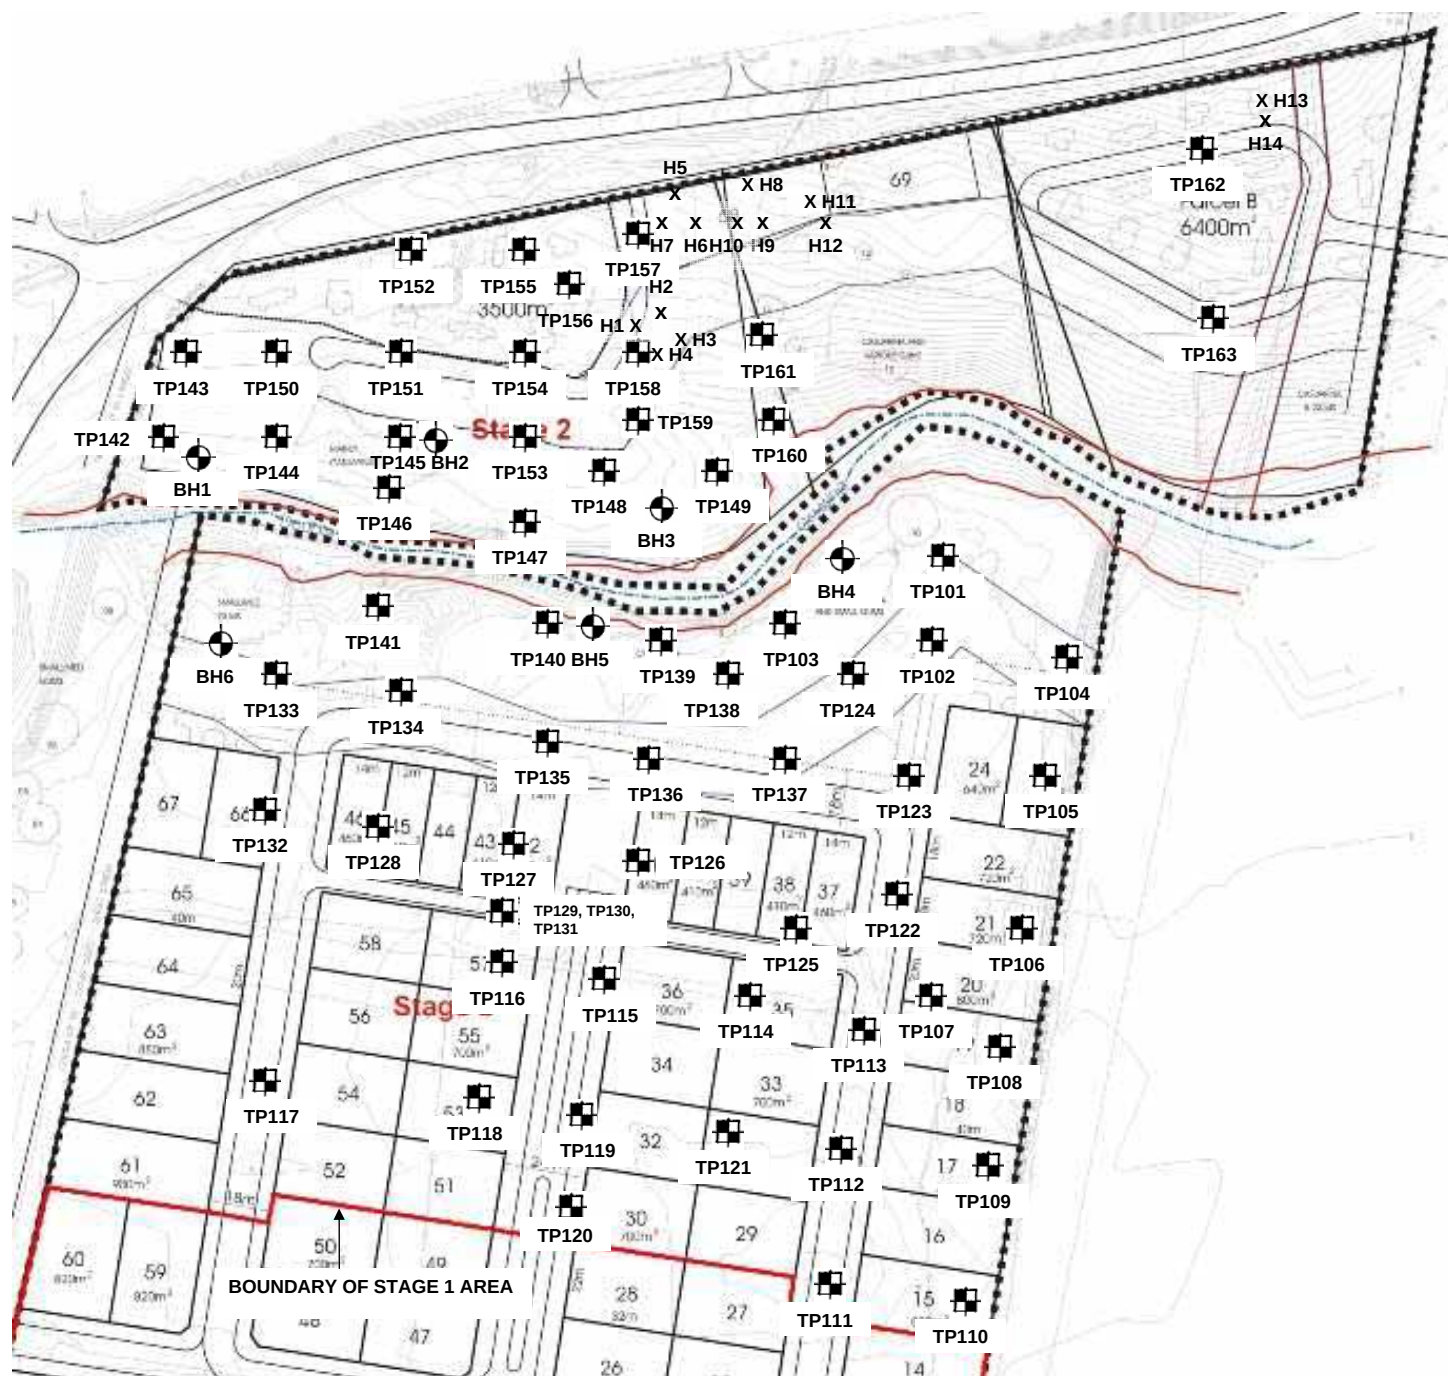
| scale | ~1:2000 | | project no: | GEOTCOFH01296AC-AE | figure no: FIGURE 2 |

Figure 2: Previous Sample Locations from Phase 1 ESA

Figures 2 and 3 show the previous sampling.

Figures 2 and 3 show the previous sampling locations.
