# POOL ETAF DOWNSTREAM MAPPING SUMMARY

Mine Subsidence Engineering Consultants  
March 2009

Metropolitan Colliery  
Eastern Tributary Stream Mapping

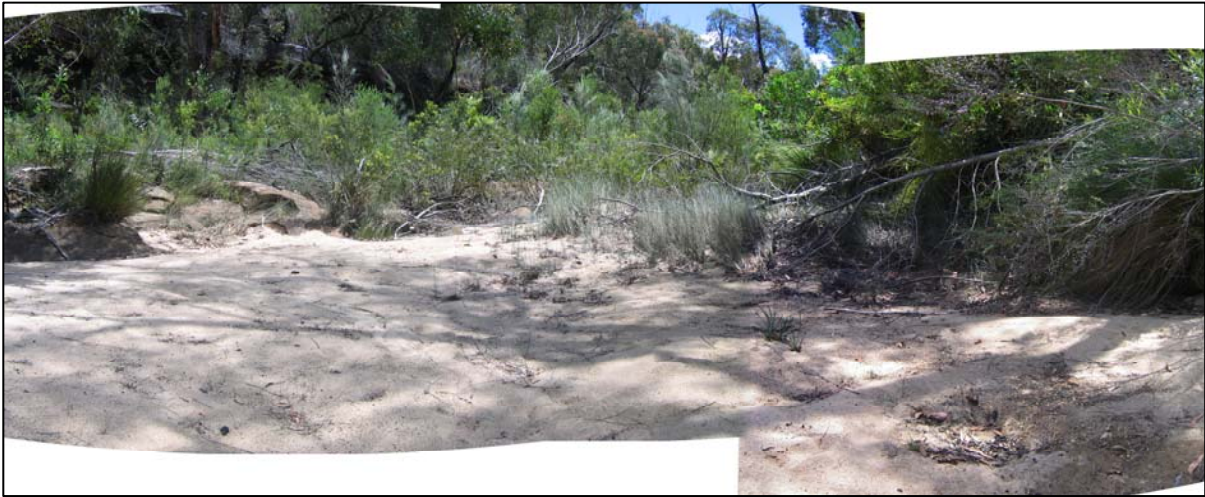
ETAM-3 Downstream end of Pool ETAM looking Upstream

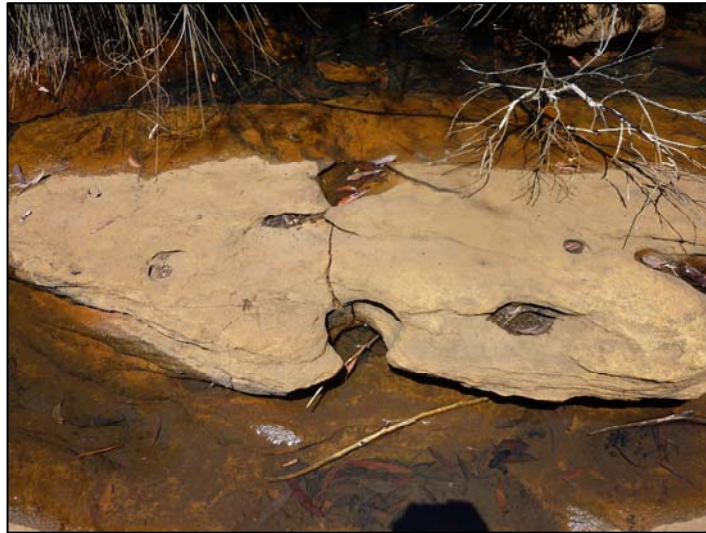
**TA26-1** Cracking in rock

- Cracking through rock surface at downstream end of ponding
- Exposed sandstone upstream of Pool TA-J
- No visible flow from minor tributary into Tributary A at confluence, but minor flow visible further downstream
- Approximate 3m change in height from Pool TA-J to minor tributary

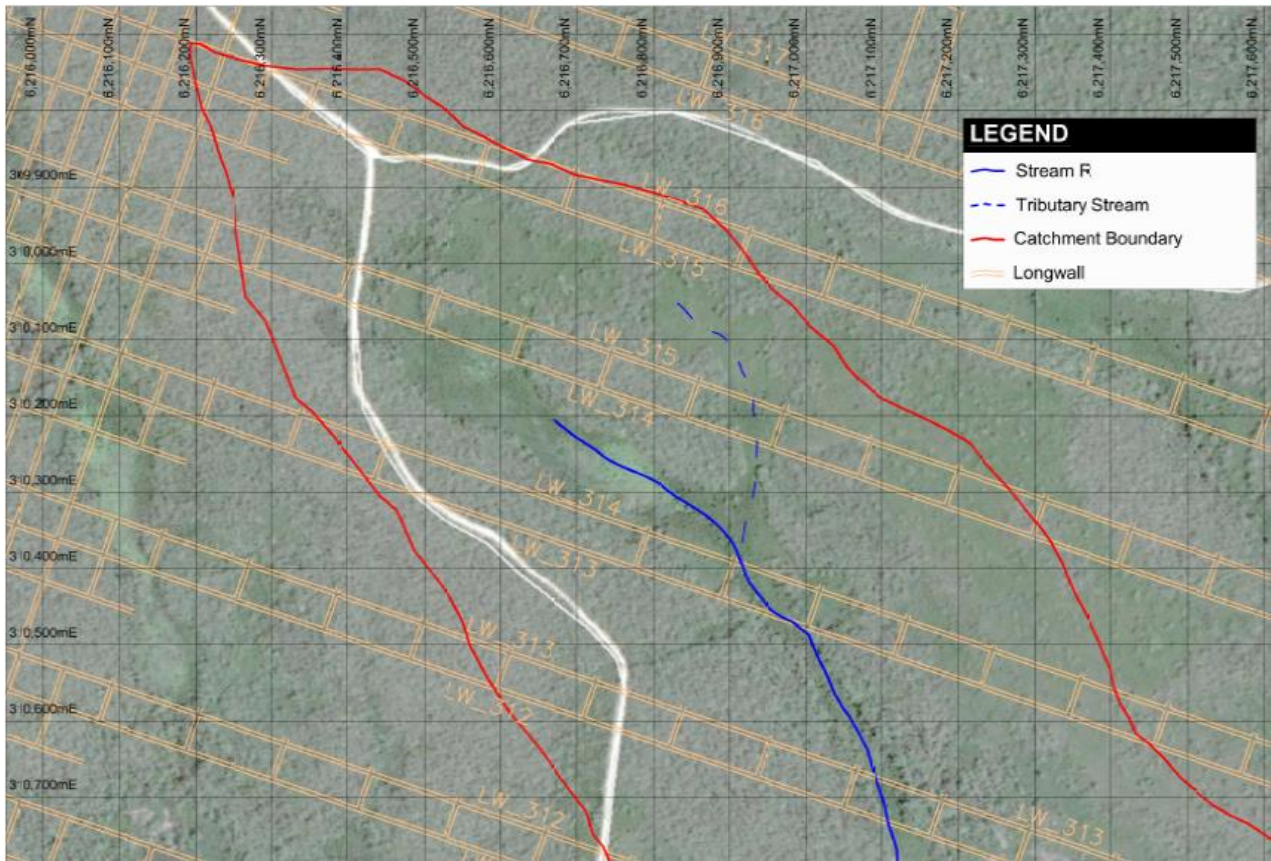
Stream R originates in an upland swamp and becomes a second order stream following inflow of a smaller stream line some 300m upstream of its outlet into the Woronora Reservoir – refer Figures 12 and 13.

**Figure 12** Stream R Upper Catchment

**Figure 13** Stream R Lower Catchment

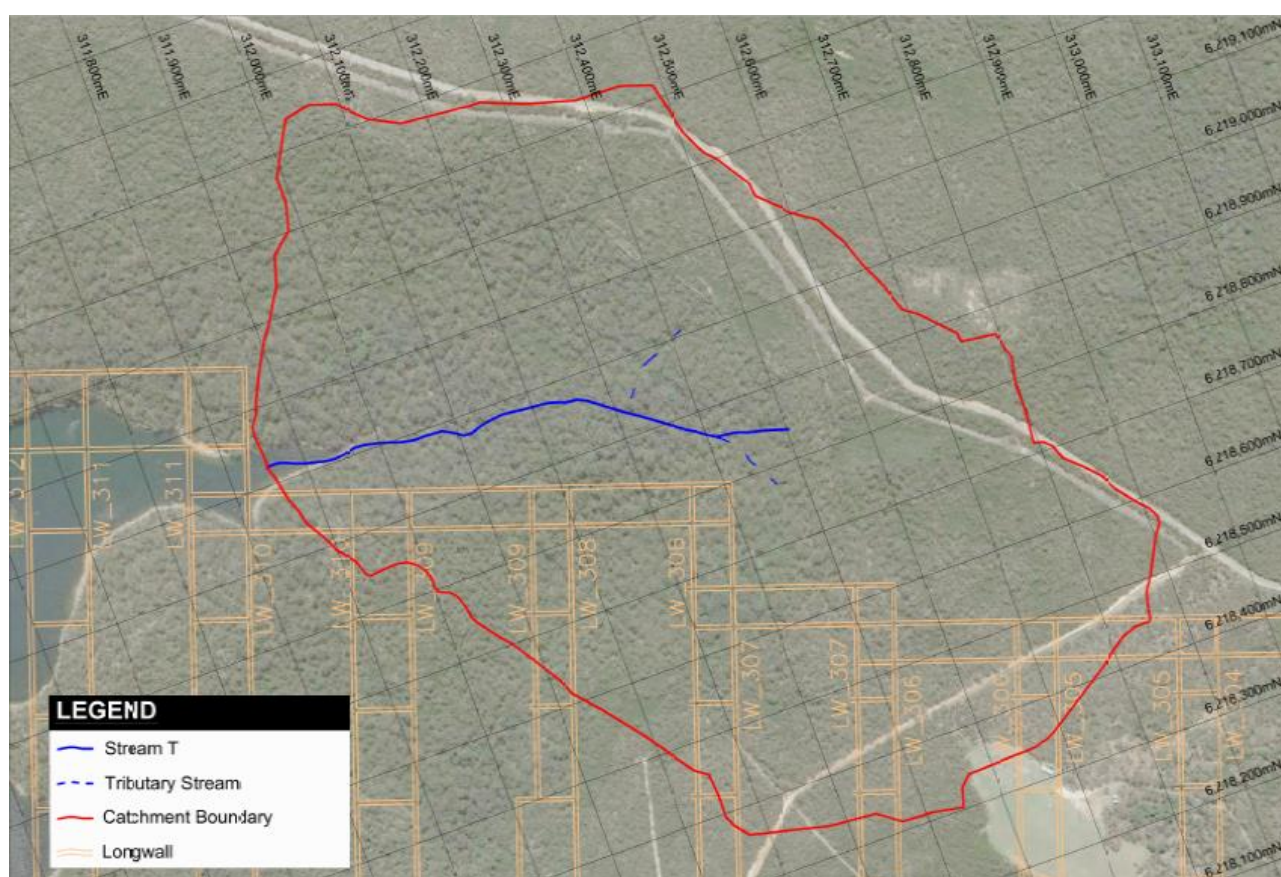
Stream T is a small second order stream – refer Figure 17. The stream morphology is similar to Stream S. There was a small continuous flow in the lower reaches of the stream which carried through to the Woronora Reservoir. The medium and larger pools mapped were larger than those observed in Stream S.

**Figure 17 Stream T Catchment**
