Aboriginal Cultural Heritage Assessment

Prepared for Metropolitan Coal Pty Ltd | 20 June 2025

# Metropolitan Coal Longwalls 317 & 318 Modification

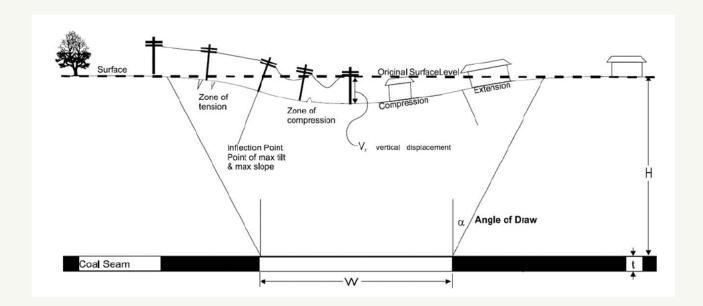
Plate 9: Diagram representation of surface subsidence components in flat topography (Department of Planning, 2008).
