REPORT

Metropolitan Coal Surface Water Review 1 January to 30 June 2019

Prepared for: Metropolitan Coal Pty Ltd

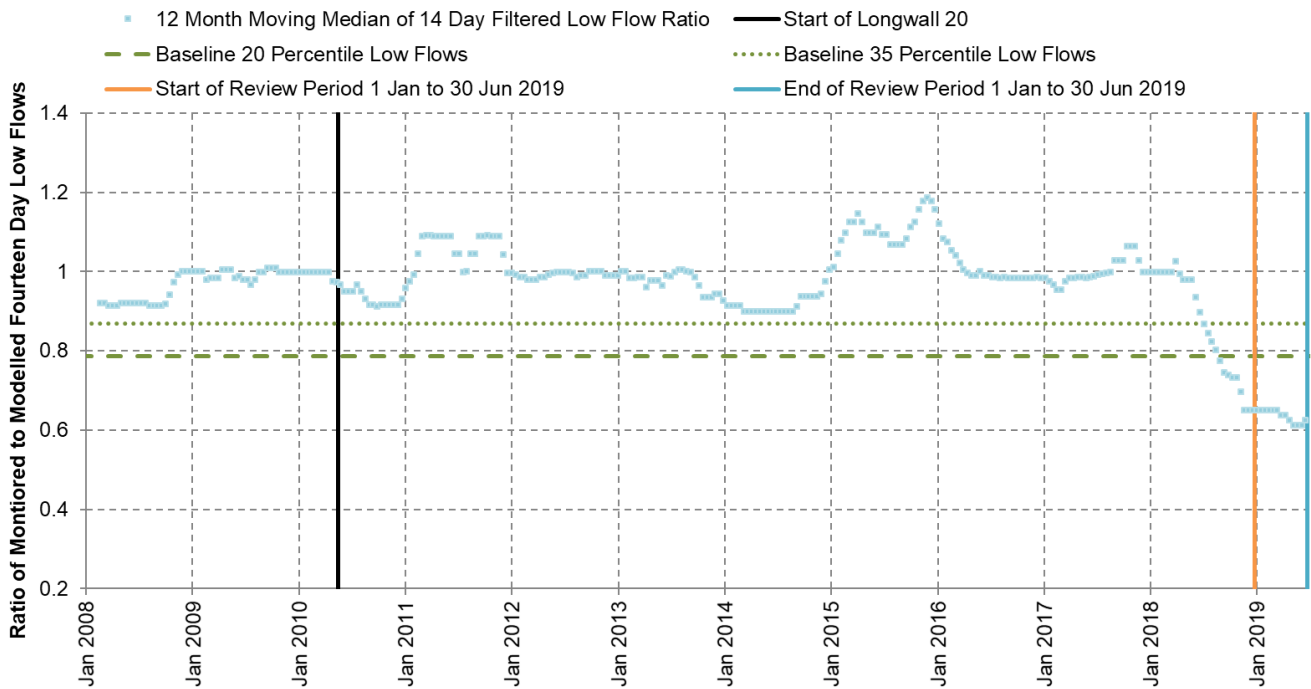
Chart 4 One Year Moving Median for the Ratios of the 14 Day Sums of Monitored and Modelled Flow Rates at Waratah Rivulet (GS 2132102)

Chart 4 shows a plot of the moving 12 month median of the ratio of 14 day sums of monitored flow at Waratah Rivulet (GS 2132102) and flows simulated with the modified AWBM to 30 June 2019.

The results shows that the moving 12 month median of the 14 day filtered low flow ratio fell below the 20th percentile of the baseline data during 2018 and remained below the 20th percentile of the baseline data during the review period. To assess if similar conditions have been observed at the control site in the region, a comparison of the 12 month median of the ratio of 14 day sums of monitored flow at a control site on O'Hares Creek at Wedderburn (GS 213200) and flows simulated via the modified AWBM have been assessed.

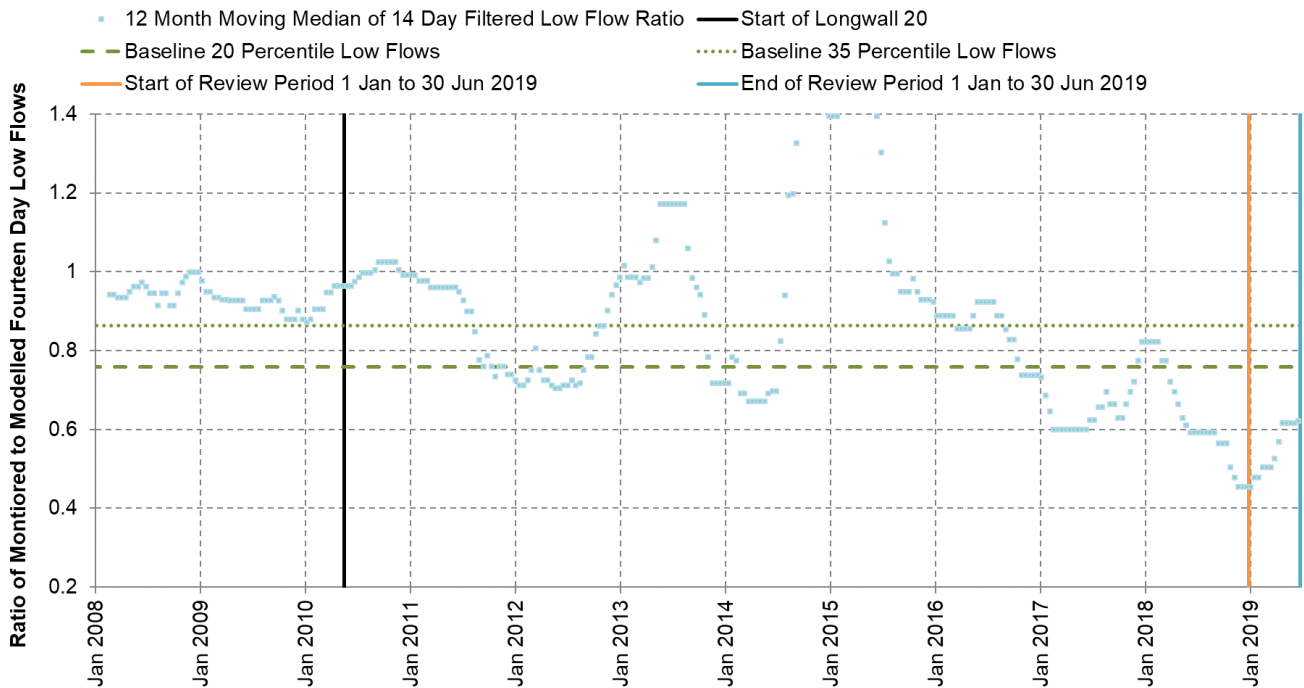
Chart 5 One Year Moving Median for the Ratios of the 14 Day Sums of Monitored and Modelled Flow Rates at O'Hares Creek at Wedderburn (GS 213200)

Chart 5 shows a plot of the moving 12 month median of the ratio of 14 day sums of monitored flow at O'Hares Creek at Wedderburn (GS 213200) and flows simulated with the modified AWBM to 30 June 2019.

The results in Chart 5 show that the moving 12 month median of the 14 day filtered low flow ratio at O'Hares Creek at Wedderburn (GS 213200) also remained below the 20th percentile of the baseline data. This illustrates that similar flow conditions have occurred at both Waratah Rivulet and the control site (O'Hares Creek at Wedderburn). As such, while the Metropolitan Coal Longwalls 301-303 Water Management Plan Trigger Action Response Plan (TARP) has reached Level 3, it is considered that the performance indicator relating to the quantity of water entering Woronora Reservoir from Waratah Rivulet has not been exceeded and an assessment against the performance measure is not required.

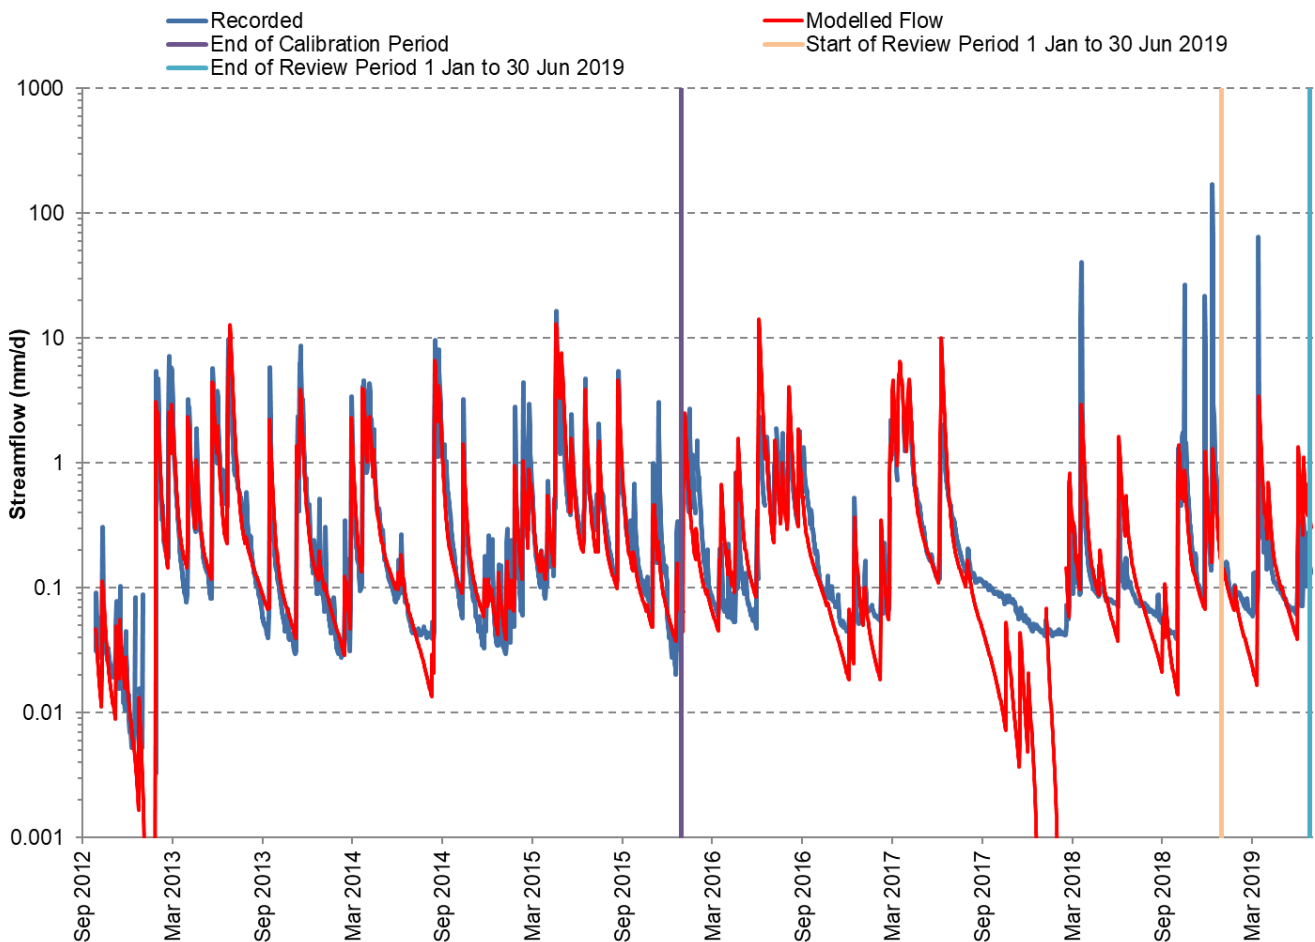
Chart 6 Monitored and Model Predicted Flows – Eastern Tributary Upstream of Woronora Reservoir

Flow data up to 30 June 2019 has been provided from gauging station 300078 – Eastern Tributary upstream of Woronora Reservoir. Flow data is available from station establishment on 23 September 2012. The available data is shown on Chart 6 below together with model predicted results.

Results show that flow has been continuous at the gauging station and that it has been generally consistent with or above model predictions. This indicates that flow reaching the Woronora Reservoir has not been reduced by mining.

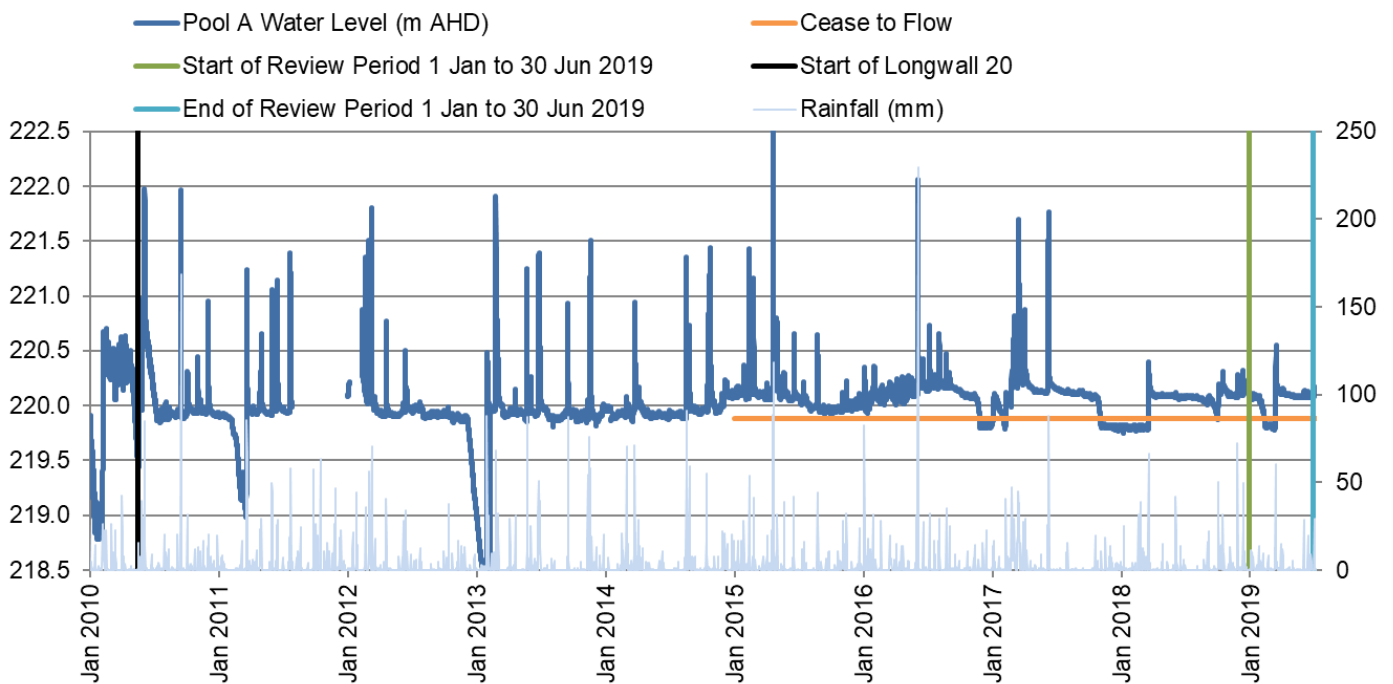
Chart A2 Pool A Waratah Rivulet⁴

⁴ Pool A cease to flow level was revised from 219.829 m AHD to 219.883 m AHD based on advice from Metropolitan Coal.

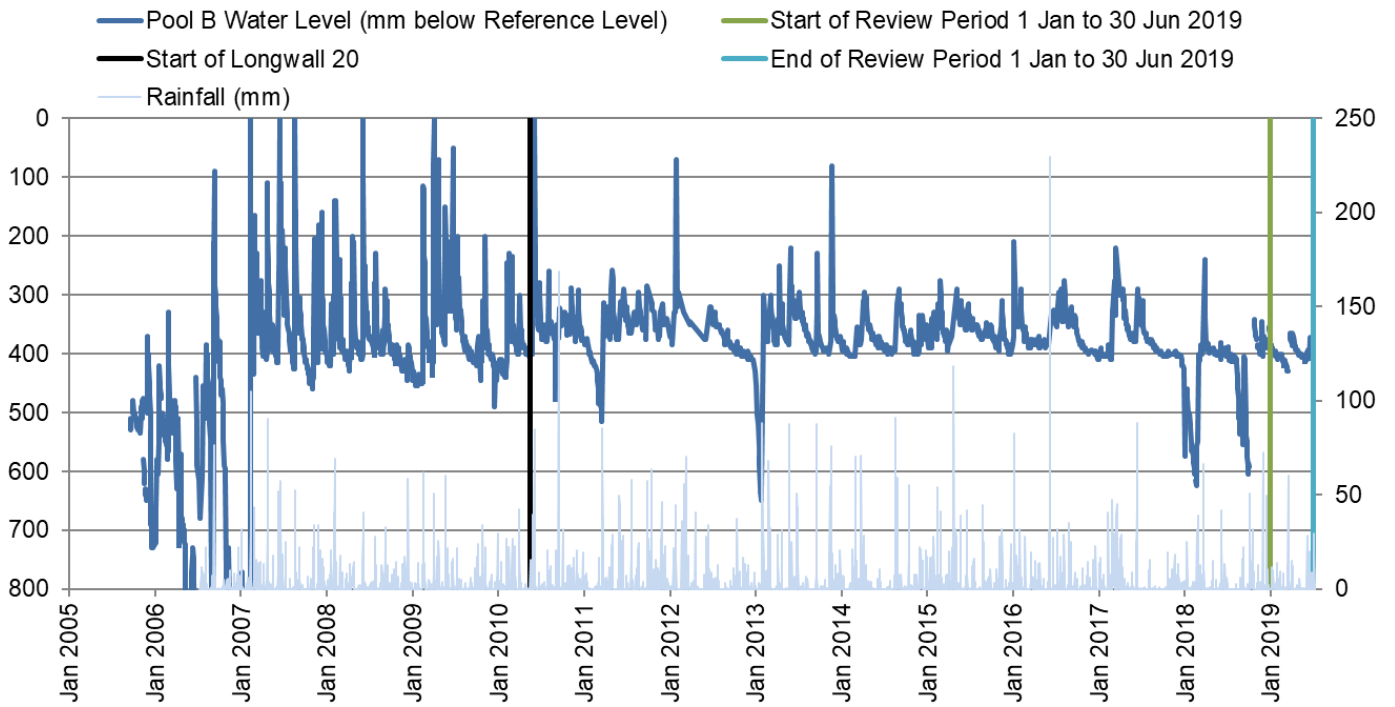
Chart A3 Pool B Waratah Rivulet (Manual Observations)⁵

⁵ Cease to Flow level has been removed from the chart for this review period as the manual observations indicate that the Cease to Flow level previously shown was incorrect.

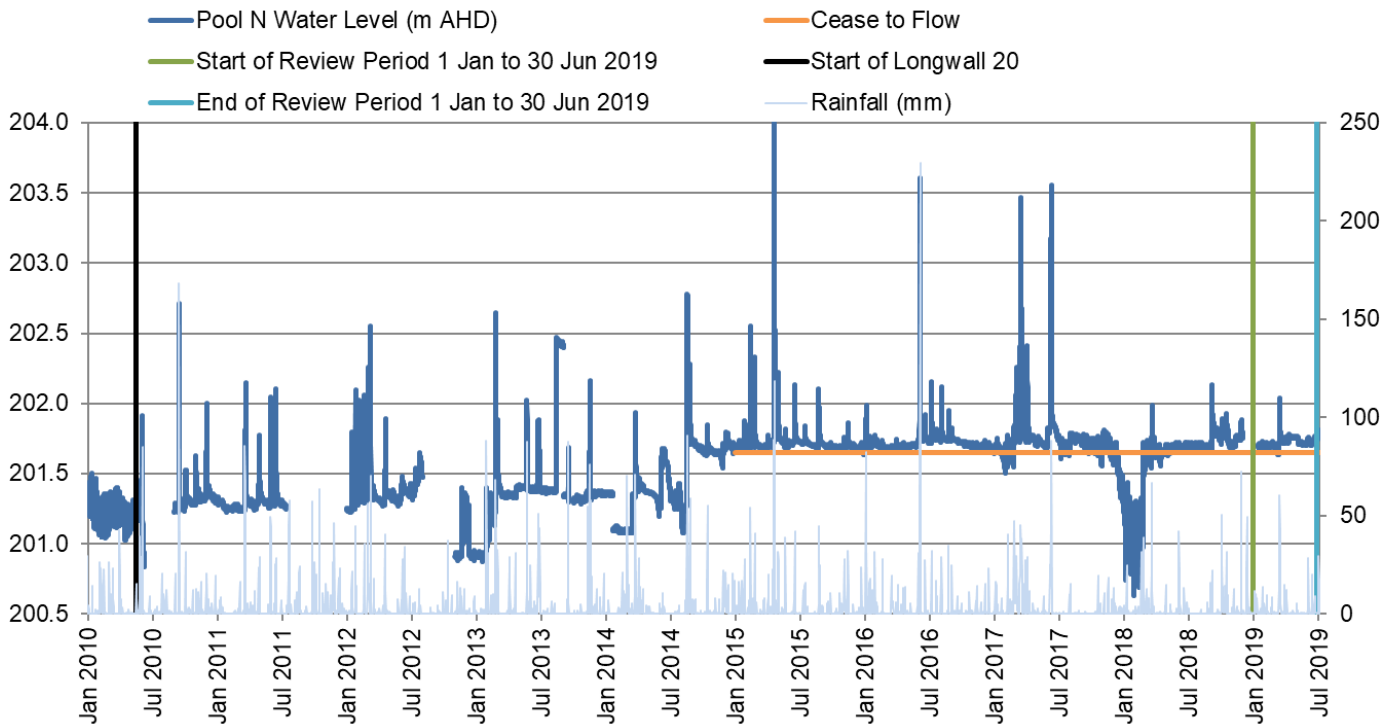
Chart A16 Pool N Waratah Rivulet⁶

⁶ Pool N water level sensor did not record any data during December 2018. Subsequently, the sensor was replaced in January 2019.

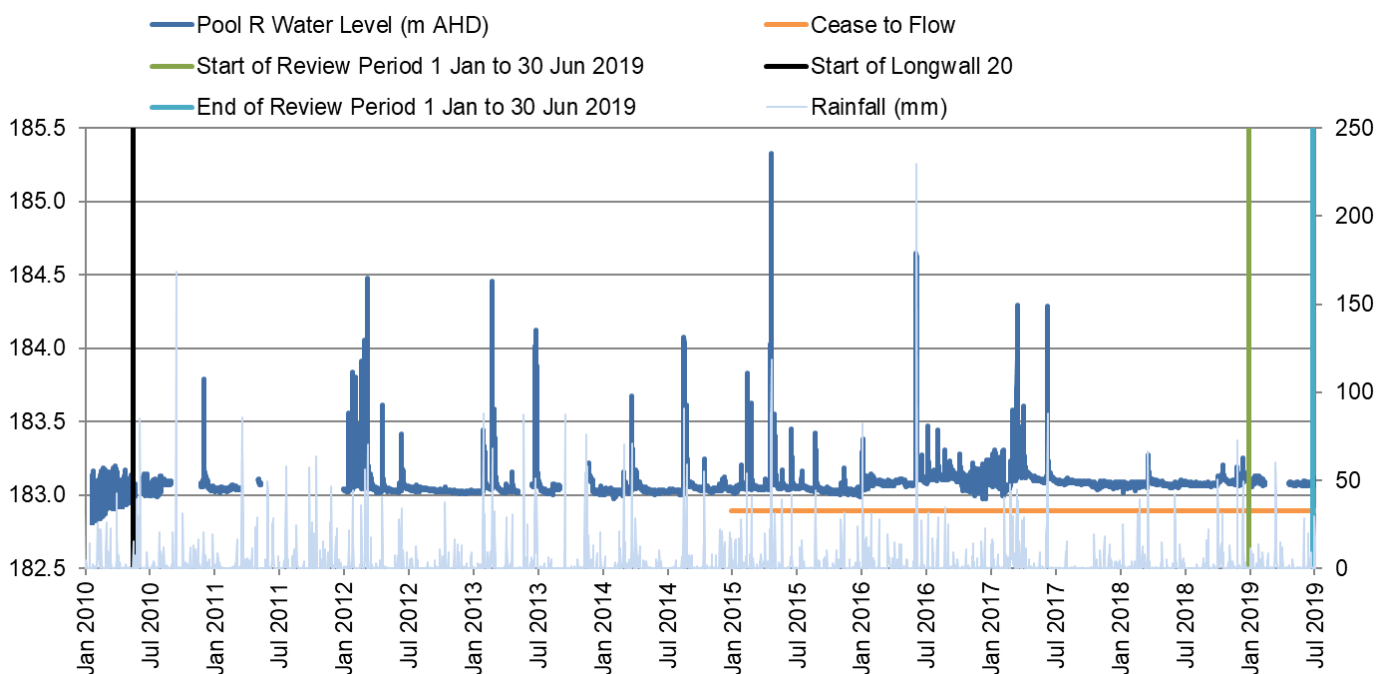
Chart A20 Pool R Waratah Rivulet⁷

⁷ The sensor malfunctioned on 14 February 2019 and was replaced on 24 April 2019. As such, no data was recorded during this period.

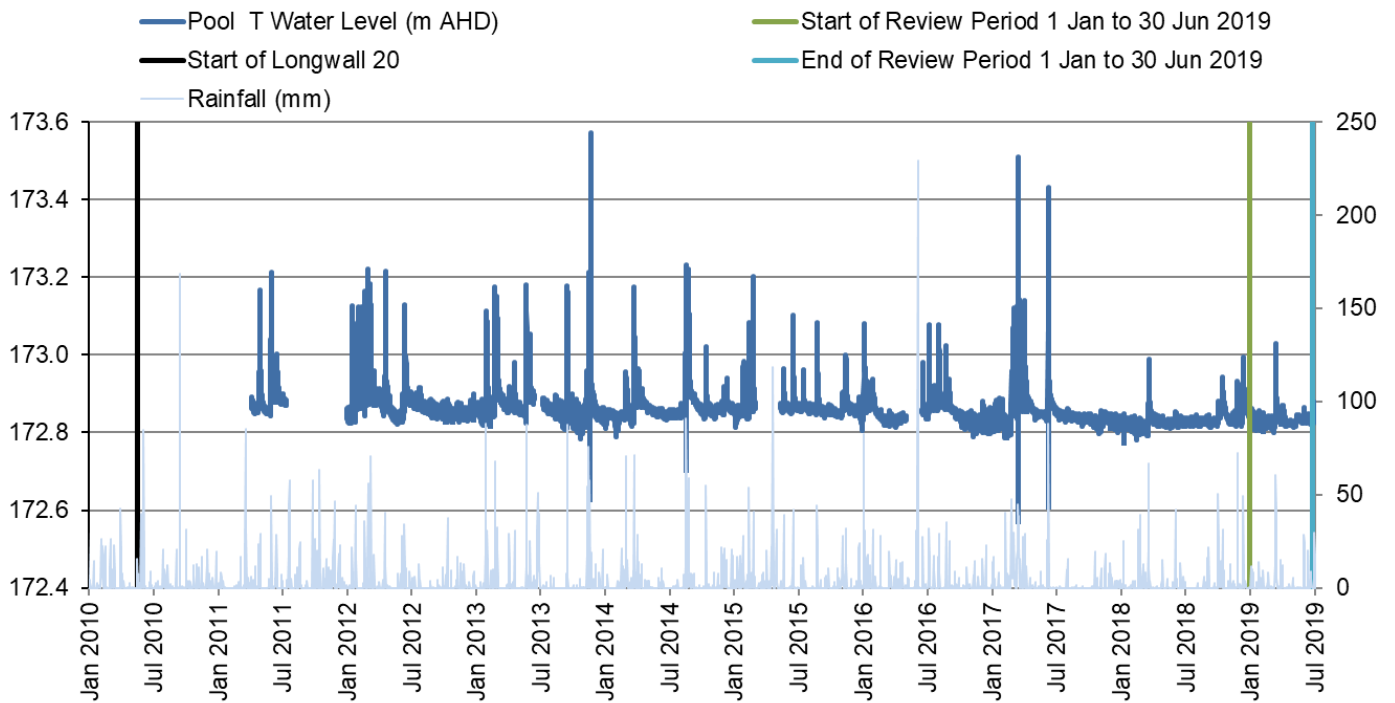
Chart A22 Pool T Waratah Rivulet⁸

⁸ The sudden drop in water level recorded on 18/3/2017 and 10/6/2017 are consistent with logger error.

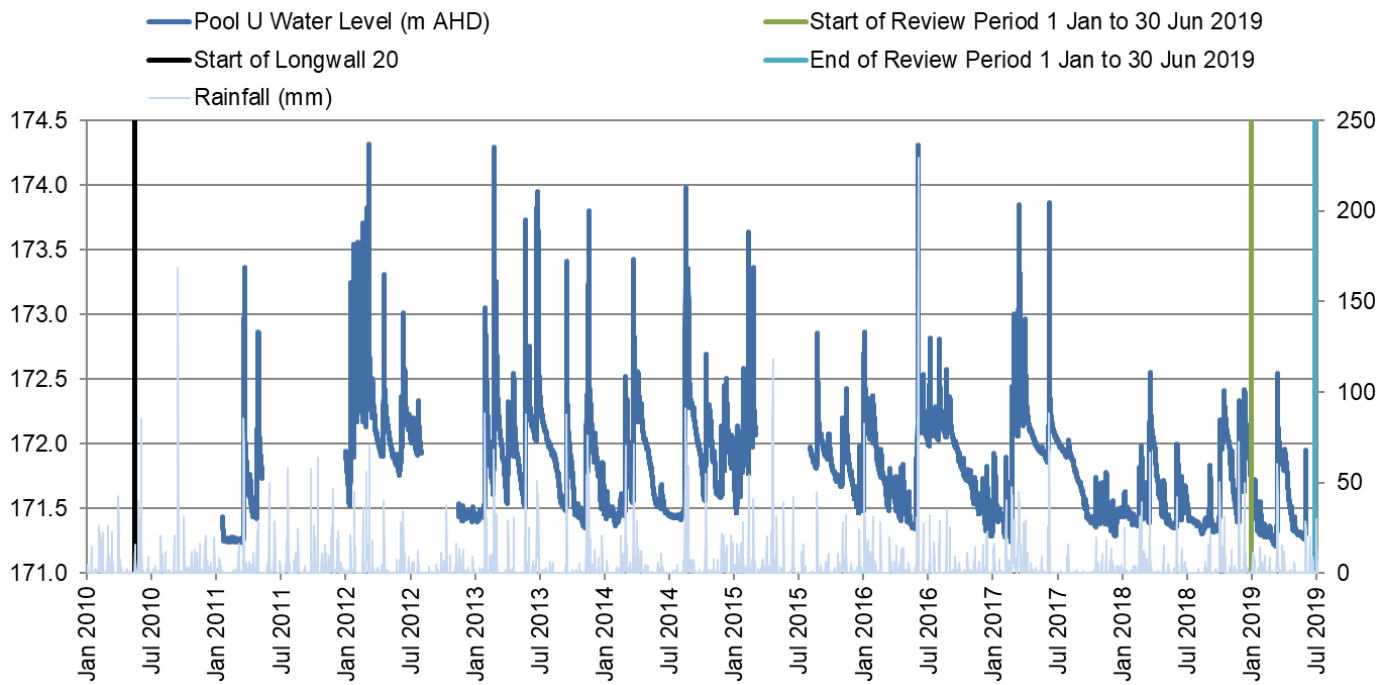
Chart A23 Pool U Waratah Rivulet⁹

⁹ The sensor malfunctioned on 6 June 2019 and was replaced in July 2019. As such, no data was recorded during this period.

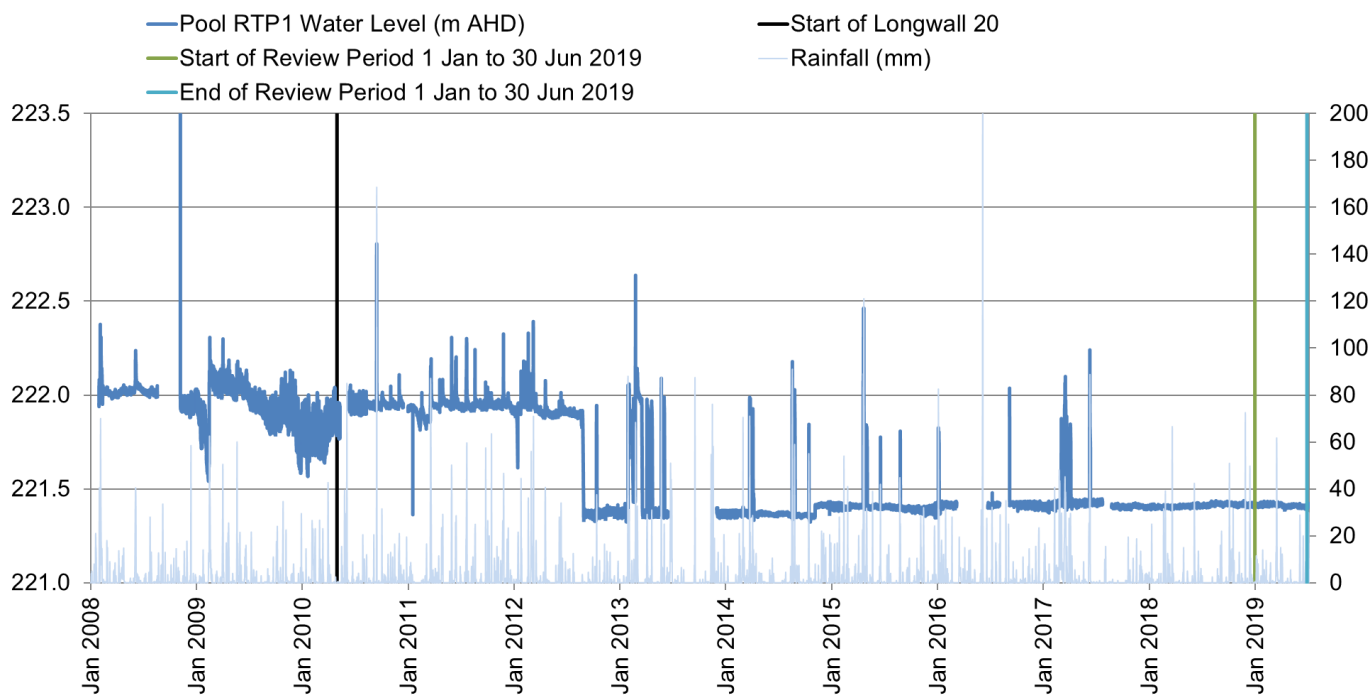
Chart A39 Pool RTP1¹²

¹² Water levels have not been able to be reduced to AHD levels. The spikes are however indicative of water level rises associated with rainfall-runoff events and should be regarded as being indicative of relative pool water level changes.

Pool RTP1 on Tributary B was dry during the review period, consistent with natural behaviour. Pool RTP2 was typically below the cease to flow level, however water levels rose for short durations following rainfall events.

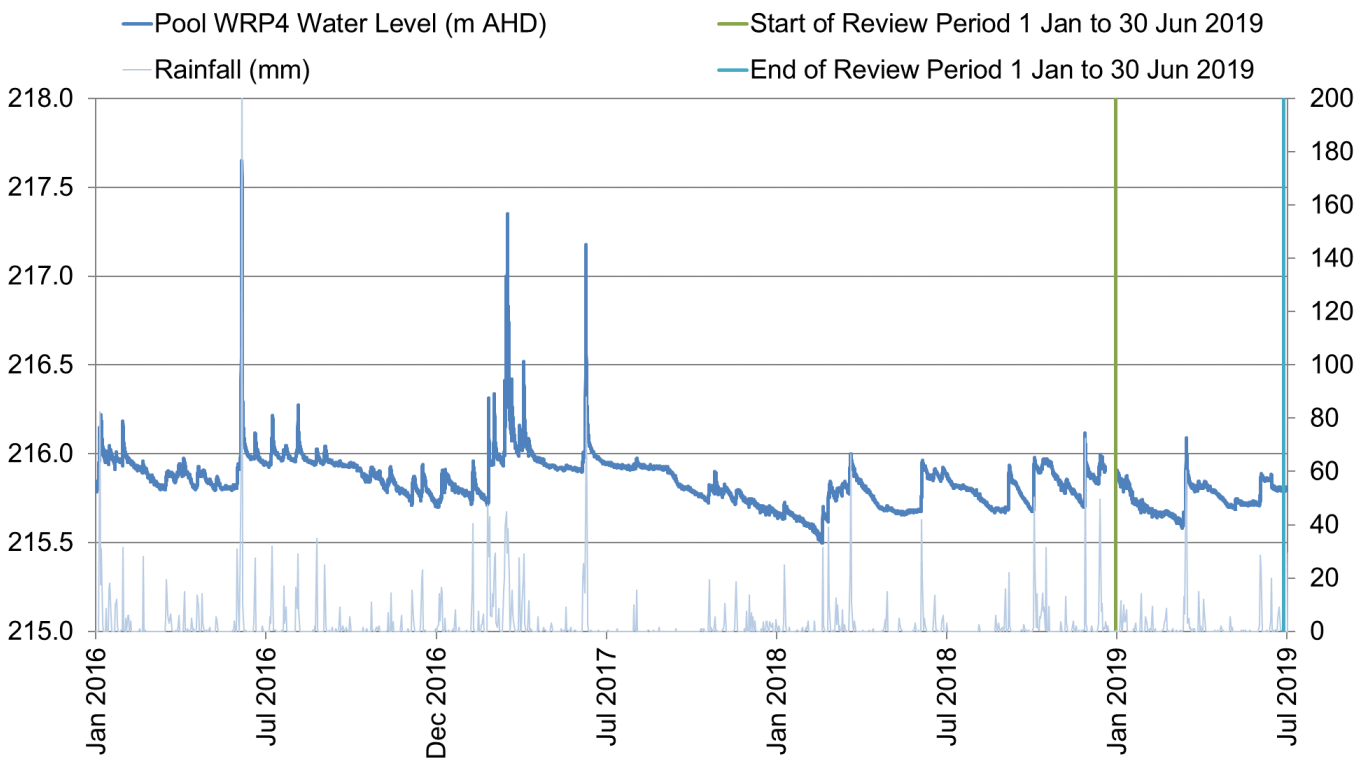
Chart A44 Pool WRP4¹⁴

¹⁴ Pool water level data for WRP4 was erroneous from 20/12/18 to 01/01/2019 and removed from the dataset. The erroneous data was a result of a logger positioning error.
