# METROPOLITAN COAL LONGWALLS 305-307

## HERITAGE MANAGEMENT PLAN

ME-TSE-MNP-0081

June 2021

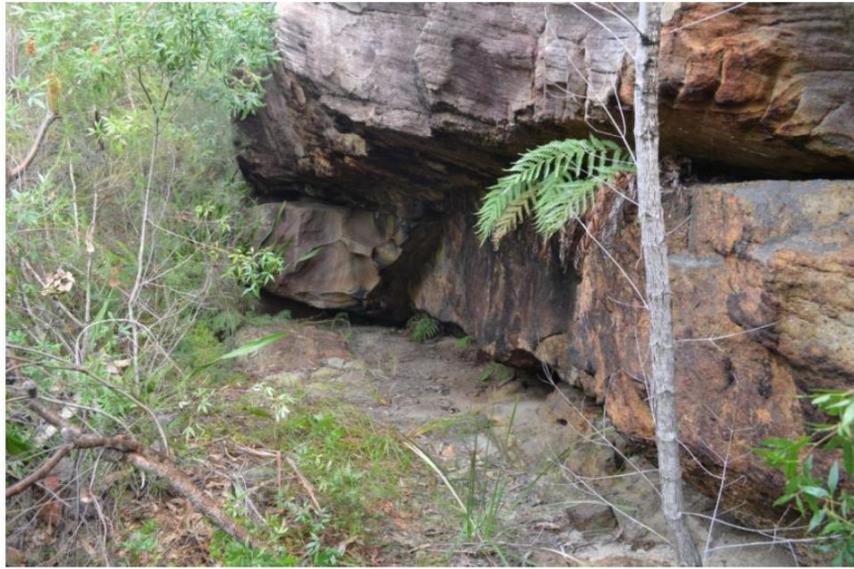
FRC 68

Source: Niche Environment and Heritage (2014)

Small shelter consisting of bedded sandstone and formed by scaling (weathering). Sharp backwall and front edge undulates. A prominent joint was observed perpendicular to the trend and parallel to the longwall approach.

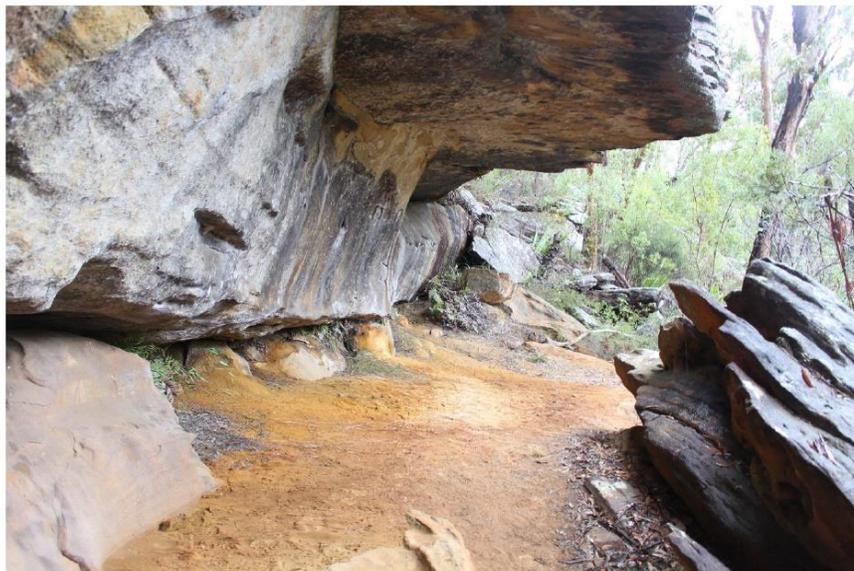
FRC 185

Source: Niche Environment and Heritage (2018)

Small shelter consisting of bedded sandstone with cavernous weathering. Undulating backwall and front edge. Block fall (in antiquity) of overhang, edges well weathered.

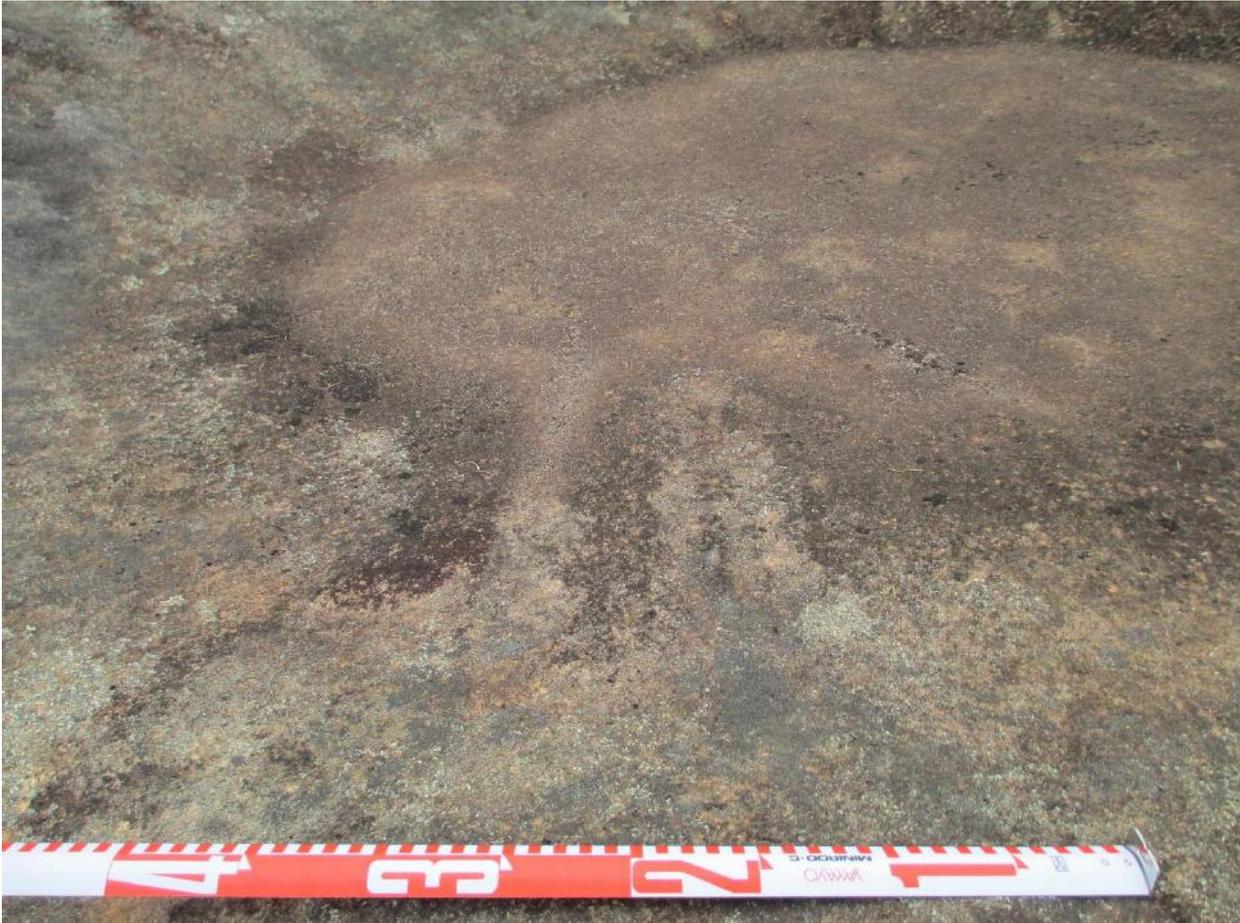
Plate 84: Detail of NEW 1. Axe Grinding Groove.
