# Historical Heritage Assessment

Prepared for South32 Illawarra Metallurgical Coal  
Prepared by Niche Environment and Heritage | 1 June 2021

Niche Environment and Heritage Pty Ltd (Niche) was commissioned by South32 Illawarra Metallurgical Coal (IMC) to prepare a Historical Heritage Assessment (HHA) for the Appin Mine Ventilation and Mine Access Project (hereafter referred to as 'the Project') at Menangle.

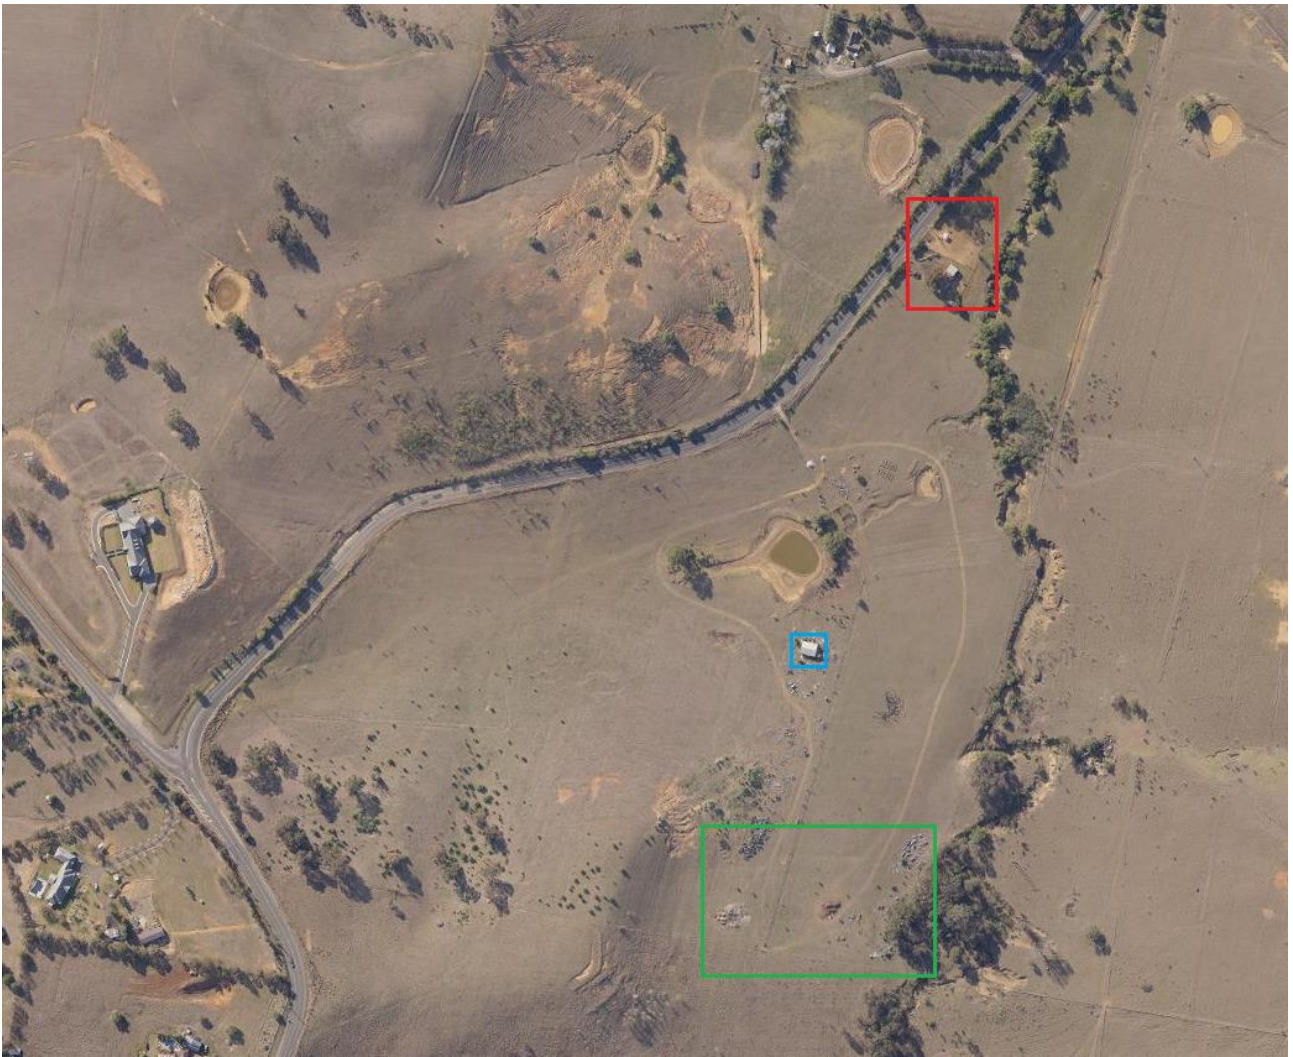
**Plate 3: Modern residential building at 345 Menangle Road indicated in red, corrugated farm shed indicated in blue and area of rubbish dumping indicated in green (Source: Niche and LPI).**

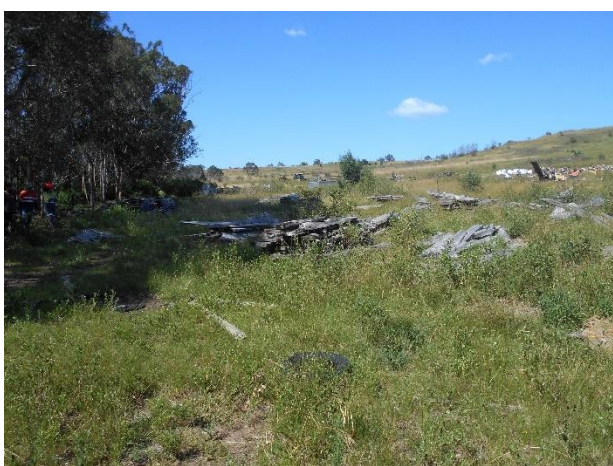
**Plate 8: Location of modern rubbish dumping at southern end of Subject Area, facing south. Foot Onslow Creek to left of frame.**

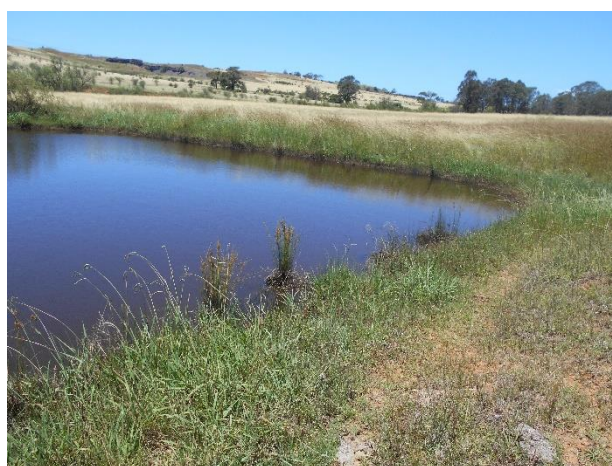
The Subject Area has been utilised for cattle grazing until early 2021. Evidence of cattle movement across the landscape was noted in the erosion and bioturbation of the bank of Foot Onslow Creek and dams.

**Plate 9: Large farm dam in centre of Subject Area, facing south-east.**

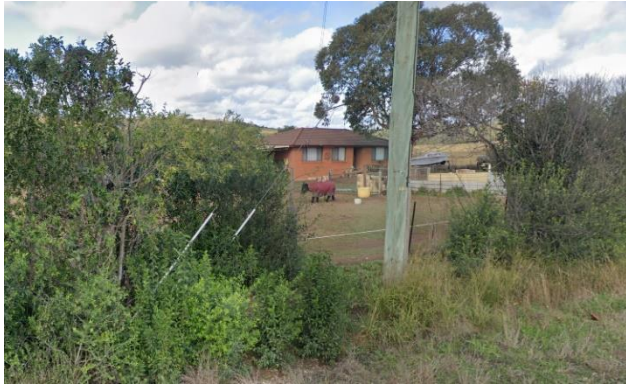
**Plate 10: Residential house located at 345 Menangle Road, facing east.**

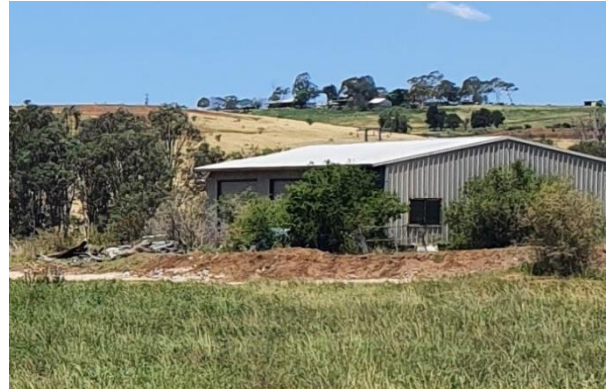
**Plate 11: Modern farm shed near dam (Source: IMC).**

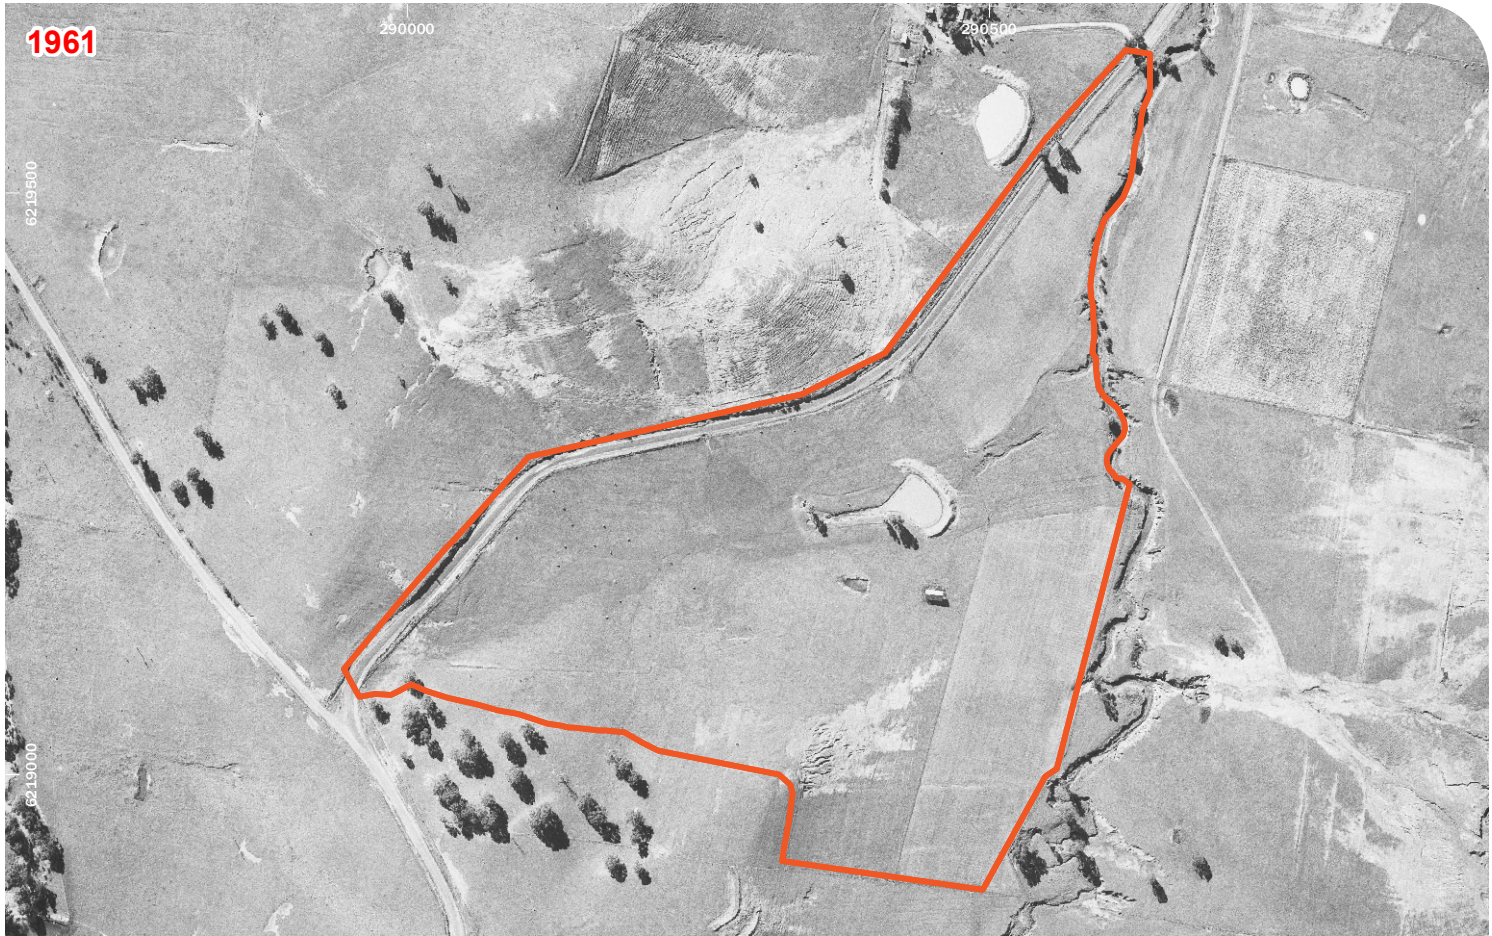
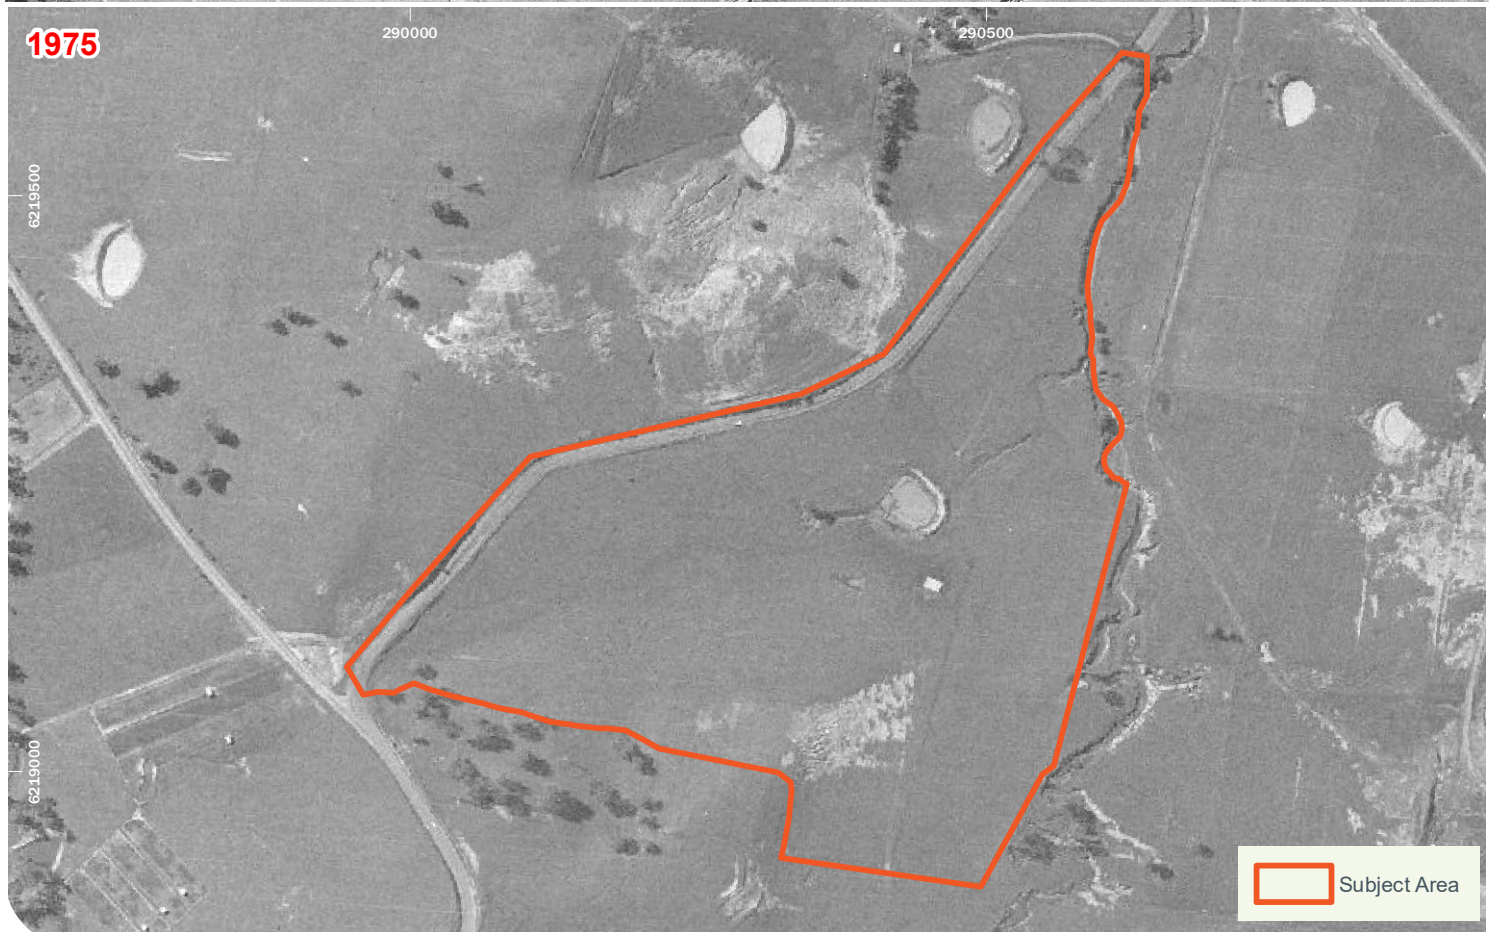
The aerial from 1961 depicts the Subject Area and Foot Onslow Creek largely cleared of vegetation. The large dam has already been constructed at this time, and there is a small structure in the location of the modern shed. There is no indication of any additional development or use of the site beyond small scale farming.

The 1975 aerial is largely unchanged from the earlier depiction, with the exception of the residential block at 345 Menangle Road. The aerial does not clearly show if the house existed at this time, but a division of the block from the surrounding field and some localised vegetation growth within the immediate area indicates that it may have been occupied.
