APPIN MINE ANNUAL REVIEW FY20

The Annual Review has been prepared to meet the requirements of Condition 4 of Schedule 6 of the BSO Project Approval 08_0150 (the Project Approval) and the NSW Resources Regulator requirement to submit an Annual Environmental Management Report (AEMR) under the Mining Leases for Appin Mine.

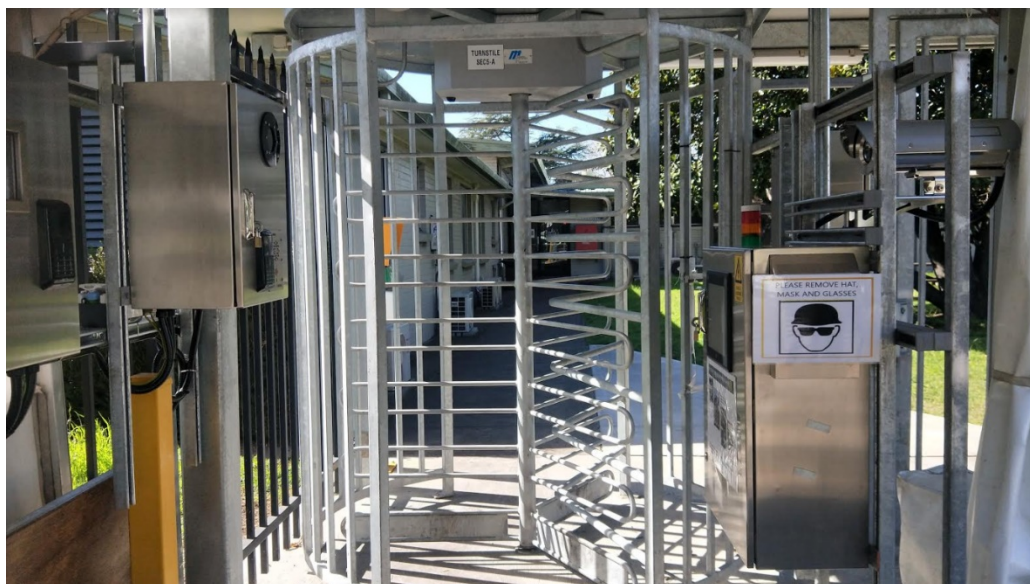
Plate 1: Site security entry control point

Site security activities were completed and commissioned at Appin Mine in June 2020 and are currently in use.

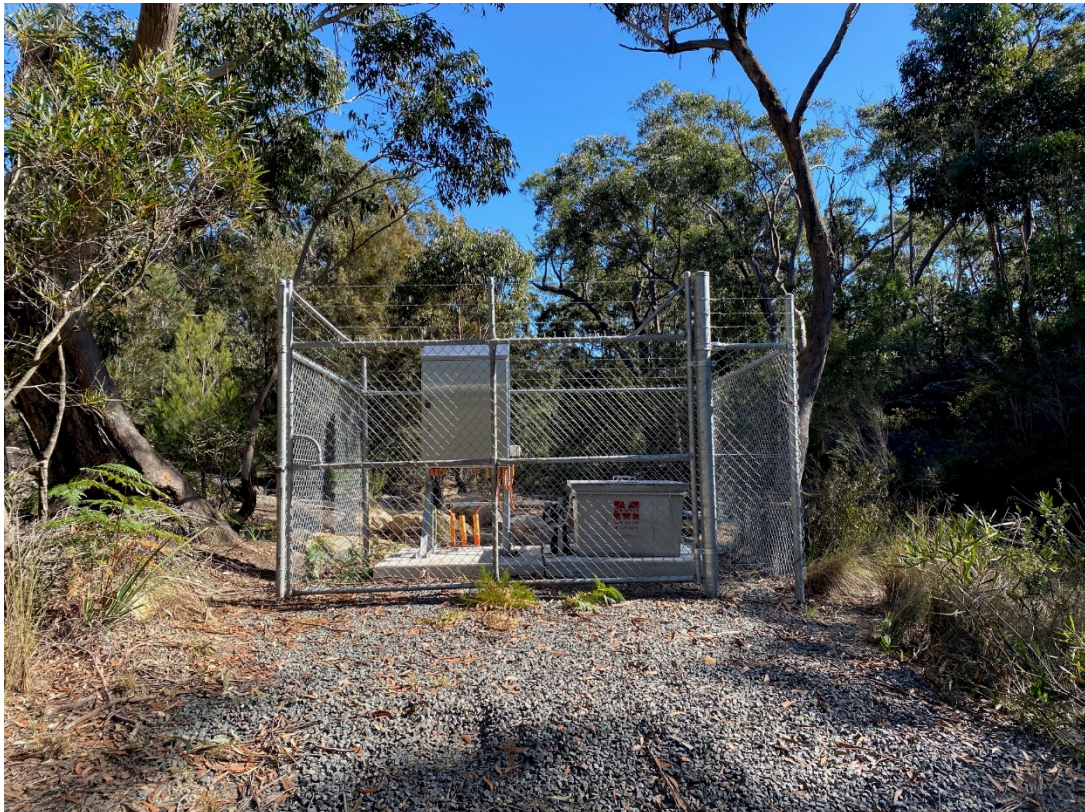
Plate 2: LDP 10 continuous monitoring station

The continuous water quality monitoring system at Licence Discharge Point (LDP) 10 (BCD discharge) was relocated closer to the discharge point, and upgraded with new probes, a submerged sample pump and sample tank/chamber. LDP 10 now has dual probes to provide redundancy and improve the reliability of the monitoring system. The system communicates with the BCD Automation System (refer to Section 4.4.4).

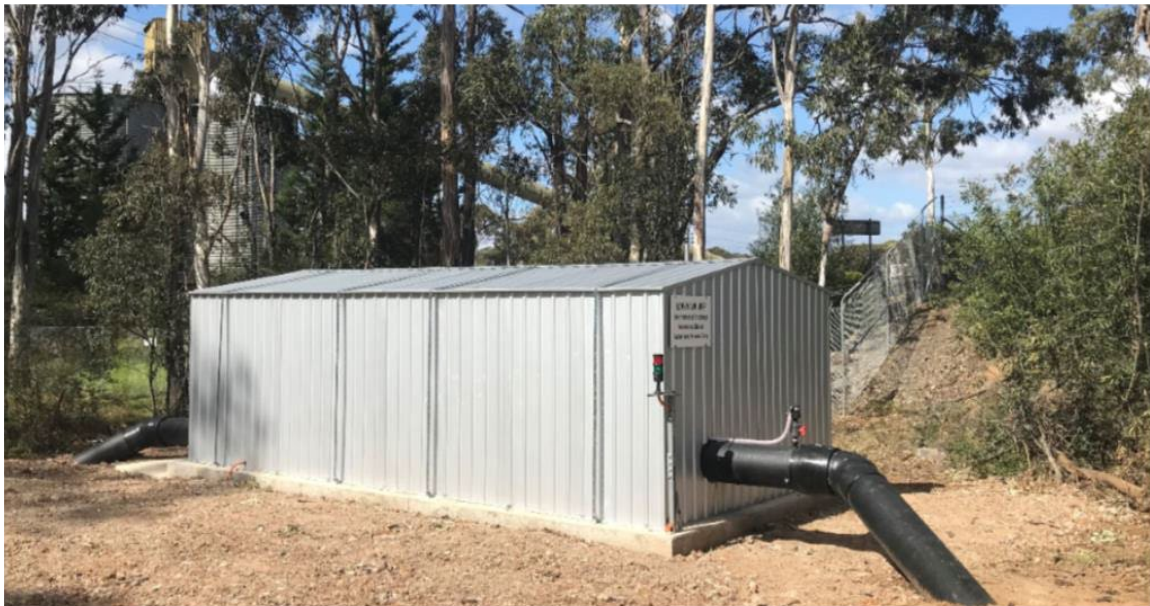
Plate 3: LDP 24 Monitoring Station Shed

Enclosed in a shed, the monitoring station consists of dual pH and conductivity analysers with transmitters and a magnetic flow meter to meet the EPL 2504 (Point 24) requirements. The monitoring system is integrated with the controls at the Appin West Plant (AW WTP) (Integrated Membrane System (IMS) 1 and IMS 2a)).

Works commenced at LDP 24 on a continuous real-time monitoring system for pH and conductivity. The monitoring system upgrade was completed during September 2019 and commissioned in October 2019.

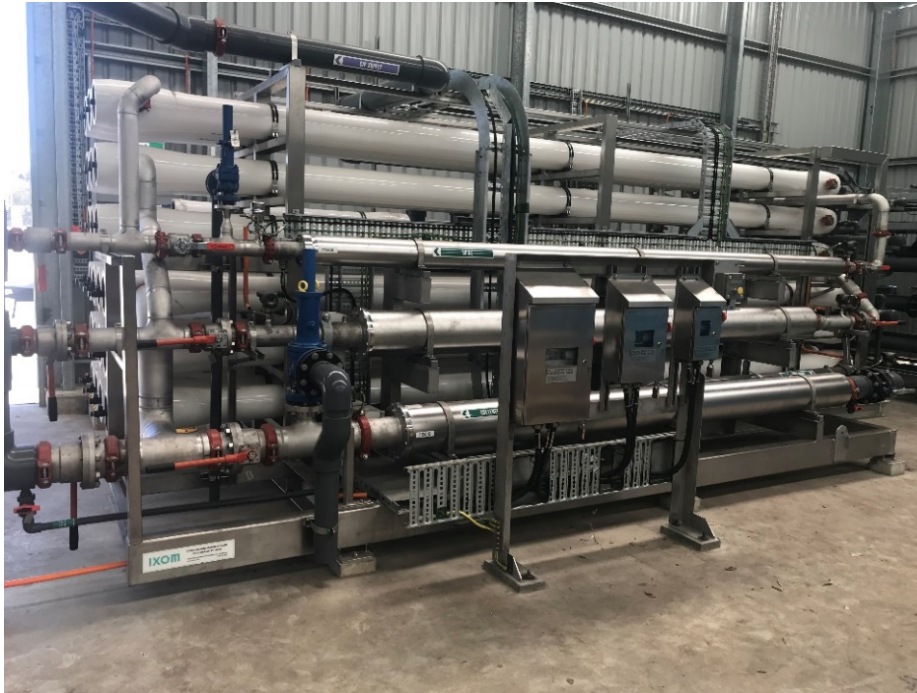
Plate 5: Reverse osmosis skid at AW WTP – IMS 2a

The new continuous real-time monitoring system for pH and conductivity commissioned at LDP 24 is integrated with the AW WTP (refer to Section 4.4.5). Water quality assessments of the discharges to the environment are ongoing to ensure compliance with revised water quality limits in EPL 2504 can be achieved, noting that plant operation may need to be amended. Further studies will be required to evaluate impacts of discharges on the environment. Additional details regarding this project are provided in Section 6.3.3.

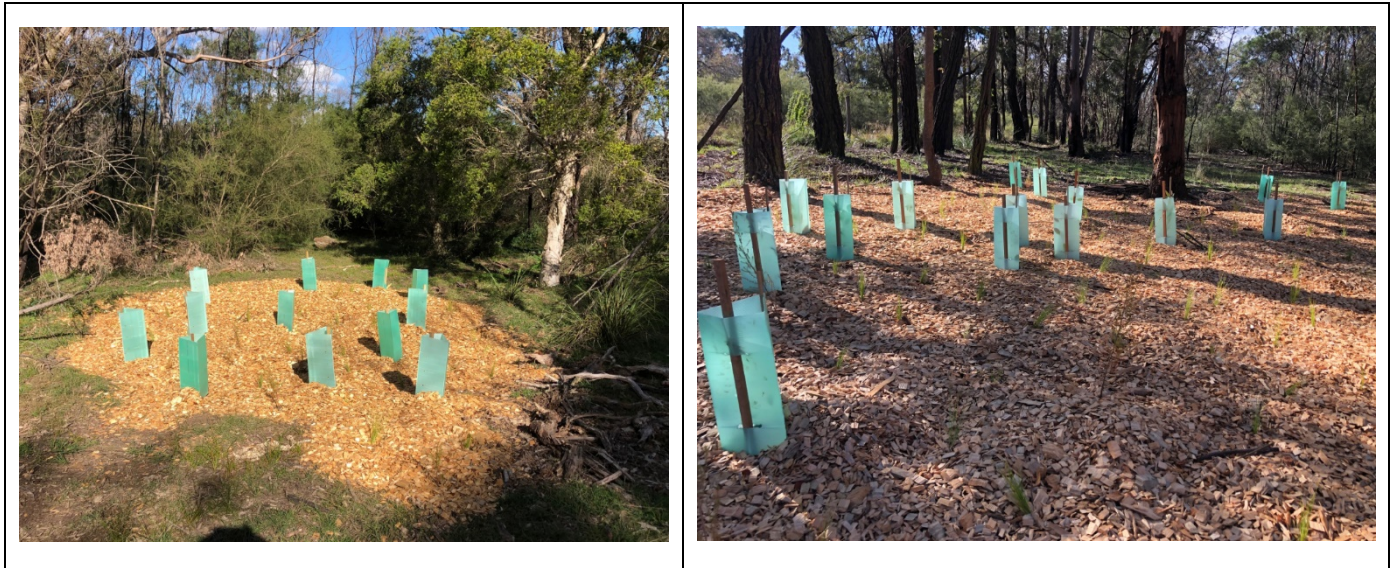
All three areas have since been rehabilitated with 500 seedlings of local grass, shrub species and 50 seedlings representing canopy species local to the area.

Plate 7: Rehabilitation following the removal of asbestos at the Cataract River Biobank Site

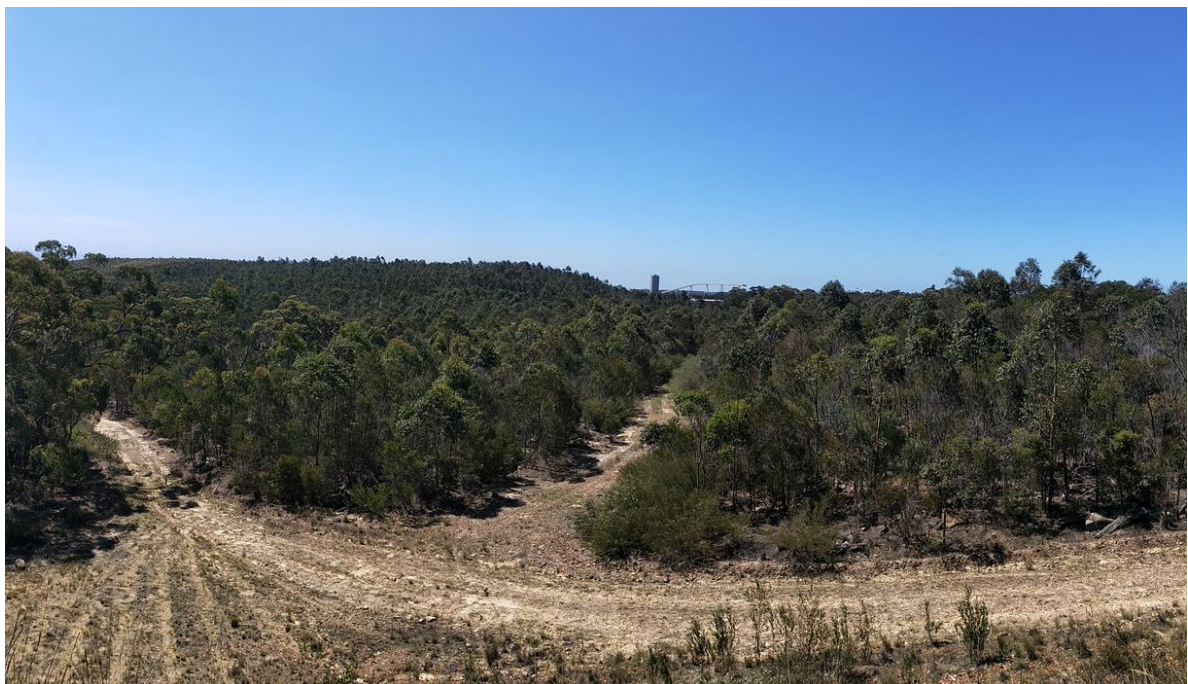
Plate 8 shows the performance of rehabilitation on Stage 2 of the emplacement.

Plate 8: Stage 2 emplacement rehabilitation FY20 (Seeded in 2007).
