APPIN MINE AREAS 7 AND 9 LONGWALLS 709 TO 711 AND 905 HERITAGE MANAGEMENT PLAN

This document UNCONTROLLED once printed				Page 1 of 29
Document ID		Version	1.1	
Last Date Updated	October 2021	Next Review Date	October 2024

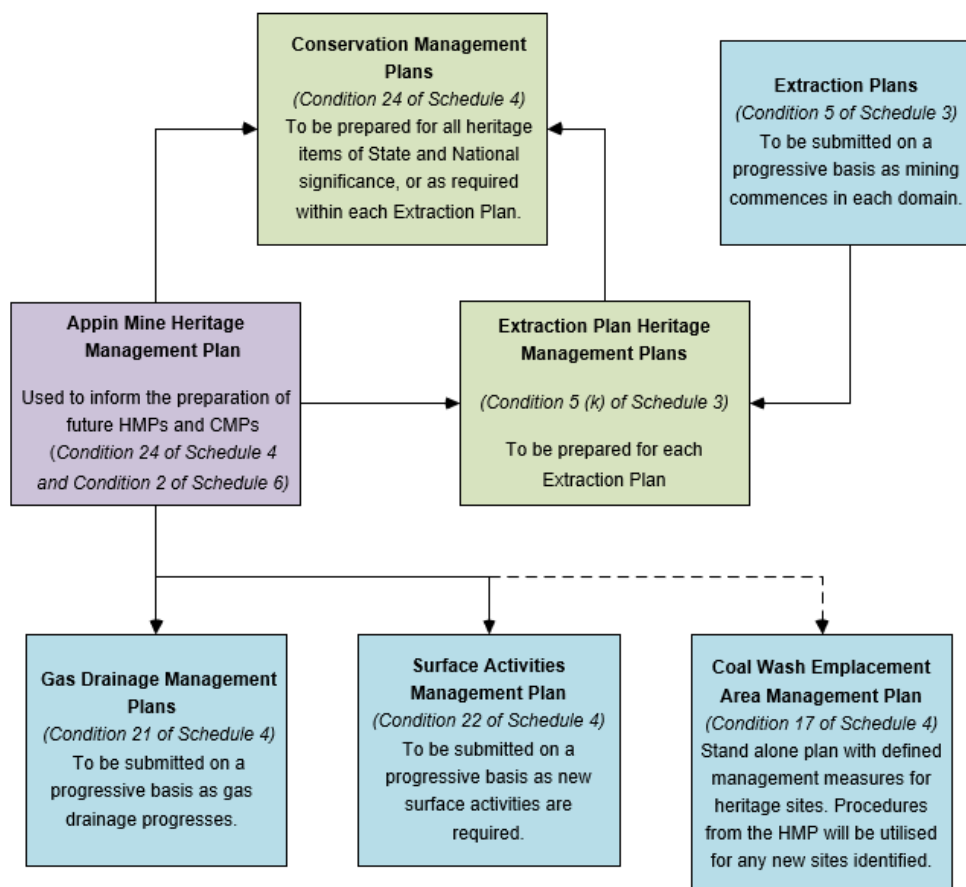
Figure 1 Management Plan Flow chart

This Appin Mine HMP is the overarching plan for managing heritage impacts associated with Appin Mine operations and informs the relevant Extraction Plan HMP, the Surface Facilities Management Plan, Coal Wash Emplacement Area Management Plan and Gas Drainage Management Plan. The Appin Mine Heritage Management Plan (South32 2020) is available on the South32 Website. The relationship and interactions between these plans are shown in Figure 1.

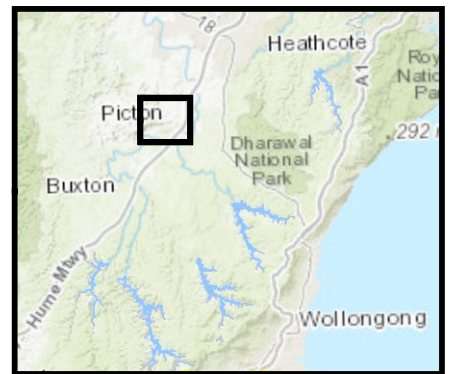
Figure 2

- Longwalls 709-711 and 905
- 600 m Study Area
- Railway Lines
- Rivers
- Creeks
- Tributaries

The locations of the recorded heritage features within the Longwalls 709 to 711 and 905 Study Area are shown in Figure 2.

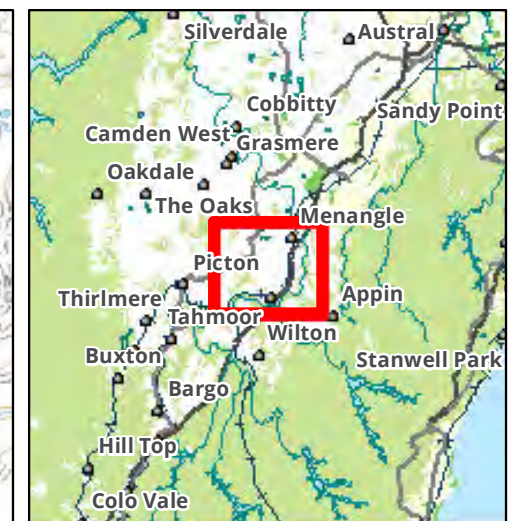
Figure 5 AHIMS records near the study area

- Study area - 35 degree angle of draw
- Study area - 600m boundary
- AHIMS record

A search of the SHR and *Wollondilly LEP 2011* was completed in order to identify any non-Aboriginal heritage located within the study area. There were no records identified by these searches (Figure 5).

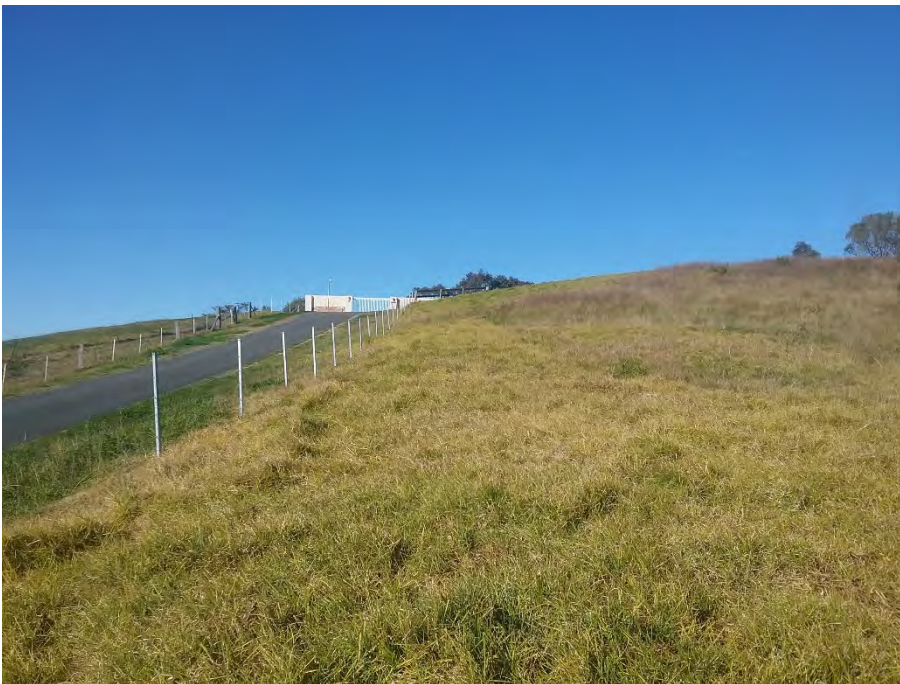
Photo 1 South facing photo showing extensive grass coverage and low visibility

In most archaeological reports and guidelines visibility refers to GSV, and is usually a percentage estimate of the ground surface that is visible and allowing for the detection of (usually stone) artefacts that may be present on the ground surface (DECCW 2010). GSV across the study area was typically low (20%) due to extensive grass coverage (Photo 1). Small areas of GSV were present along fence lines, along access tracks (Photo 2) and where erosion and disturbance had occurred.

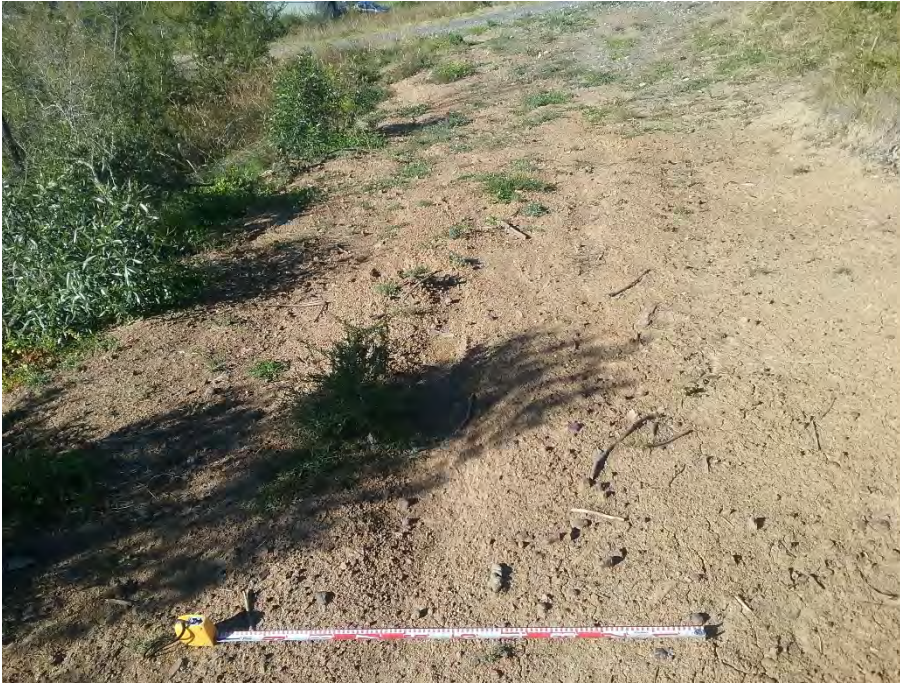
Photo 2 South facing photo showing visibility along access tracks

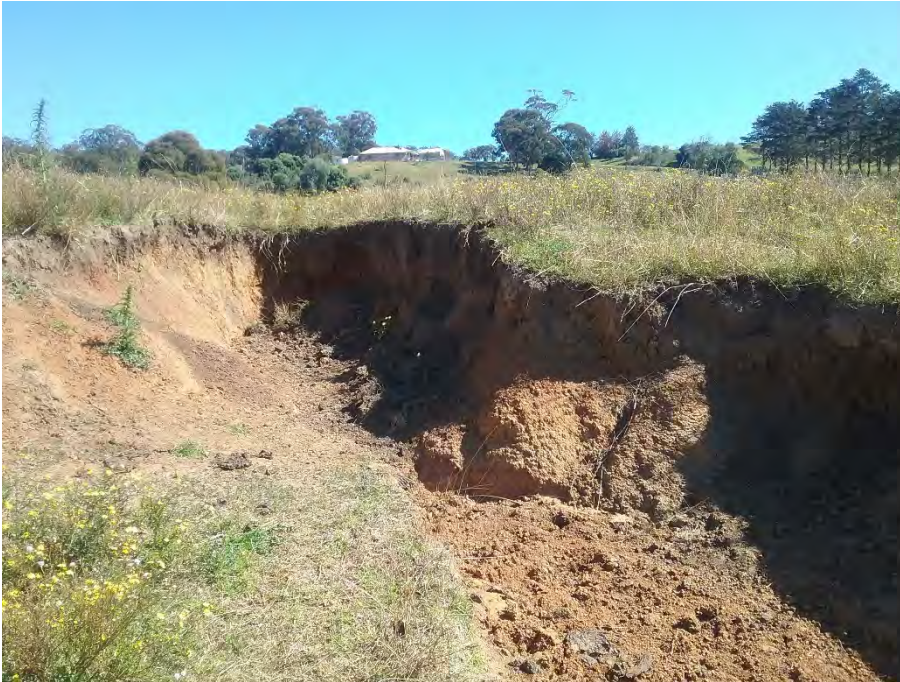
Photo 3 West facing photo showing exposure created by erosion

Exposure refers to the geomorphic conditions of the local landform being surveyed, and attempts to describe the relationship between those conditions and the likelihood the prevailing conditions provide for the exposure of (buried) archaeological materials. Whilst also usually expressed as a percentage estimate, exposure is different to visibility in that it is in part a summation of geomorphic processes, rather than a simple observation of the ground surface (Burke & Smith 2004, p.79, DECCW 2010). Overall, the study area displayed areas of exposure of less than approximately 20% of the total area due to extensive grass coverage. Areas of exposure were located where erosions had occurred (Photo 3), along access tracks, at the base of mature trees (Photo 4), and around fence lines.

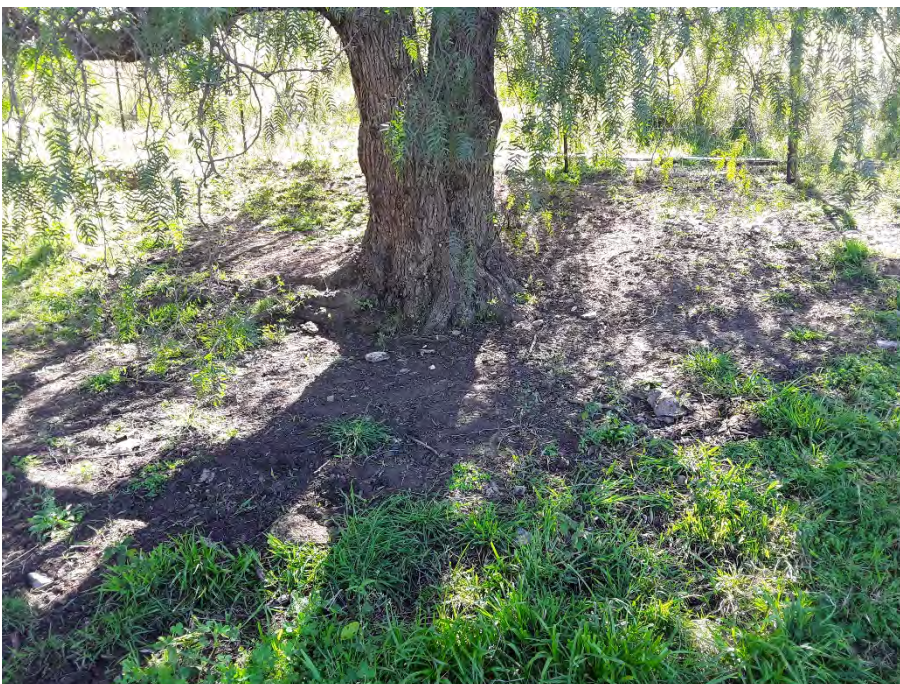
Photo 4 East facing photo showing exposure around the base of trees

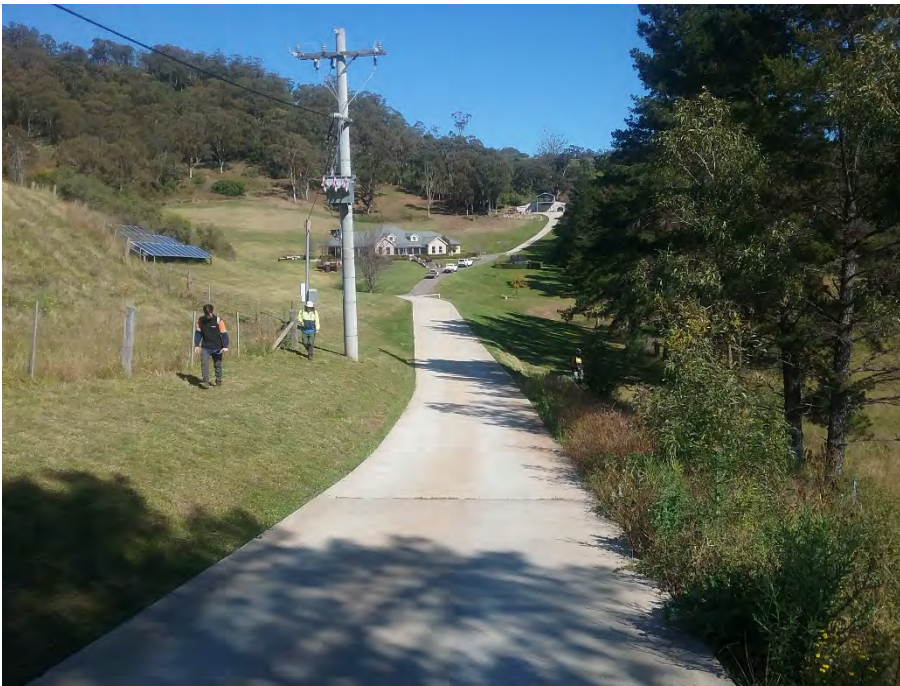
Photo 5 West facing photo showing disturbances from residential development

Disturbance in the study area is associated with natural and human agents. Natural agents generally affect small areas and include the burrowing and scratching in soil by animals, such as wombats, foxes, rabbits and wallabies, and sometimes exposure from slumping or scouring. Disturbances associated with recent human action are prevalent in the study area and cover large sections of the land surface. The agents include residential development such as landscaping and construction of residential buildings (Photo 5); farming

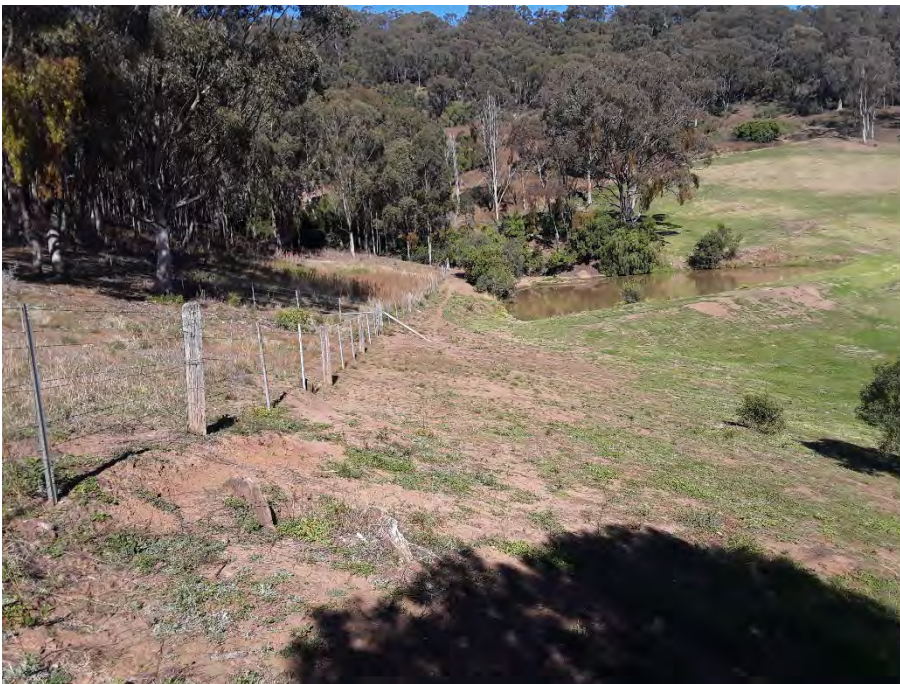
Photo 6 North facing photo showing disturbances from the construction of dams

practices, such as initial vegetation clearance for creation of paddocks, fencing and stock grazing (Photo 6); agricultural practices such as fruit orchards; and creation of artificial dams throughout the entire study area (Photo 7).

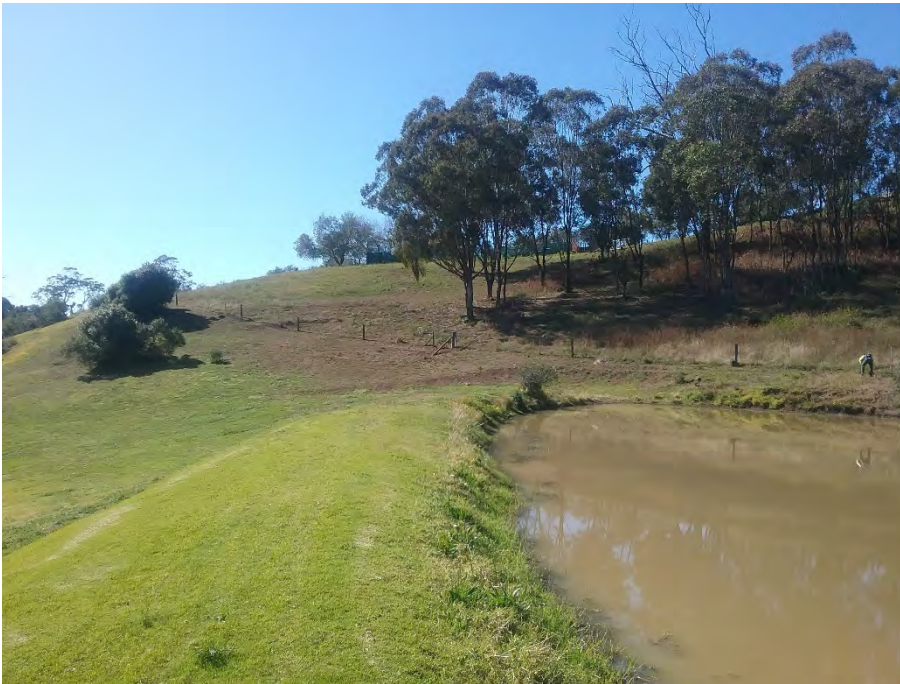
Photo 7 East facing photo showing disturbances from dam construction

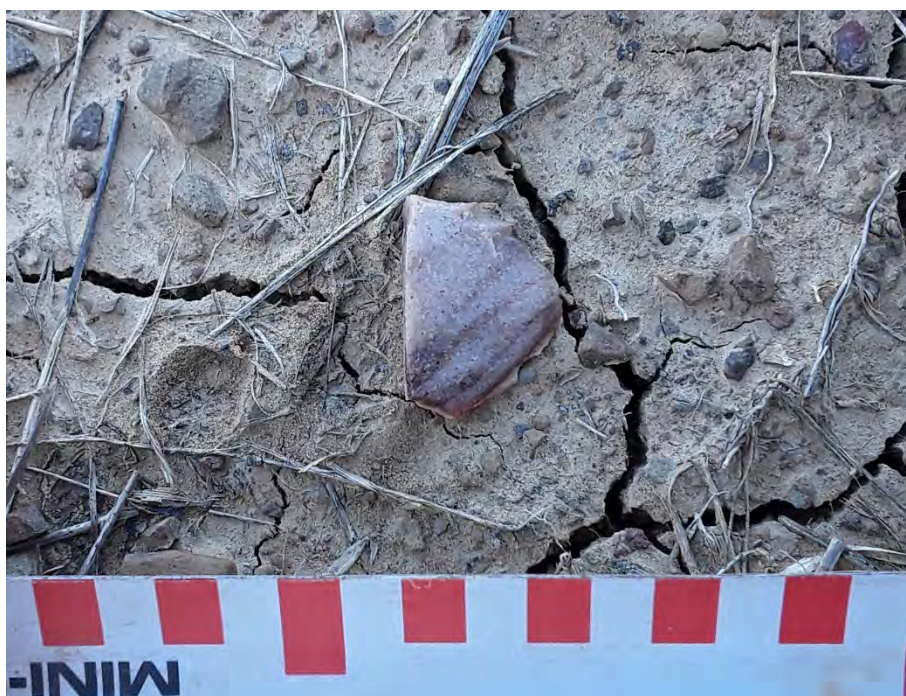
Photo 8 Hawkey Road ISO1

The site is located on a small crest adjacent to a drainage line in the southern part of Lot 81 DP880173. The artefact consists of a silcrete distal flake fragment with a plunge termination measuring 25.21 millimetres (mm) long by 20.45 mm wide and 4.04 mm thick (Photo 8).

This site has low predicted systematic tensile strains and an overall subsidence movement of less than 20 mm. The site is located on a small crest adjacent to a drainage line in the southern part of Lot 81 DP880173 and is an open site. Surface cracking could develop above the proposed longwalls and fracturing of exposed bedrock could also occur along streams. It is unlikely that surface artefacts will be impacted by surface cracking, which is in line with the impacts assessed in the BSO ACHA. Based on the risk assessment and minimal predicted subsidence impacts, Hawkey Road ISO 1 will not be subject to further archaeological assessment.

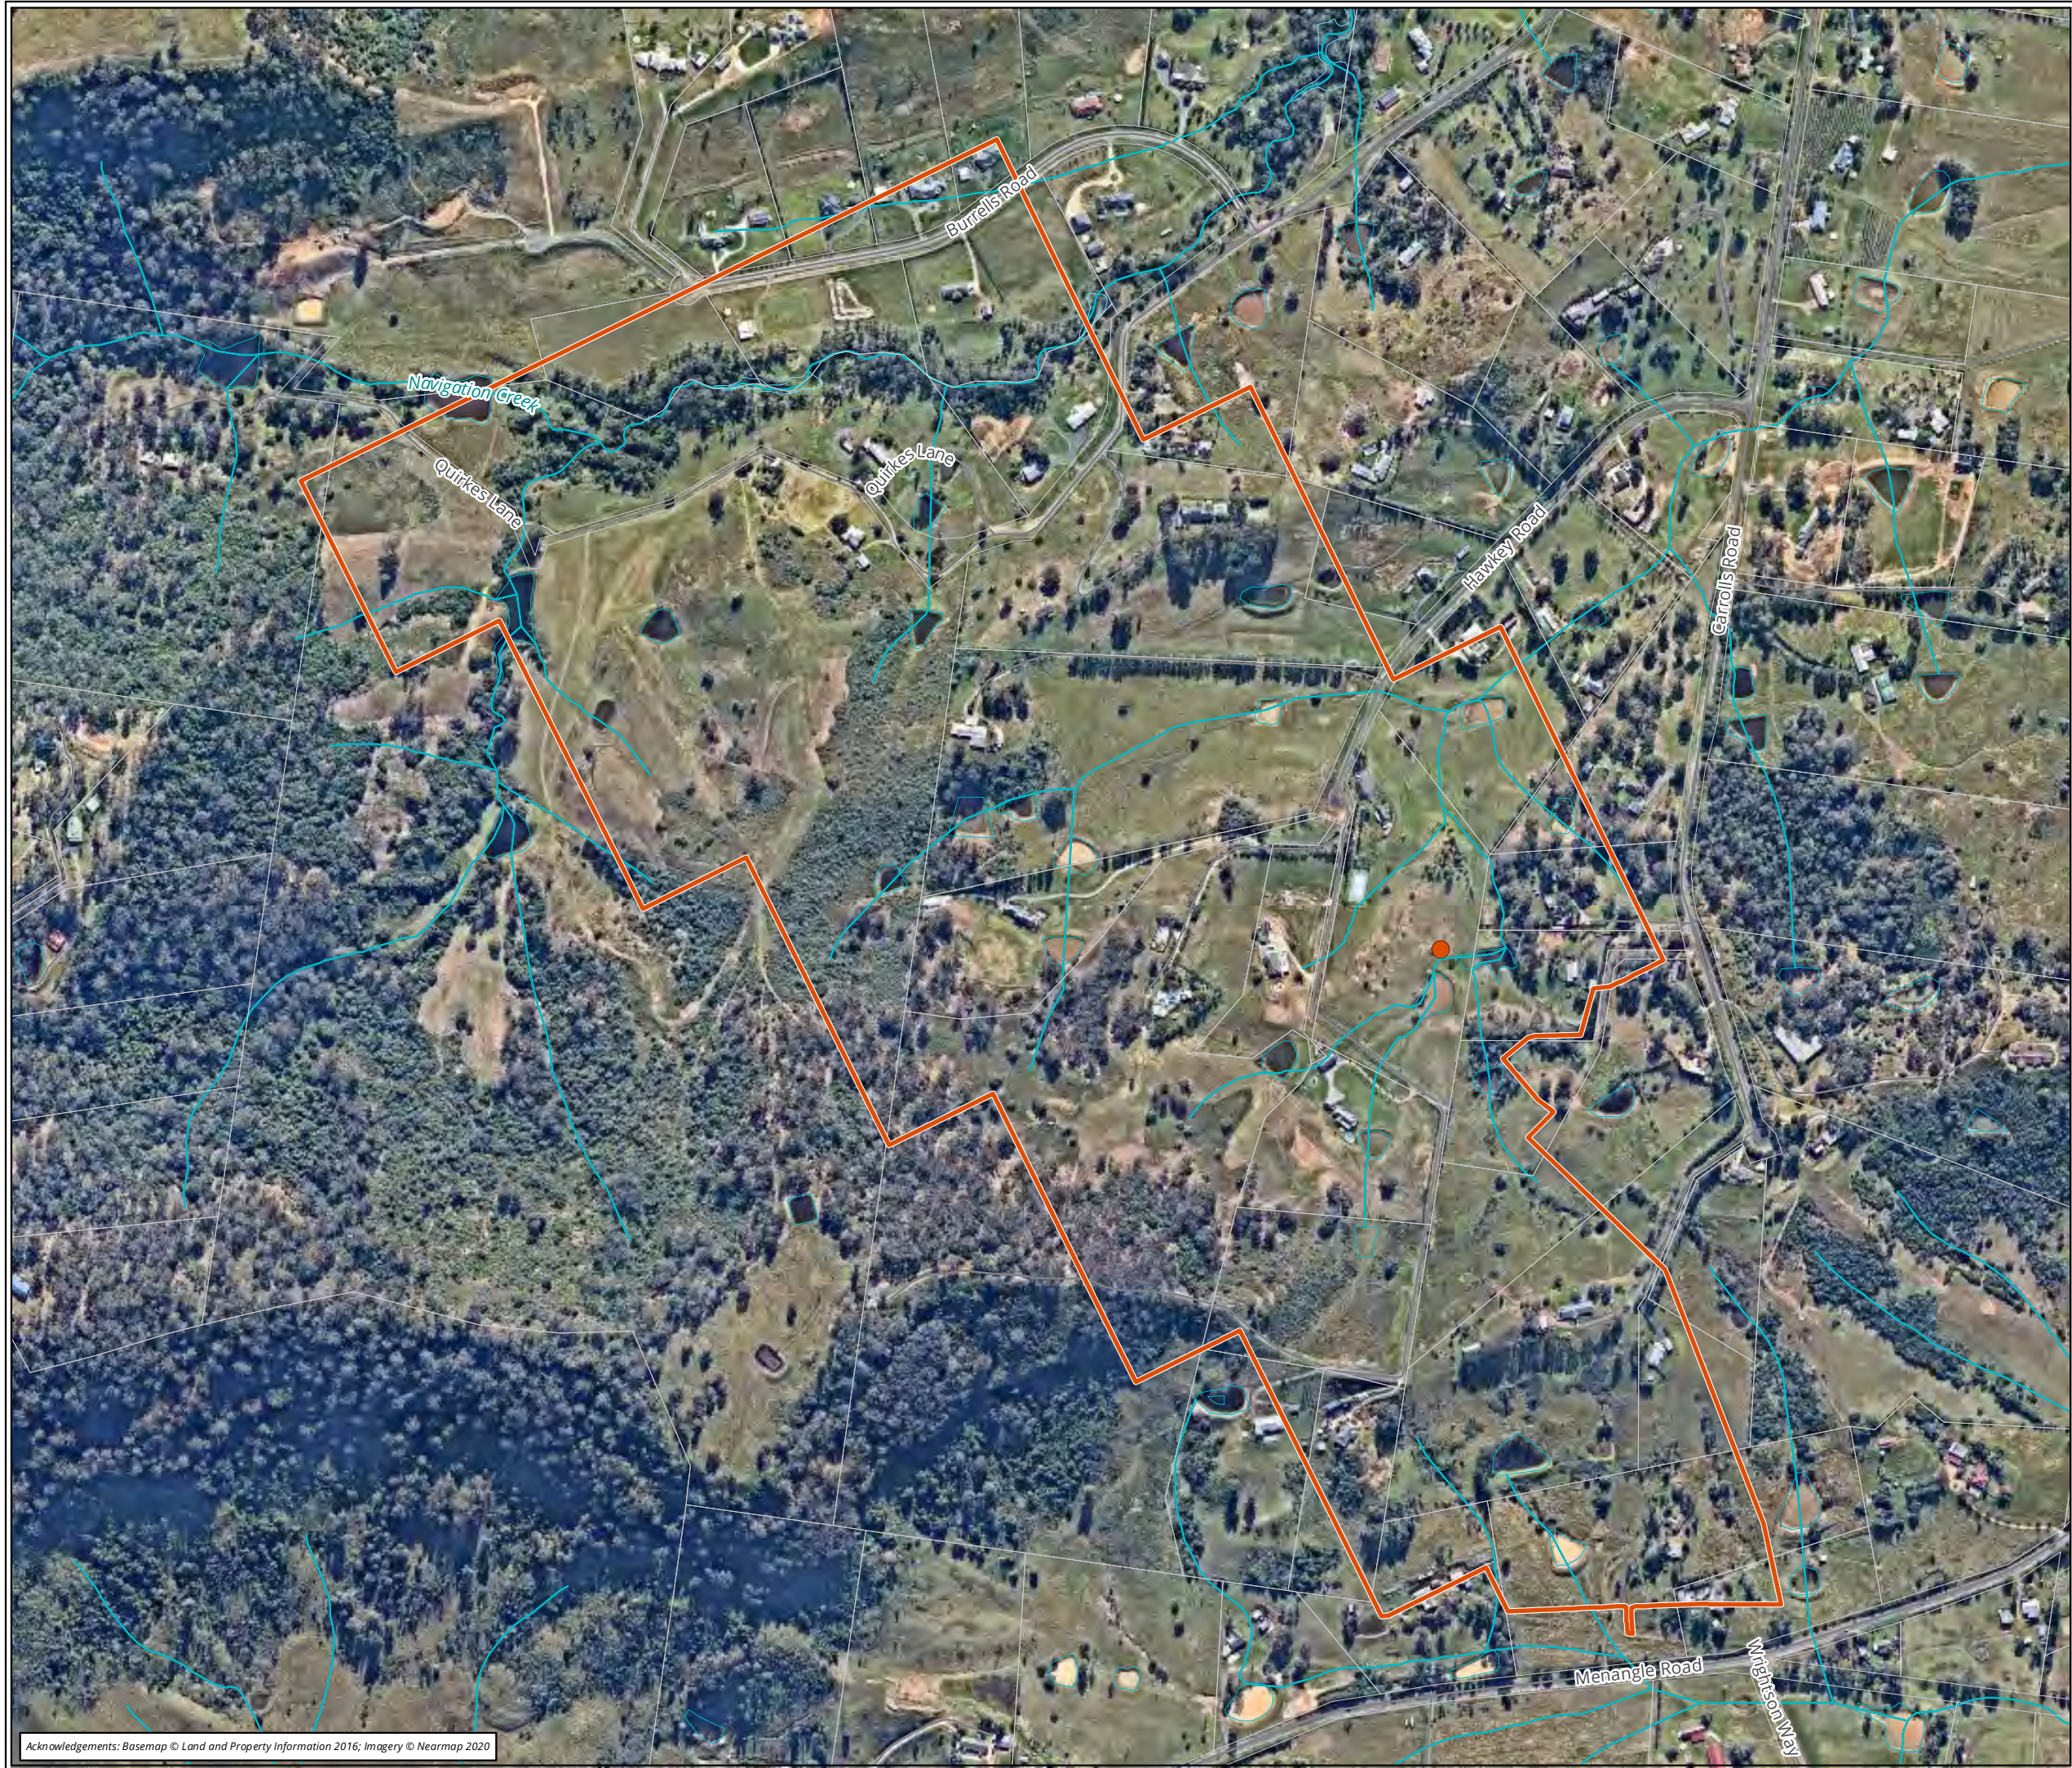
Figure 8 Survey results

- Legend**
- Supplementary field investigation area
 - AHIMS 52-2-4630 - Hawkey Road ISO1
 - Lot
 - Roads
 - Watercourses
