# Acid Sulfate Soils Assessment

Malbec Properties Pty Ltd

Proposed Residential Subdivision  
South West Rocks, NSW

P0802023JR03\_v2  
June 2010

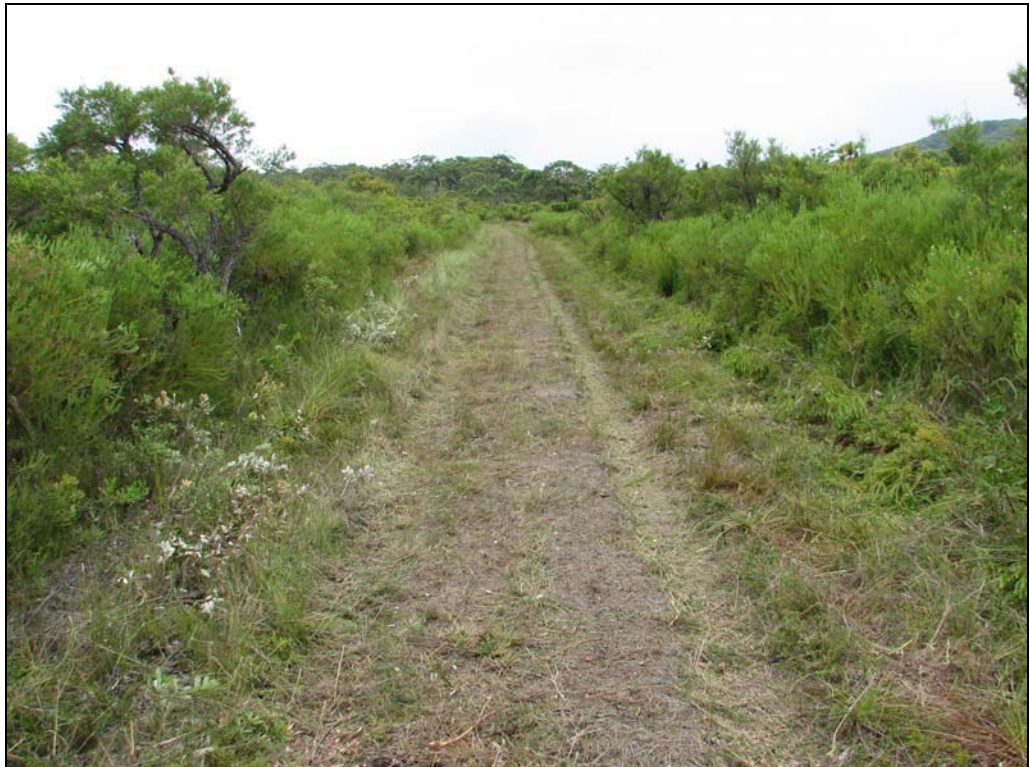
Figure 2: View to the south-west across the eastern portion of the site (20 February 2010).

The site is covered by thick coastal heath 2 – 3 m high in the eastern half of the site (Figure 2) which has been cleared and become grassland in the centre and western portions. Some remnant Eucalyptus and Melaleuca trees are scattered across the site also. There is a residential dwelling on each of the two lots and several dirt tracks cut through the site for vehicle access.
