**SUPPLEMENTARY GEOTECHNICAL
INVESTIGATION
ROYAL NORTH SHORE HOSPITAL
REDEVELOPMENT, ST LEONARDS**

Thiess Pty Ltd

GEOTLCOV23589AA-AH
23 September 2008

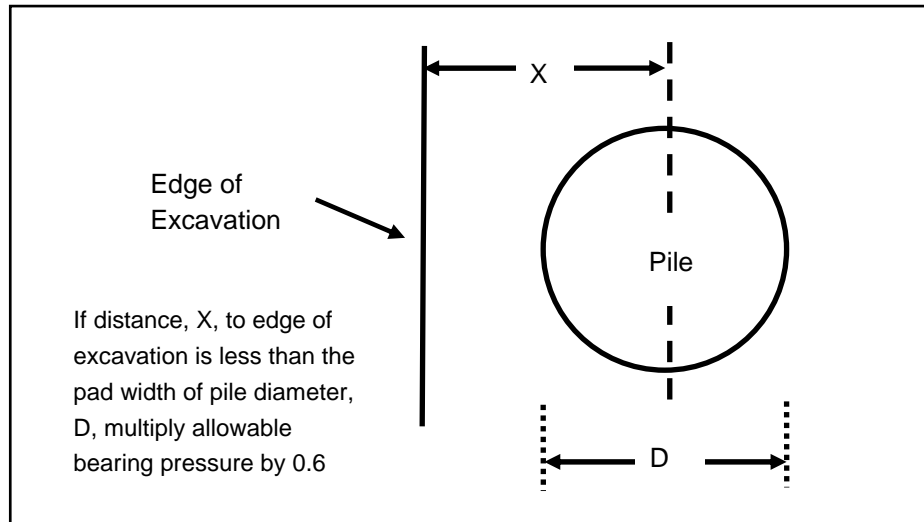
The allowable bearing pressure of pads or piles founded near the edge of an excavation, such as retention system piles, should be downgraded. Pads or piles where the distance from the centre of the

footing to the edge of an excavation lies closer than the footing width perpendicular to the line of the excavation or the pile diameter (see sketch below) should have design bearing pressures downgraded by multiplying the allowable bearing pressure by 0.6.

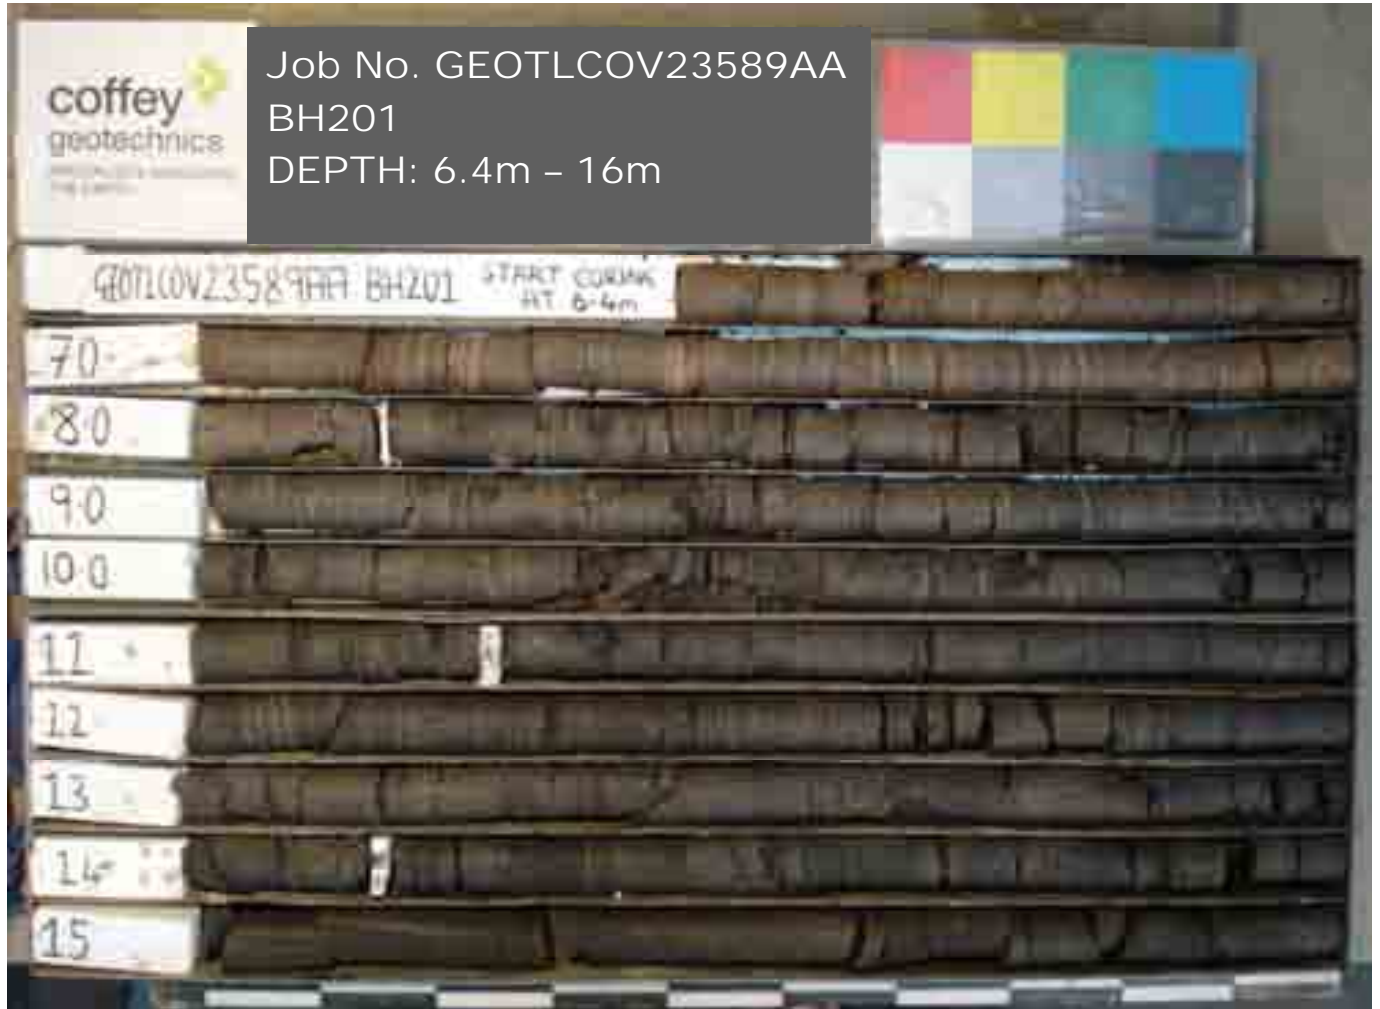
drawn	MT		client: THIESS PTY LTD	
approved	DS		project: ROYAL NORTH SHORE HOSPITAL REDEVELOPMENT, ST LEONARDS	
date	09/09/2008		title: ROCK CORE PHOTOGRAPH – BH201	
scale	Not to scale		project no: GEOTLCOV23589AA	
original size	A4		Photo no: BH201 1 of 3

Rock core was taken to our laboratory and colour photographed. Point load strength index tests were carried out on the rock cores. The results of the point load tests are presented on the engineering logs.
