**GRAHAM BROOKS
AND ASSOCIATES**

Building 19
Royal North Shore Hospital

Supplementary Heritage Impact Statement

October 2008

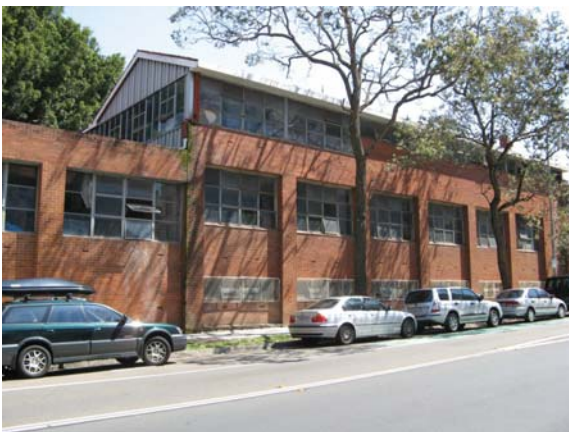
Figure 2-2

View of Building 19 from Herbert Street, with the single storey addition to the former Mortuary on the left

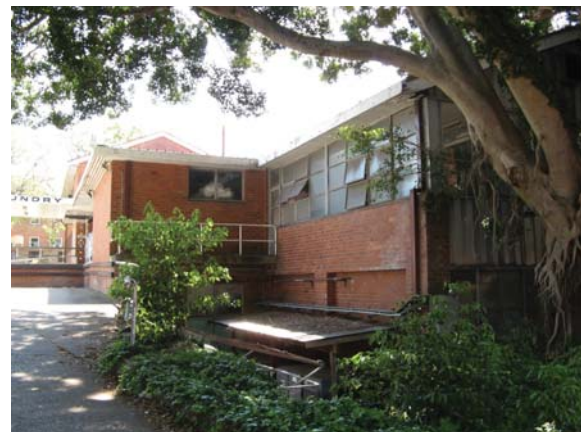
Figure 2-3

West elevation of the Laundry Building

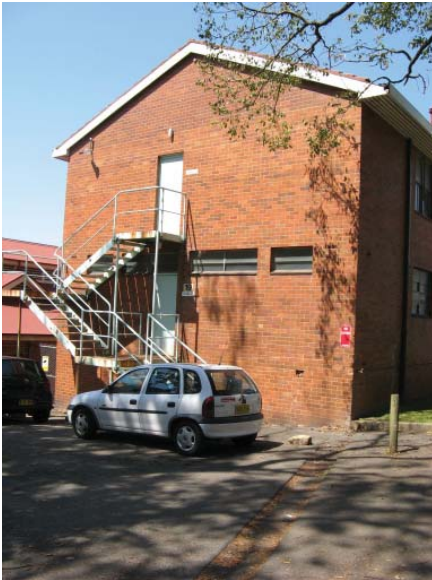
Figure 2-4
North elevation of the Laundry

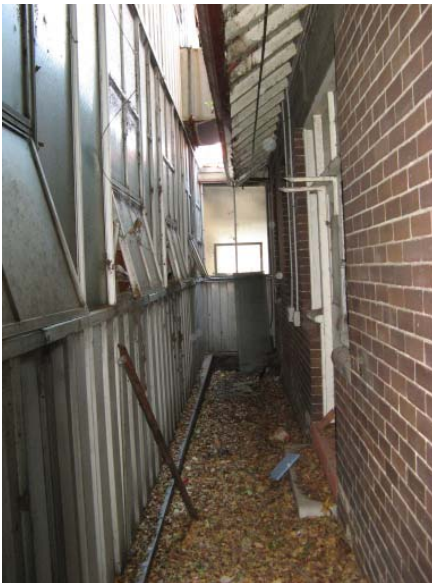
Figure 2-5
North elevation of the former Mortuary (on the right) and the south elevation of the Laundry (on the left)

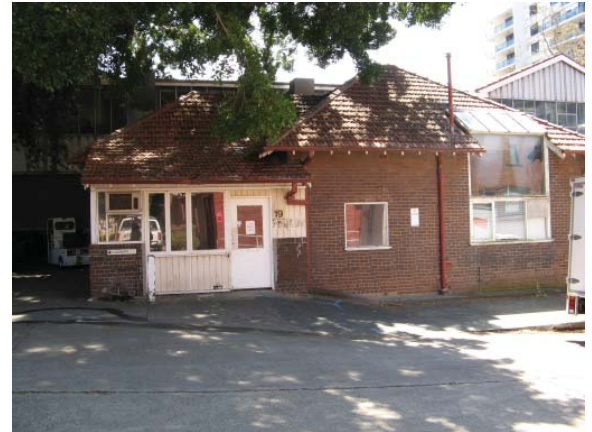
Figure 2-6
View of the south elevation of the former Mortuary, showing the closed in verandah and the enlarged skylight

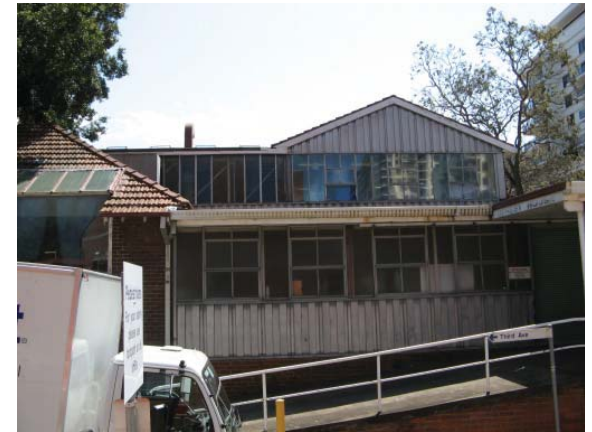
Figure 2-7
South elevation of the eastern addition to the former Mortuary with the top floor of the Laundry visible at the rear

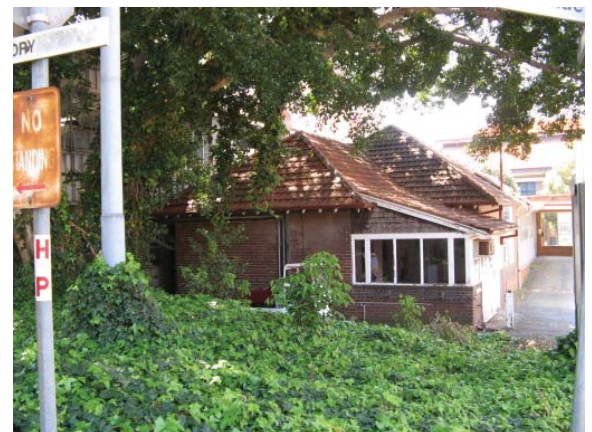
Figure 2-8
South and east elevation of the former Mortuary, with the ramp access to the eastern addition visible on the right

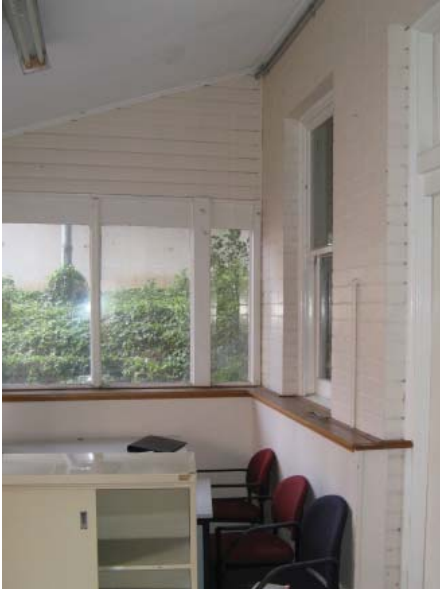
Figure 2-9
Office fitout of the former Mortuary verandah

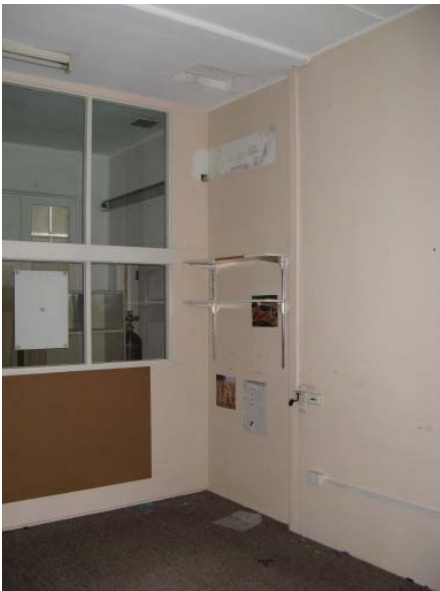
Figure 2-10
The former chapel space has been renovated for office use

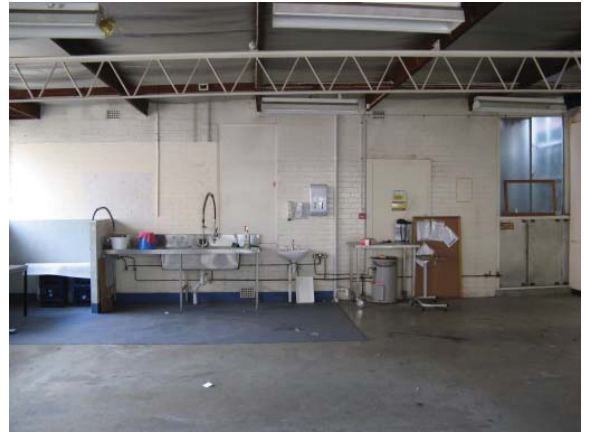
Figure 2-11
Shows the western wall of the extension to the former Mortuary which was the exterior eastern wall

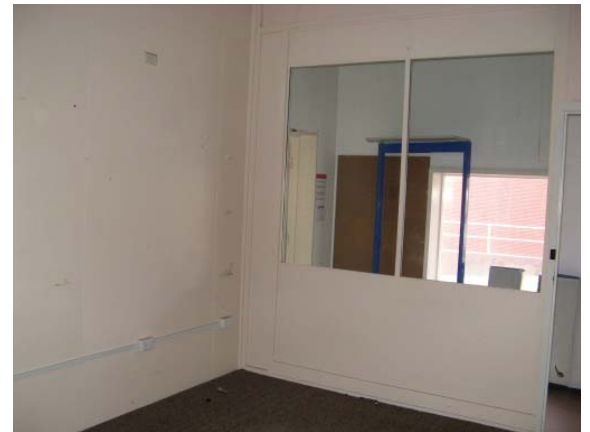
Figure 2-12
View through to the former Cool Room space of the Mortuary, now fitted out for office accommodation

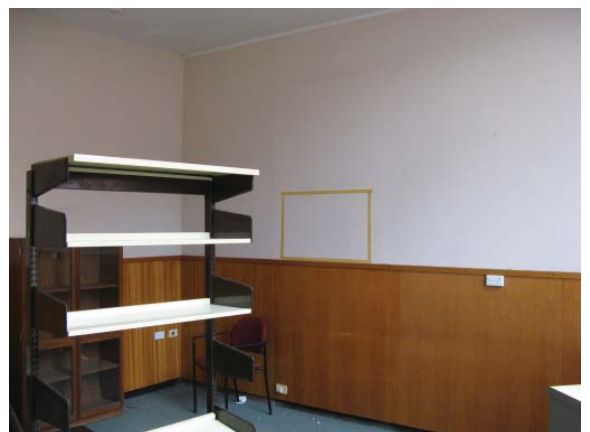
Figure 2-13
Office fitout of the former post mortem room

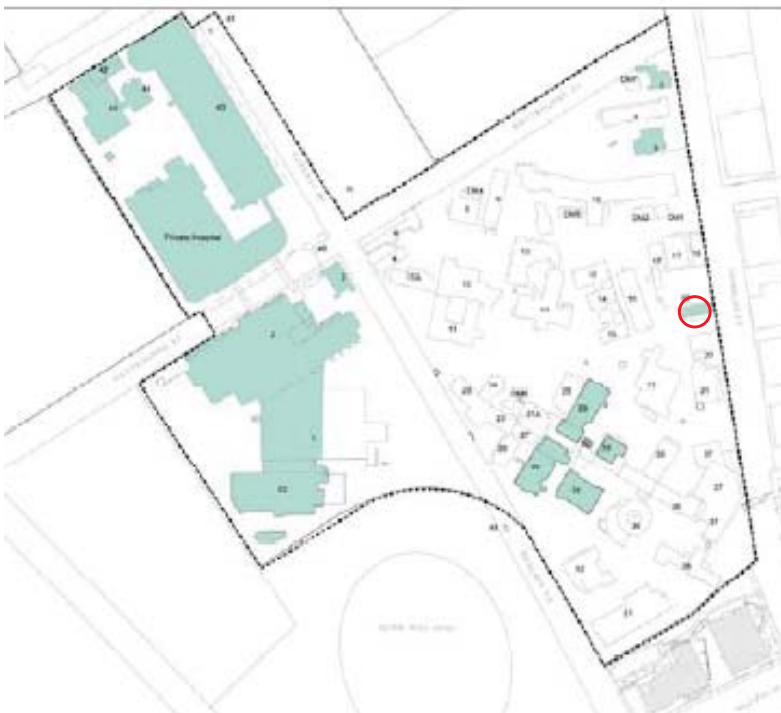
Figure 5-1

Plan of the Royal North Shore Hospital site showing the existing buildings to be retained marked in green. The location of the former Mortuary component of Building 19 is indicated with a red circle.

The retained building plan from the *Royal North Shore Hospital Amended Concept Plan and Preferred Project Report*, reproduced in Figure 5-1, confirms the former Mortuary Building component is to be retained in the proposed redevelopment.
