# Surface Water Hydrology Assessment and Management

## Hansons Somersby Quarry Project

P0701949JR04\_v3  
January 2010

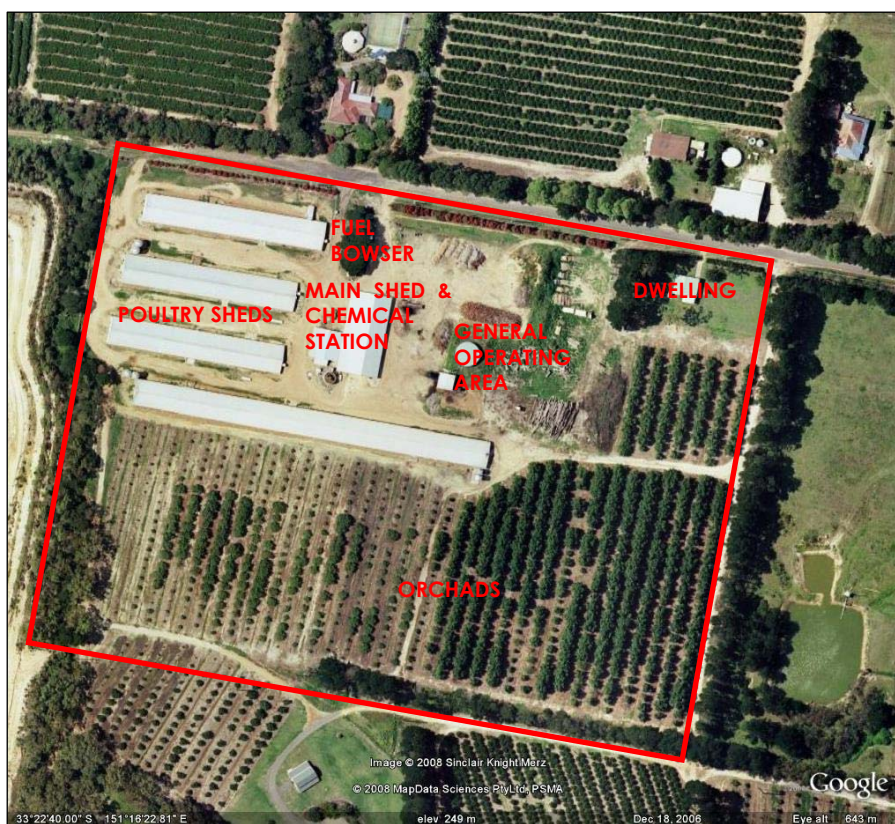
| Drawn: | MLB | <b>Location of Proposed Quarry Extension Site and its Existing Landuse</b><br>Source: Google Earth, 2009 | Drawing No: |

The proposed extension site (Figure 1) is identified as part of Lot 10 DP 1090880, Keighley Road, Somersby within the Gosford City Council local government area (LGA) and is zoned as 1 (a) Non-Urban. The site has a total area of approximately 8 ha and is currently used for intensive agriculture including:

- Existing weatherboard/fibro clad dwelling fronting Keighley Road,
- Four poultry sheds of varying size (averaging 1573 m<sup>2</sup>),
- A fuel pump, and
- Various farm equipment and storage sheds.

Figure 1 (Attachment B) provides the location of these onsite activities and structures.

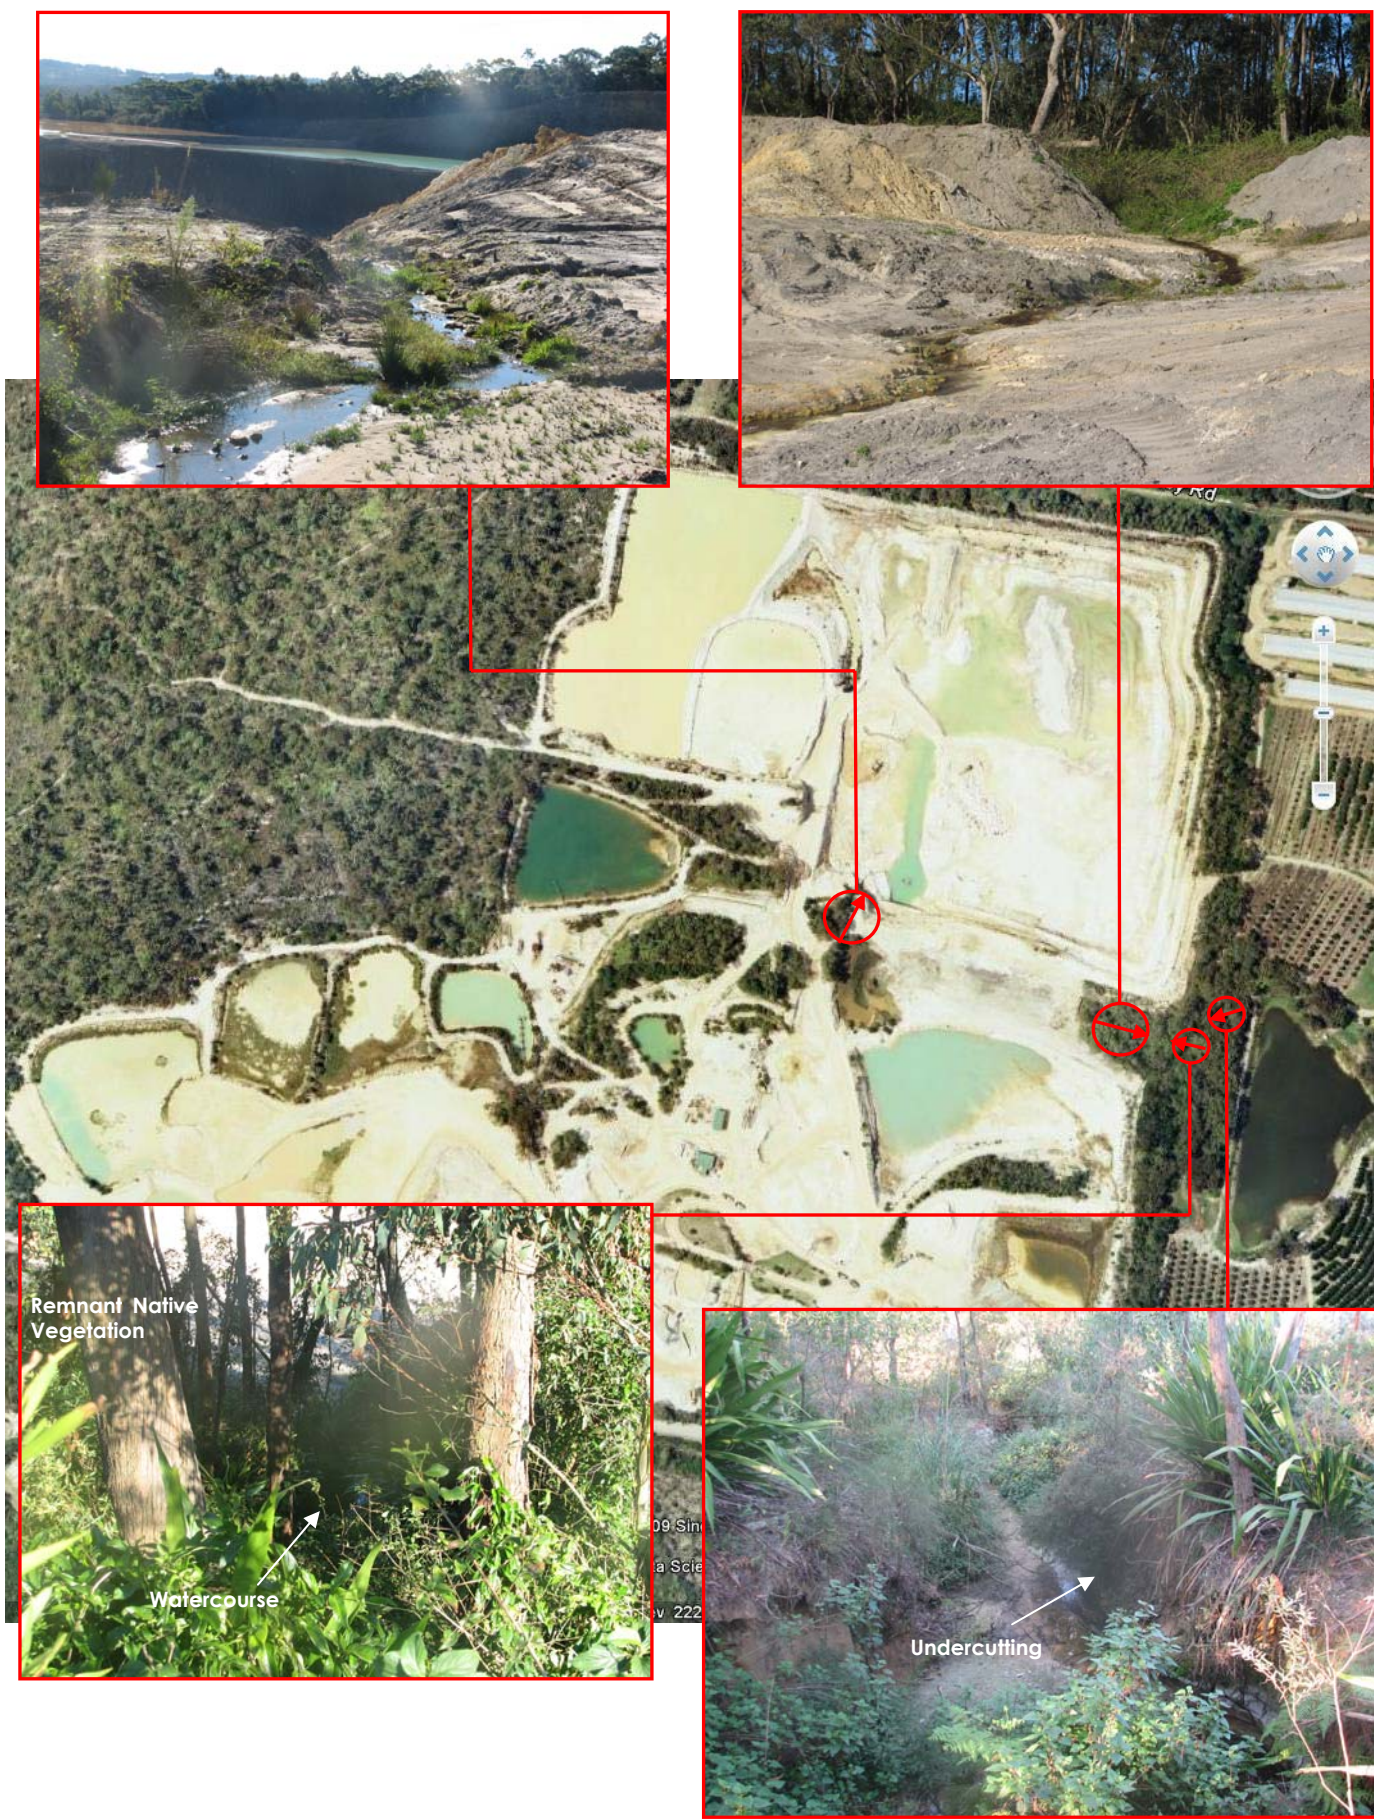
| Drawn: | MLB | <b>Quarry Site - Drainage Line</b> | Drawing No: |

Further downstream, but before it enters the quarry site, the condition of the watercourse improves with denser vegetation lining the banks. Although consisting primarily of weed species, remnant vegetation also occurs in this area (Figure 3).

Unnamed tributary 1 enters the quarry site through a constructed bund. From here, only remnants of the channel exist. All vegetation, excluding some scattered grasses, has been recently cleared for quarrying

activities. Bed widths range from approximately 0.1m up to 0.5m and bank heights range from 0m to approximately 1.0m and are highly eroded. The watercourse then flows into an active quarry pit and terminates (Figure 3).

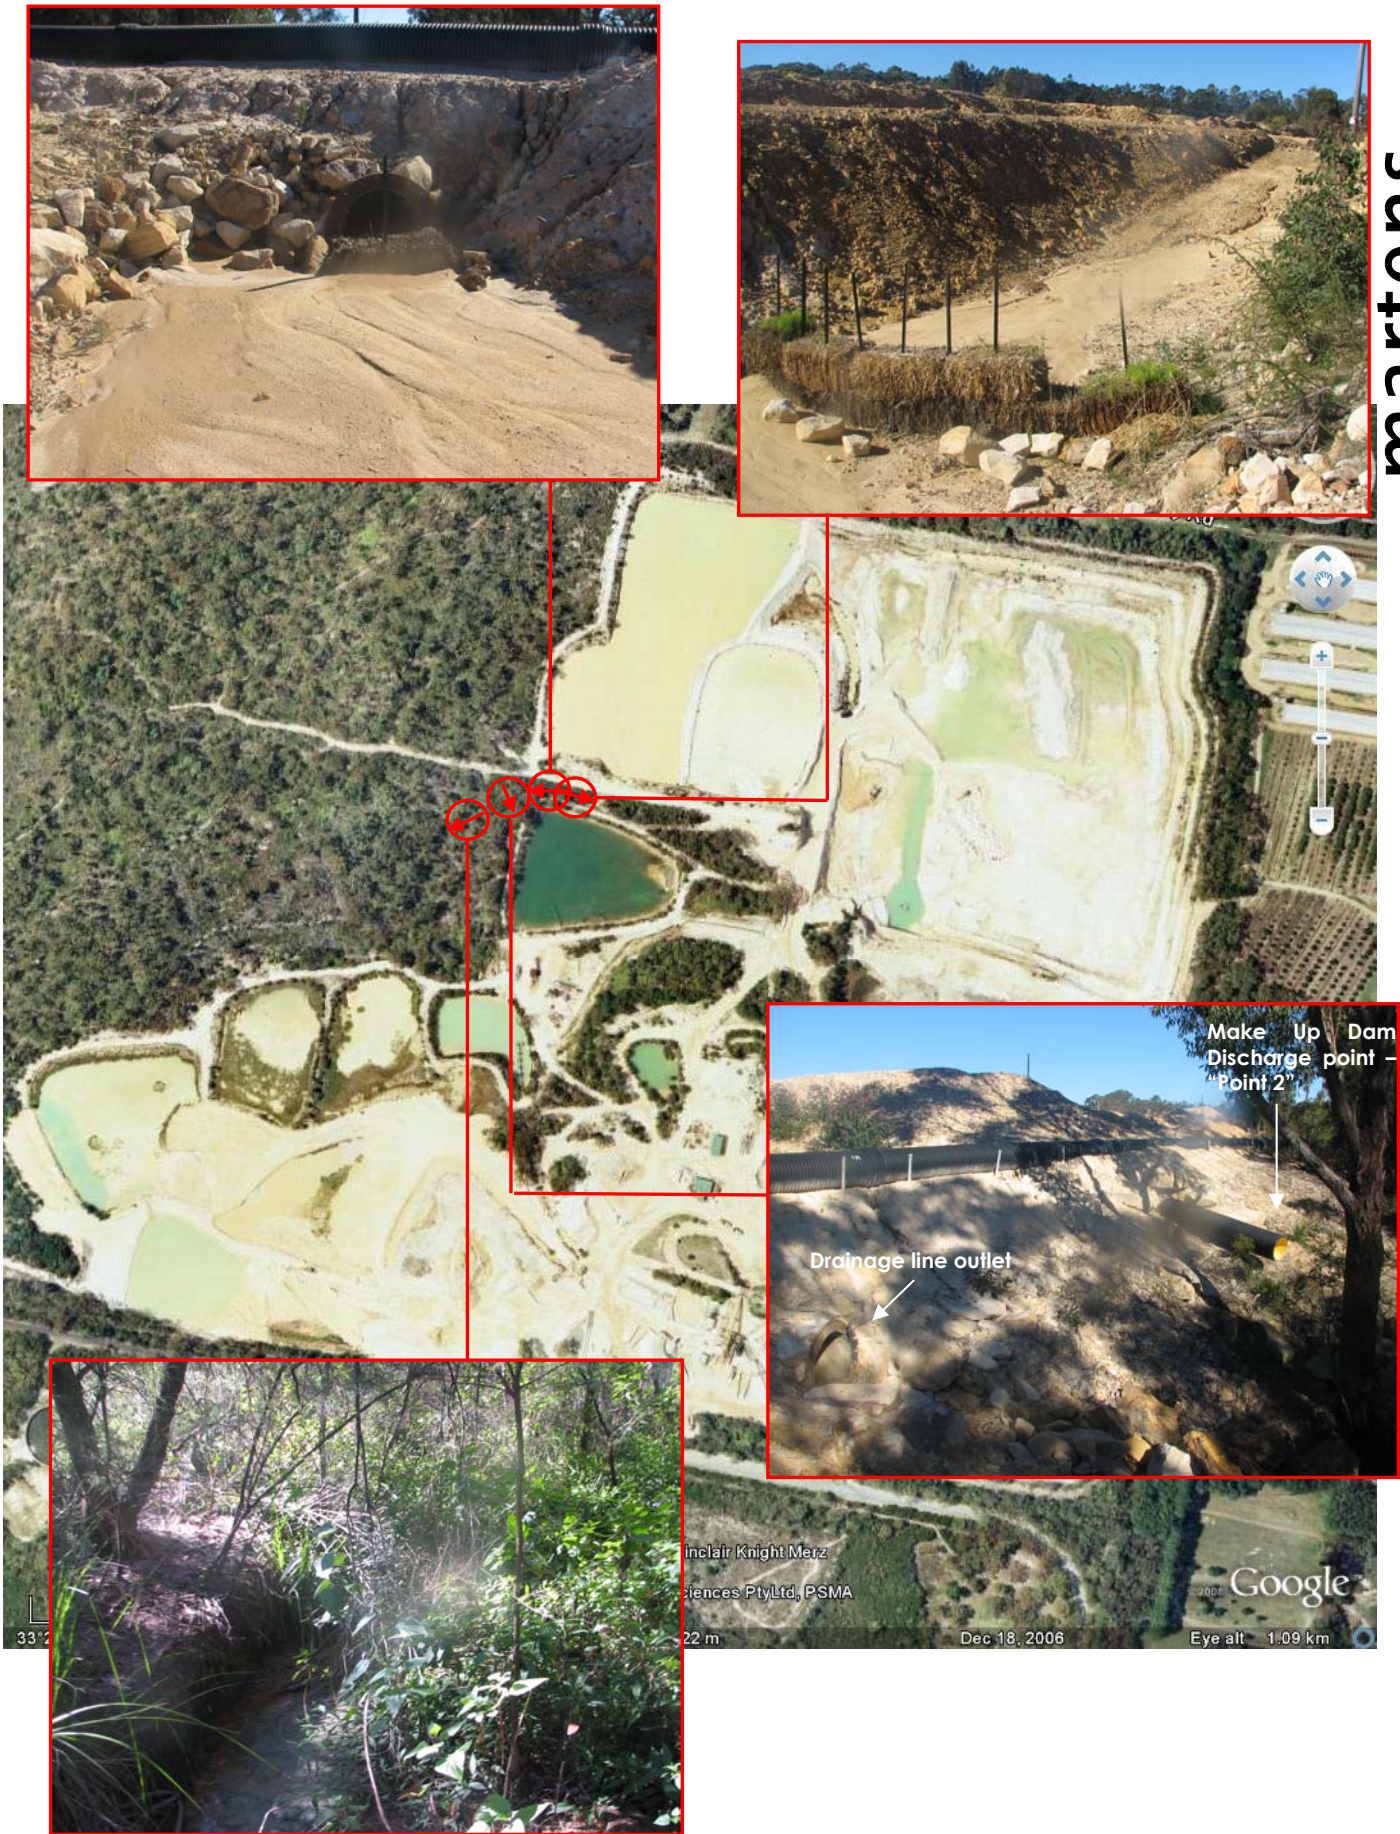
| Martens & Associates Pty Ltd | | Environment Water Wastewater Geotechnical Civil Management | |
|---|---|---|---|
| Drawn: | MLB | Quarry Site – Drainage Line | Drawing No: |

There is some evidence of a downstream channel near the quarries western boundary which receives site runoff during high flow events. As shown in Figure 4, this area is highly silted has no bed or bank vegetation. Flow is constricted within a 'channel' that has formed between 2 banks constructed either side for quarry dams.

Runoff passes through 2 rows of staked hay bales (for sediment and erosion control) before flowing in a 600mm pipe under the site's western boundary road. Rip rap has been placed at the outlet to prevent scour of the downstream receiving environments.

The morphology of the downstream portion of the watercourse is similar to the upstream portion however; the condition of the watercourse is improved. The channel is experiencing some minor silting from quarry runoff however there is no evidence to suggest erosion of banks or undercutting. This can be attributed to the outlet rip rap and denser mainly native vegetation that line both banks (Figure 4).

Evidence of the original watercourse exiting the site at the western boundary (Figure 4) was observed. However, there is reduced flow in this depression due to interception of flow by the existing pit. Rip rap has been placed at the outlet to protect the downstream channel.

Flow within the watercourse downstream of the site comes principally from the quarry 'make up' dam (Figure 4 and Figure 6) as the original channel has been totally intercepted by the existing operation. Section 3.1.4 further details the quarry discharge point.

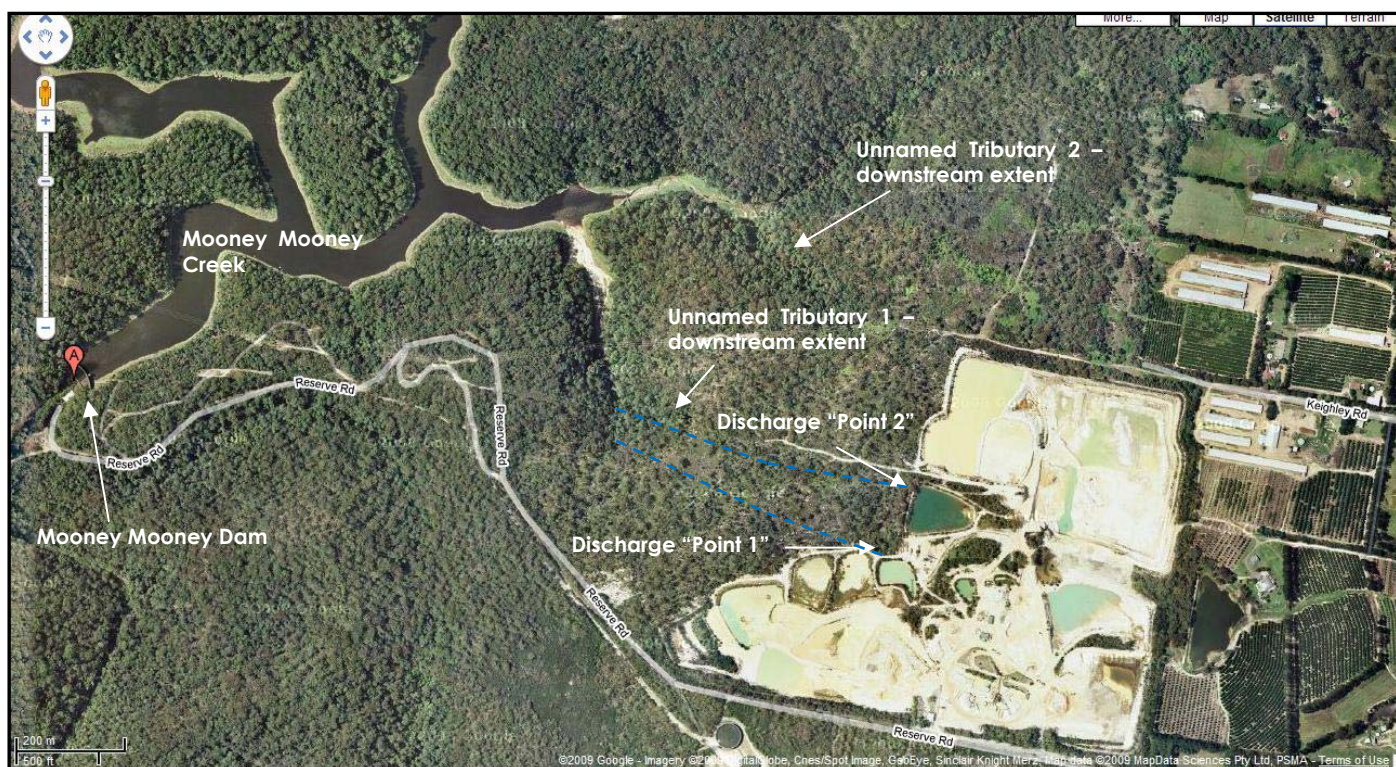
| Drawn: | MLB | <b>Catchment View and Location of Mooney Mooney Dam</b><br>Source: Google Earth, 2009 | Drawing No: |

Unnamed Tributary 1 flows through neighbouring Brisbane Waters National Park as a minor tributary of Mooney Mooney Creek. This portion of Mooney Mooney Creek is dammed downstream of where the tributary join the main creek.

Unnamed Tributary 1 is classed, under the Stahler system, as a first order stream. Given it is not considered an environmental corridor and is of minimal quality for terrestrial and aquatic habitat, the tributary is considered a 'Category 3' watercourse, according to Landcom, 2004. Category 3 watercourses typically carry out the function of protecting bank stability, native vegetation and water quality for the greater catchment area. This is particularly important for unnamed tributary 1 which flows directly into Mooney Mooney Creek, which forms part of the Gosford-Wyong Water Supply Scheme and is covered by the Water Sharing Plan for the Kulnurra Mangrove Mountain Groundwater Sources (as 'Zone 8'). Water from this portion of Mooney Mooney Creek is dammed by Mooney Mooney Dam (Figure 5) which is pumped to the Somersby Treatment Plan and then to Gosford residents.

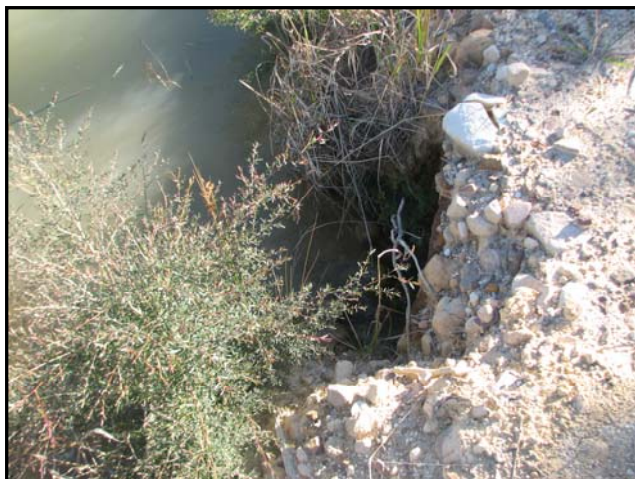
'Point 1' inlet

South of Point 2 is the other licensed discharge point identified as 'Point 1' on the Environmental Protection License (EPL) (Figure 5). Overflow from the 'process dam' flows into twin 600mm cast iron pipes, under an internal road and out into a concrete lined channel approximately 400mm deep and 3100mm wide (top width) (Figure 6). This channel continues into the adjoining National Park. Review of the site aerial and contours suggests that flow from this point reaches Unnamed Tributary 1 at a point downstream. It is noted, however, that overflow from this discharge point does not occur as frequently as from Point 2.

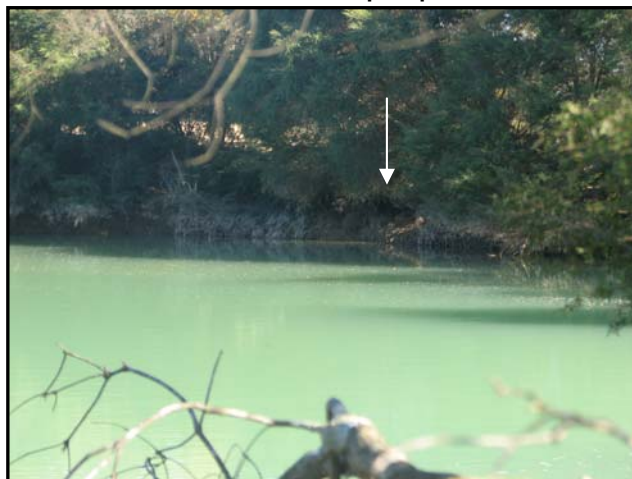
'Point 1' inlet and pump dam

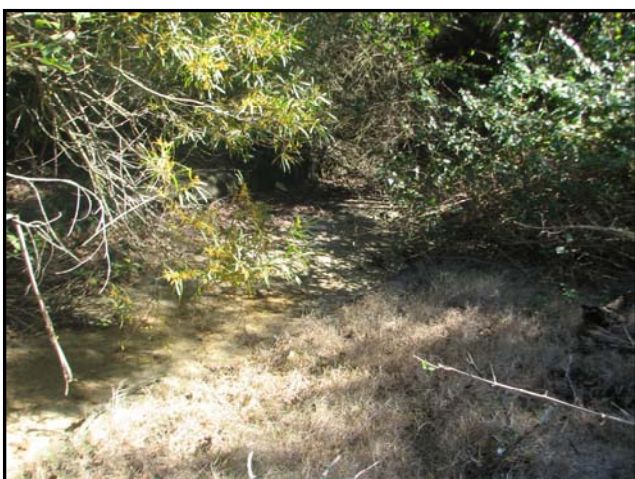
'Point 1' outlet – concrete lined channel

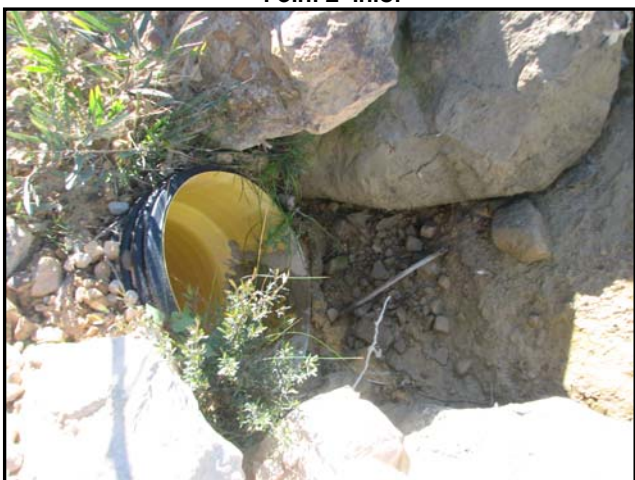
'Point 2' inlet

Unnamed Tributary 1 receives waters directly from the overflow from the quarries 'make up dam' (Figure 5) via a single 450mm HDPE corrugated pipe. This discharge point is one of two points on site licensed by NSW EPA (identified as "Point 2" on the Environmental Protection Licence). As shown in Figure 6, rip rap has also been placed at the outlet of this discharge point to prevent erosion and scour from occurring. At the time of inspection there was a steady flow from this discharge point.

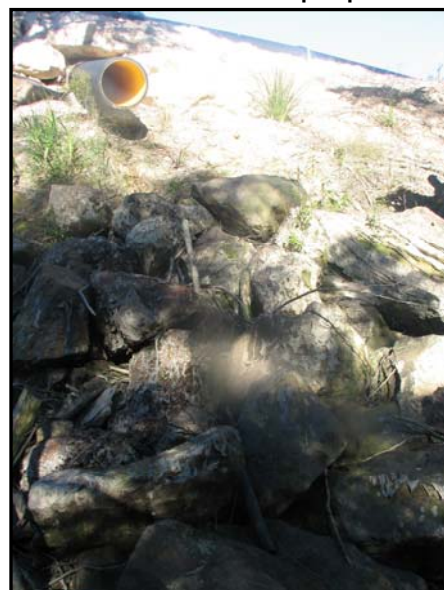
'Point 2' outlet – rip rap

It is therefore recommended that this rip rap be maintained as part of the proposal and the ongoing operation of the quarry.
