Hanson Construction Materials Pty Ltd

# Sediment and Erosion Control Plan: Hanson's Somersby Quarry Project

P0701949JR07\_v1  
January 2010

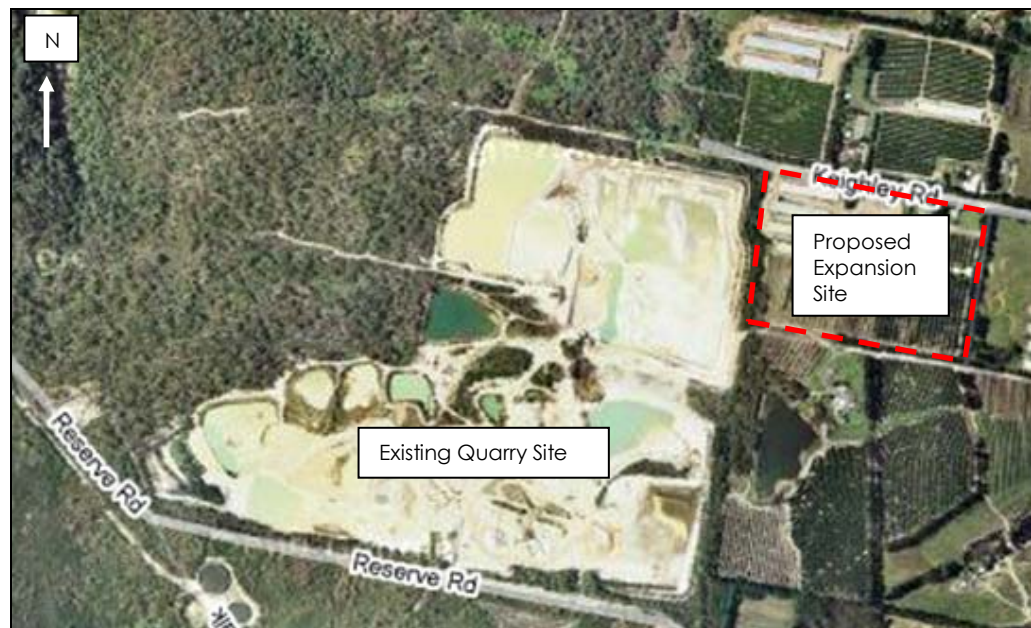
Figure 1: Existing quarry site and proposed expansion site (Source: Google Maps, 2009).

The existing quarry site (Central Coast Sands) and proposed expansion site are depicted in Figure 1.

The proposed expansion site (Figure 1) is identified as part of Lot 10 DP 1090880, Keighley Road, Somersby within the Gosford City Council local government area (LGA) and is zoned as 1 (a) Non-Urban. The site has a total area of approximately 8 ha and is currently used for intensive agriculture including:
