Appendix D – Erosion Features

Ulan Creek Erosion Features_EF2

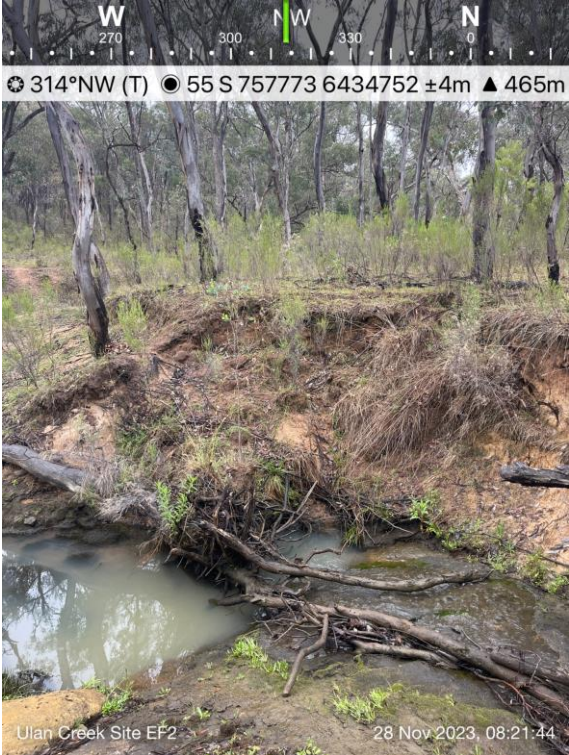
<div style="display: flex; justify-content: space-between; font-size: x-small; margin-top: 5px;"> Ulan Creek Site EF2 28 Nov 2023, 08:21:44 </div>

<p>Notes: Erosion at EF2 appears comparable to 2022.</p>

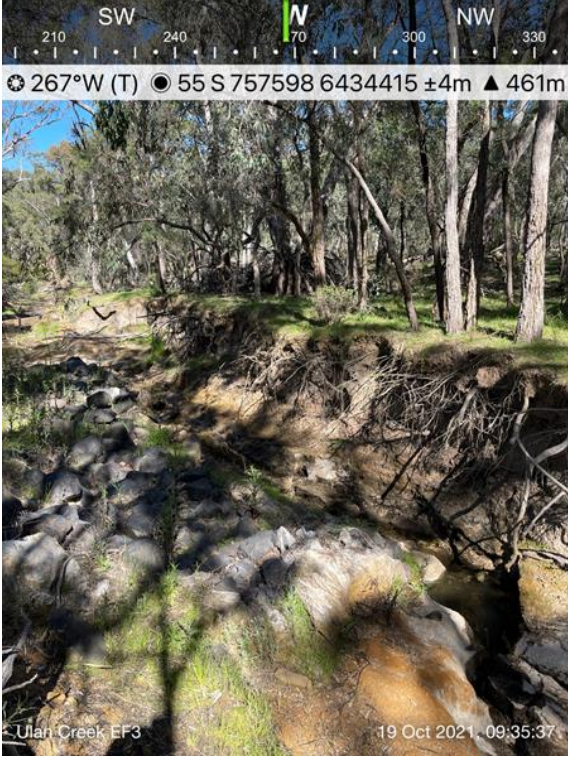
<p style="text-align: center;">Ulan Creek EF3 19 Oct 2021, 09:35:37</p>

<p style="text-align: center;">Ulan Creek EF3 11 Oct 2022, 09:26:31</p>
<p>Notes: Erosion at EF3 remains active in 2021 with recent signs of further undercutting and material loss along the RHB. Ground vegetation had not established.</p>	<p>Notes: Erosion at EF3 remains active in 2022 with recent signs of further undercutting and material loss along the RHB.</p>
2023

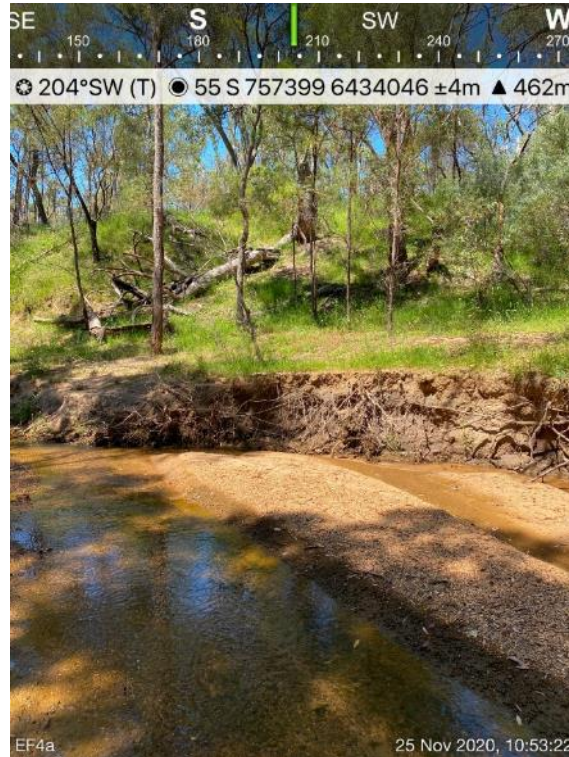
Notes: Erosion at EF4a remains very active in 2020 with recent signs of undercutting along the RHB.

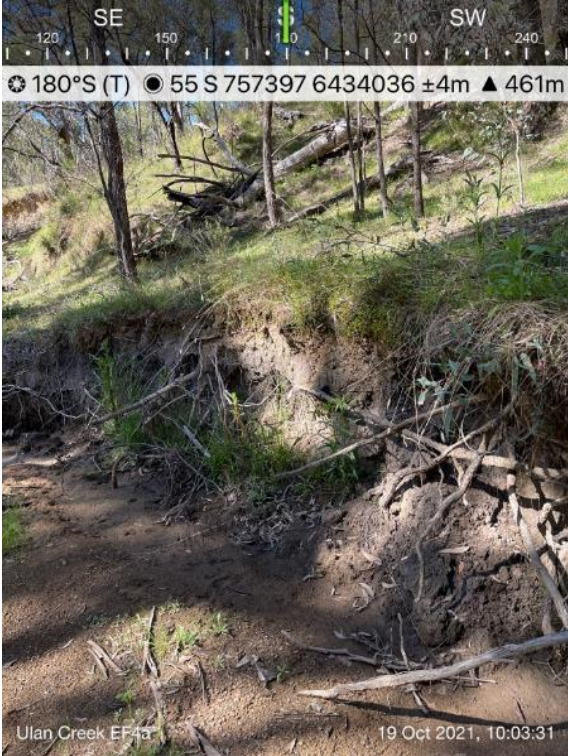
<div style="display: flex; justify-content: space-between; font-size: x-small; margin-top: 5px;"> EF4a 11 Oct 2022, 09:52:37 </div>
<p>Notes: In 2021 the erosion at EF4a appears comparable to previous monitoring. In 2021 the erosion was active along the RHB.</p>	<p>Notes: In 2022 the erosion at EF4a appears comparable to previous monitoring. In 2022 the erosion was active along the RHB.</p>

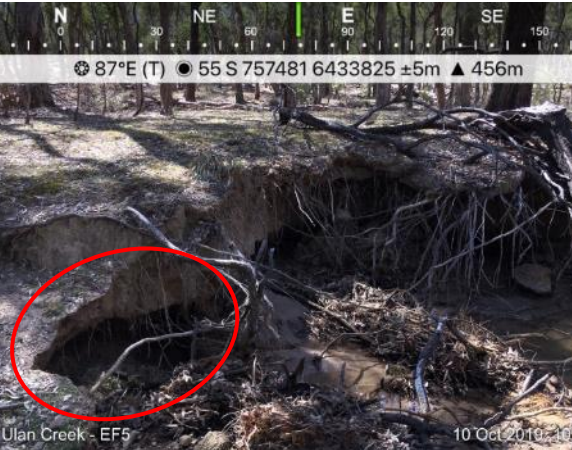
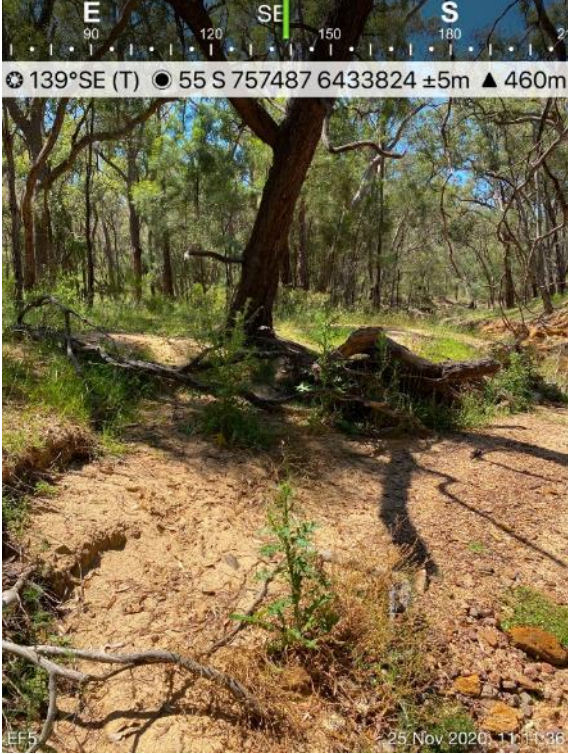
<p data-bbox="799 1052 1369 1142"> E 90 120 SE 150 S 180 210 139°SE (T) ● 55 S 757487 6433824 ±5m ▲ 460m </p> <p data-bbox="799 1769 1369 1803"> EF5 25 Nov 2020 11:14:36 </p>
<p>Notes: In 2019 the erosion at EF5 was active with signs of further bank undercutting along the LHB. In 2020 the LHB was almost infilled with deposited sand and gravel material.</p>

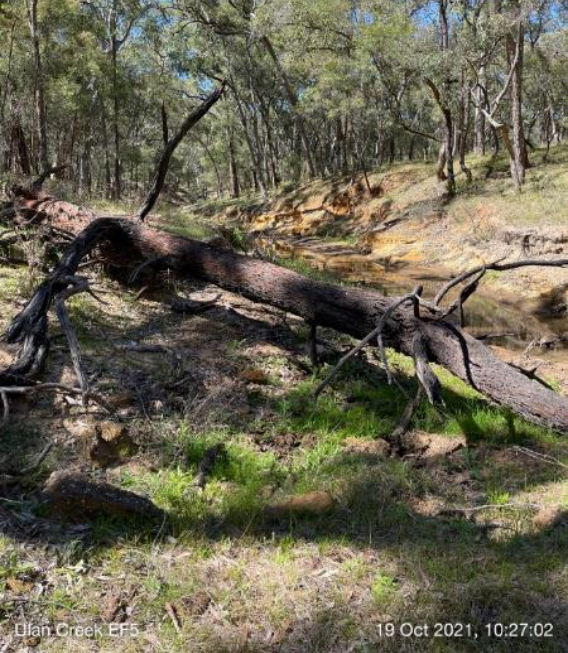
<div style="display: flex; justify-content: space-between; font-size: x-small; margin-top: 5px;"> EF5 11 Oct 2022, 10:10:24 </div>
<p>Notes: In 2021 the erosion at EF5 appears comparable to previous monitoring. Since the previous monitoring in 2020 a tree had fallen into the creek from the LHB.</p>	<p>Notes: In 2022 the erosion at EF5 appears comparable to previous monitoring.</p>

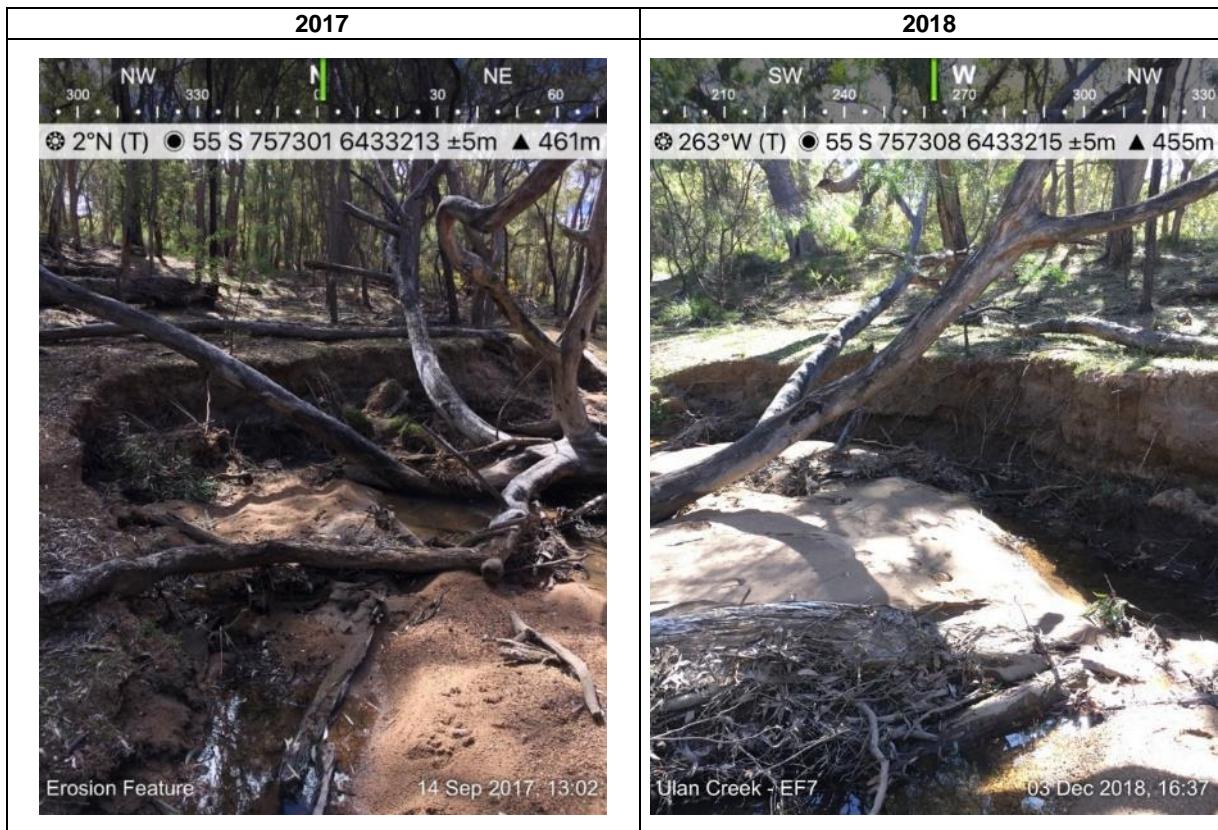
Ulan Creek Erosion Features_EF7

Notes: Erosion at EF7 appears to be very active with signs of significant bank undercutting and new slumping along the RHB noted in 2019

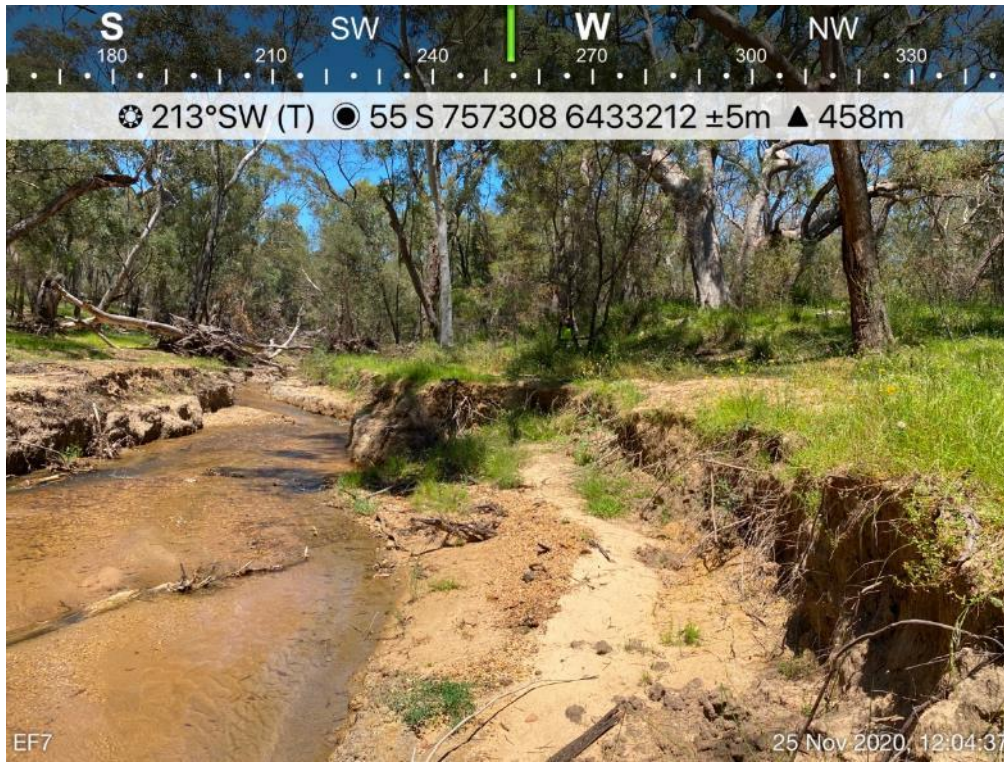
Notes: Erosion at EF7 remains very active in 2020 along the RHB. The large fallen tree has been relocated downstream. Sand and gravel deposits that had accumulated around the tree have also been transported downstream as the flow line has been cleared of such material since 2019.

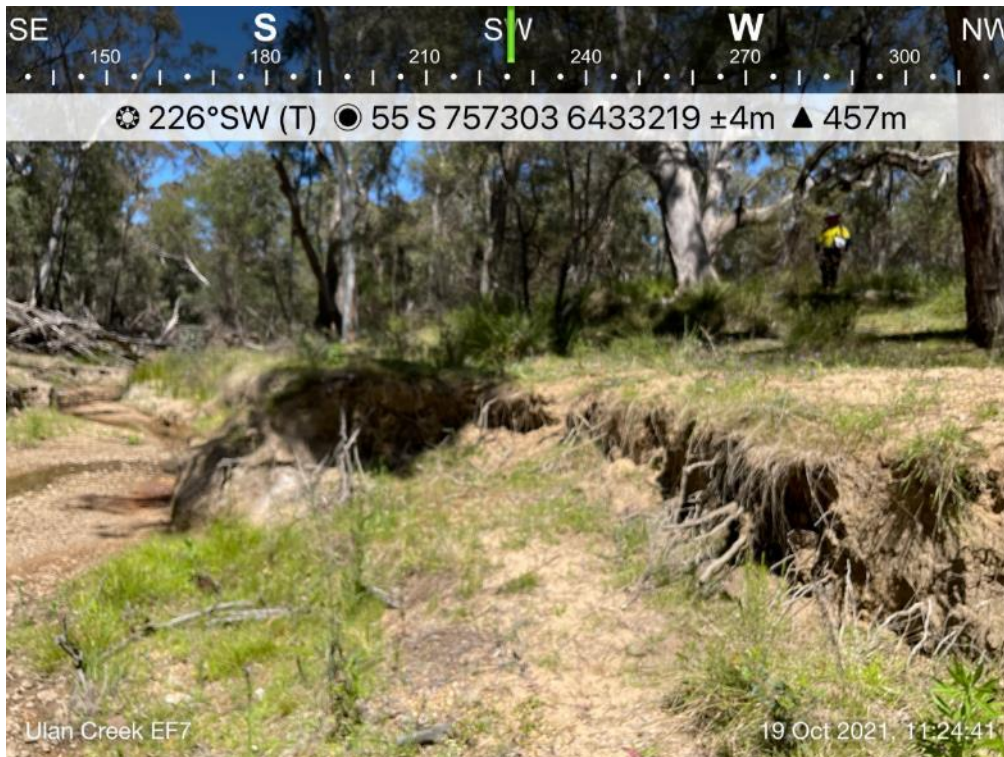
Notes: In 2021 the rate of erosion at EF7 along the RHB had slowed since 2020, also the coverage of ground vegetation had improved.

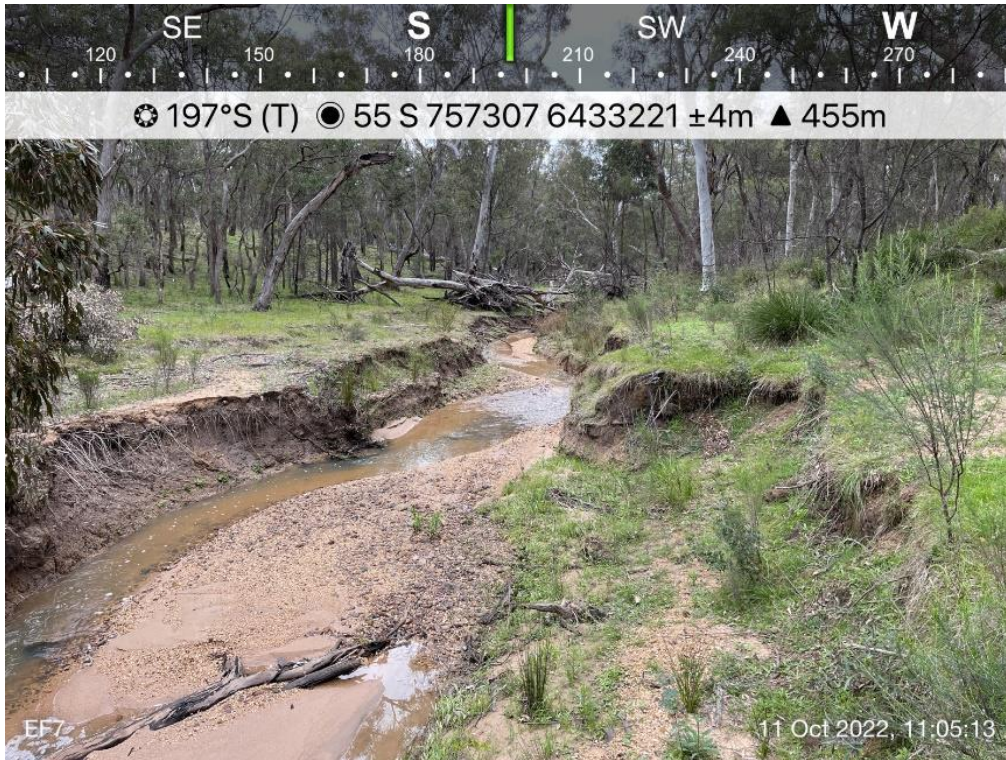
Notes: In 2022 the rate of erosion at EF7 along the RHB had further slowed and was potentially stabilising. The LHB was actively eroding in 2022. A tree had fallen onto the creek from the LHB since 2021.

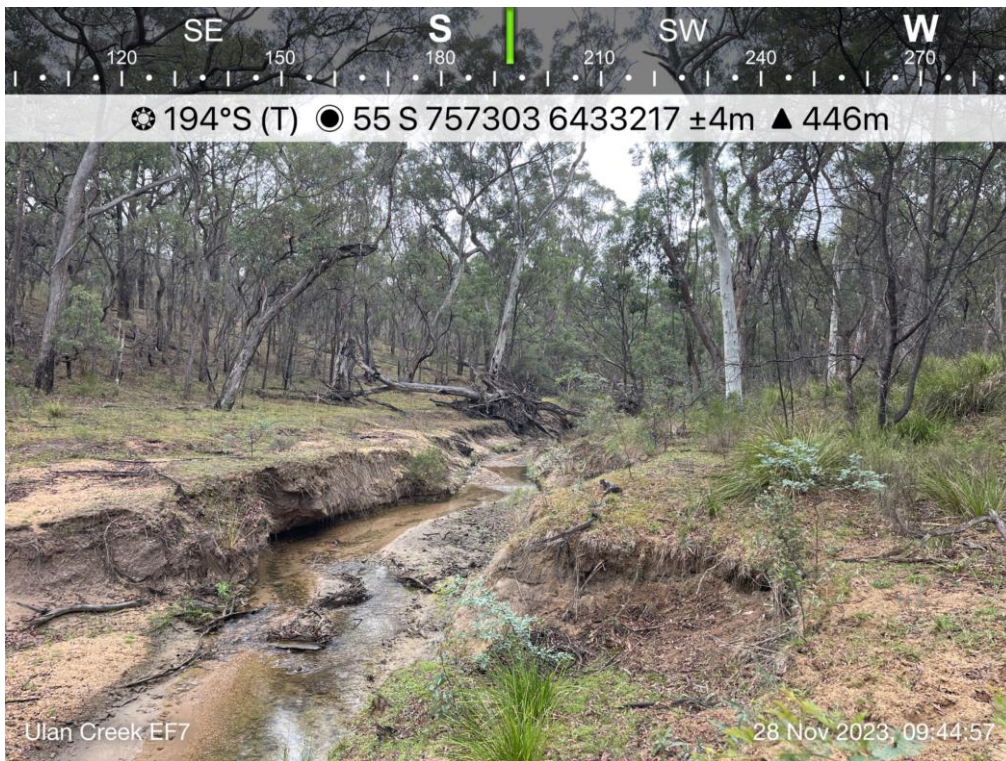
2023

Notes: Erosion at EF7 appears comparable to 2022, however bank undercutting along the LHB has occurred since 2022.

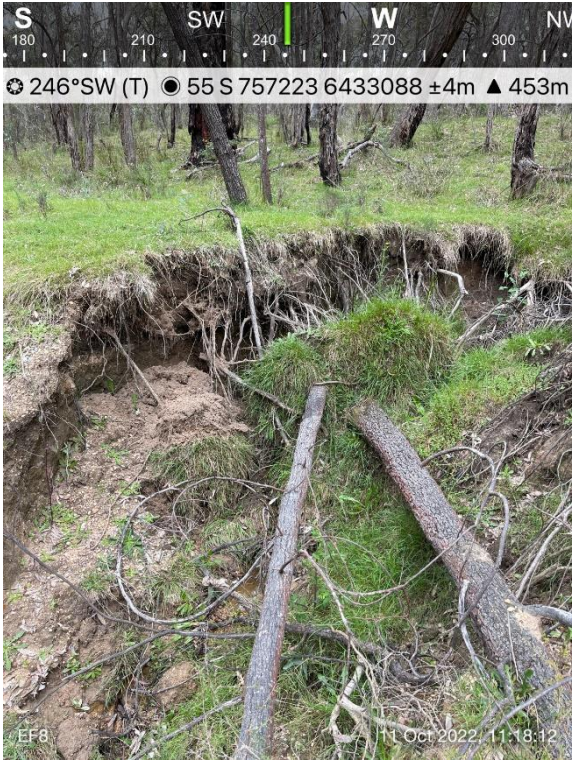
<p>Notes: In 2022 erosion at EF8 displayed a continuation of material loss along the LHB.</p>

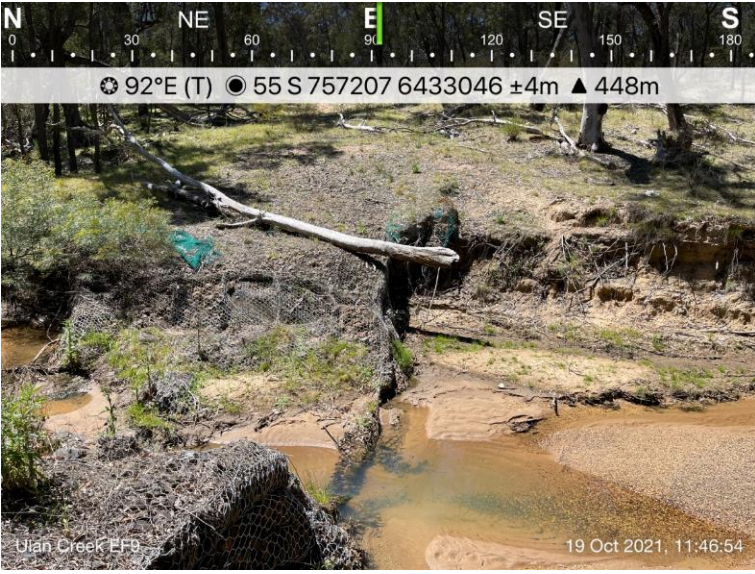
2021

<p>Ulan Creek EF9 19 Oct 2021, 11:46:54</p>
<p>Notes: Erosion at EF9 appears comparable to 2020.</p>
2022

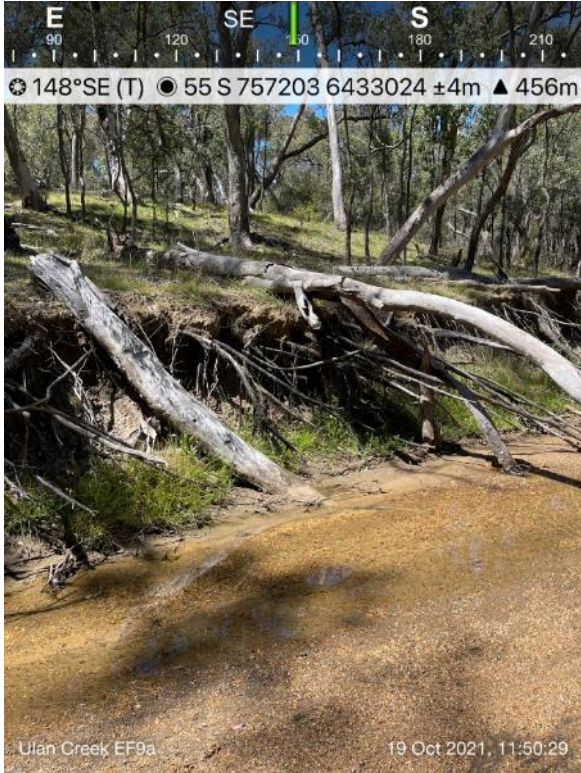
<p style="font-size: small; margin-top: 5px;">Ulan Creek EF9a 19 Oct 2021, 11:50:29</p>

<p style="font-size: small; margin-top: 5px;">EF9a 11-Oct-2022, 11:25:24</p>
<p>Notes: In 2021 the rate of erosion at EF9a along the LHB had slowed since 2020, also the coverage of ground vegetation had improved at the base of the bank.</p>	<p>Notes: In 2022 the rate of erosion at EF9a along the LHB was comparable to 2021.</p>

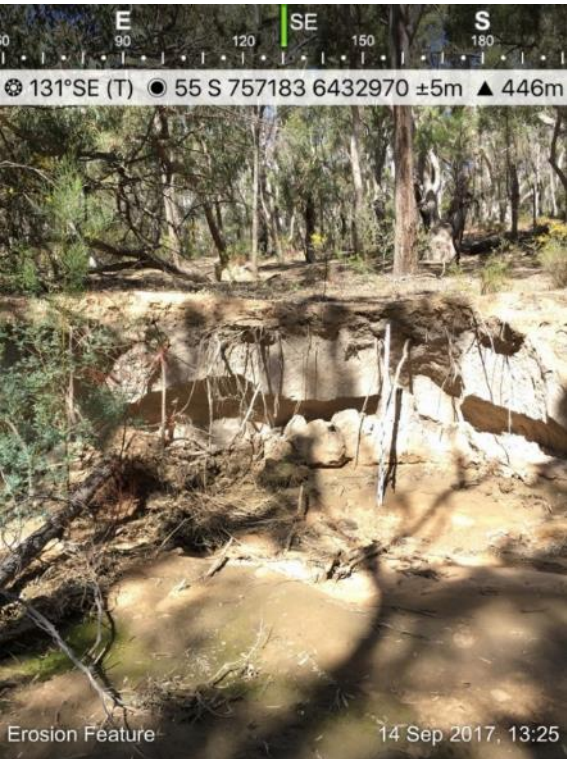
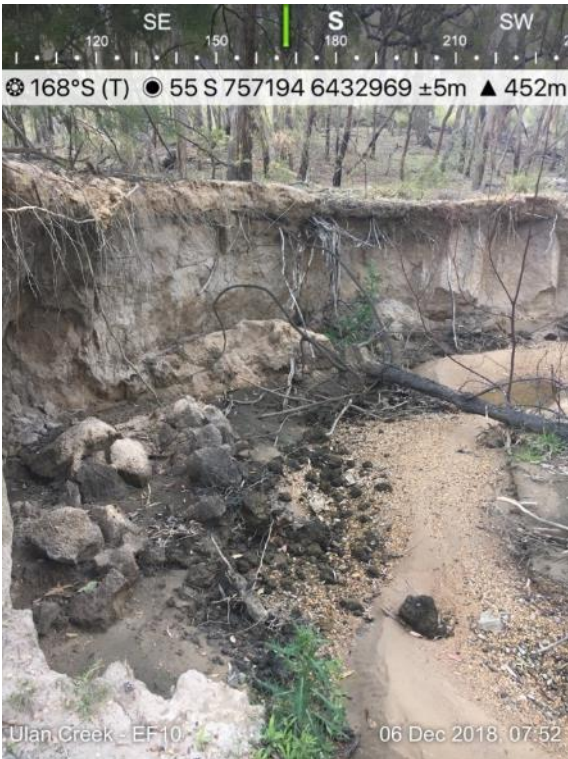
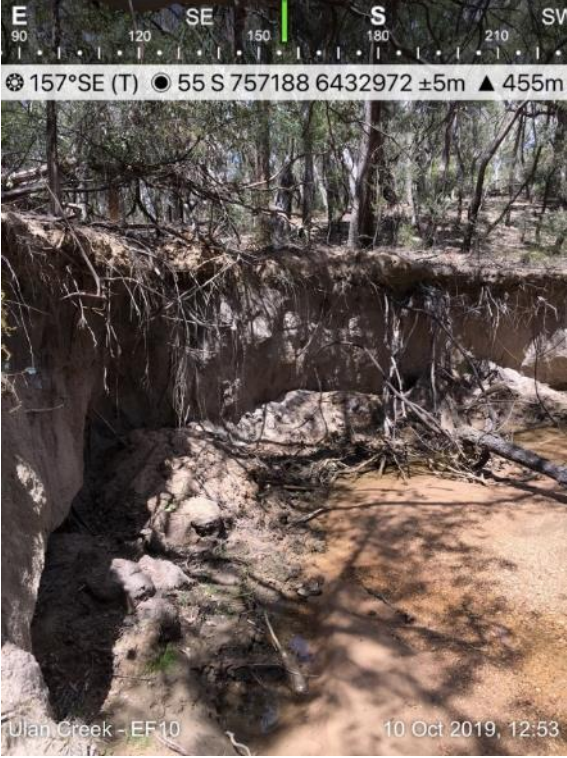
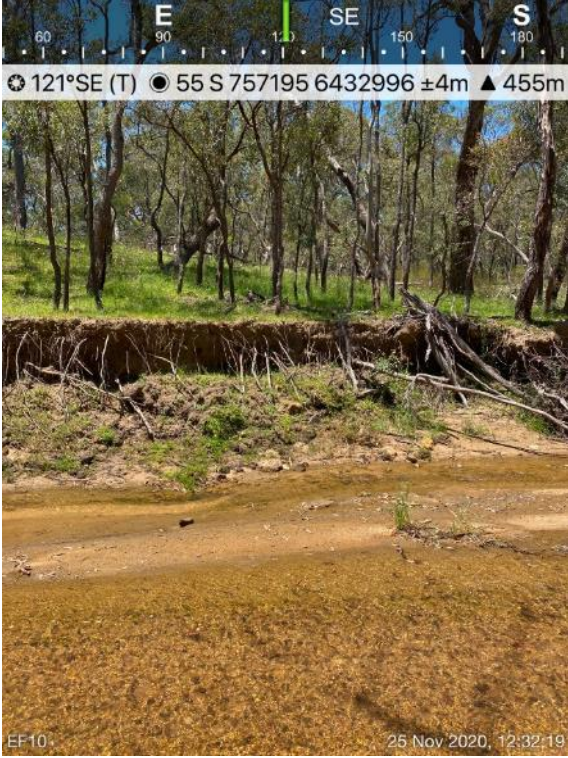
Table 4 Ulan Creek Erosion Features_EF10

<p>Notes: 2018 identified signs of recently eroded material when compared to 2017. Erosion at EF10 in 2019 did not identify another significant erosion event, however there were signs of continuation of some material loss along the LHB. In 2020 the erosion appears active.</p>

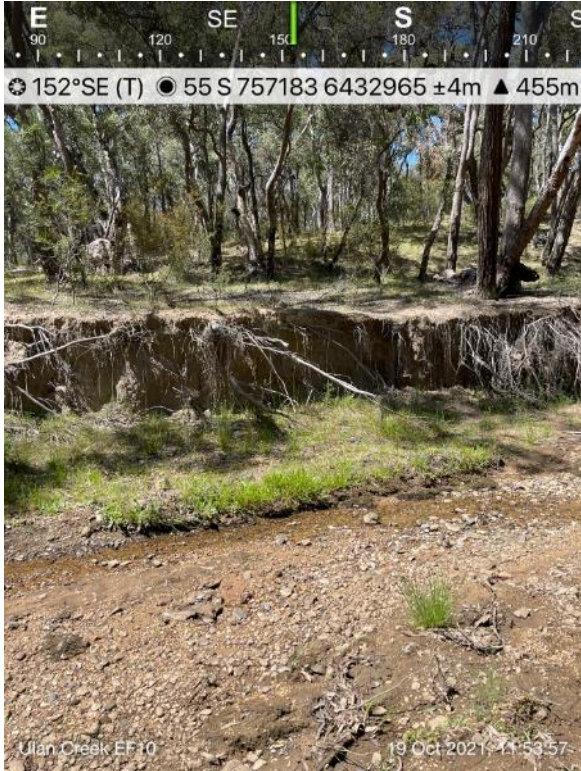
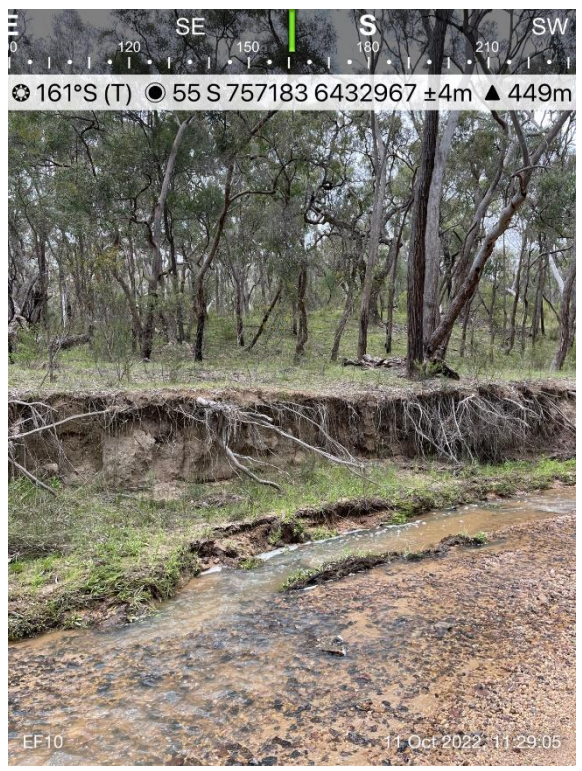
Table 23 Ulan Creek Erosion Features_EF10 (cont.)

<p>Notes: In 2021 the rate of erosion at EF10 along the LHB had slowed since 2020, also the coverage of ground vegetation had improved.</p>	<p>Notes: In 2022 the rate of erosion at EF10 along the LHB was comparable to 2021.</p>

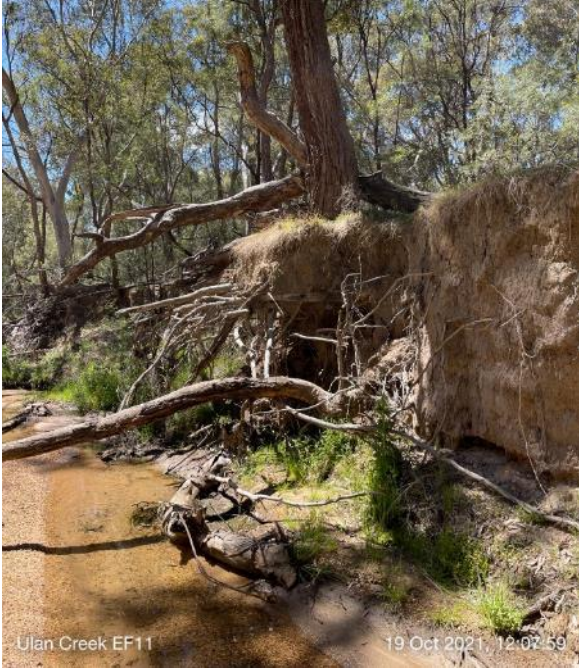
<p style="font-size: small; margin-top: 5px;">Ulan Creek EF11 19 Oct 2021, 12:07:59</p>	<div style="text-align: center; margin-bottom: 5px;">

<p style="font-size: small; margin-top: 5px;">EF11 11 Oct 2022, 11:49:44</p>
<p>Notes: In 2021 the rate of erosion at EF11 along the LHB had slowed since 2020, also the coverage of ground vegetation had improved.</p>	<p>Notes: In 2022 the rate of erosion at EF11 along the LHB was comparable to 2021.</p>

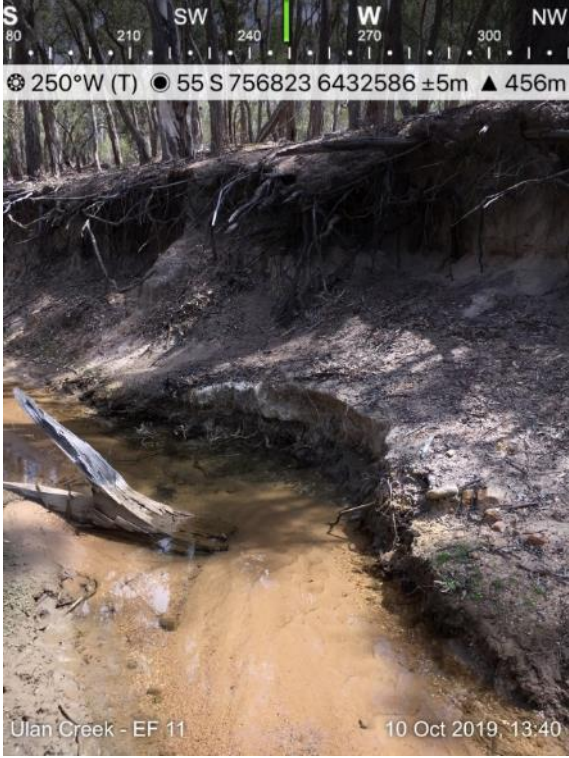
<p style="font-size: small; margin-top: 5px;">Ulan Creek - EF 11 10 Oct 2019, 13:40</p>	  <p style="font-size: small; margin-top: 5px;">EF11a 25 Nov 2020, 13:21:26</p>
<p>Notes: Erosion at EF11a remains active in 2020 with signs of material loss along the RHB. A scour hole noted in previous monitoring was almost infilled with sand and gravel material.</p>

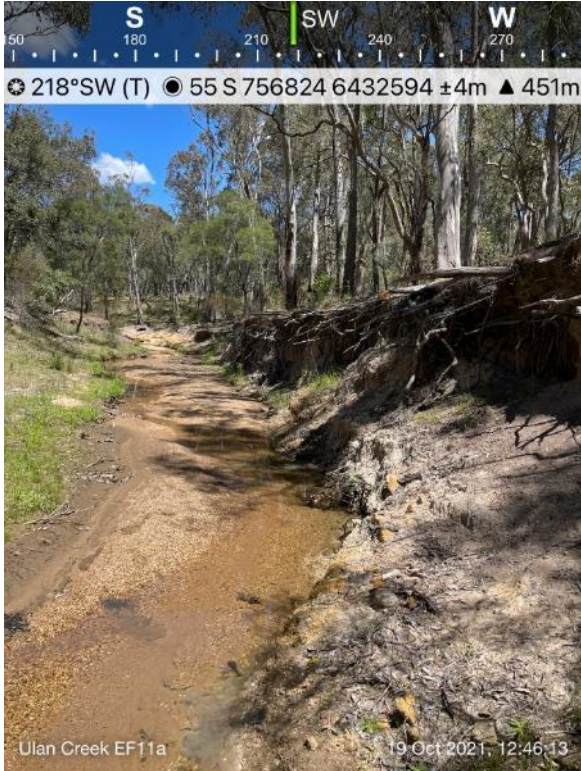
<p style="font-size: small; margin-top: 5px;">Ulan Creek EF11a 19 Oct 2021, 12:46:13</p>

<p style="font-size: small; margin-top: 5px;">EF11a 11 Oct 2022, 12:26:47</p>
<p>Notes In 2021 the erosion at EF11a appears comparable to previous monitoring, although there was almost no ground vegetation in 2021.</p>	<p>Notes: In 2022 the rate of erosion at EF11a along the LHB was comparable to 2021.</p>
