# UCMPL Annual Flora Monitoring Report 2025

Ulan Coal Mines Pty Ltd

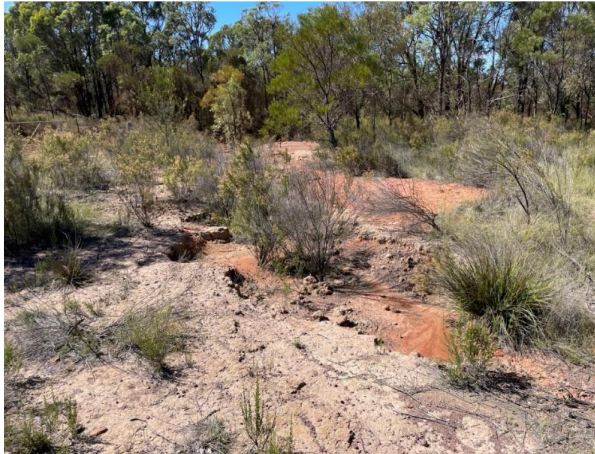
No areas of erosion were identified within the offset areas during 2025. A Bobadeen Offset Erosion Remediation Plan has been prepared to address the previously identified active gully erosion at Gate 23 in the Bobadeen Offset Area (Plate 5). Erosion repairs were completed in 2025 (Plate 6). UCMPL will continue to monitor the area for further erosion and growth of vegetation.

Plate 5: Erosion near Gate 23 identified during 2024

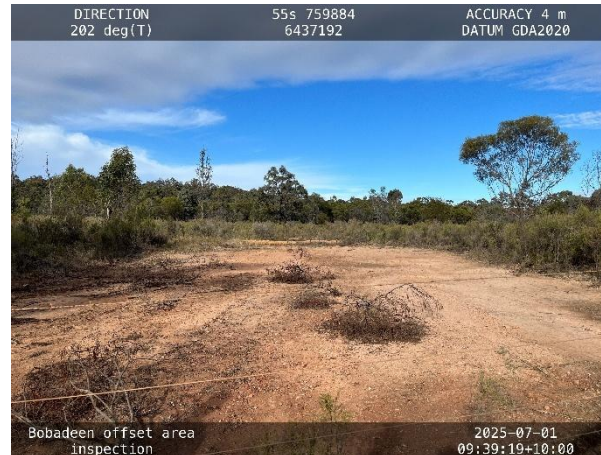
Plate 6: Repaired area of erosion near Gate 23

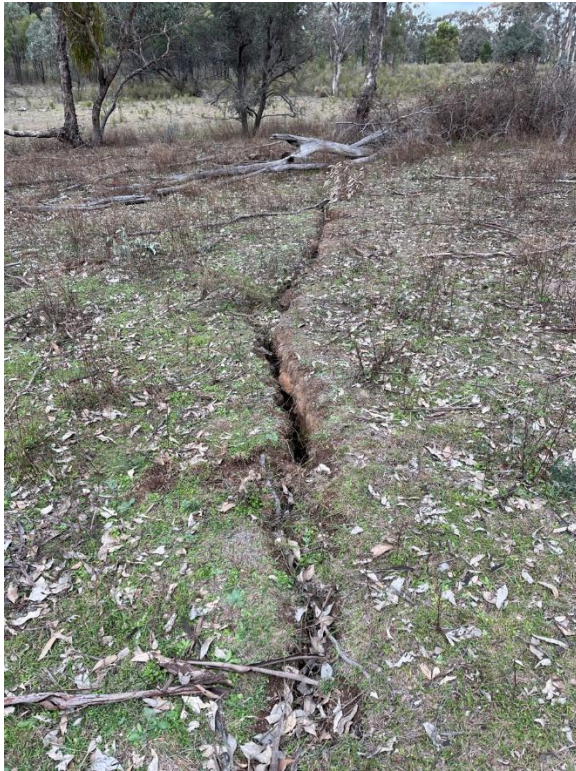
Subsidence cracks were recorded across UW LW7 and UW LW8. It has been observed over the last few years that most subsidence cracks fill in naturally due to the sandy soil texture across most longwalls. Subsidence cracks are not typically observed in subsequent monitoring periods; however, a persistent subsidence crack was recorded on UW LW8 in spring 2024, autumn 2025 (Plate 7) (55H 753900 6432778) and spring 2025 (Plate 8), indicating that management intervention may be required to remediate the crack. The crack is in basalt derived soil with a much higher clay content than the surrounding sandstone derived soils.

Plate 7: Subsidence crack recorded during Autumn 2025

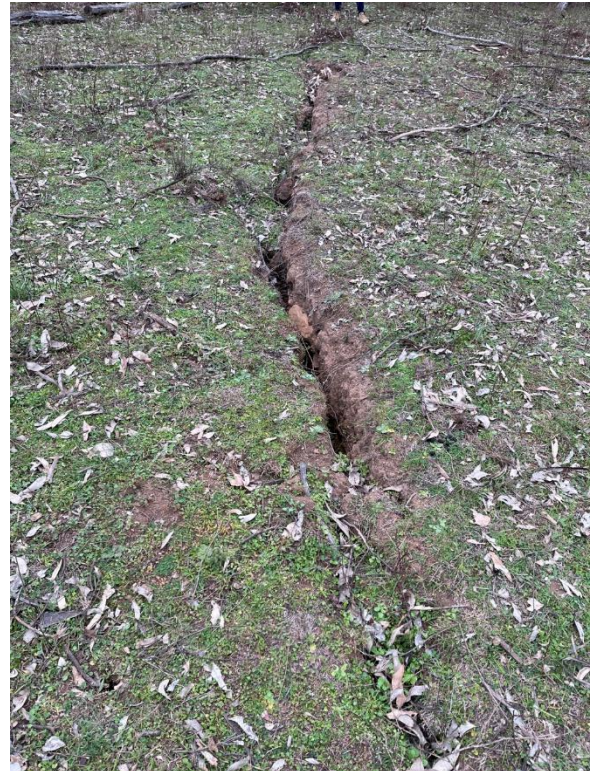
Plate 8: The same crack recorded during Spring 2025
