Appendix D – Erosion Features

Ulan Creek Erosion Features\_EF2

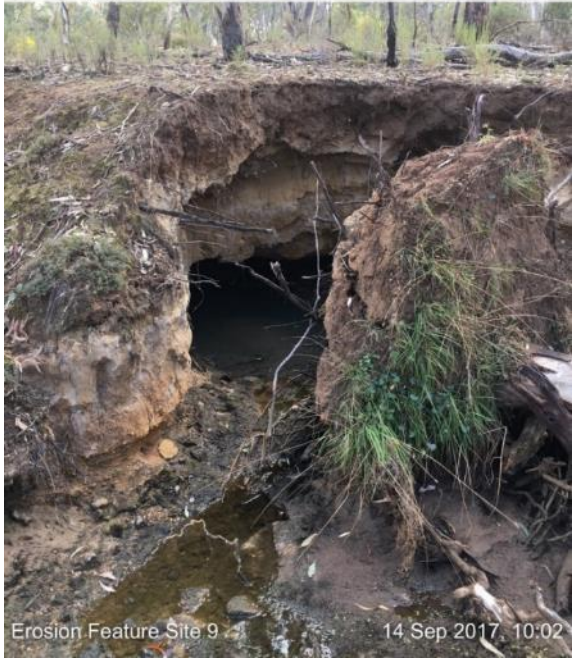
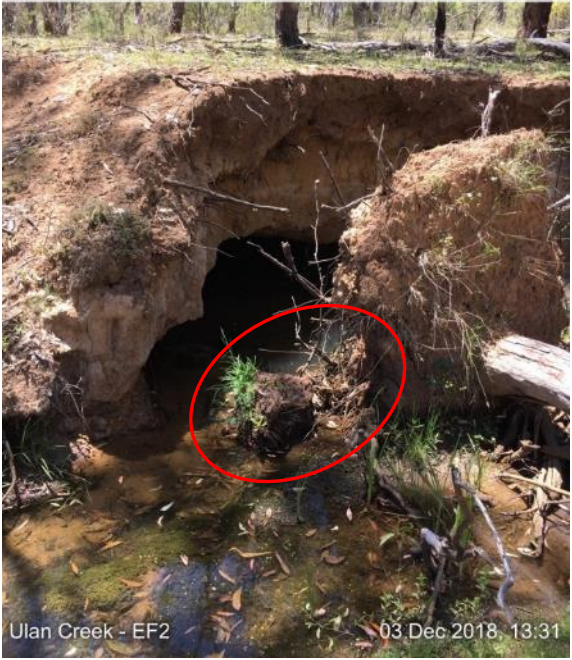
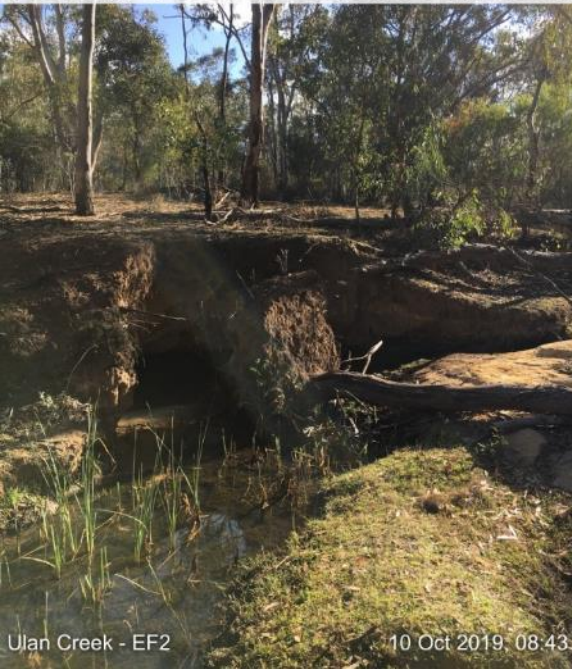
| 2017 | 2018 |
|---|---|
| <p><b>Notes:</b> Erosion at EF2 remains very active in 2020, signs of tunnelling and mass wasting along the RHB. Material loss around base of the fallen tree since 2018. The fallen tree had been repositioned since 2019.</p> | |

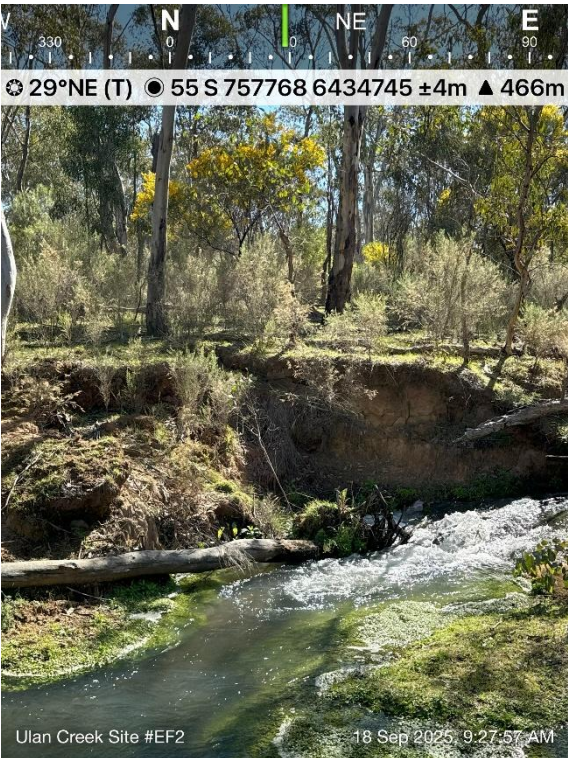
| <p>2025</p> <p>Ulan Creek Site #EF2</p> <p>18 Sep 2025, 9:27:57 AM</p> | |

| <p><b>Notes:</b> Erosion at EF2 appears comaparble to 2024.</p> | |

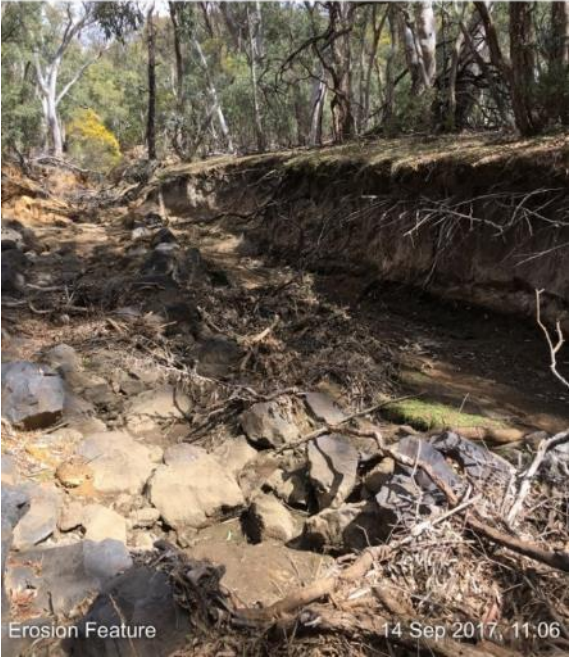
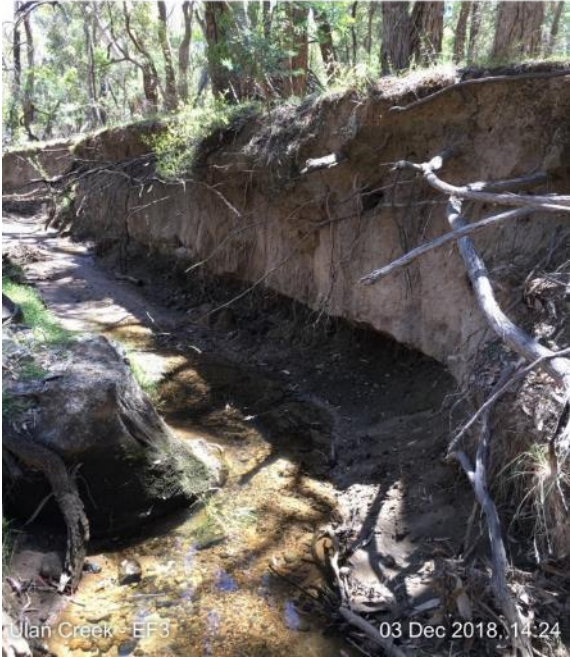
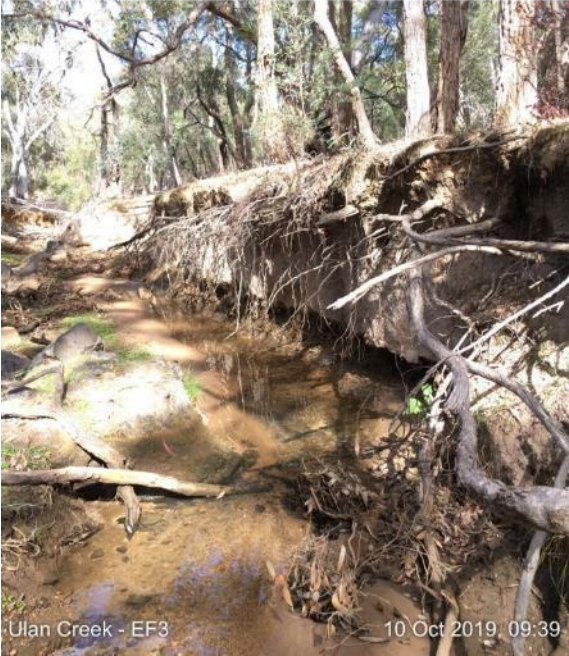
Ulan Creek Erosion Features\_EF3

| 2017 | 2018 |
|---|---|
| <p><b>Notes:</b> Erosion at EF3 remains very active in 2020 with recent signs of further undercutting and material loss along the RHB.</p> | |

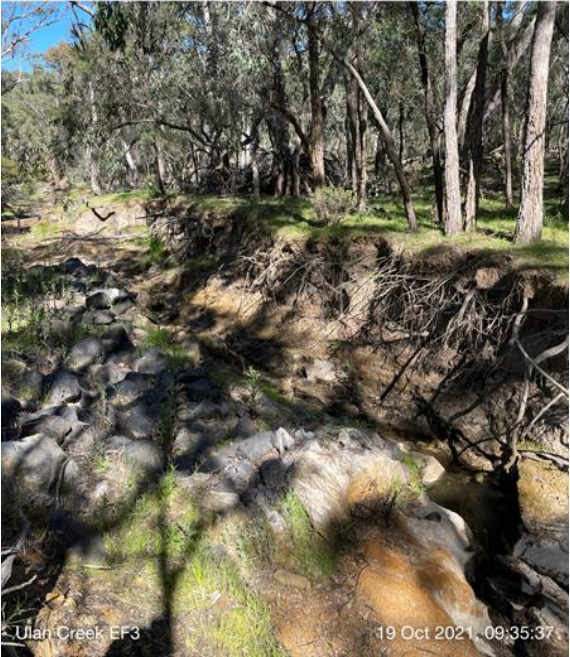
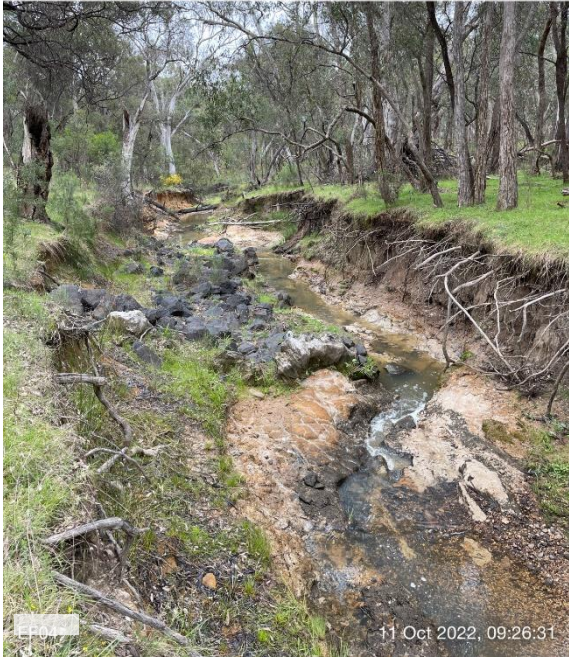
| 2021 | 2022 |
|---|---|
| <p><b>Notes:</b> Erosion at EF3 remains active in 2021 with recent signs of further undercutting and material loss along the RHB. Ground vegetation had not established.</p> | <p><b>Notes:</b> Erosion at EF3 remains active in 2022 with recent signs of further undercutting and material loss along the RHB.</p> |

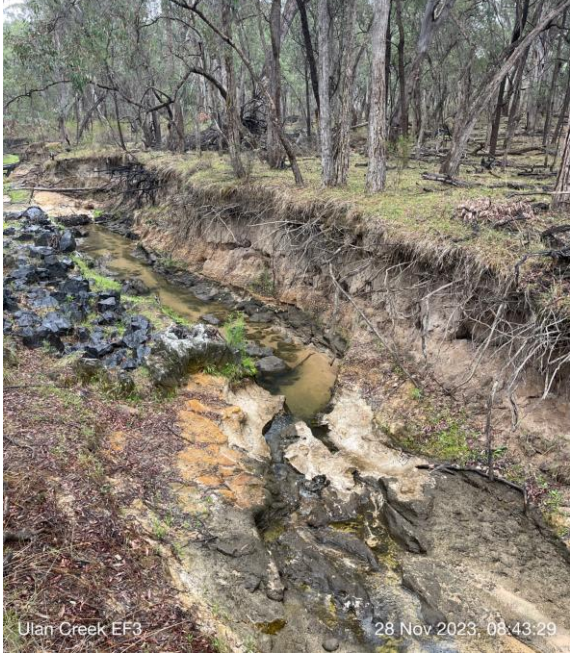
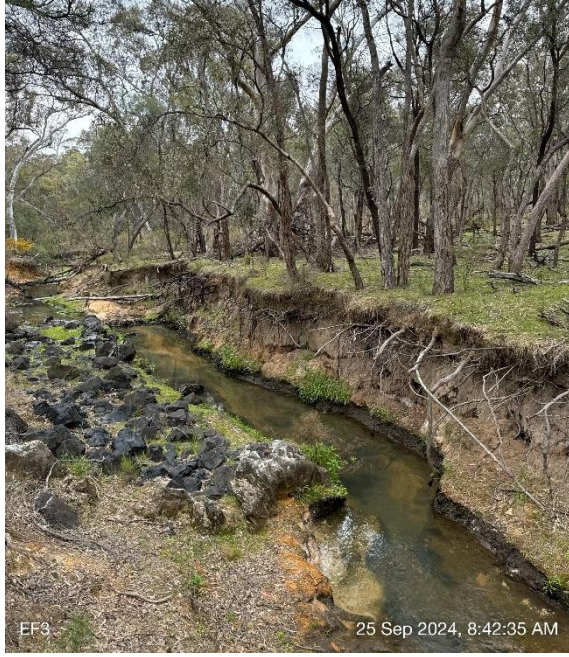
| 2021 | 2022 |
|---|---|
| <p><b>Notes:</b> Erosion at EF3 appears comaparble to 2022.</p> | <p><b>Notes:</b> Erosion at EF3 appears comaparble to 2023.</p> |

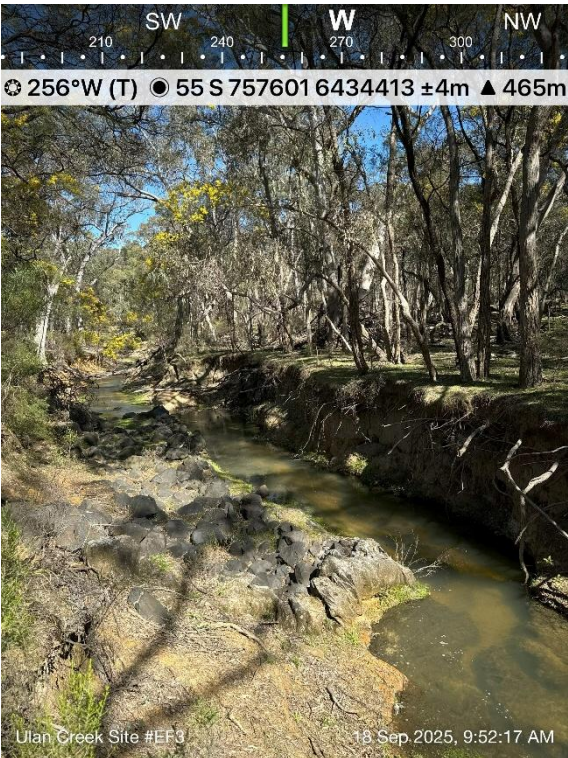
| 2025 | |
|---|--|
| <p><b>Notes:</b> Erosion at EF3 appears comaparble to 2024.</p> | |

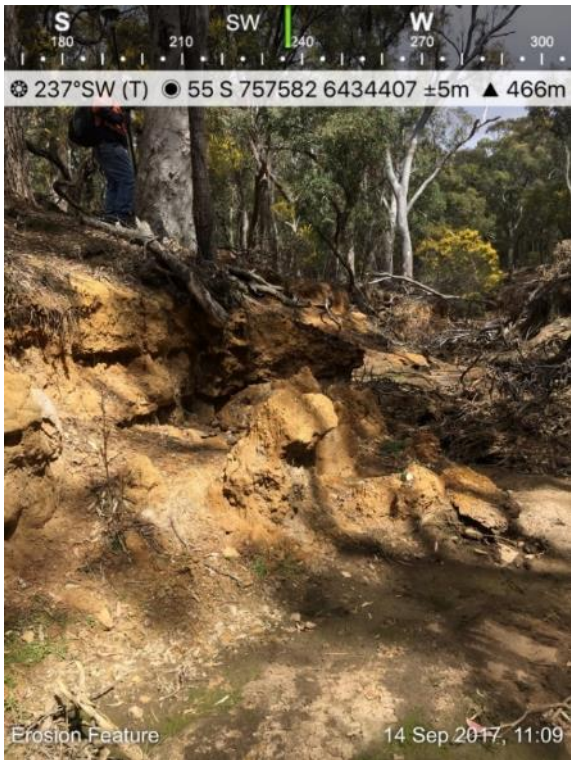
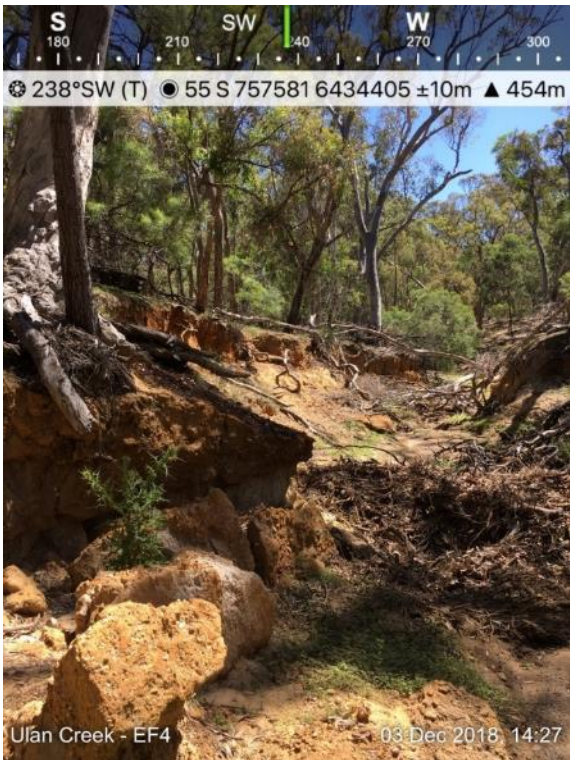
### Ulan Creek Erosion Features\_EF4

| 2017 | 2018 |
|---|---|
| <p><b>Notes:</b> In 2019 the erosion at EF4 appears comparable to 2018. In 2020 the erosion was very active along the LHB.</p> | |

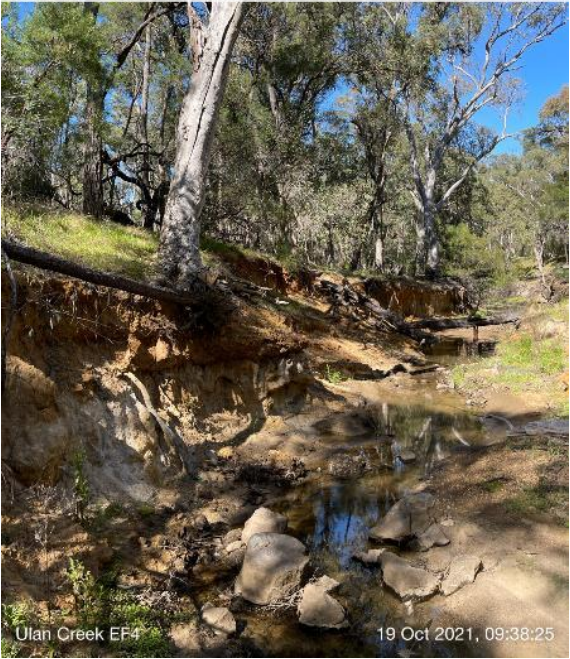
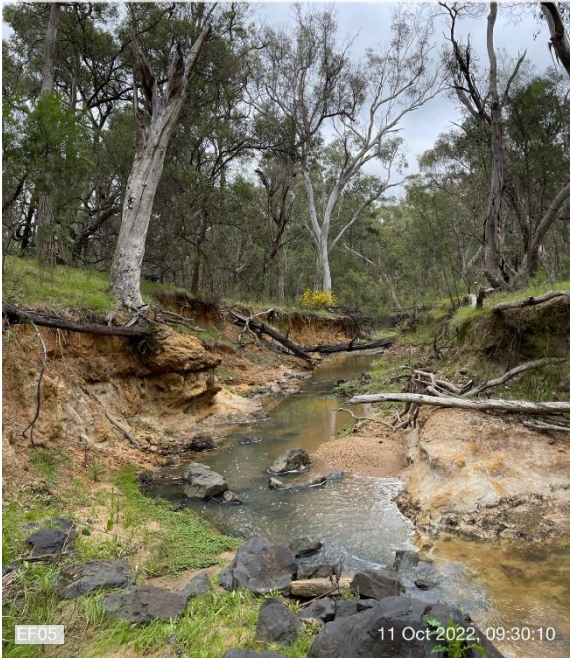
| 2021 | 2022 |
|---|---|
| <div><div><div>S180210240270</div><div>223°SW (T) 55 S 757577 6434405 ±3m ▲ 464m</div><div></div><div>Ulan Creek EF419 Oct 2021, 09:38:25</div></div></div> <div><p><b>Notes:</b> In 2021 the erosion at EF4 appears comparable to previous monitoring. In 2021 the erosion was very active along the LHB.</p></div> | <div><div><div>S180210240270300</div><div>233°SW (T) 55 S 757582 6434408 ±4m ▲ 464m</div><div></div><div>EF0511 Oct 2022, 09:30:10</div></div></div> <div><p><b>Notes:</b> In 2022 the erosion at EF4 appears comparable to previous monitoring. In 2022 the erosion was active along the LHB.</p></div> |

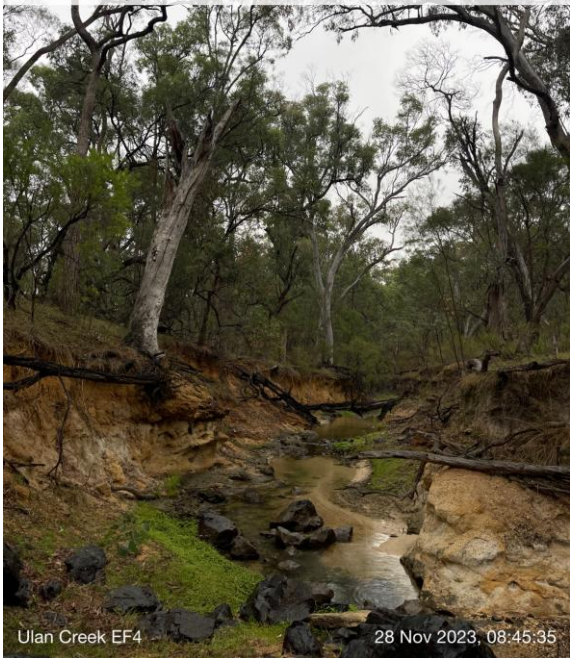
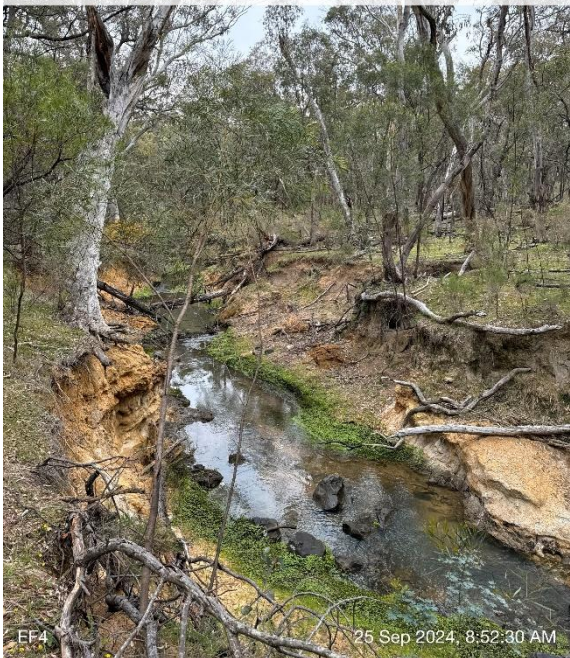
| 2021 | 2022 |
|---|---|
| <div><div><div>S180210240270300</div><div>234°SW (T) 55 S 757580 6434404 ±4m ▲ 465m</div><div></div><div>Ulan Creek EF428 Nov 2023, 08:45:35</div></div></div> <div><p><b>Notes:</b> Erosion at EF4 appears comaparble to 2022.</p></div> | <div><div><div>21024027030033</div><div>260°W (T) 55 S 757581 6434401 ±4m ▲ 465m</div><div></div><div>EF425 Sep 2024, 8:52:30 AM</div></div></div> <div><p><b>Notes:</b> Erosion at EF4 appears comaparble to 2023.</p></div> |

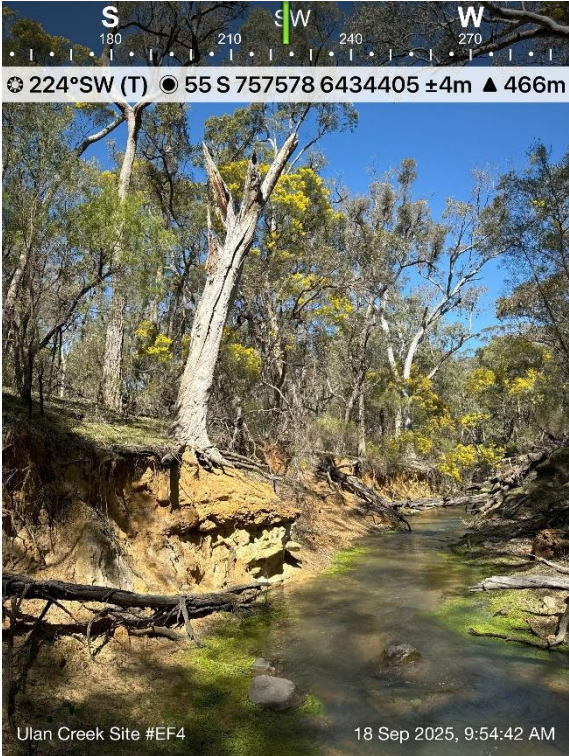
| <p>Ulan Creek Site #EF4 18 Sep 2025, 9:54:42 AM</p> | |

| <p><b>Notes:</b> Erosion at EF4 appears comaparble to 2024.</p> | |

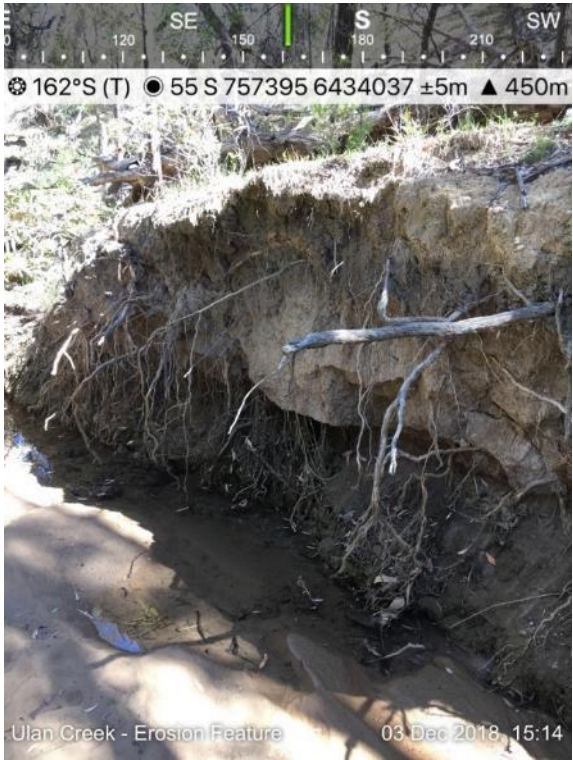
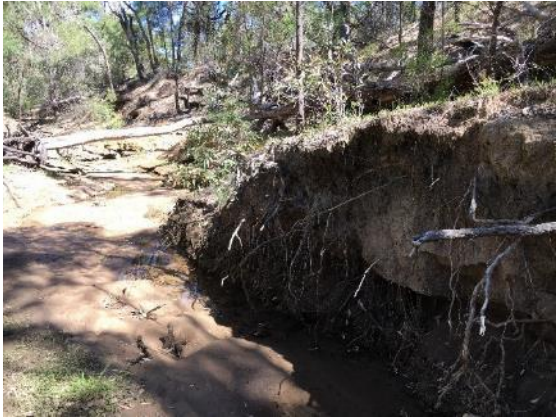
Ulan Creek Erosion Features\_EF4a

| 2018 | |
|---|---|
| <p><b>Notes:</b> Erosion at EF4a remains very active in 2020 with recent signs of undercutting along the RHB.</p> | |

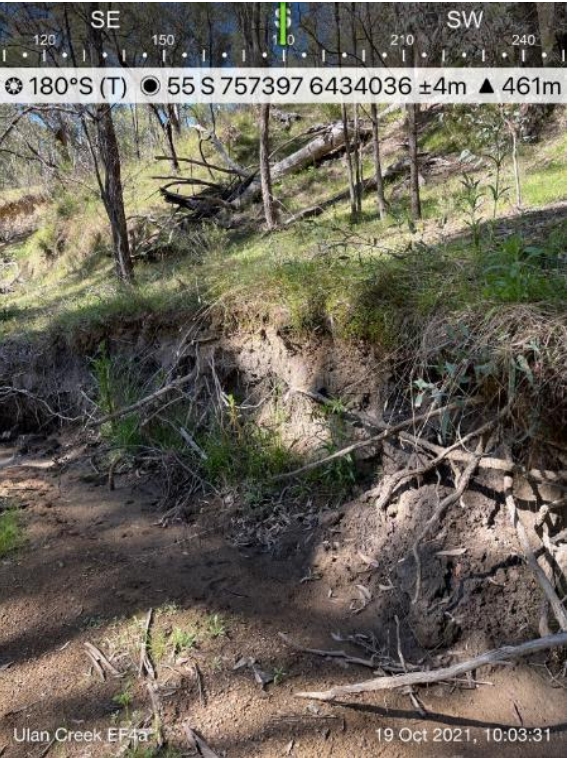
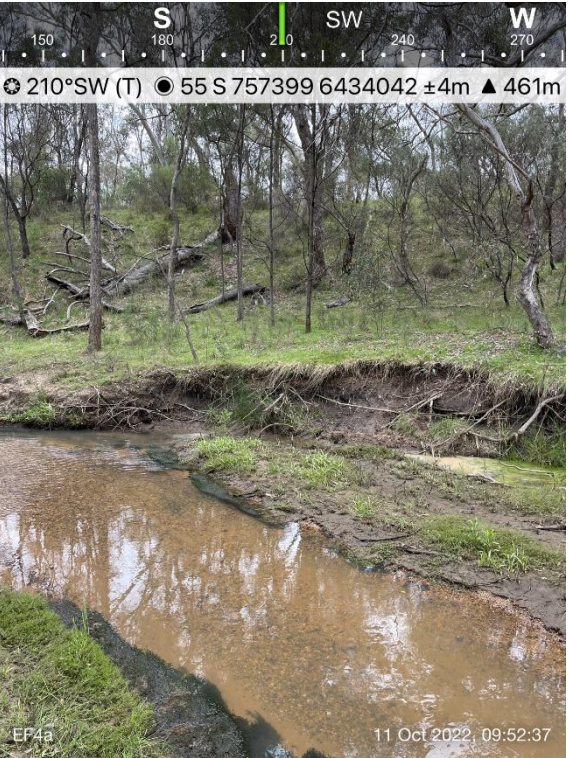
| 2021 | 2022 |
|---|---|
| <p><b>Notes:</b> In 2021 the erosion at EF4a appears comparable to previous monitoring. In 2021 the erosion was active along the RHB.</p> | <p><b>Notes:</b> In 2022 the erosion at EF4a appears comparable to previous monitoring. In 2022 the erosion was active along the RHB.</p> |

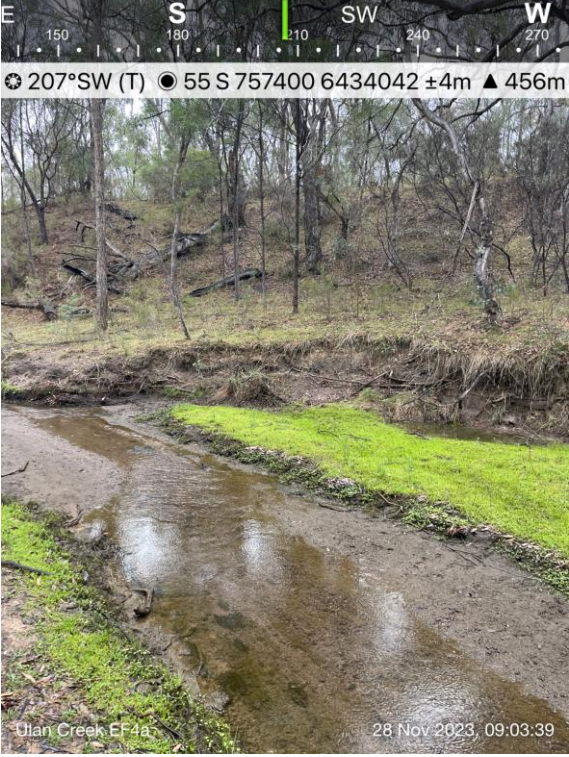
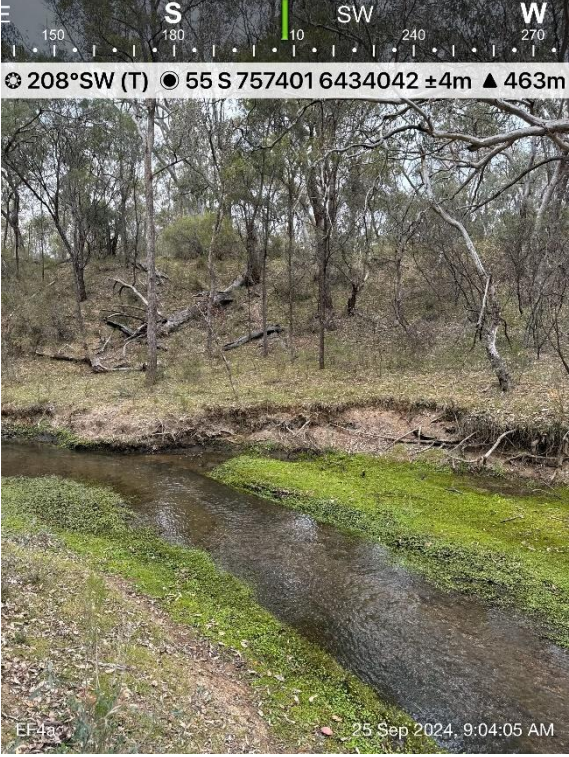
| 2021 | 2022 |
|---|---|
| <p><b>Notes:</b> Erosion at EF4a appears comparable to 2022.</p> | <p><b>Notes:</b> Erosion at EF4a appears comparable to 2023.</p> |

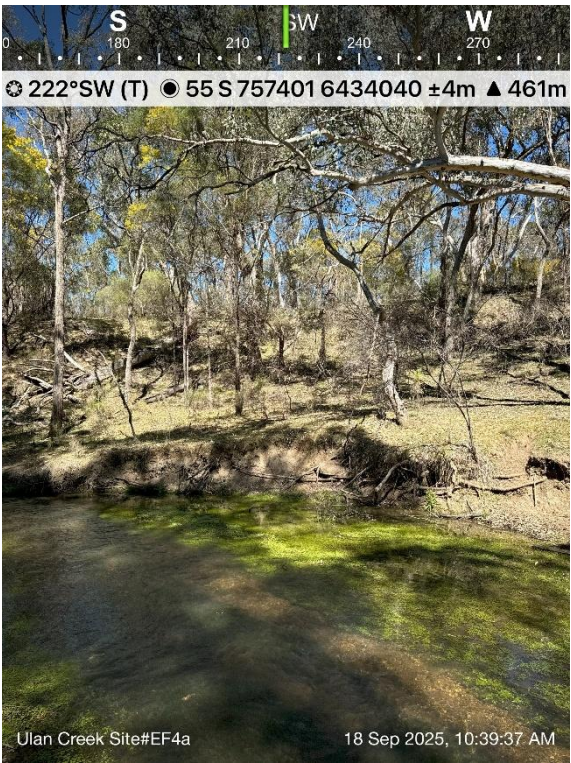
| 2025 | |
|---|--|
| <p><b>Notes:</b> Erosion at EF4a appears comparable to 2024.</p> | |

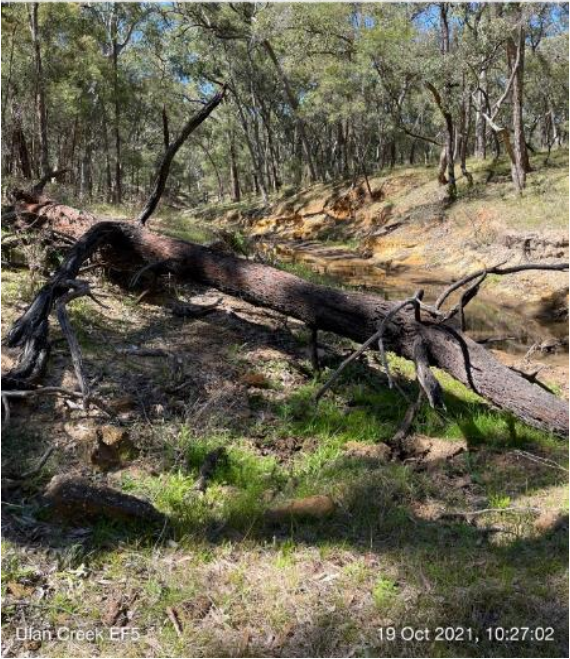
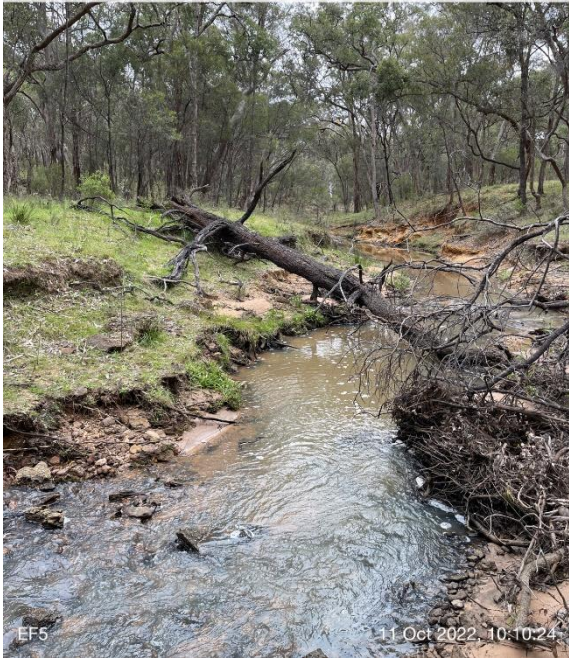
| 2021 | 2022 |
|---|---|
| <div><div><div>SE120150180210SW</div><div>166°S (T) 55 S 757484 6433822 ±4m ▲ 458m</div><div></div><div>Ulan Creek EF519 Oct 2021, 10:27:02</div></div></div> <div><p><b>Notes:</b> In 2021 the erosion at EF5 appears comparable to previous monitoring. Since the previous monitoring in 2020 a tree had fallen into the creek from the LHB.</p></div> | <div><div><div>E9012015180210S</div><div>152°SE (T) 55 S 757479 6433832 ±4m ▲ 453m</div><div></div><div>EF511 Oct 2022, 10:10:24</div></div></div> <div><p><b>Notes:</b> In 2022 the erosion at EF5 appears comparable to previous monitoring.</p></div> |

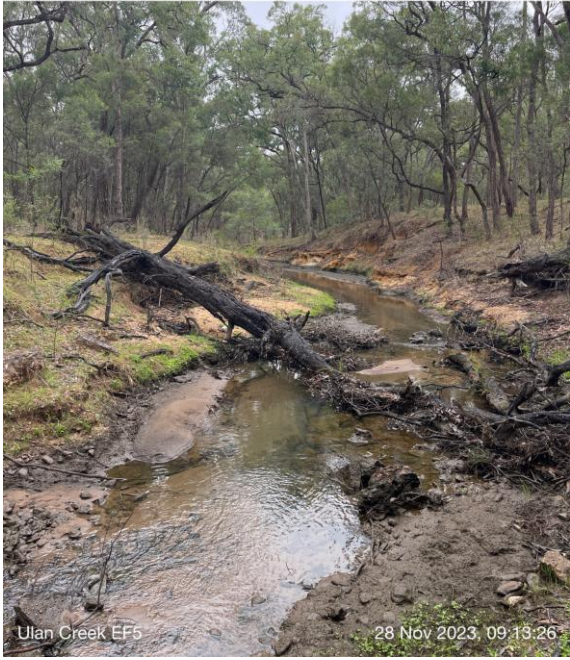
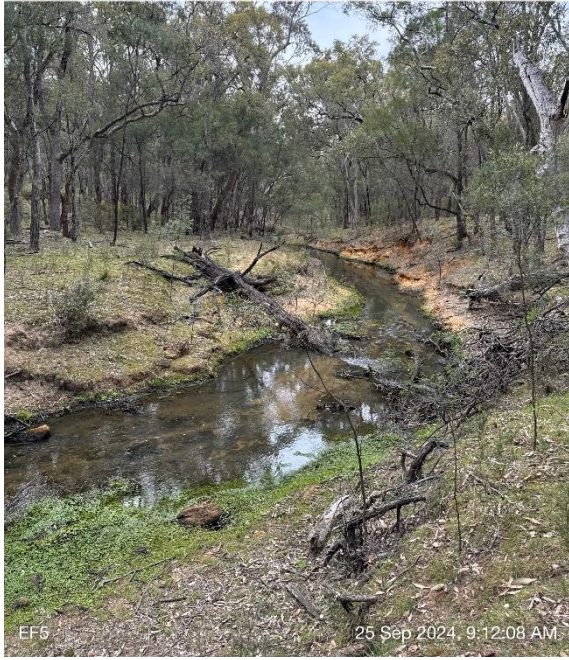
| 2021 | 2022 |
|---|---|
| <div><div><div>E9012015180210SW</div><div>157°SE (T) 55 S 757479 6433825 ±4m ▲ 454m</div><div></div><div>Ulan Creek EF528 Nov 2023, 09:13:26</div></div></div> <div><p><b>Notes:</b> Erosion at EF5 appears comaparble to 2022.</p></div> | <div><div><div>E9012015180210S</div><div>153°SE (T) 55 S 757475 6433830 ±4m ▲ 460m</div><div></div><div>EF525 Sep 2024, 9:12:08 AM</div></div></div> <div><p><b>Notes:</b> Erosion at EF5 appears comaparble to 2023.</p></div> |

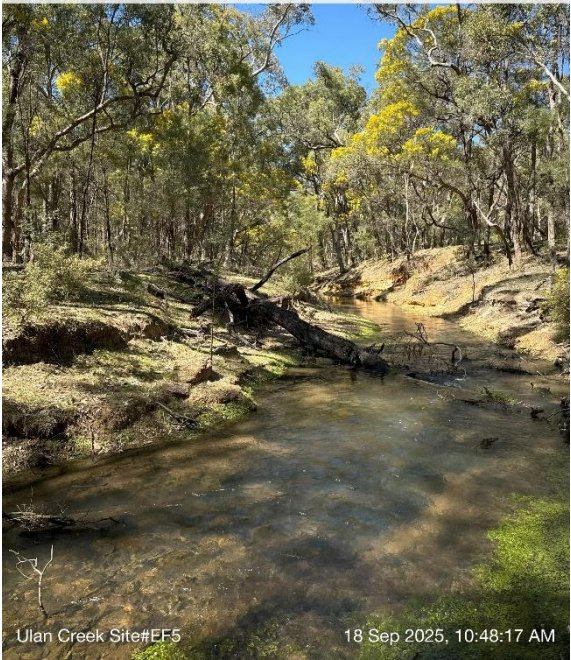
| 2025 | |
|---|--|
| <p><b>Notes:</b> Erosion at EF5 appears comaparble to 2024.</p> | |

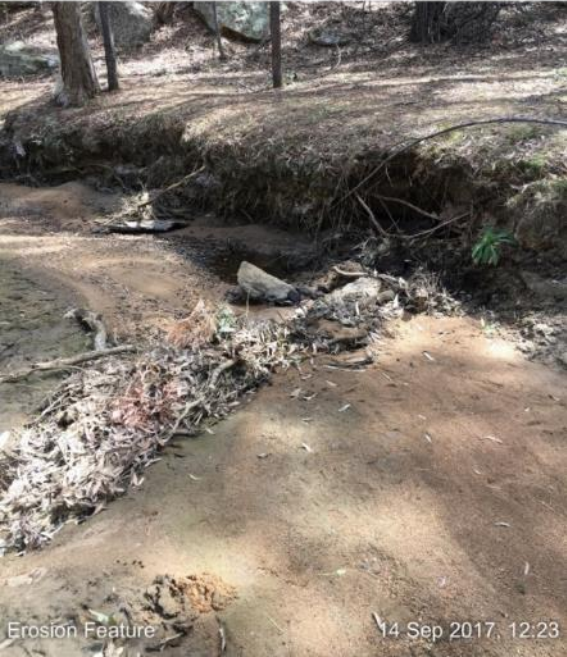
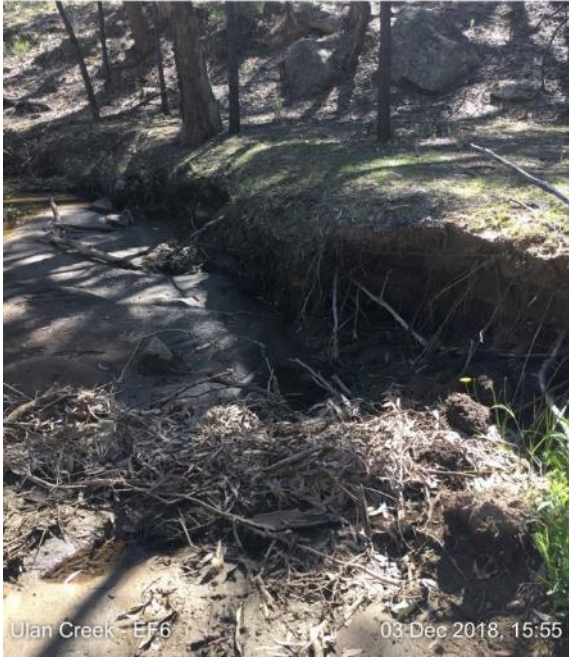
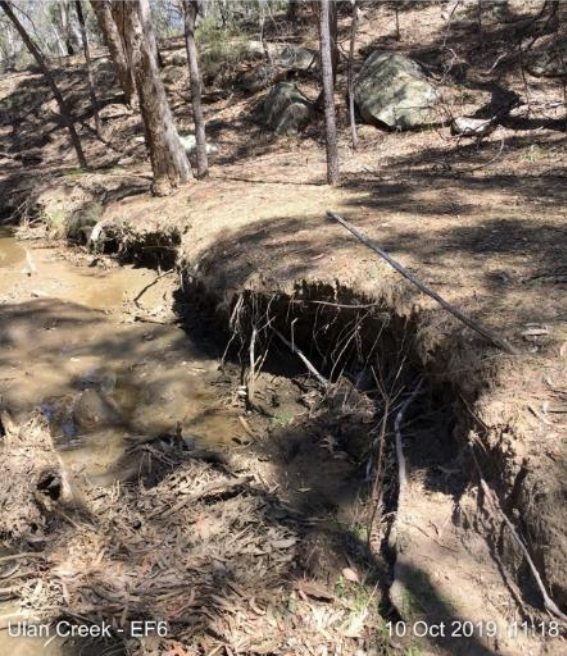
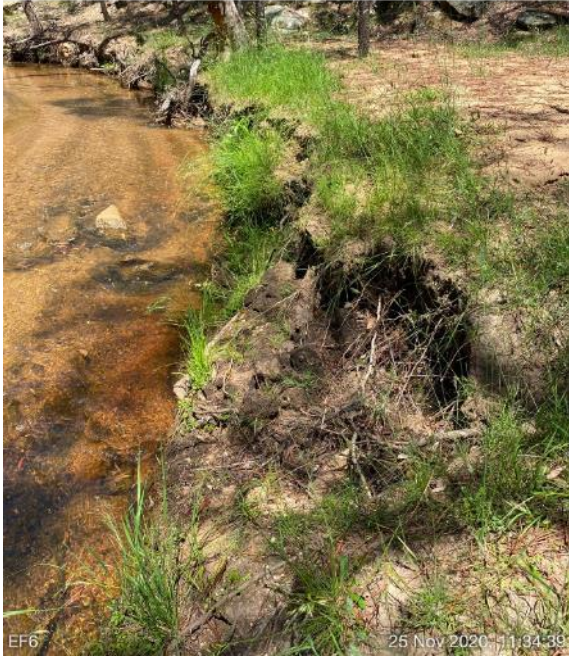
Ulan Creek Erosion Features\_EF6

| 2017 | 2018 |
|---|---|
| <p><b>Notes:</b> Erosion at EF6 remains active in 2020 with signs of further bank undercutting and slumping along the RHB since 2019.</p> | |

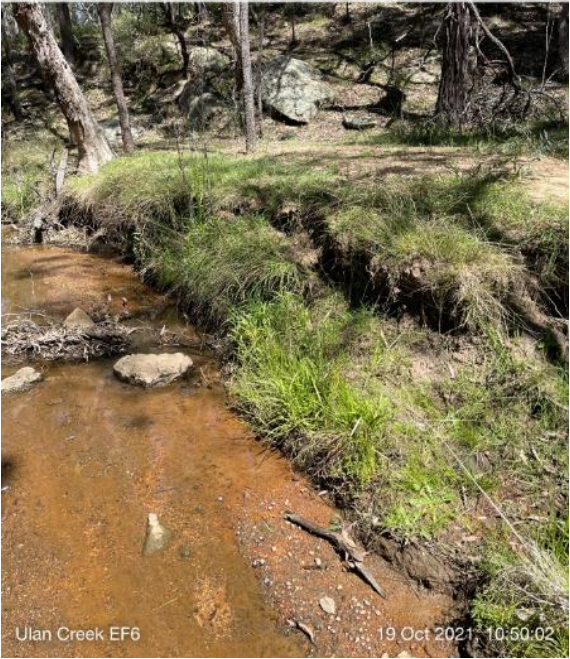
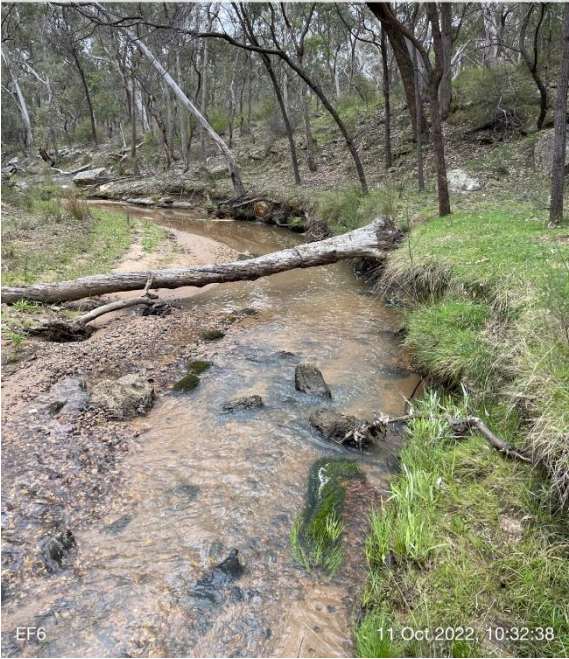
| 2021 | 2022 |
|---|---|
| <div><div><div>SWW</div><div>210240270300330</div><div>262°W (T) 55 S 757395 6433657 ±4m ▲ 458m</div><div></div><div>Ulan Creek EF619 Oct 2021, 10:50:02</div></div></div> <div><p><b>Notes:</b> In 2021 the rate of erosion along the RHB at EF6 had slowed since 2020, also the coverage of ground vegetation had improved slightly.</p></div> | <div><div><div>SSW</div><div>180210240270</div><div>227°SW (T) 55 S 757399 6433656 ±4m ▲ 457m</div><div></div><div>EF611 Oct 2022, 10:32:38</div></div></div> <div><p><b>Notes:</b> In 2022 the erosion at EF5 appears comparable to previous monitoring. Since the previous monitoring in 2020 a tree had fallen into the creek from the RHB</p></div> |

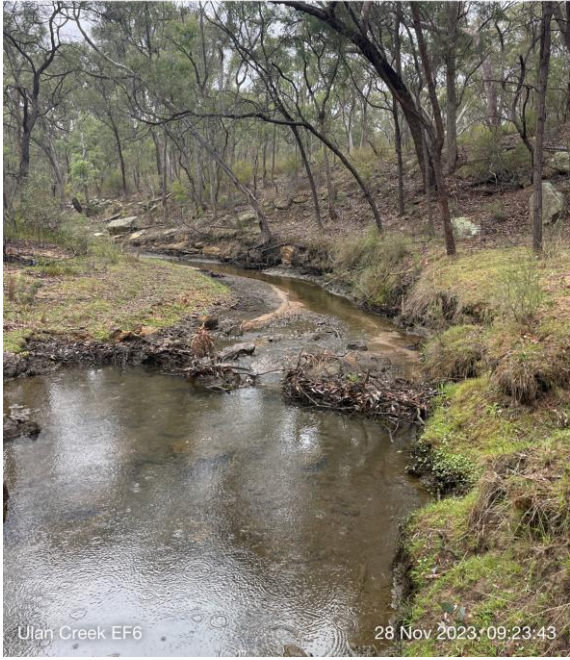
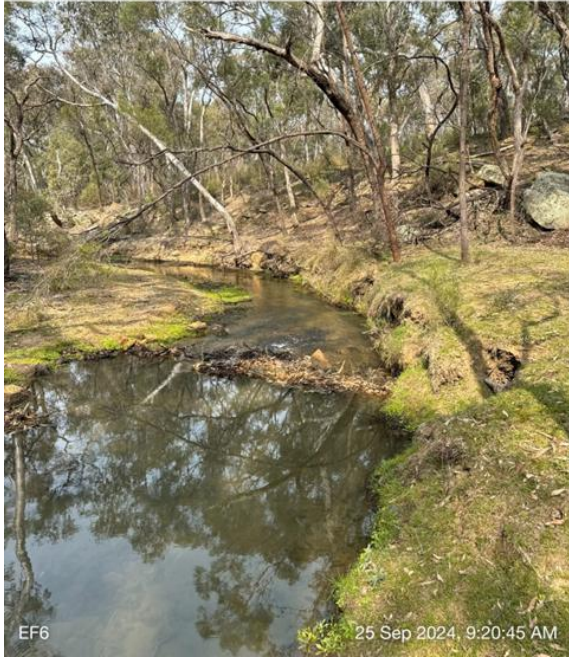
| 2021 | 2022 |
|---|---|
| <div><div><div>SSW</div><div>180210240270</div><div>225°SW (T) 55 S 757397 6433656 ±4m ▲ 457m</div><div></div><div>Ulan Creek EF628 Nov 2023, 09:23:43</div></div></div> <div><p><b>Notes:</b> Erosion at EF6 appears comaparble to 2022.</p></div> | <div><div><div>SSW</div><div>180210240270</div><div>226°SW (T) 55 S 757399 6433657 ±4m ▲ 459m</div><div></div><div>EF625 Sep 2024, 9:20:45 AM</div></div></div> <div><p><b>Notes:</b> Erosion at EF6 appears comaparble to 2023.</p></div> |

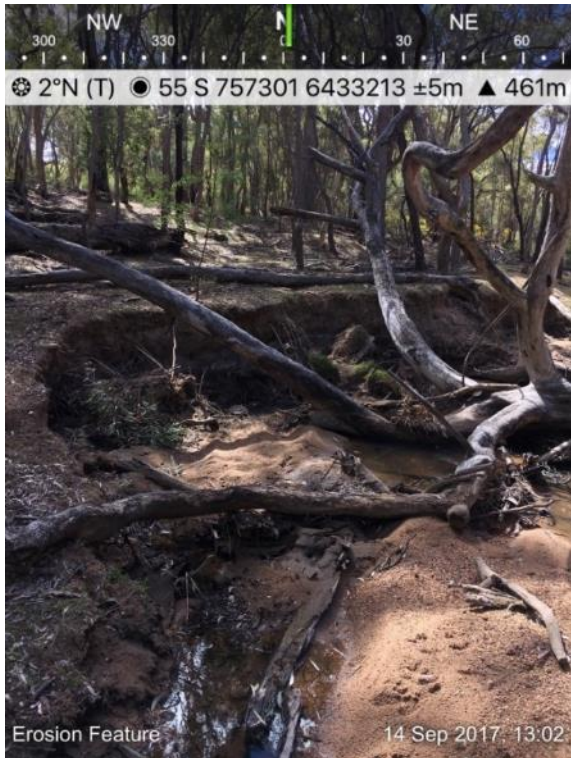
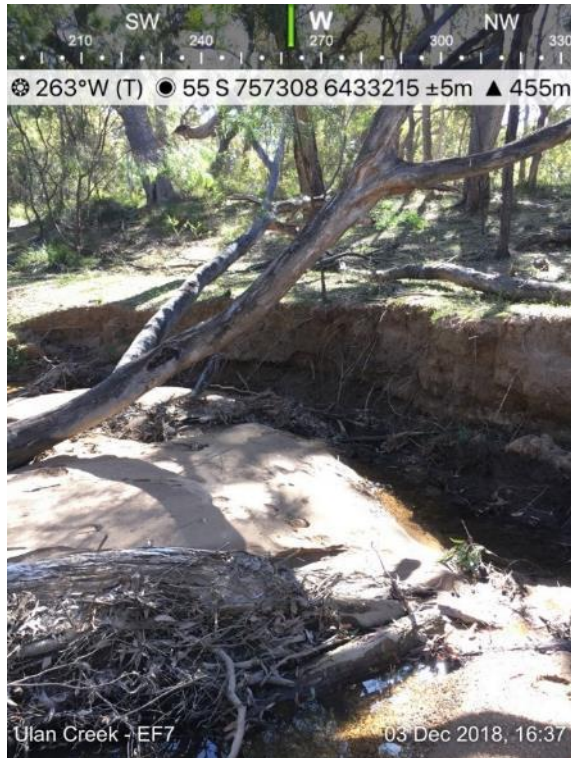
Ulan Creek Erosion Features\_EF7

| 2017 | 2018 |
|---|---|
| <div><div><div>300NW330N30NE60</div><div>☉ 2°N (T) ● 55 S 757301 6433213 ±5m ▲ 461m</div><div>A photograph of a creek bed with a large, fallen log in the foreground. The ground is sandy and eroded. A compass rose and coordinates are visible at the top.</div><div>Erosion Feature14 Sep 2017, 13:02</div></div></div> | <div><div><div>210SW240W270NW330</div><div>☉ 263°W (T) ● 55 S 757308 6433215 ±5m ▲ 455m</div><div>A photograph of a creek bed with a large, fallen log in the foreground. The ground is sandy and eroded. A compass rose and coordinates are visible at the top.</div><div>Ulan Creek - EF703 Dec 2018, 16:37</div></div></div> |
| <p><b>Notes:</b> Erosion at EF7 appears to be very active with signs of significant bank undercutting and new slumping along the RHB noted in 2019</p> | |

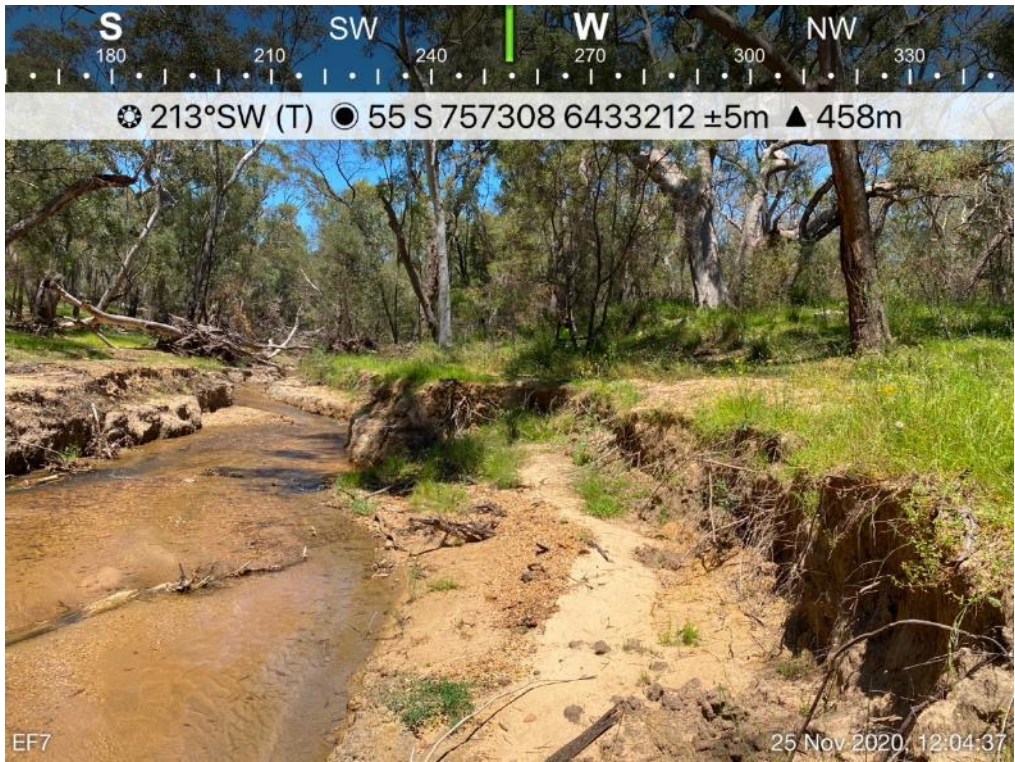
**Notes:** Erosion at EF7 remains very active in 2020 along the RHB. The large fallen tree has been relocated downstream. Sand and gravel deposits that had accumulated around the tree have also been transported downstream as the flow line has been cleared of such material since 2019.

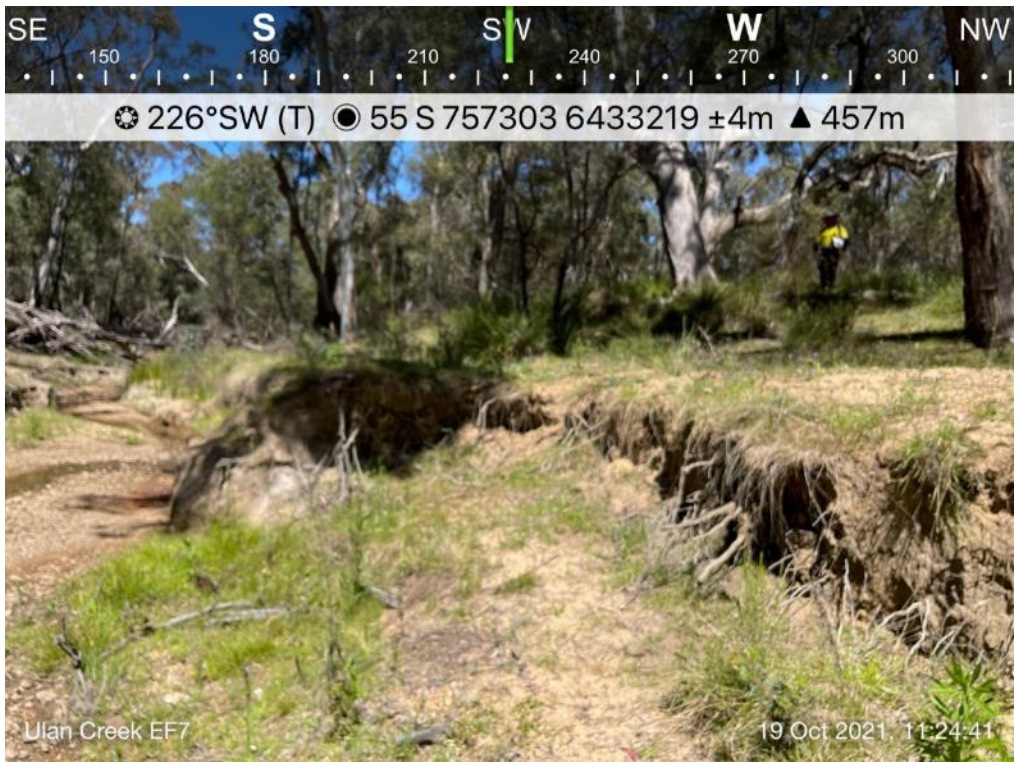
**Notes:** In 2021 the rate of erosion at EF7 along the RHB had slowed since 2020, also the coverage of ground vegetation had improved.

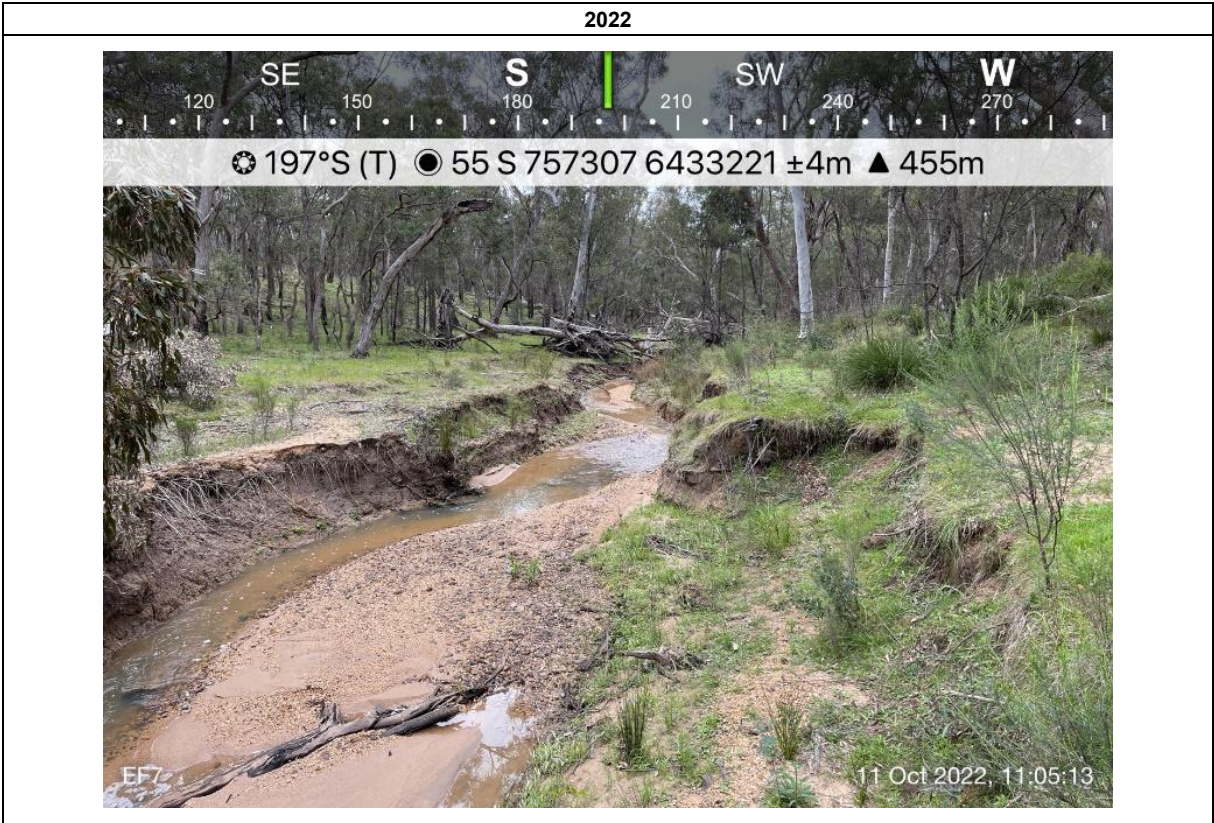
**Notes:** In 2022 the rate of erosion at EF7 along the RHB had further slowed and was potentially stabilising. The LHB was actively eroding in 2022. A tree had fallen onto the creek from the LHB since 2021.

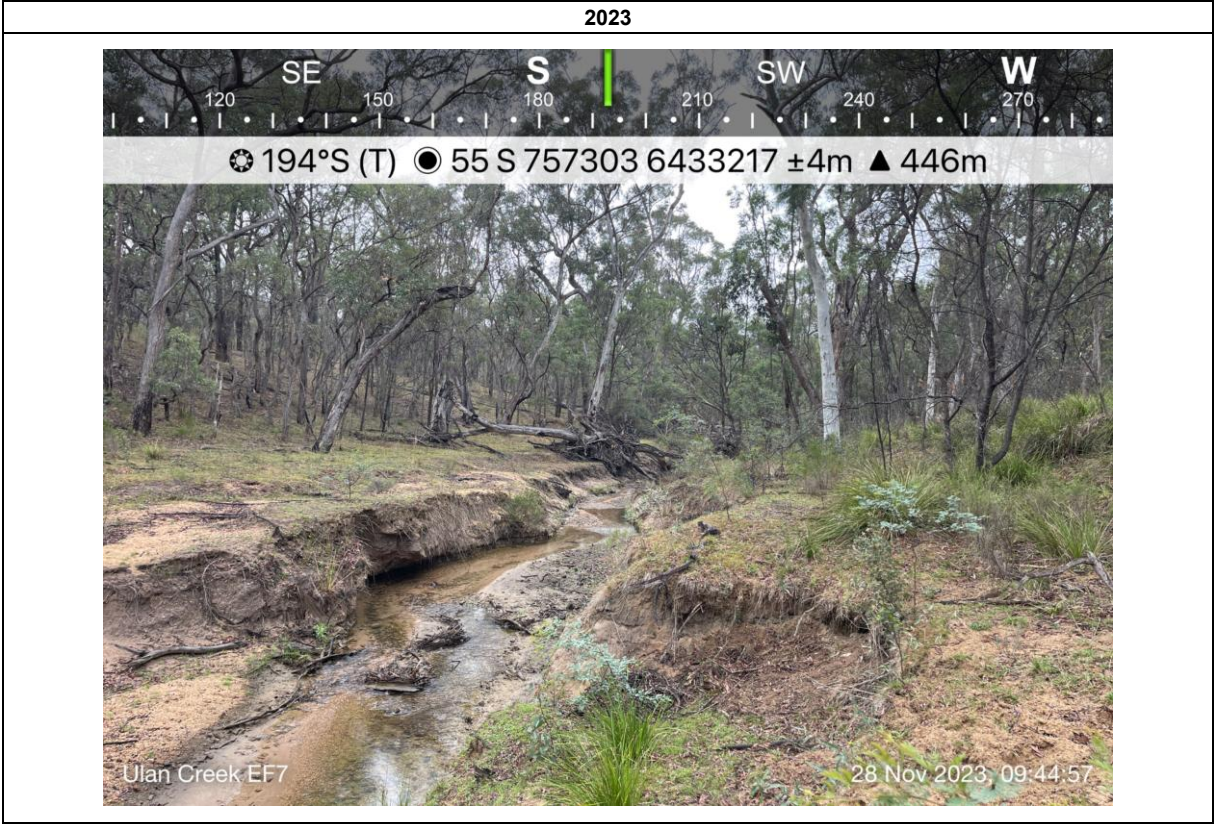
**Notes:** Erosion at EF7 appears comparable to 2022, however bank undercutting along the LHB has occurred since 2022.

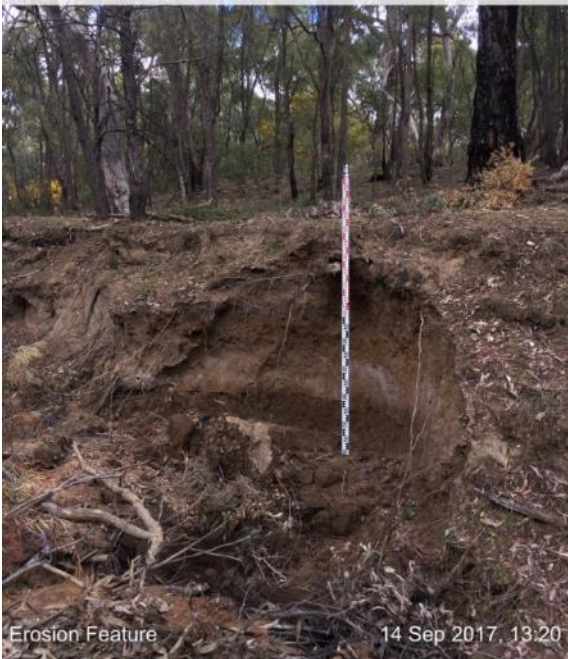
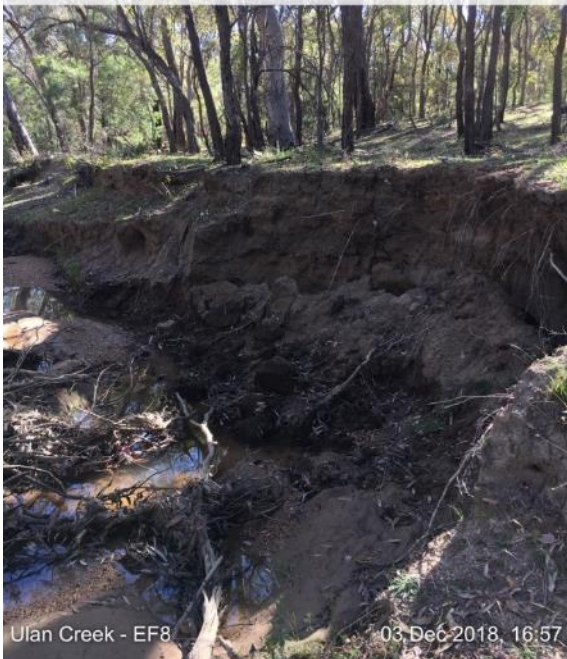
Ulan Creek Erosion Features\_EF8

| 2017 | 2018 |
|---|---|
| <div><div><div>S 180 210 SW 240 W 270 N</div><div>244°SW (T) ● 55 S 757225 6433086 ±5m ▲ 454m</div><div>A photograph of a deep, vertical erosion gully in a wooded area. A white measuring pole is placed vertically in the center of the gully for scale. The soil is dark brown and appears moist. The surrounding forest has thin trees and some fallen branches are visible on the ground.</div><div>Erosion Feature14 Sep 2017, 13:20</div></div></div> <div><div><div>S 180 210 SW 240 W 270 N</div><div>221°SW (T) ● 55 S 757228 6433080 ±5m ▲ 455m</div><div>A photograph showing a more extensive erosion feature with a small stream flowing through it. The banks are steep and show signs of slumping. The water is dark and reflects the surrounding trees. The forest is dense with sunlight filtering through the canopy.</div><div>Ulan Creek - EF803 Dec 2018, 16:57</div></div></div> | |

**Notes:** 2018 identified significant bank erosion & slumping when compared to 2017. Erosion at EF8 in 2019 displayed a continuation of material loss along the bank. In 2020 the erosion along the bank remains very active, a tree has fallen into the creek downstream since 2019. Image for 2021 was not available.
