Appendix D – Erosion Features

Ulan Creek Erosion Features\_EF2

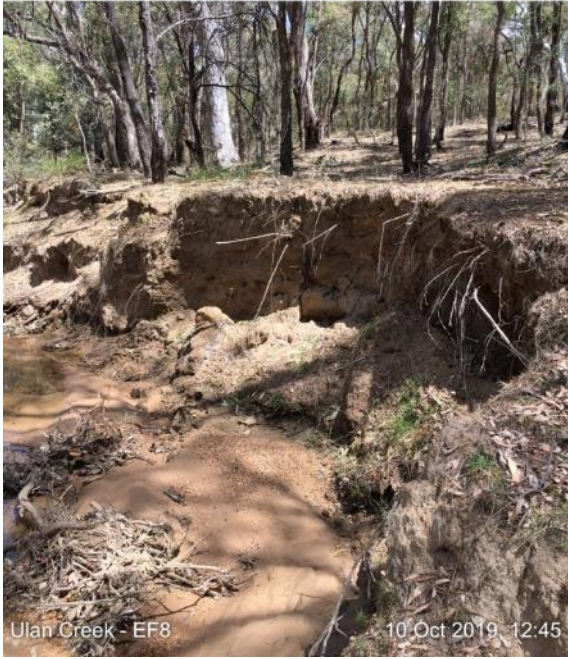
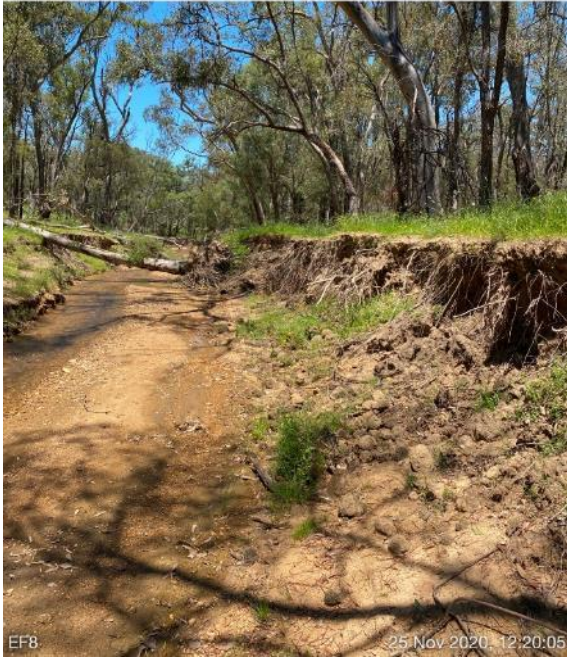
**Notes:** 2018 identified significant bank erosion & slumping when compared to 2017. Erosion at EF8 in 2019 displayed a continuation of material loss along the bank. In 2020 the erosion along the bank remains very active, a tree has fallen into the creek downstream since 2019. Image for 2021 was not available.

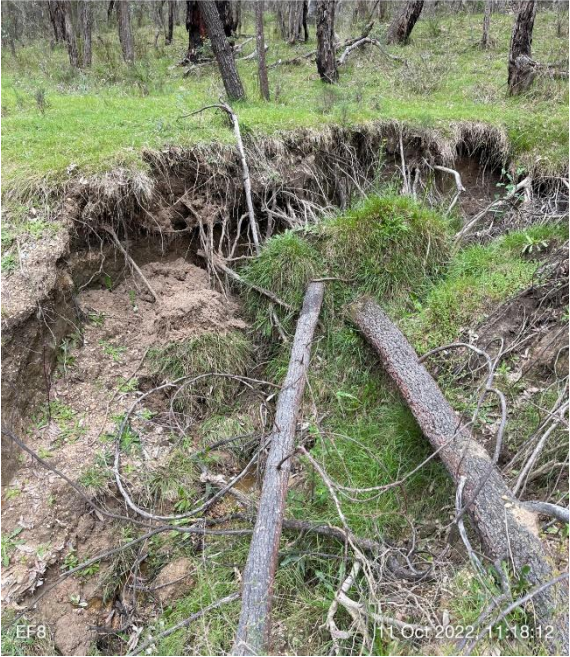
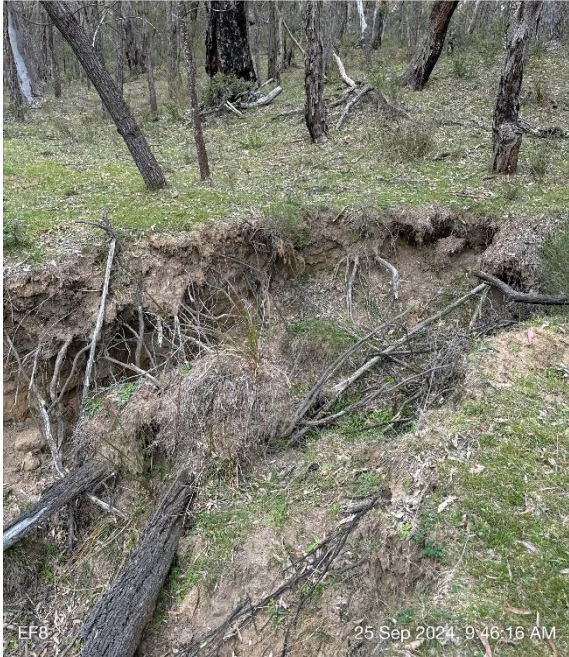
| 2022 | 2024 |
|---|---|
| <p><b>Notes:</b> In 2022 erosion at EF8 displayed a continuation of material loss</p> | <p><b>Notes:</b> Erosion at EF8 appears comaparble to 2023.</p> |

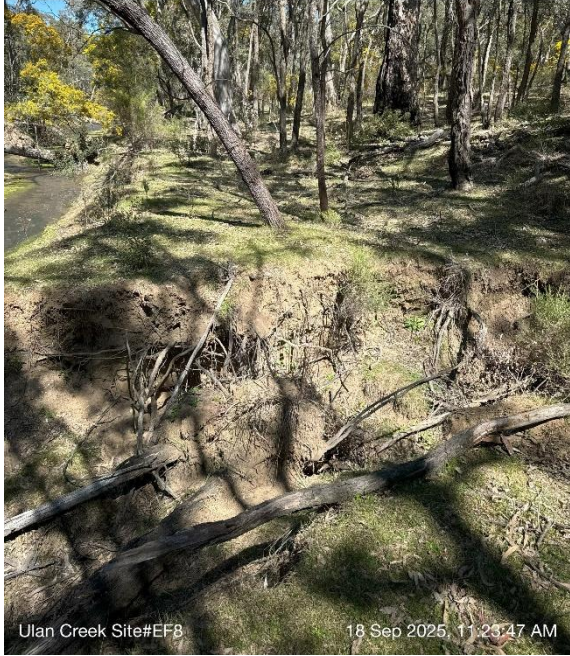
| 2022 | 2024 |
|---|---|
| <div><div><div>S180SW240W270NW300</div><div>232°SW (T) 55 S 757222 6433088 ±4m ▲ 454m</div><div>A photograph of the erosion feature in 2025. The top of the image shows a compass rose with directions S, SW, W, and NW, and a scale from 180 to 300. Below the compass is the text '232°SW (T) 55 S 757222 6433088 ±4m ▲ 454m'. The main image shows the erosion gully with exposed roots and a fallen log. The bottom left corner is labeled 'Ulan Creek Site#EF8' and the bottom right corner shows the date and time '18 Sep 2025, 11:23:47 AM'.</div></div></div> | |
| <p><b>Notes:</b> Erosion at EF8 appears more active when campared to 2024.</p> | |

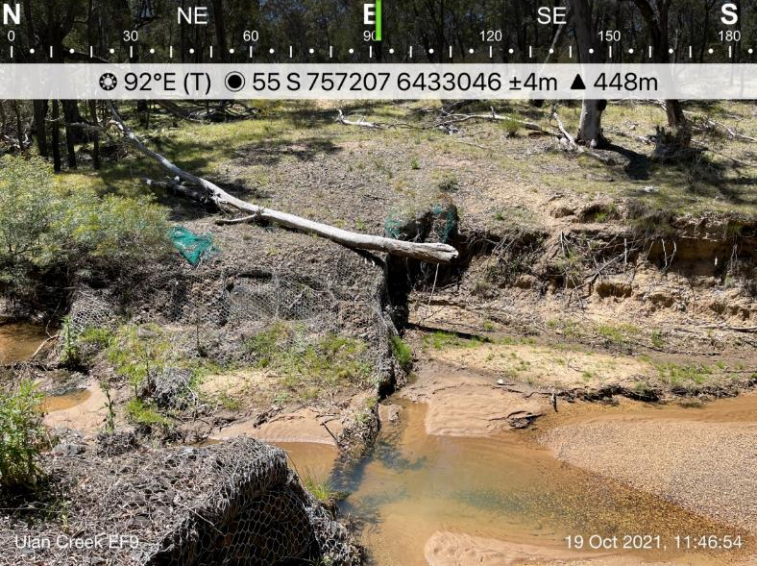
| 2021& 2022 | |
|---|---|
| <p><b>Notes:</b> Erosion at EF9 appears comparable to 2020.</p> | |

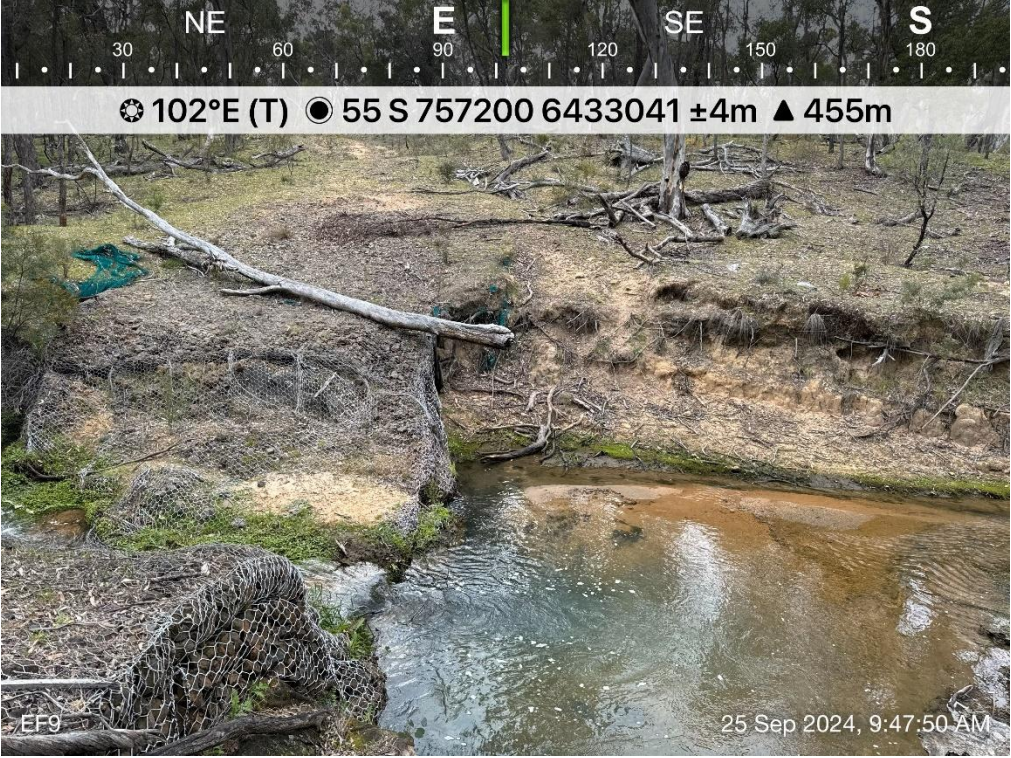
| 2021& 2022 | |
|---|---|
| <p><b>Notes:</b> Erosion at EF9 appears comparable to 2023.</p> | |

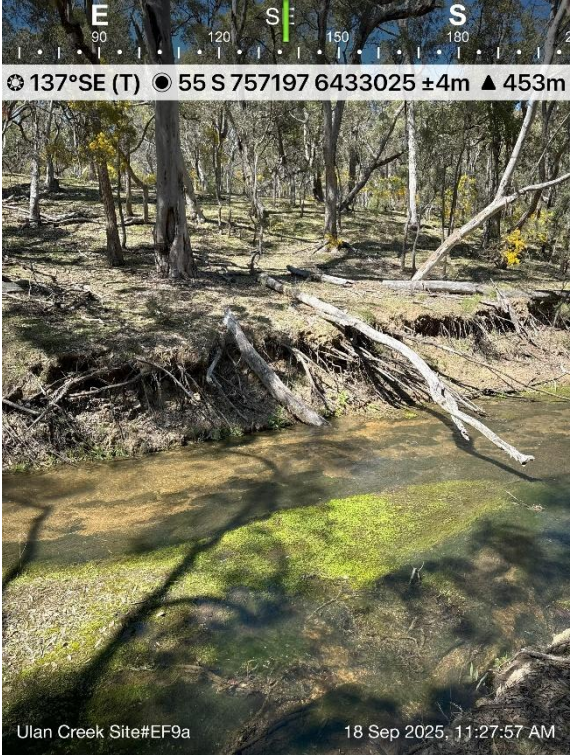
| <p>Ulan Creek Site#EF9a 18 Sep 2025, 11:27:57 AM</p> | |

| <b>Notes:</b> Erosion at EF9a was comparable to 2024 | |

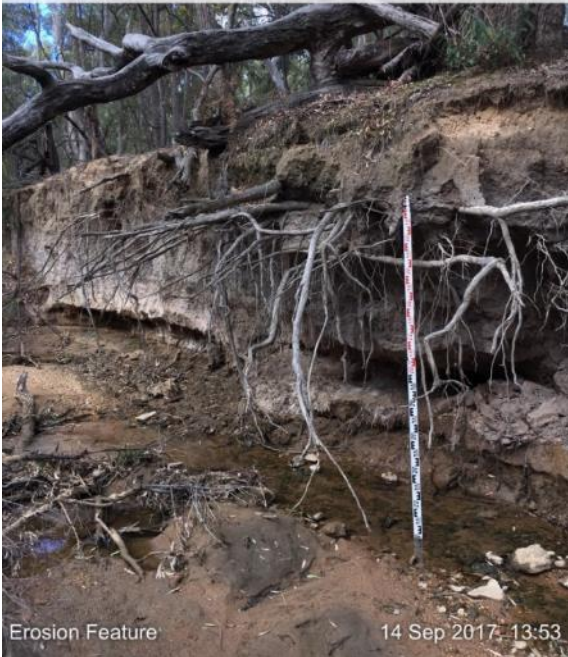
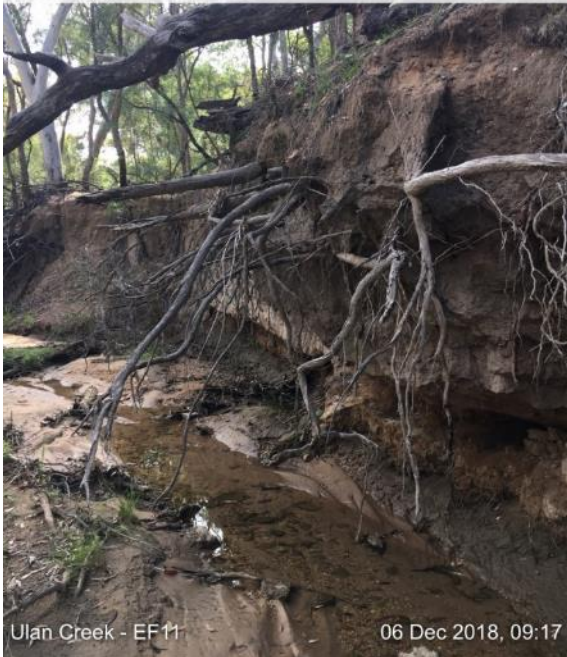
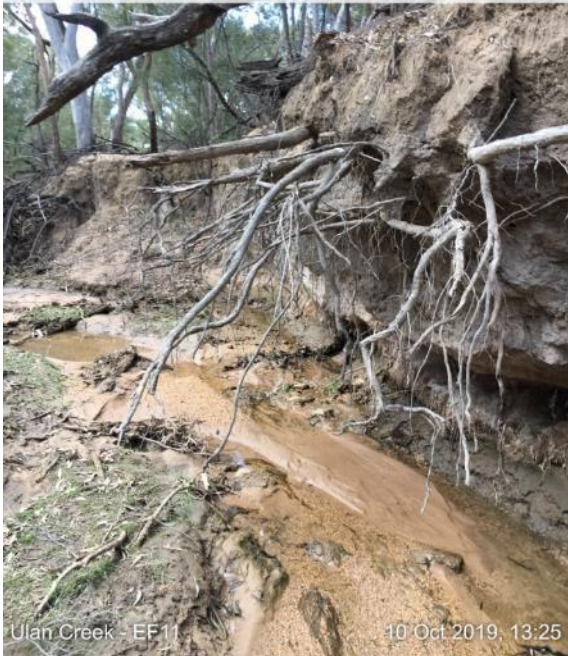
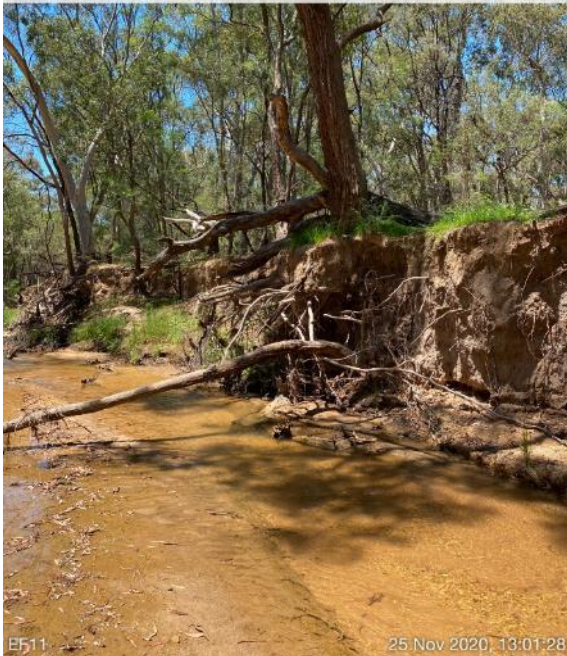
Ulan Creek Erosion Features\_EF11

| 2017 | 2018 |
|---|---|
| <p><b>Notes:</b> Erosion at EF11 appears comparable with 2018. In 2020 the erosion was very active.</p> | |

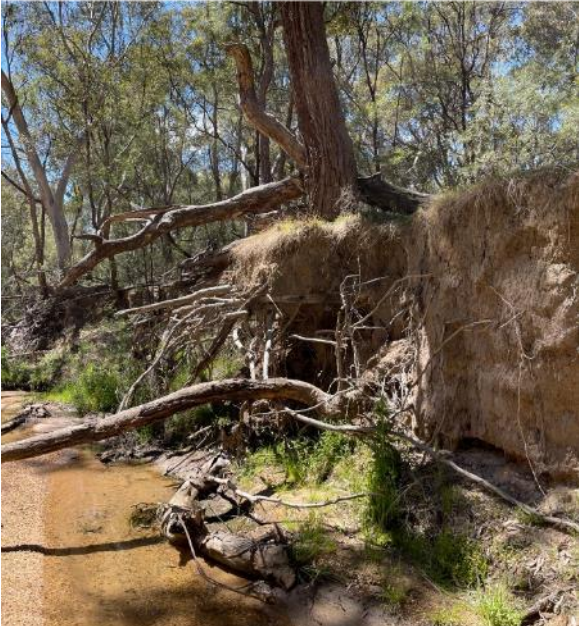
| 2021 | 2022 |
|---|---|
| <p><b>Notes:</b> In 2021 the rate of erosion at EF11 along the LHB had slowed since 2020, also the coverage of ground vegetation had improved.</p> | <p><b>Notes:</b> In 2022 the rate of erosion at EF11 along the LHB was comparable to 2021.</p> |

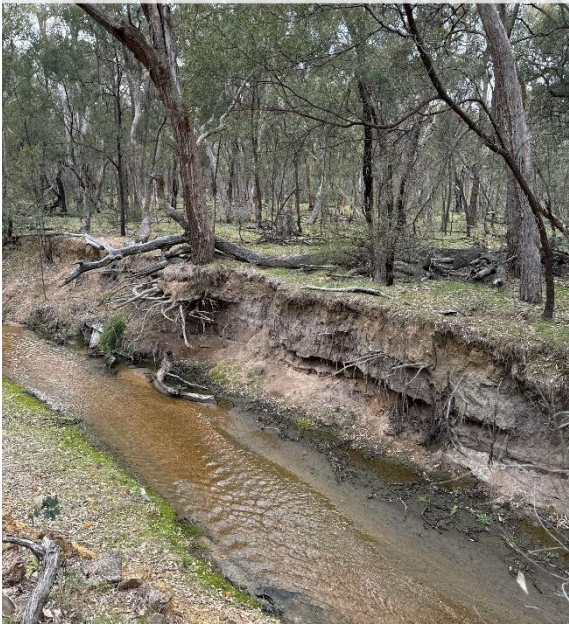
| 2021 | 2022 |
|---|---|
| <p><b>Notes:</b> Erosion at EF11 appears comparable with 2023, with some erosion since that time along the lower bank wall.</p> | <p><b>Notes:</b> Erosion at EF11 appears comparable with 2024</p> |

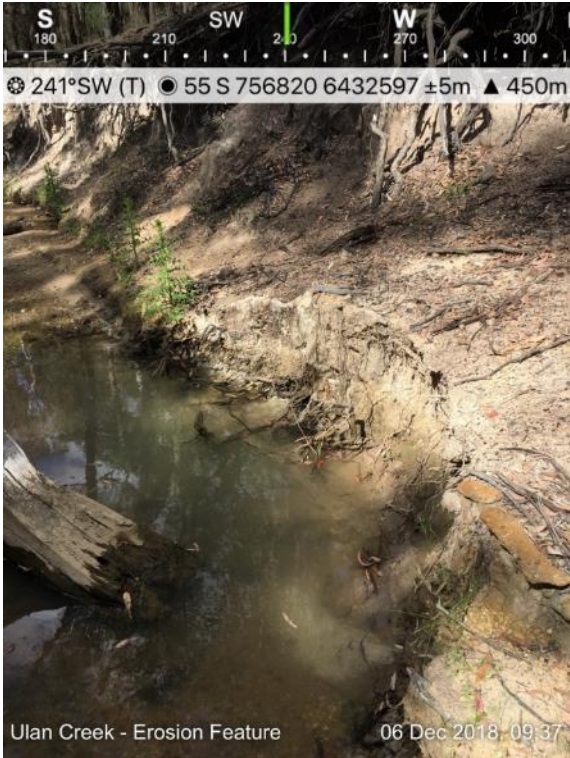
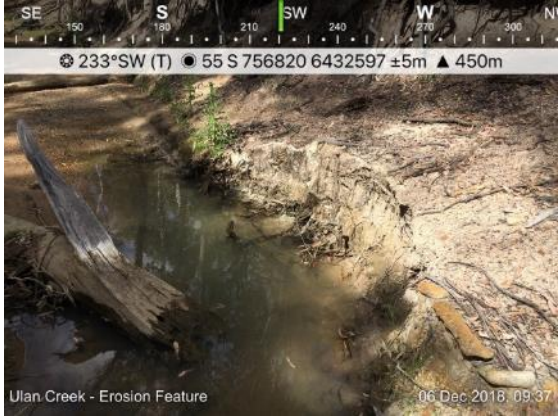
| 2018 | |
|---|---|
| <p>A photograph of an erosion feature in Ulan Creek. The image shows a deep, narrow channel in the bank with exposed roots and a large log in the water. A scale bar at the top indicates a distance of 241°SW (T) and a height of 450m. The photo is dated 06 Dec 2018, 09:37.</p> | <p>A photograph of the same erosion feature in Ulan Creek. The image shows a deep, narrow channel in the bank with exposed roots and a large log in the water. A scale bar at the top indicates a distance of 233°SW (T) and a height of 450m. The photo is dated 06 Dec 2018, 09:37.</p> |

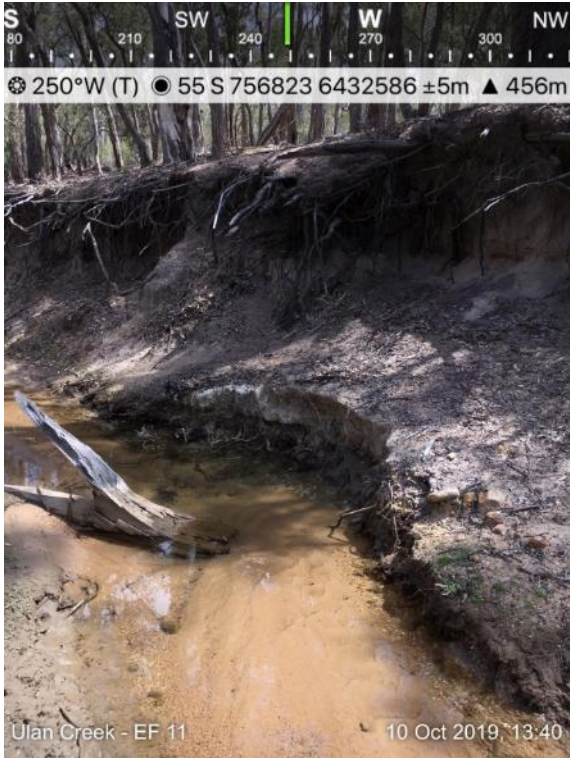
| 2018 | |
|---|---|
| <p>A photograph of an erosion feature in Ulan Creek. The image shows a deep, narrow channel in the bank with exposed roots and a large log in the water. A scale bar at the top indicates a distance of 250°W (T) and a height of 456m. The photo is dated 10 Oct 2019, 13:40.</p> | <p>A photograph of the same erosion feature in Ulan Creek. The image shows a deep, narrow channel in the bank with exposed roots and a large log in the water. A scale bar at the top indicates a distance of 220°SW (T) and a height of 453m. The photo is dated 25 Nov 2020, 13:21:26.</p> |
| <p><b>Notes:</b> Erosion at EF11a remains active in 2020 with signs of material loss along the RHB. A scour hole noted in previous monitoring was almost infilled with sand and gravel material.</p> | |

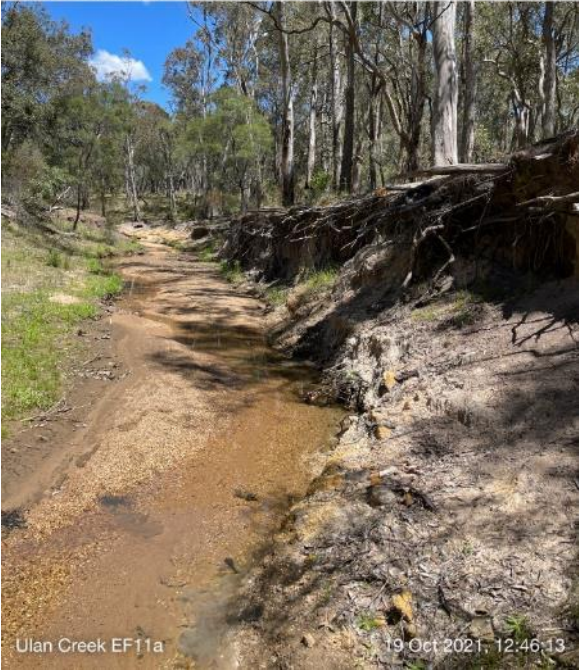
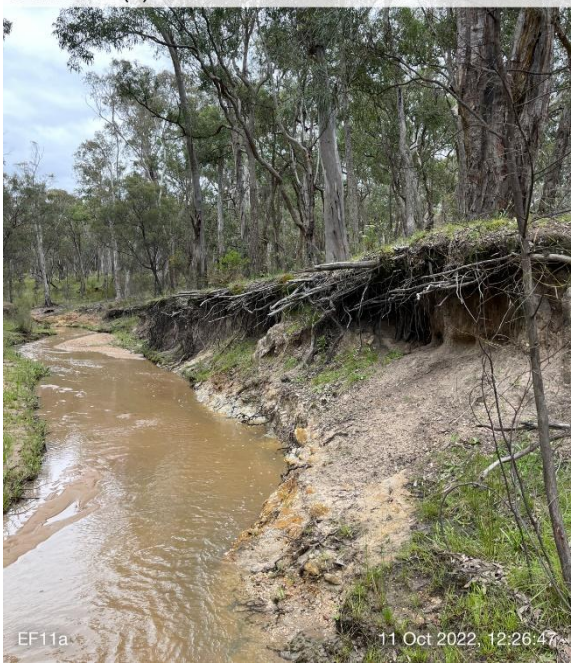
| 2021 | 2022 |
|---|---|
| <p><b>Notes</b> In 2021 the erosion at EF11a appears comparable to previous monitoring, although there was almost no ground vegetation in 2021.</p> | <p><b>Notes:</b> In 2022 the rate of erosion at EF11a along the LHB was comparable to 2021.</p> |

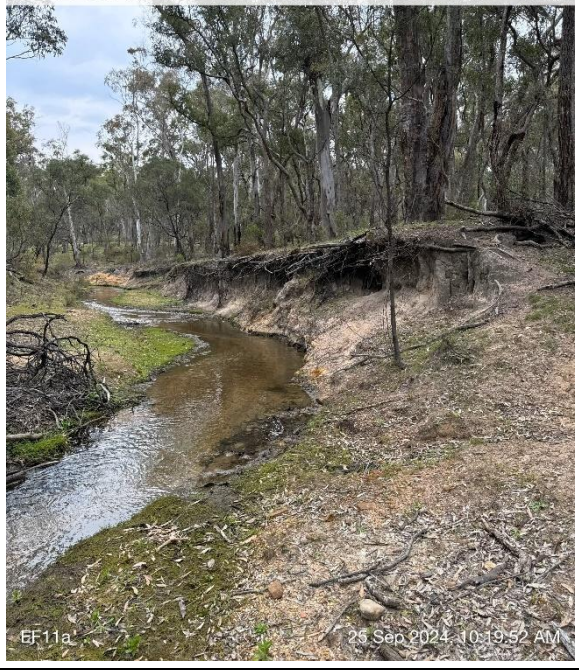
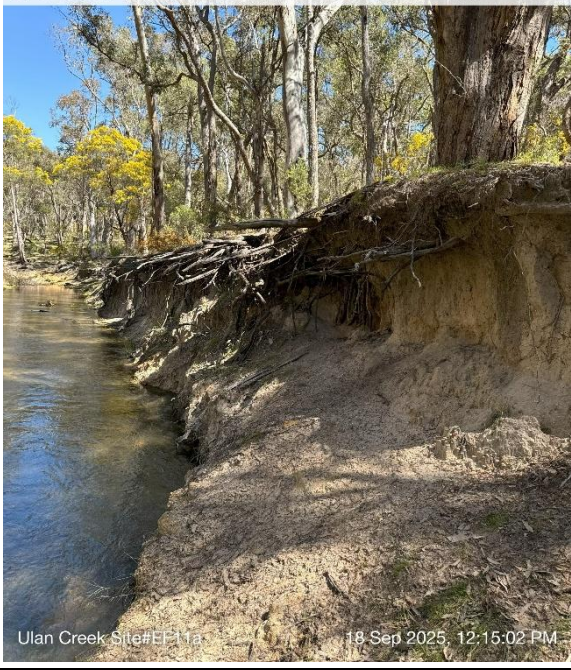
| 2021 | 2022 |
|---|---|
| <p><b>Notes:</b> In 2024 the rate of erosion at EF11a along the LHB was comparable to 2022.</p> | <p><b>Notes:</b> Erosion at EF11a appears comparable with 2024</p> |
