PKC Site Demolition Project

Response to additional issues raised

File note: Stack Condition and Related Issues

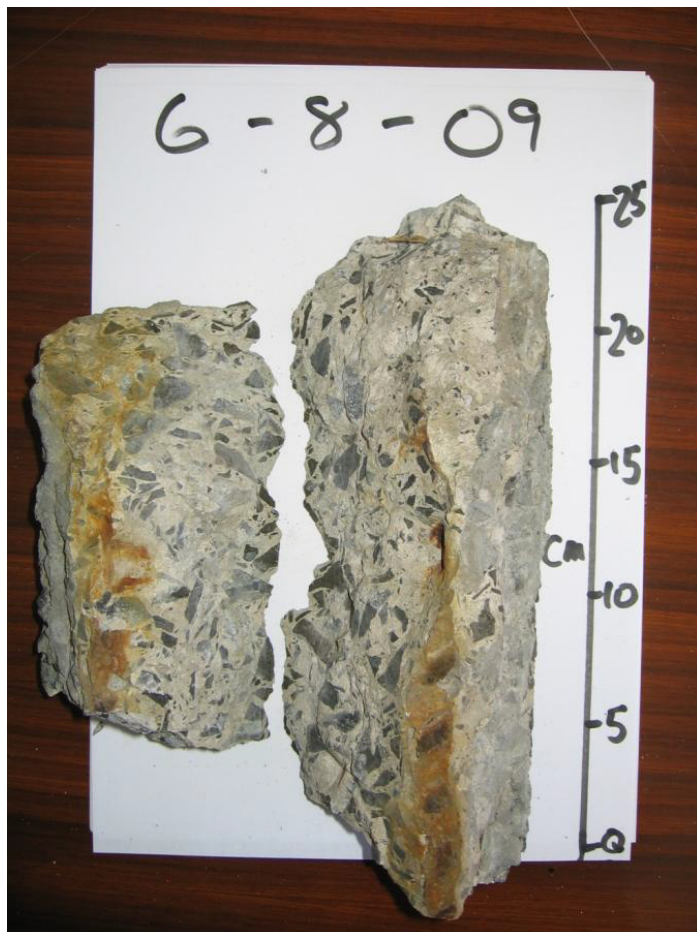
In response to the risks, PKC has instituted an exclusion zone around the base of the stack. Regular audits monitor and collect the concrete which falls from the stack. An example of the size and nature of the concrete found at the base of the stack is provided in the following photograph:

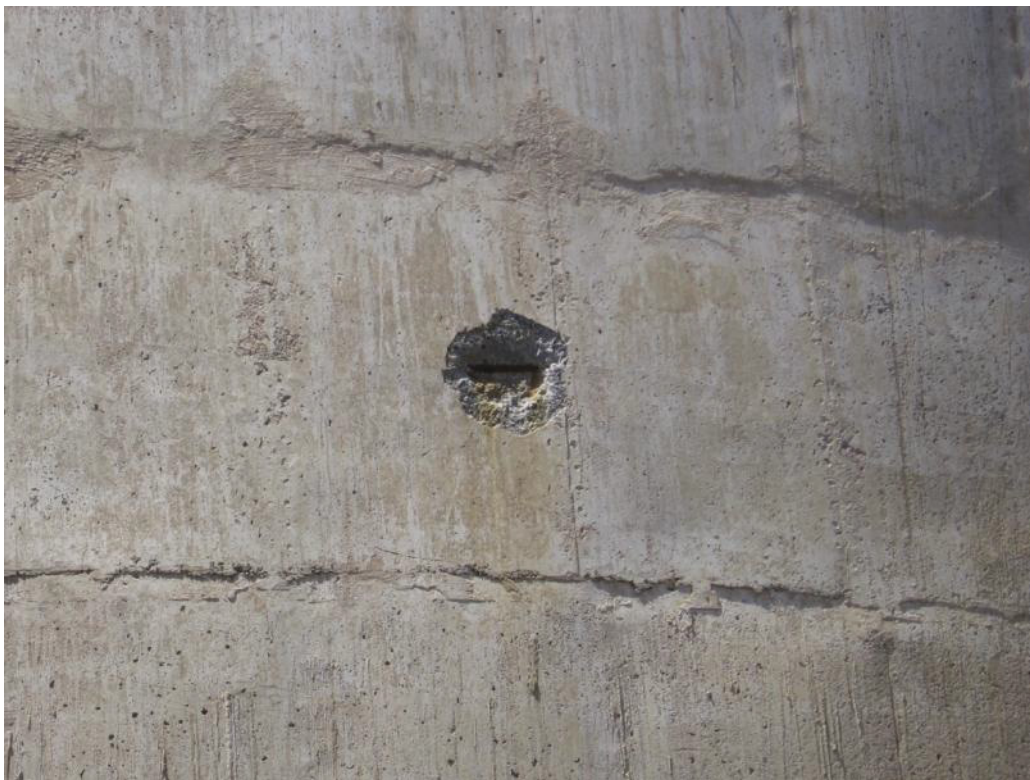
An example of a part of the stack face from which a concrete chunk has fallen is shown below:

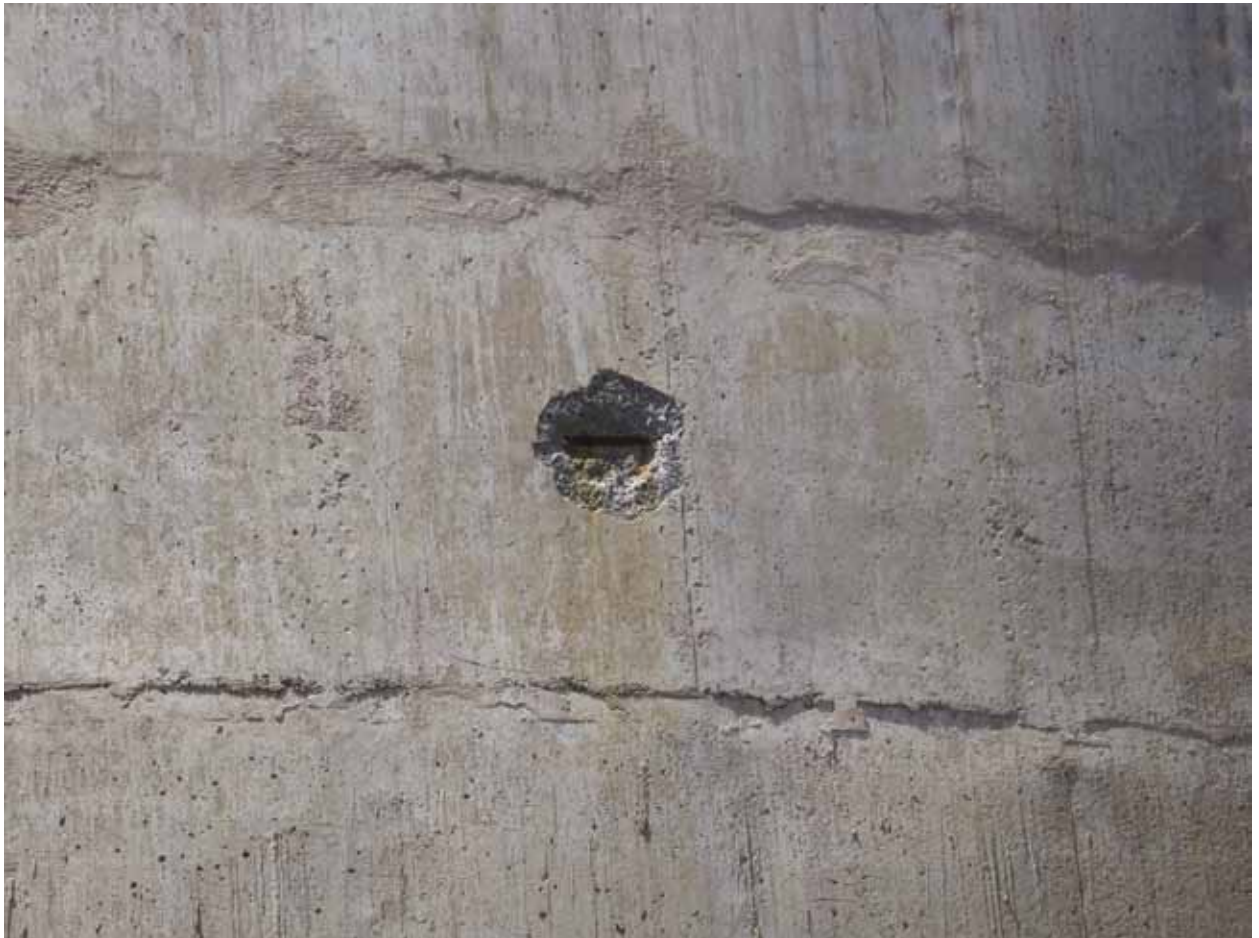
Appendix 11 shows a typical stack spill zone.

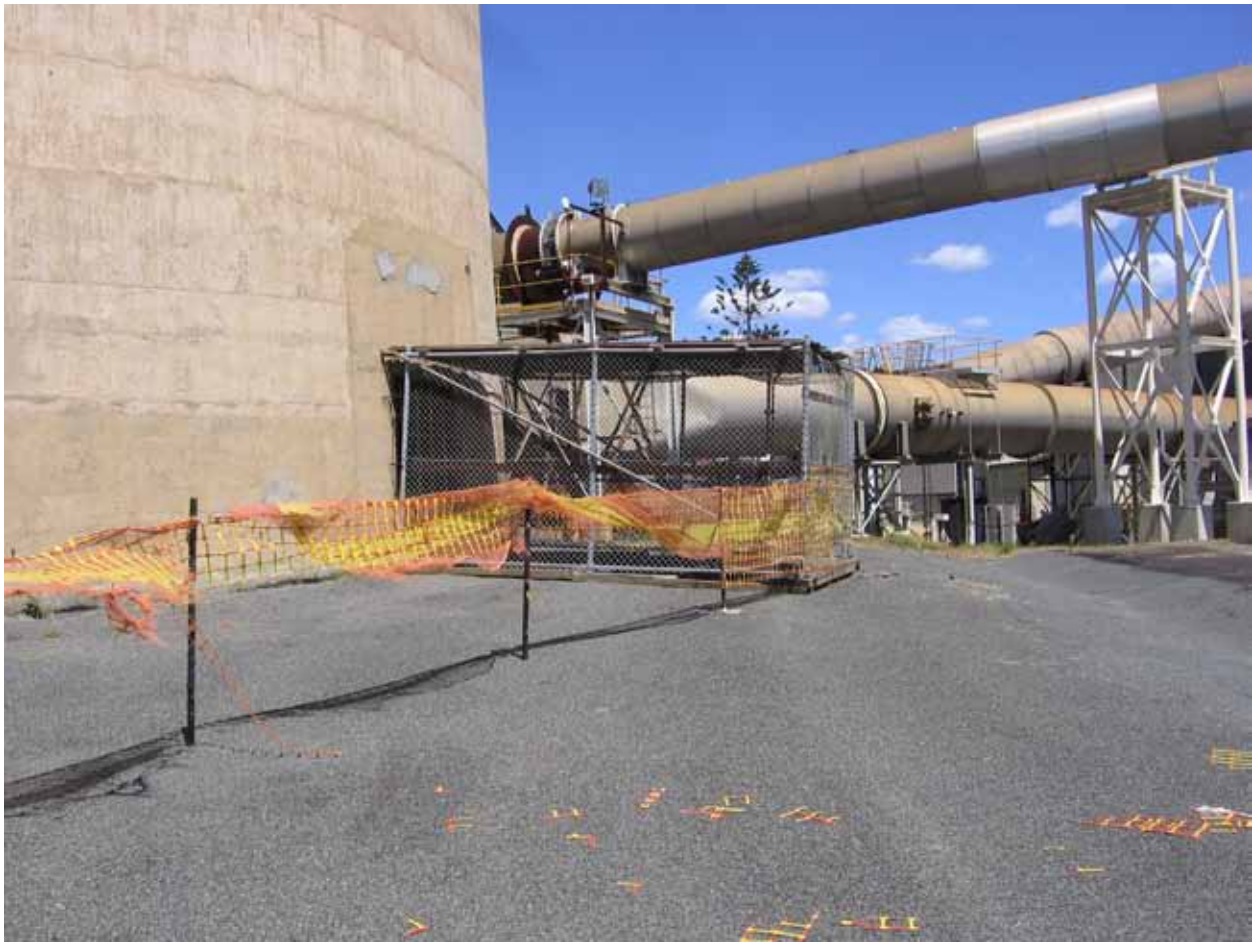
Appendix12

Due to the realisation of the potential harm that could be suffered, we have adopted an exclusion zone around the base of the stack. Further it became apparent that PKC staff had to visit the access door at the bottom of the stack mainly due to BASE jumpers trying to gain access at a frequency that made their exposure unacceptable. As a consequence we constructed a 'safety canopy' to facilitate safe access to the entrance at the base of the

stack. The exclusion zone and canopy are shown in Appendices 12 & 13. The BASE jumpers are intelligent and most resourceful in their attempts (some of which have been successful) to gain access to the stack. Appendix 15 shows the steel doors that have been disabled by the BASE jumpers, one of which fell on a member of PKC staff, narrowly avoiding a serious injury, and Appendix 14 shows the extent PKC has had to go to control access. This is extremely irritating as it now takes several hours of grinding and cutting for PKC to gain access to the stack for legitimate purposes.
