Port Kembla Copper Smelter Chimney

Military Road, Port Kembla

19 November 2013

131780

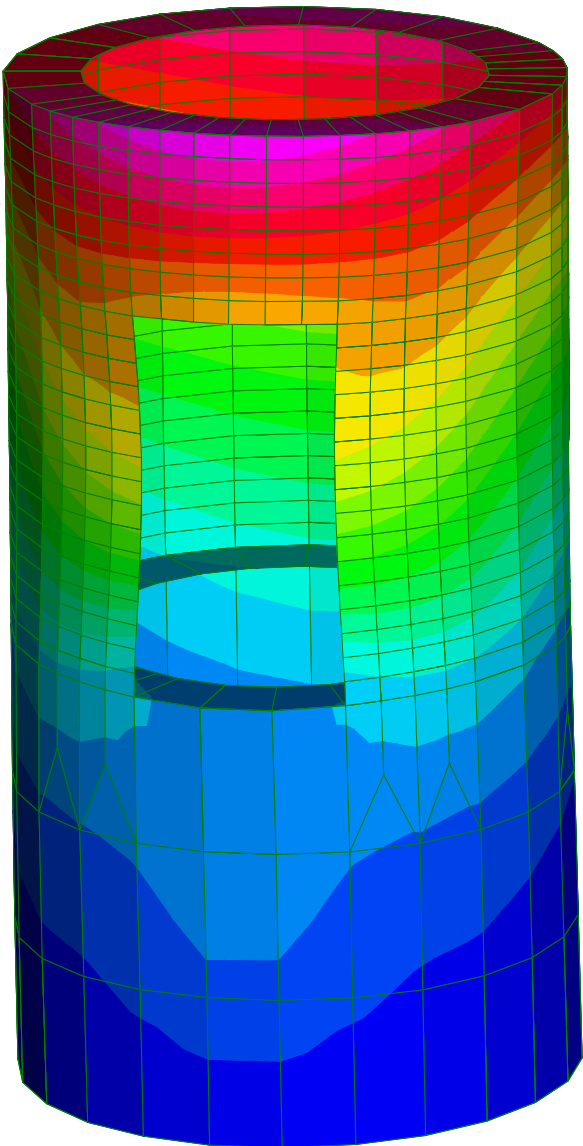
FIGURE 2

Mode 6: 16.5617
9: 1.35G [Combination 1], Pinned Base
Scale: 20.0 %

A buckling analysis was run on the critical portions of the wall and the Euler load factor was determined as being 16, adjacent to the duct openings. Results are shown in Figure 2. The buckling load factor is sufficiently high for us to believe that the wall does not have a buckling problem.
