# Kings Forest Development

## Precinct 5

### SEDIMENT AND EROSION MANAGEMENT PLAN

Document Title: Sediment and Erosion Management Plan | Precinct 5 Bulk Earthworks, Kings Forest

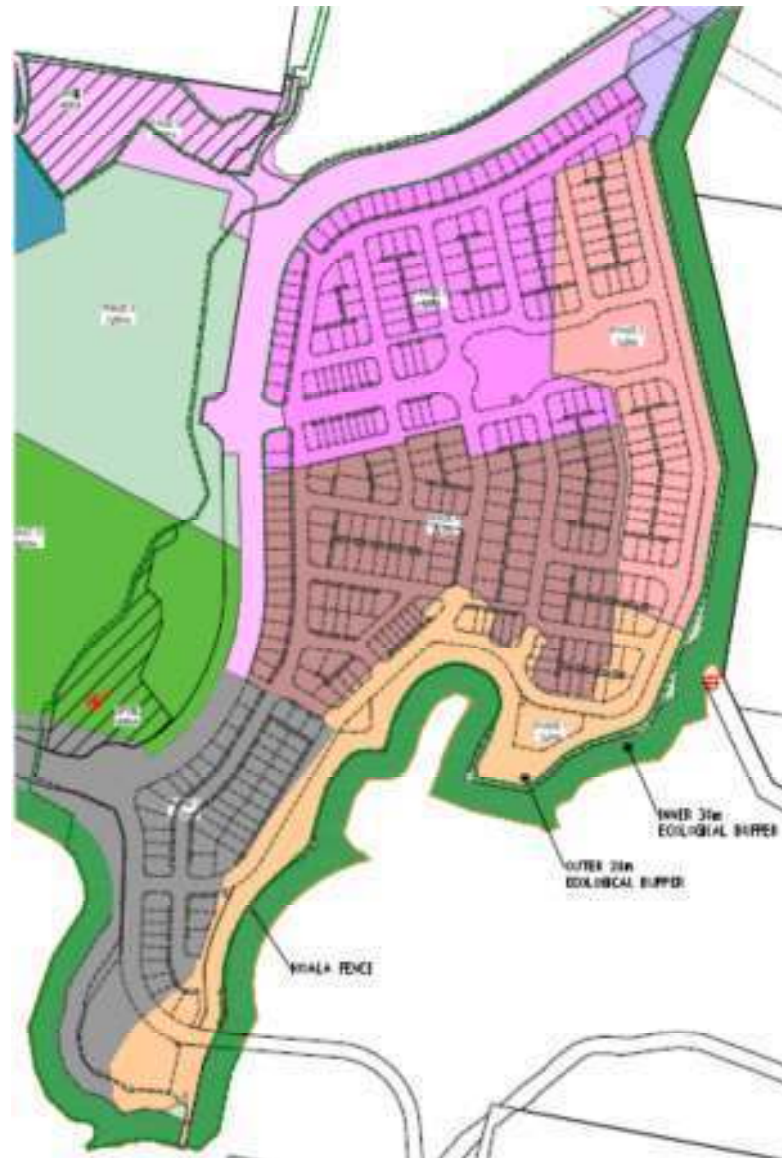
**Figure 3: Environmental Buffers with Koala fence location adjacent works**

The site is subject to a Cultural Heritage no-go zone to the northeast of the site; which no personnel nor construction equipment will be permitted to enter. In addition, an ecological buffer zone is conditioned around the perimeter of the site which will include a combination of permanent koala fencing and temporary construction phase koala fencing.

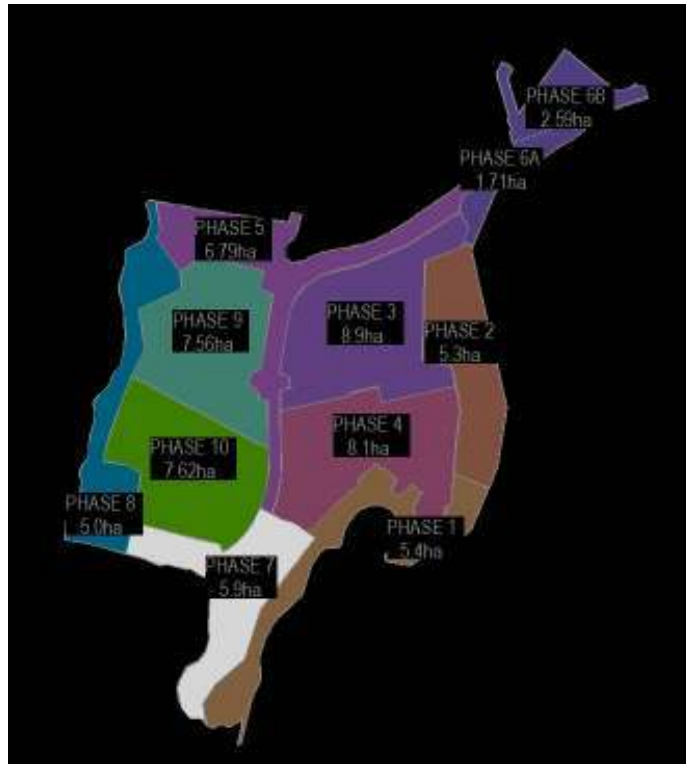
**Figure 4: Construction Phasing**

The project will be divided in to 8 separate phases as nominated in Condition A6 of major approval MP08\_0194(as modified) to reduce the exposure time of any disturbed areas and to limit the size of the sediment basins to a more reasonable and economical size. The first phases of the works which are represented on drawing 12301-BE1-ESC-070 contained within **APPENDIX A** will take an estimated 18 weeks (4.5 months) to construct. Mortons-Urban Solutions propose that Phases 1 to 6 will be constructed in the package 'Bulk Earthworks 1', with Phases 7 to 10 to follow in a separate package.

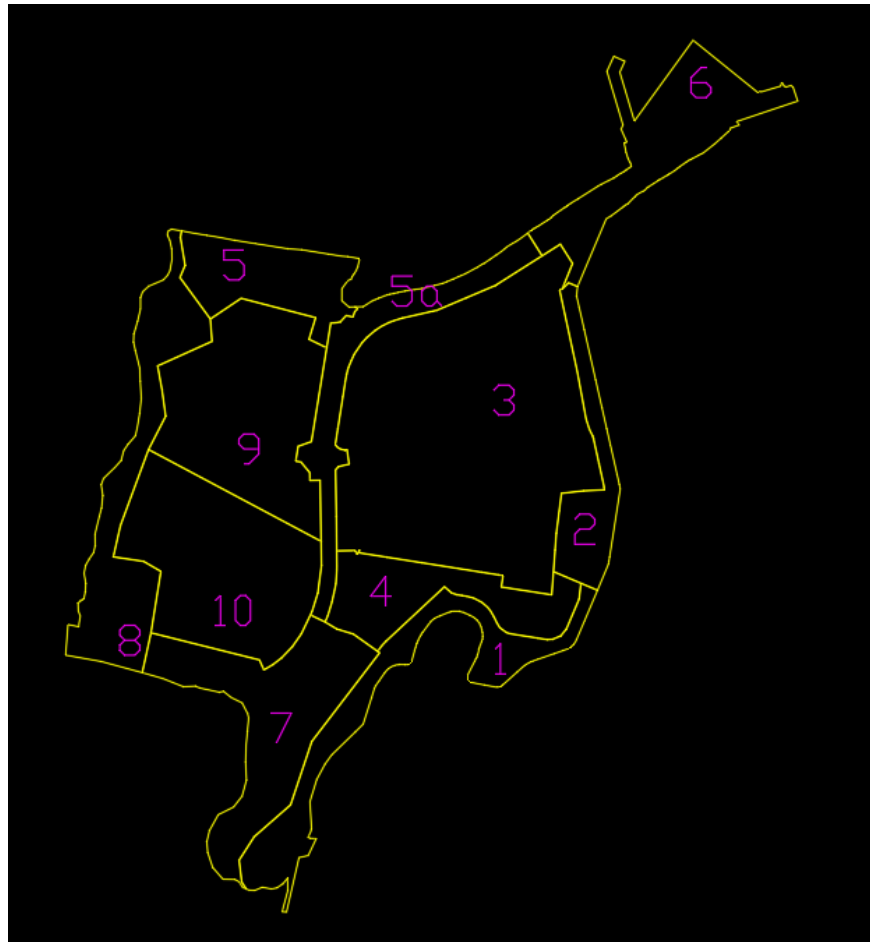
**Figure 5: Soil Loss Catchments – based on topography**

Based on topography and anticipated construction timing, the construction phases have been divided into 11 soil loss catchments, per Figure 4 and 14 basin catchments per Figure 5:

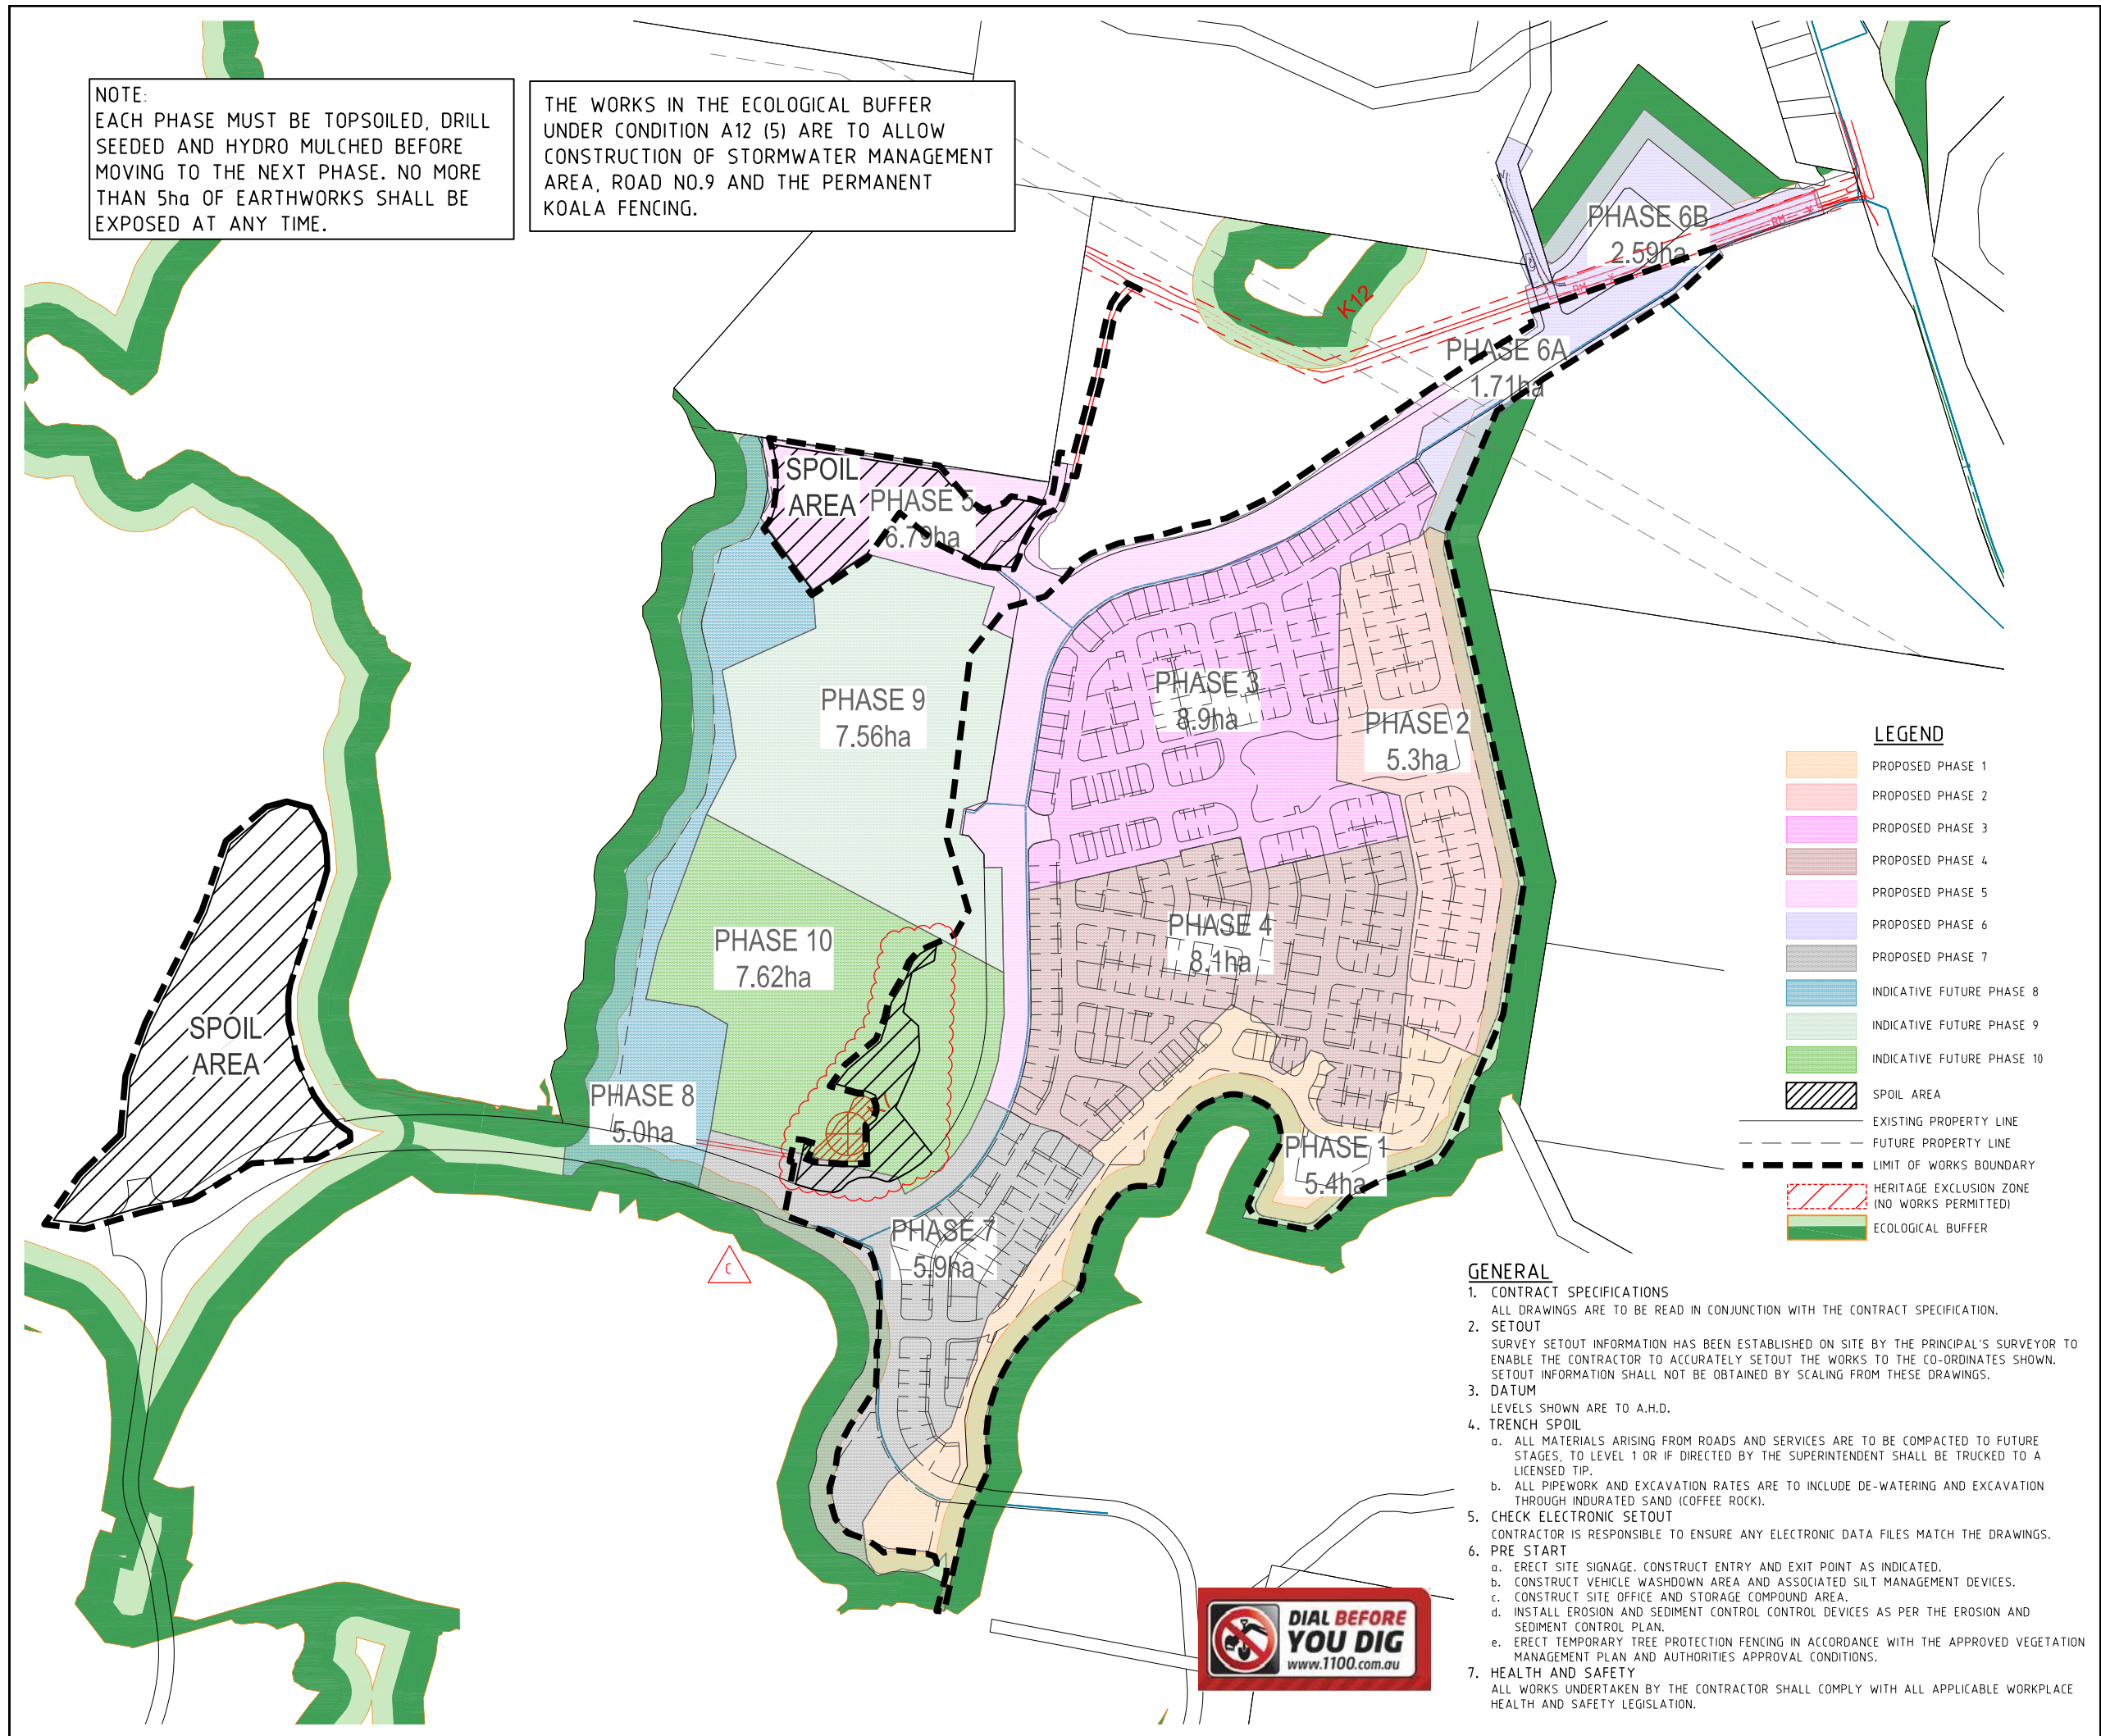
DRAWING NUMBER	AMEND.
12301-BE1-ESC-070	C

PROJECT NAME  
**KINGS FOREST**  
BE1 SEDIMENT & EROSION CONTROL

The subject site is identified in Figure 1 and the phasing of the Sequence 1 works are shown on Mortons-Urban Solutions Drawing 12301-BE1-ESC-070 included in **Appendix A**. This phasing is in accordance with the approved drawings, 12301-ALL-041 Rev B and 12301-SK-050 Rev A as amended by Conditions A6 and 9f of Major Approval MP08\_0194(as modified).

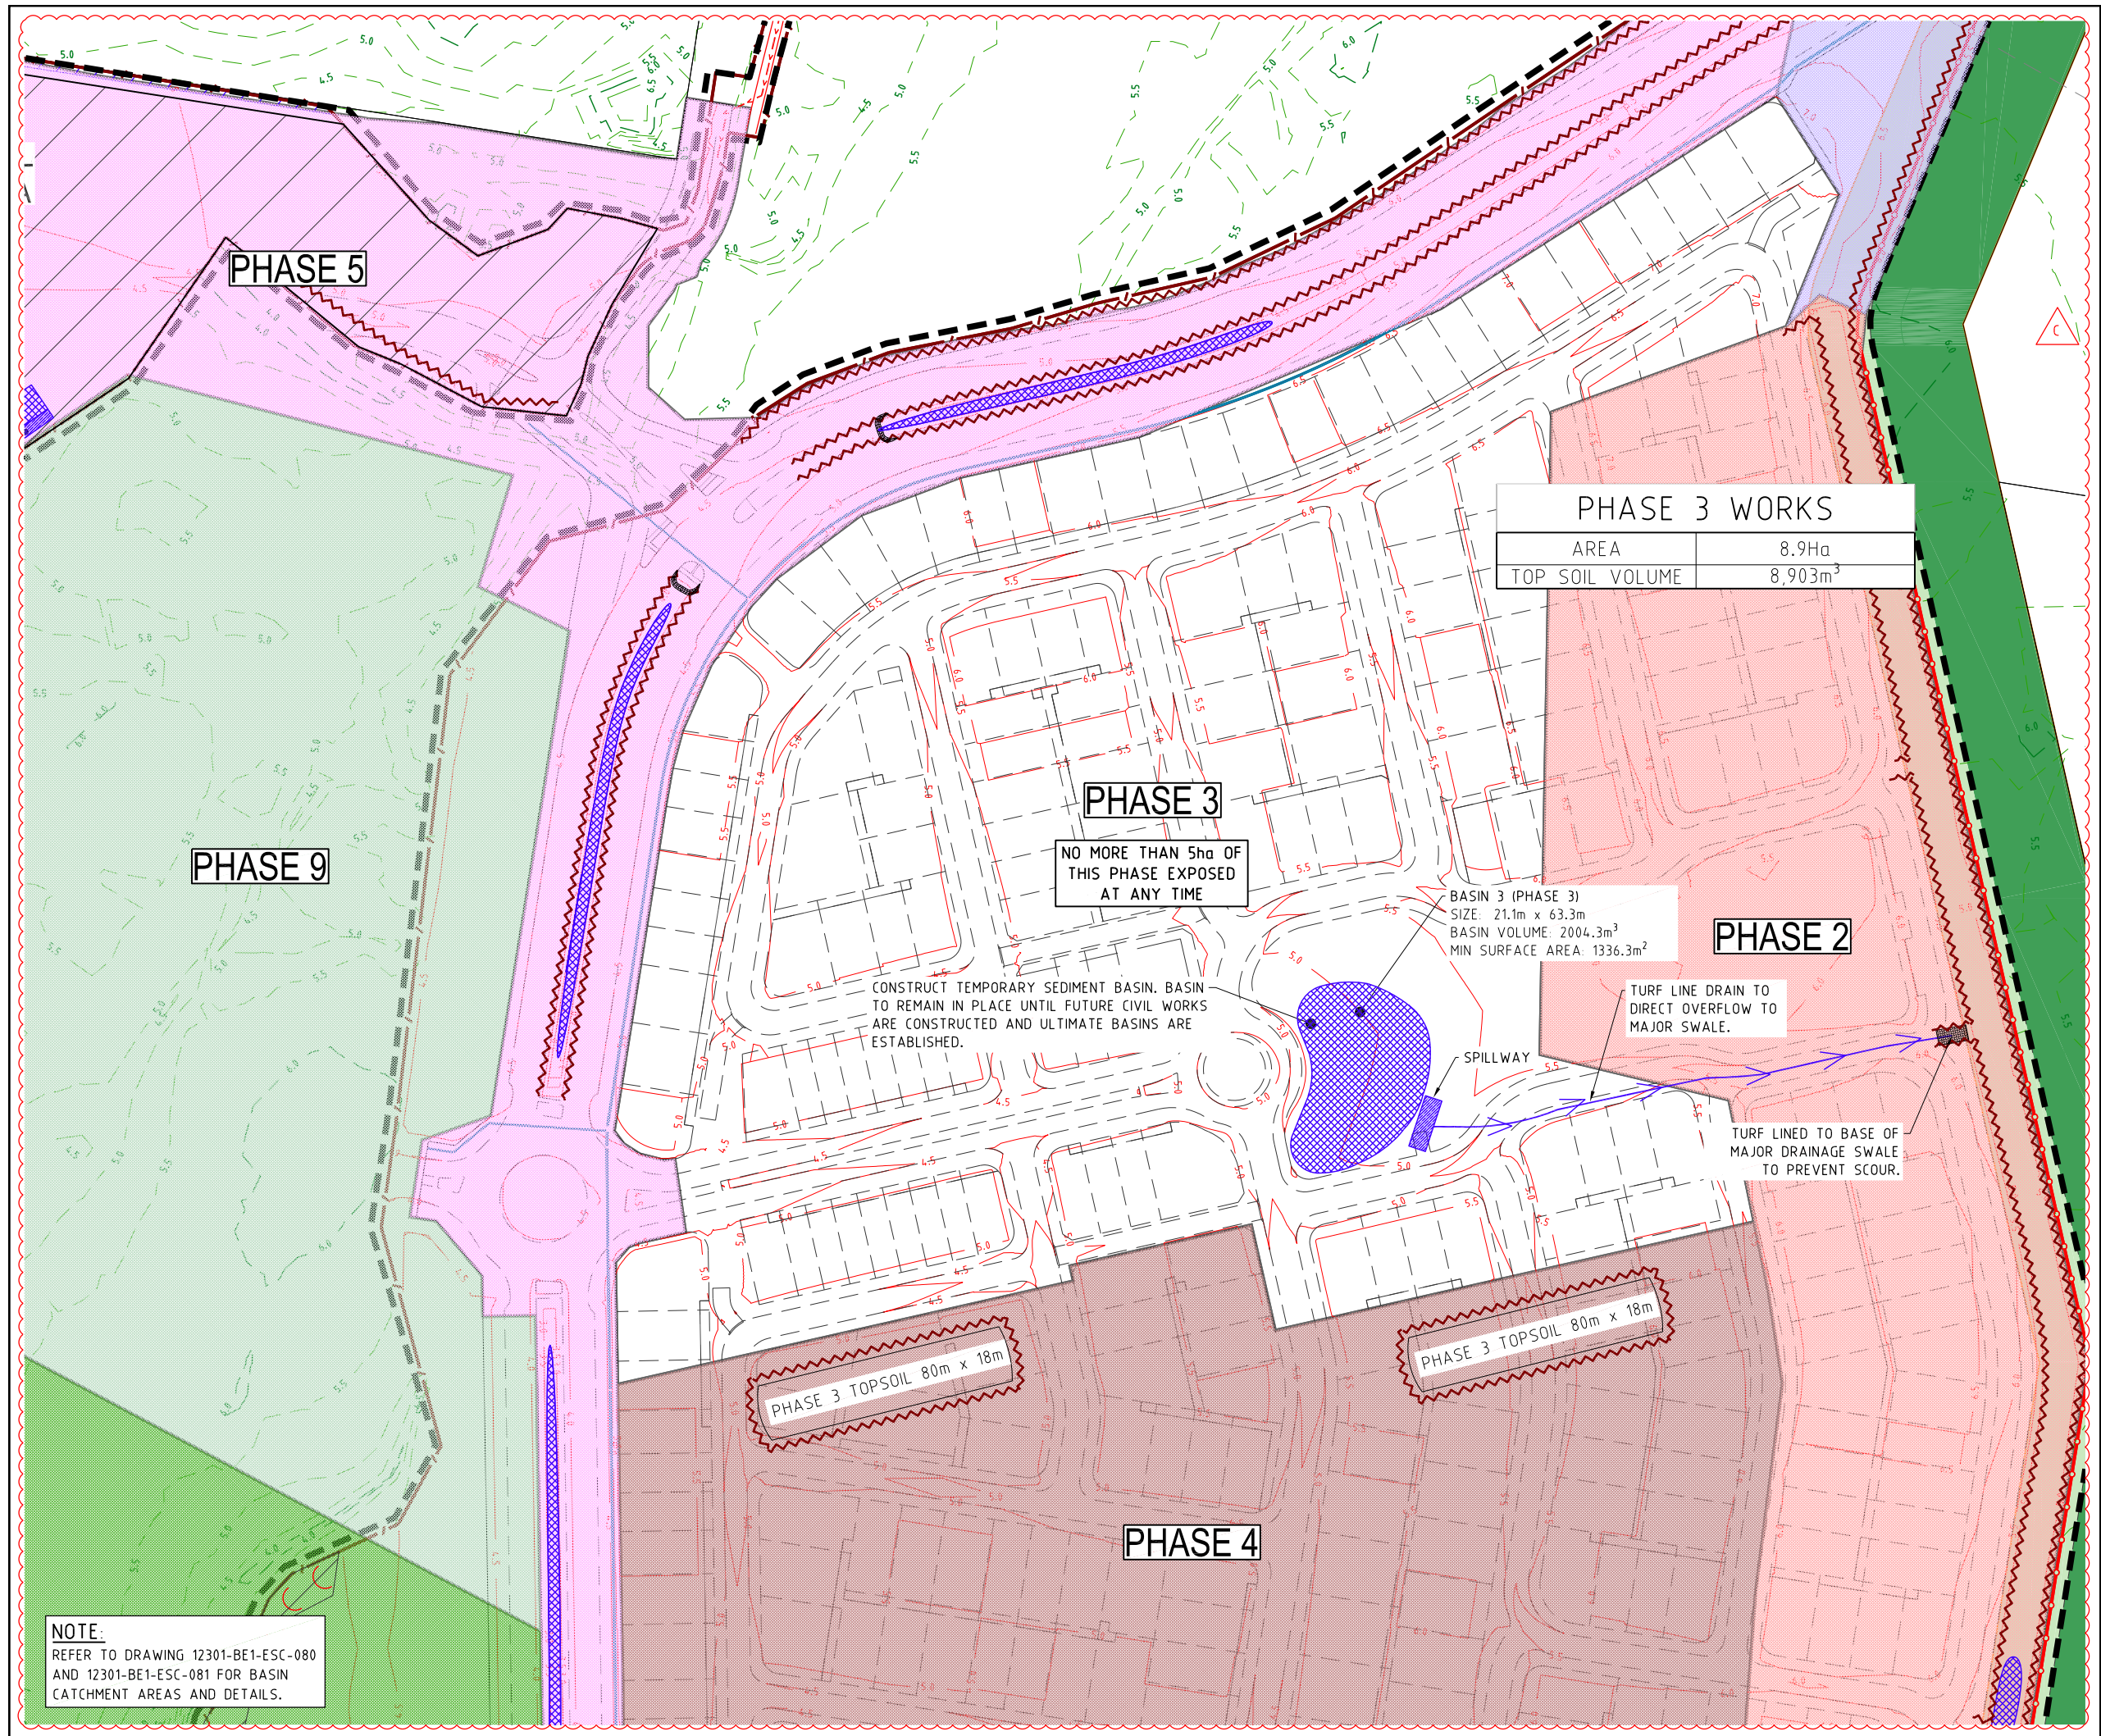
NOTE:  
REFER TO DRAWING 12301-BE1-ESC-080  
AND 12301-BE1-ESC-081 FOR BASIN  
CATCHMENT AREAS AND DETAILS.

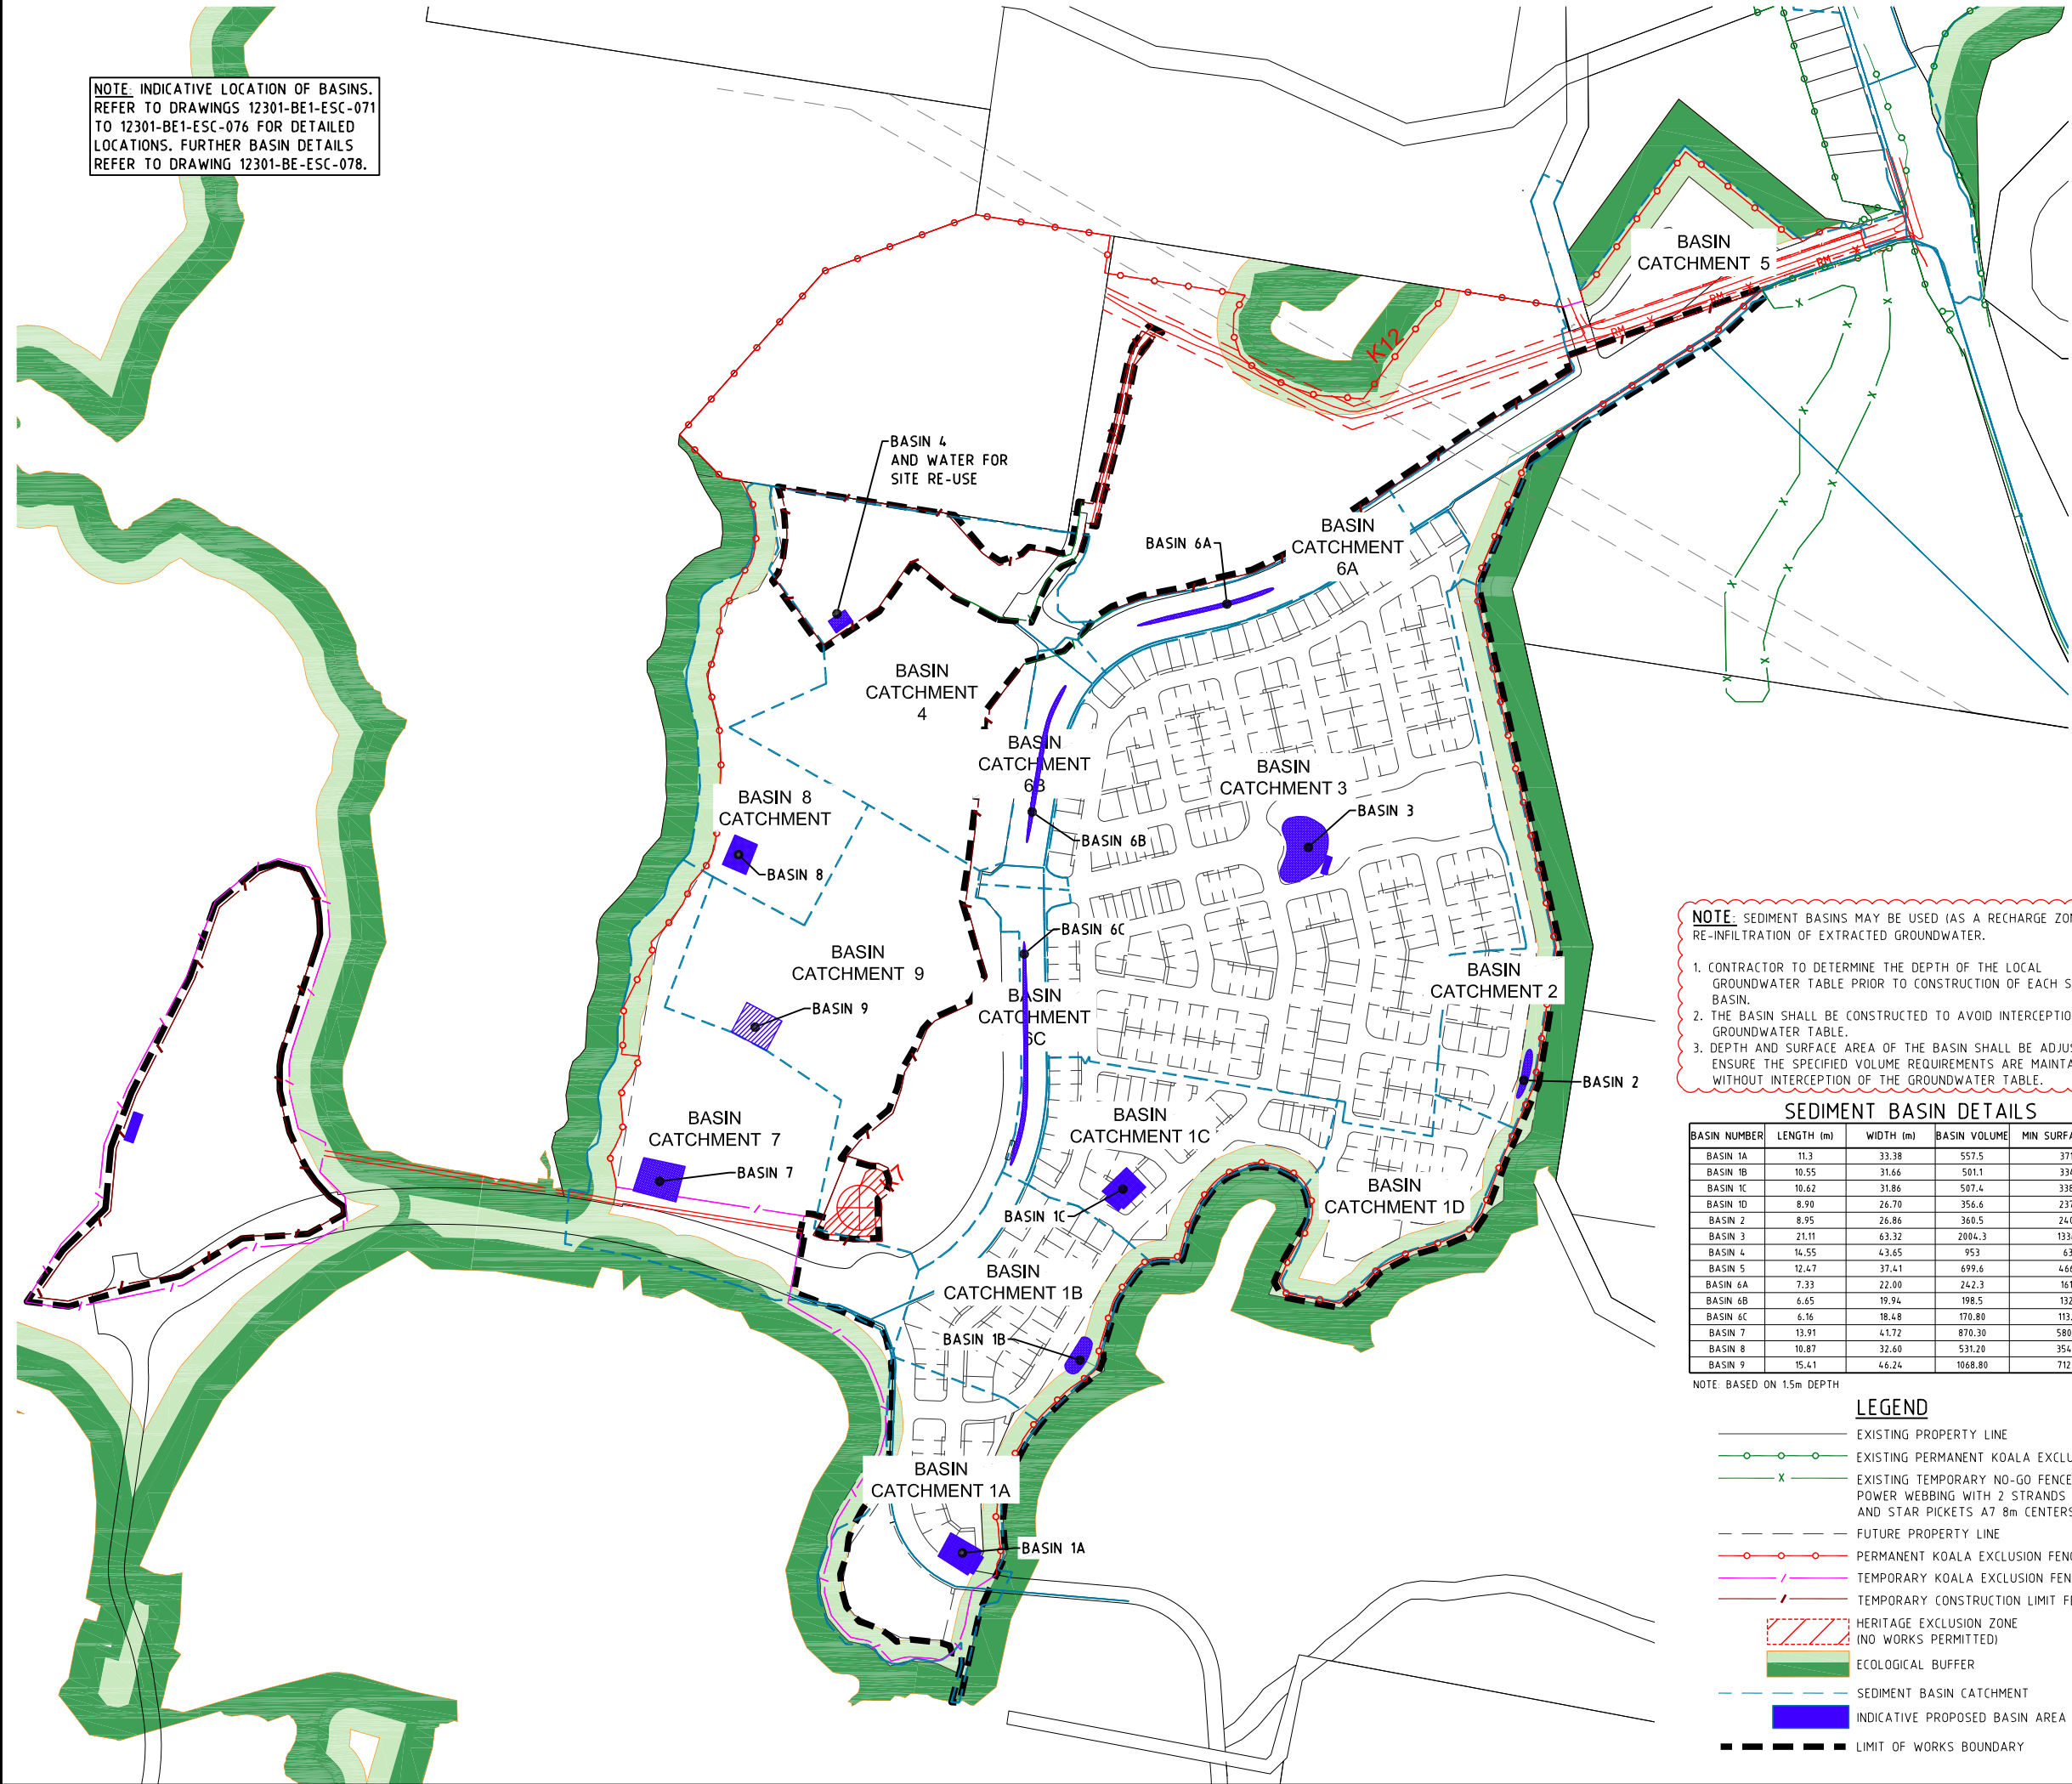
DESIGNED RB	DRAWN CB
APPROVED <i>[Signature]</i>	PEQ 4706 DATE 27-03-20
DRAWING NUMBER	AMEND.
12301-BE1-ESC-080	D

- NOTE: SEDIMENT BASINS MAY BE USED (AS A RECHARGE ZONE) FOR RE-INFILTRATION OF EXTRACTED GROUNDWATER.
1. CONTRACTOR TO DETERMINE THE DEPTH OF THE LOCAL GROUNDWATER TABLE PRIOR TO CONSTRUCTION OF EACH SEDIMENT BASIN.
  2. THE BASIN SHALL BE CONSTRUCTED TO AVOID INTERCEPTION OF THE GROUNDWATER TABLE.
  3. DEPTH AND SURFACE AREA OF THE BASIN SHALL BE ADJUSTED TO ENSURE THE SPECIFIED VOLUME REQUIREMENTS ARE MAINTAINED WITHOUT INTERCEPTION OF THE GROUNDWATER TABLE.

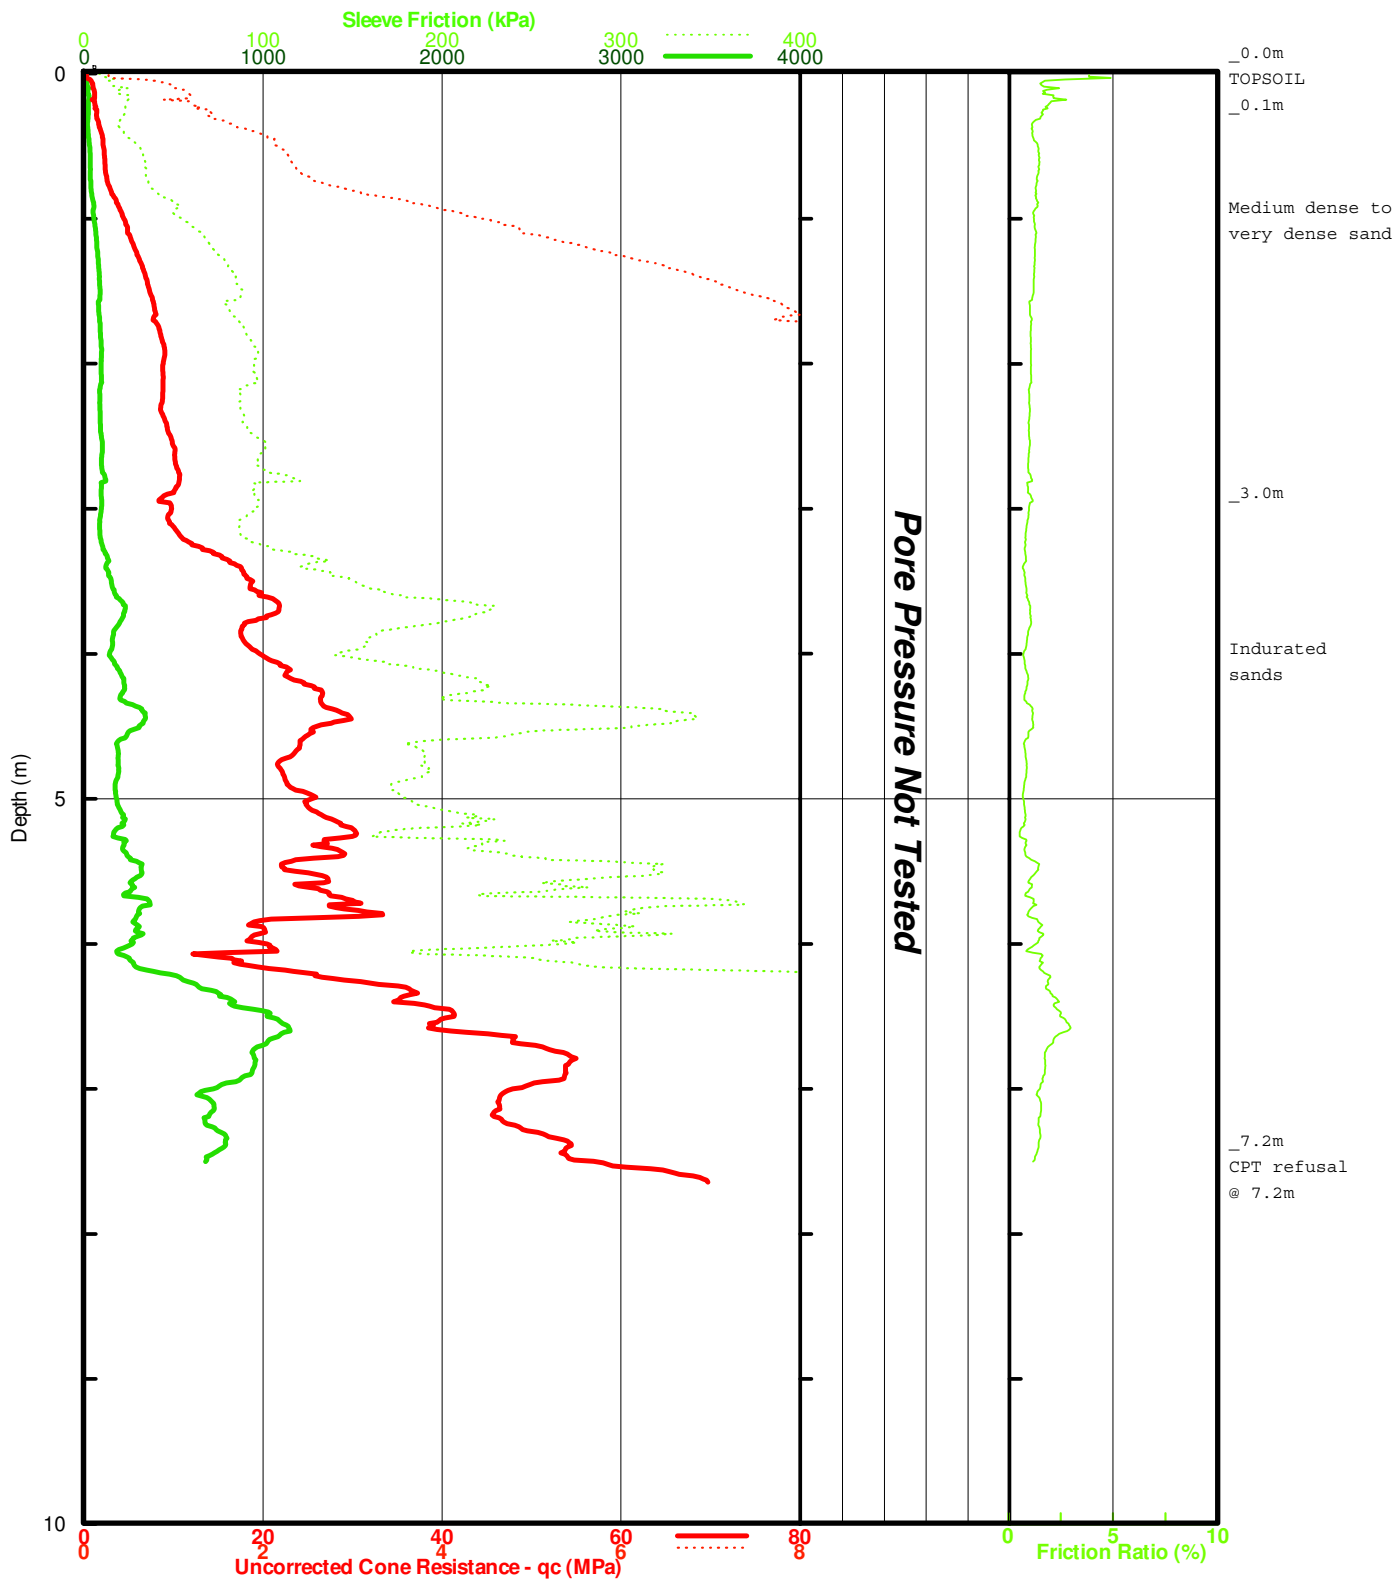
## CPT-01

Job Number : G1006-105  
Test Date : 22/06/2010  
DGPS Position : 56 J 0554891, 6870004  
DGPS Format : WGS 84

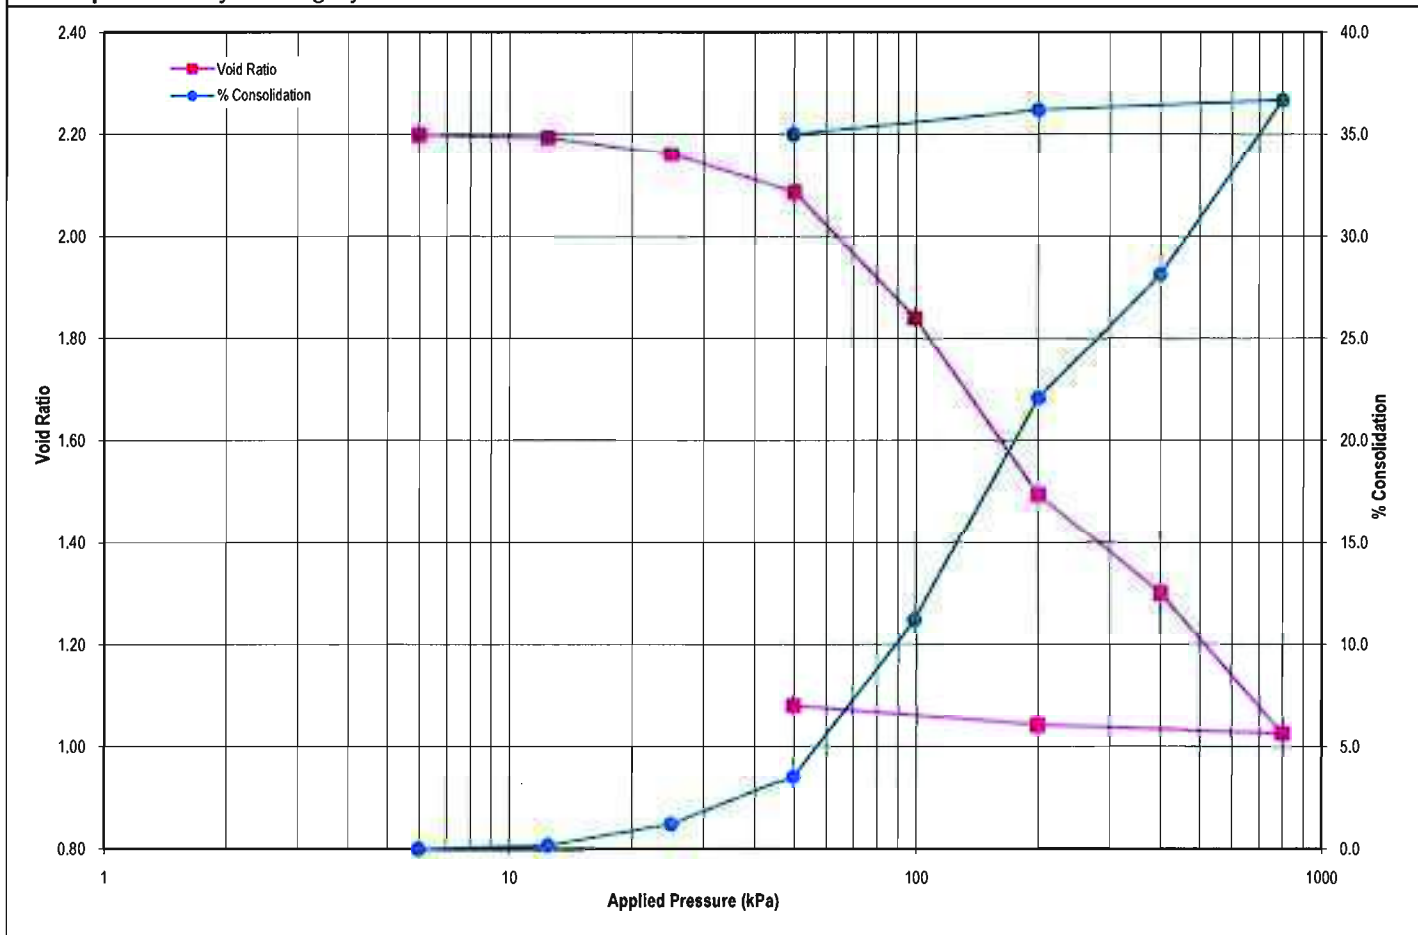
**Description:** Clay - dark grey

Wet Density ( $t/m^3$ ): 1.40	Initial Moisture (%): 80.4	Test Condition: Inundated on load
Particle Density ( $t/m^3$ ): 2.49	Initial Voids Ratio: 2.199	Initial Degree of Saturation (%): 91.0
Undisturbed sample supplied by the client	Remarks: Tested as Received	Page 1 of 2
