3 INVESTIGATION WORK

4 SUBSURFACE CONDITIONS

The following is a summary of the conclusions and recommendations in regard to the geotechnical and acid sulphate soil investigation for the proposed water and sewer mains at Piggabeen Road Package 2, Cobaki. However, the preceding sections of this report should be read for a full description of the conclusions and recommendations.

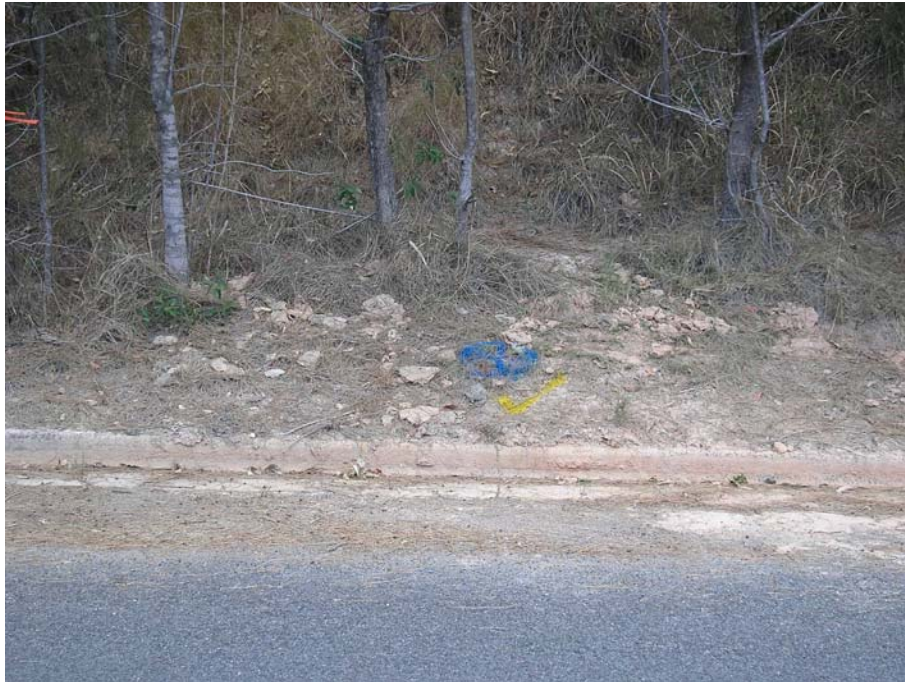
PLATE 4 Hillside rising immediately from road shoulder on south side of Piggabeen Road.

On the southern side of the road, free groundwater was not encountered by the borehole termination depths of 2.5m in BH1, BH5 or BH6, however the low permeability clay soils at these locations were very moist, and seepage would probably occur if holes were left open for an extended period. Free groundwater was similarly not encountered within the boreholes on the southern side of the road, BH9 and BH11, by termination depths of 2.1m and 3.0m. These 2 boreholes were in a stronger, residual type soil profile, close to the toe of the hillslope.

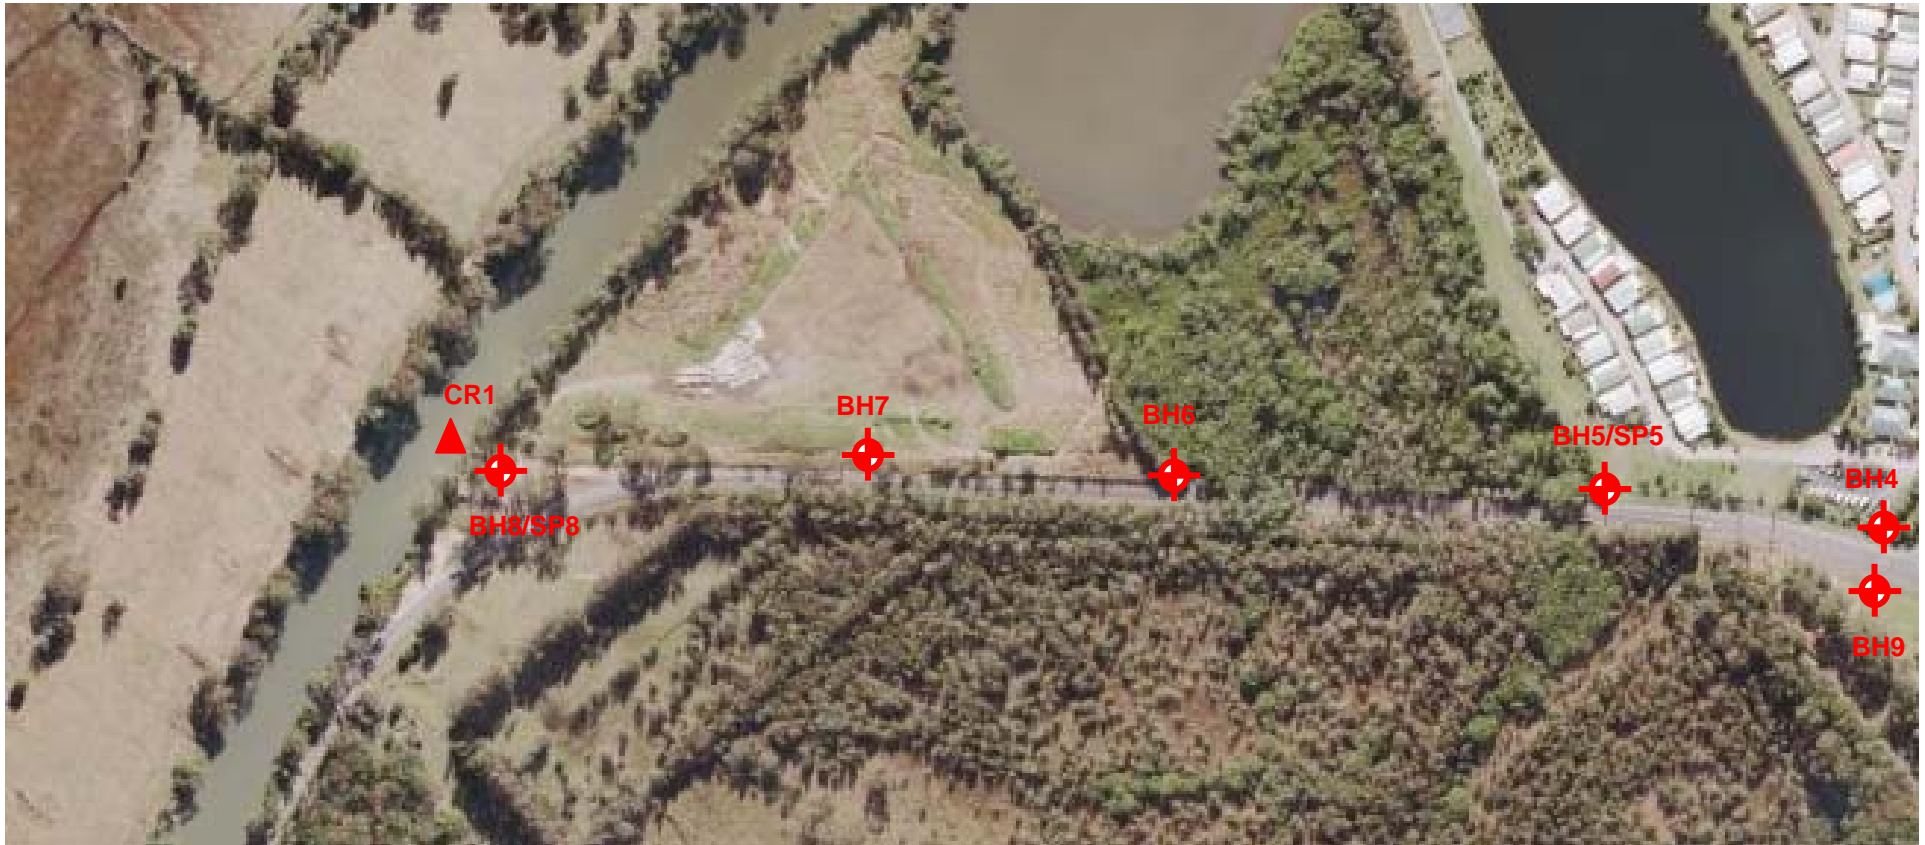
FIGURE 1

Fieldwork for the investigation was carried out on the 8th and 9th October 2009, and included the drilling of a total of 10 boreholes at the locations shown on the attached site plan, Figure 1. The material encountered at each location is described on borehole log sheets included in Annex A.
