# DURALIE COAL MINE Biodiversity Management Plan

### BIODIVERSITY MANAGEMENT PLAN

DECEMBER 2022  
 Document No. Version J  
 ID: 01135722-002

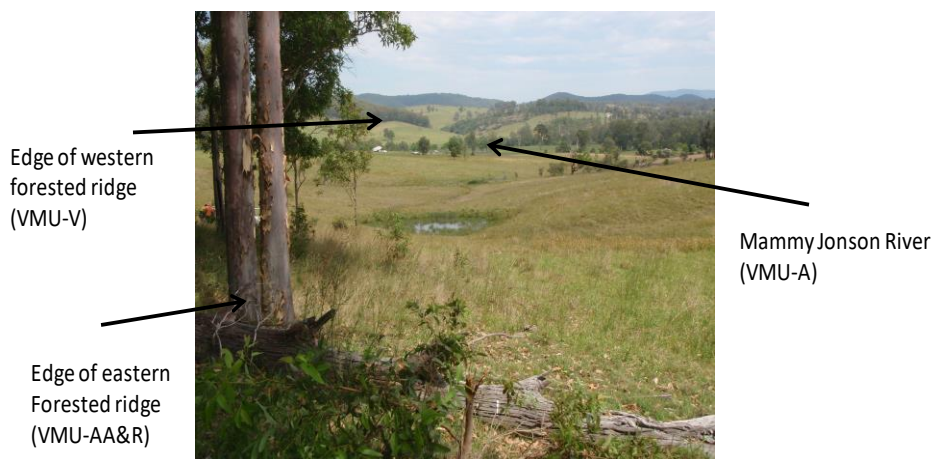
**Plate 1:** The ridge to river to ridge connectivity that will be re-established within the Duralie Biodiversity Management Plan. The non-forested paddocks in this photo are targeted for revegetation in the Plan (Vegetation Management Units AA, V and floodplain Vegetation Management Unit in between).

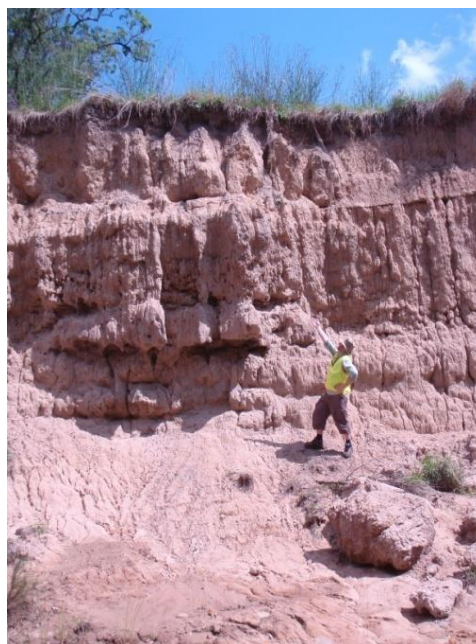
**Plate 2:** Bank erosion in Vegetation Management Unit A

The Mammy Johnsons River, which traverses the site, retains an almost continuous canopy layer throughout the area. Where vegetation remains intact, banks are resistant to the erosive forces of moderate (common) flood events. Removal of vegetation has occurred in some areas including a highly eroded bank of a side channel within VMU A (Plate 2). Section 6.8 describes how this would be addressed.

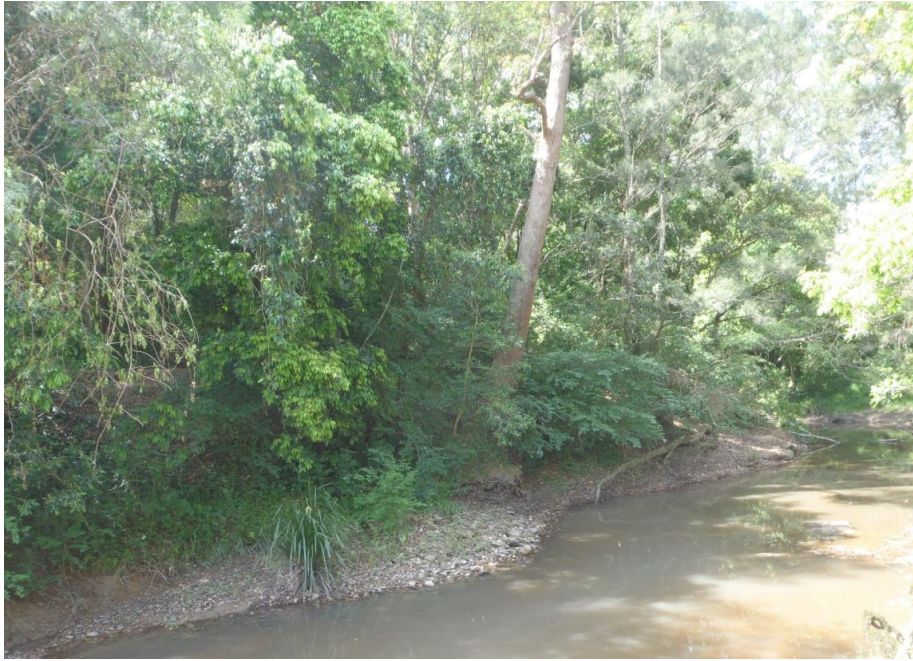
**Plate 3:** Vegetation Management Unit A - High quality closed riparian forest along Mammy Johnsons River

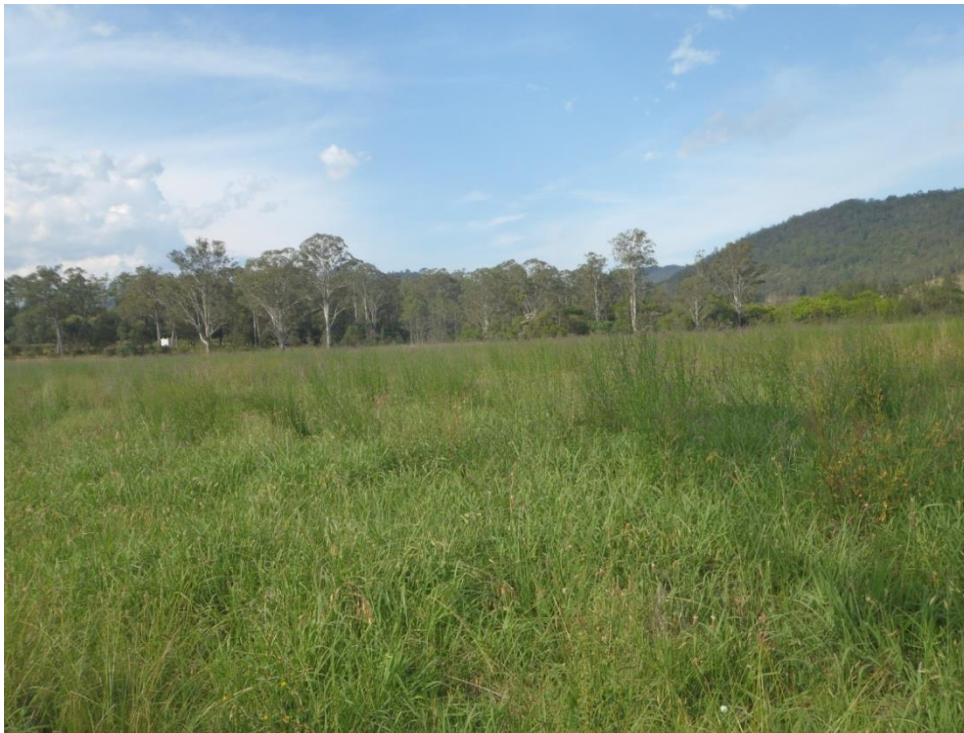
**Plate 4:** Vegetation Management Unit S - Exotic pasture on alluvial flats

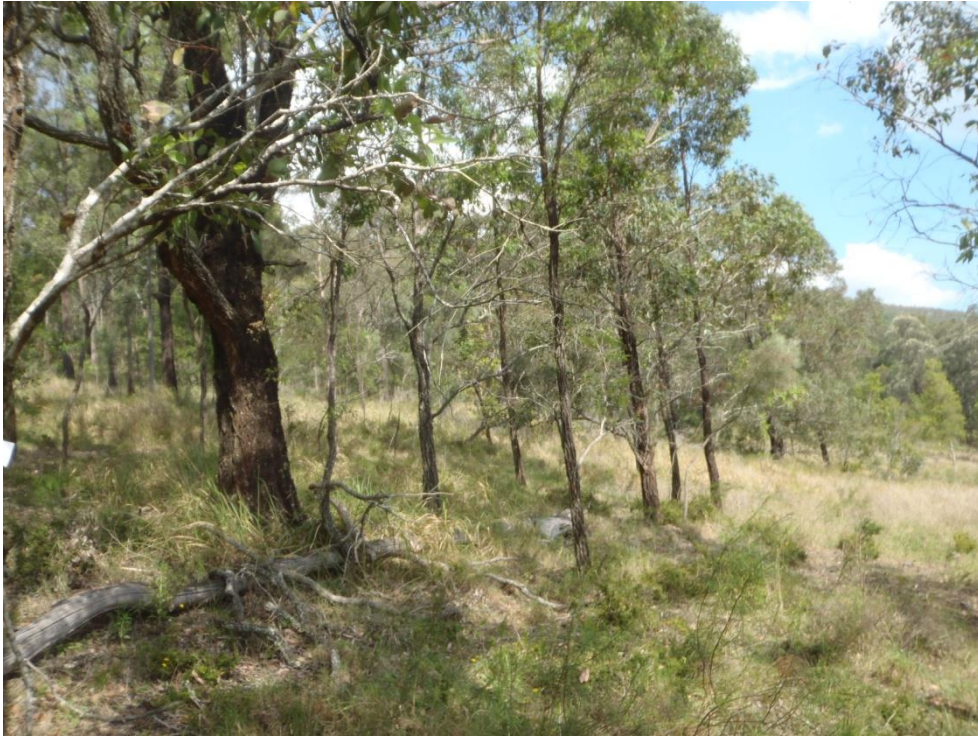
**Plate 5:** Vegetation Management Unit C - Natural regeneration of ironbark community

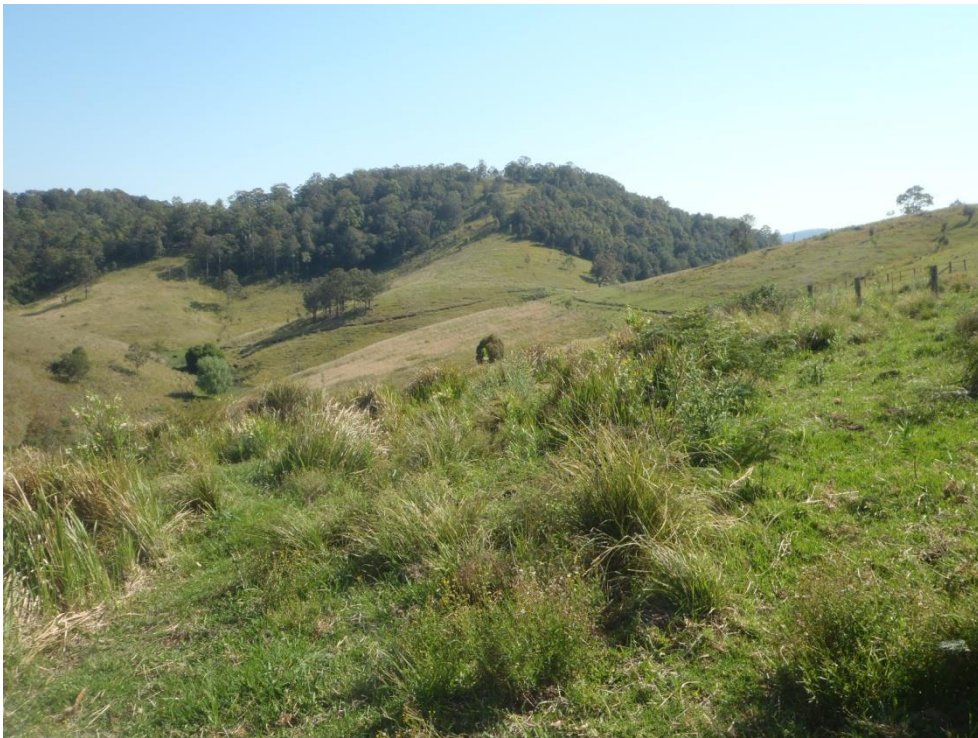
**Plate 6:** Vegetation Management Unit H - Cleared elevated slopes of spotted gum community

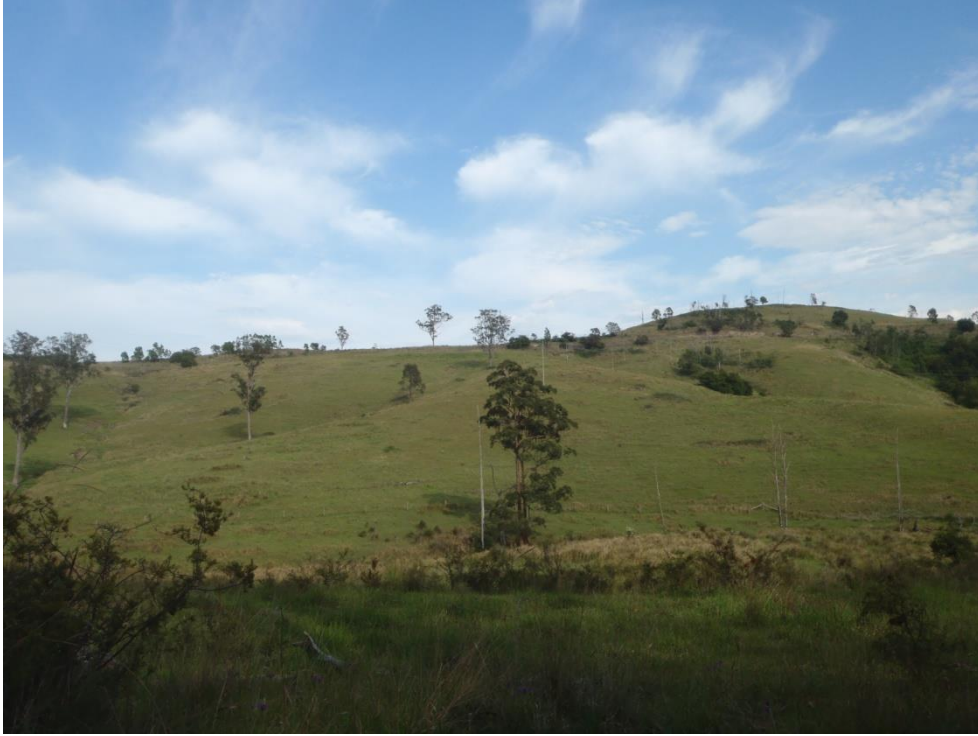
**Plate 7:** Vegetation Management Unit V - Westerly aspect of cleared area; spotted gum vegetation community

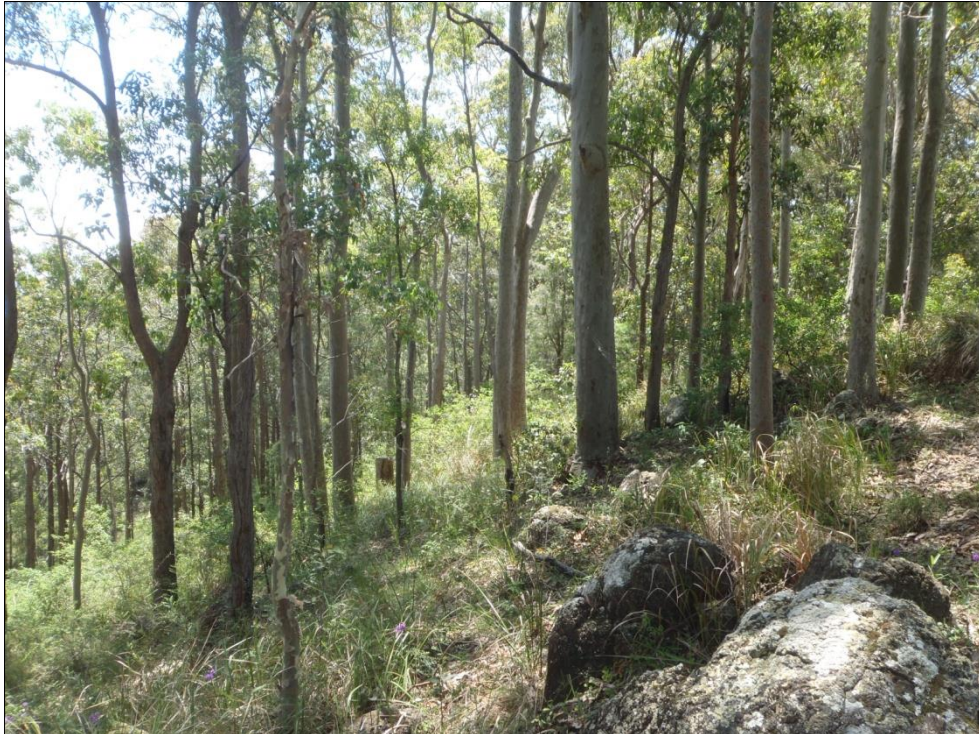
**Plate 8:** Vegetation Management Unit R - Naturally regenerating upper slopes

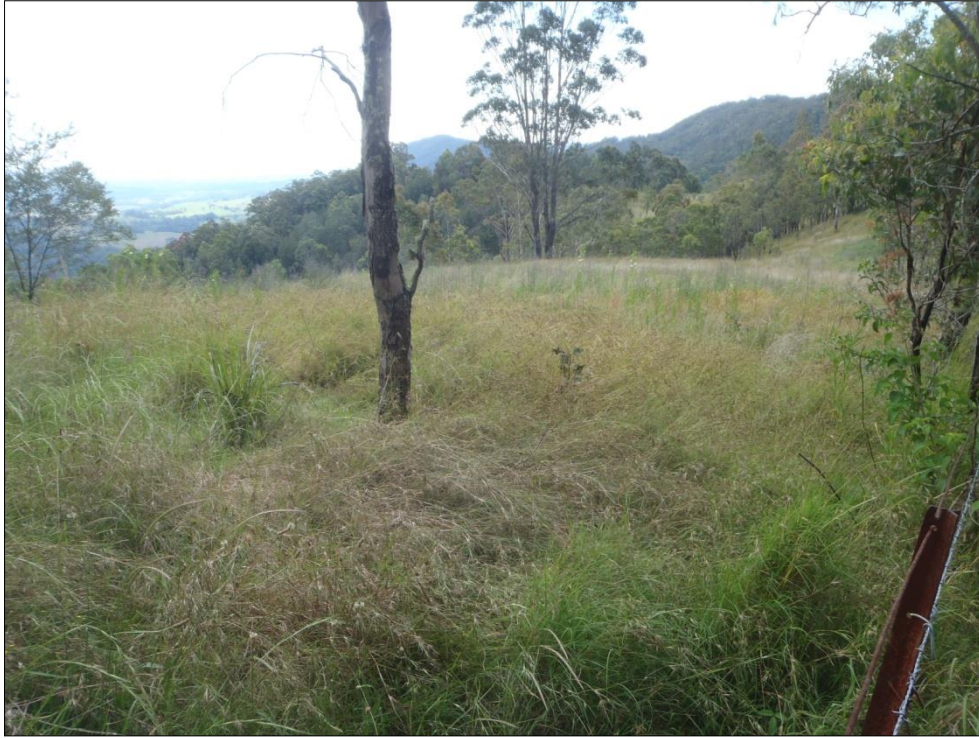
**Plate 9:** Vegetation Management Unit P - Open native grasslands on ridge-tops transitioning to forest.

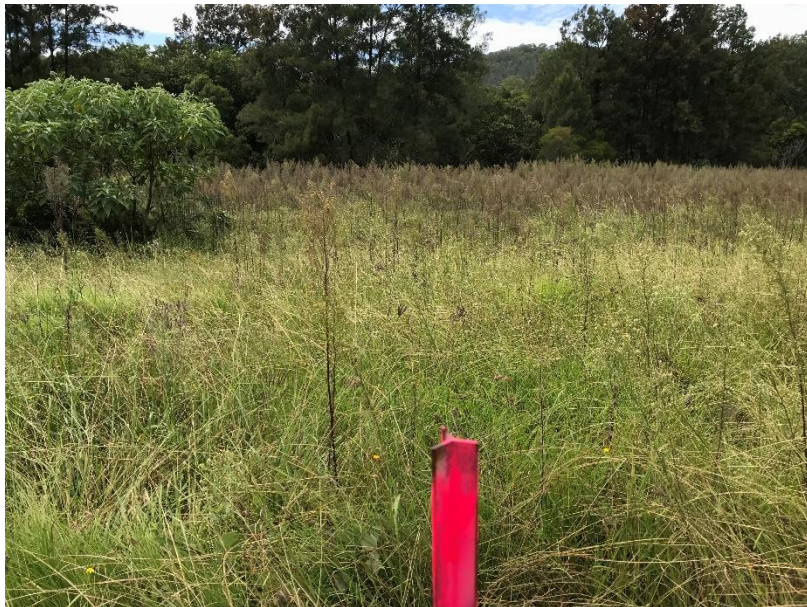
**Plate 1:** VMU F showing exotic ground cover and scattered Wild tobacco looking towards Mammy Johnson River

Weeds observed included Privet, Blackberry and Wild Tobacco.

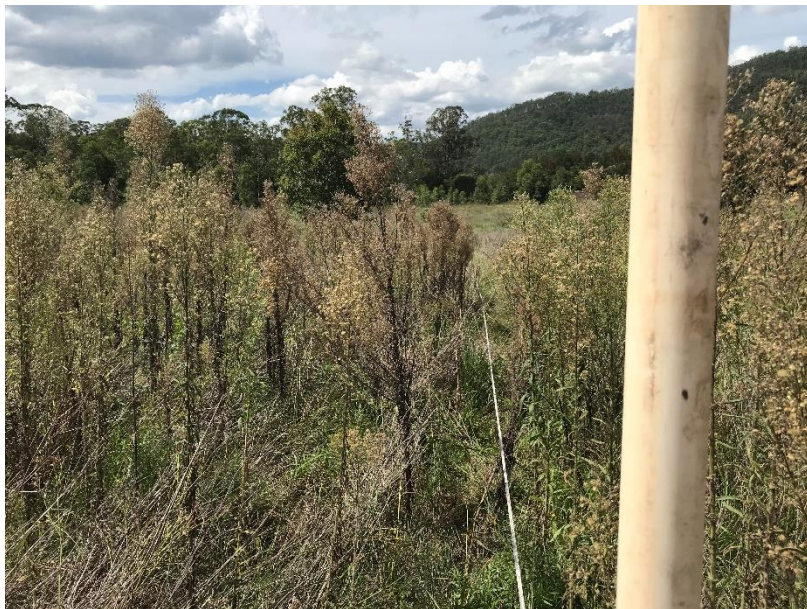
**Plate 2:** VMU S transect. Note the prevalence and density of weeds

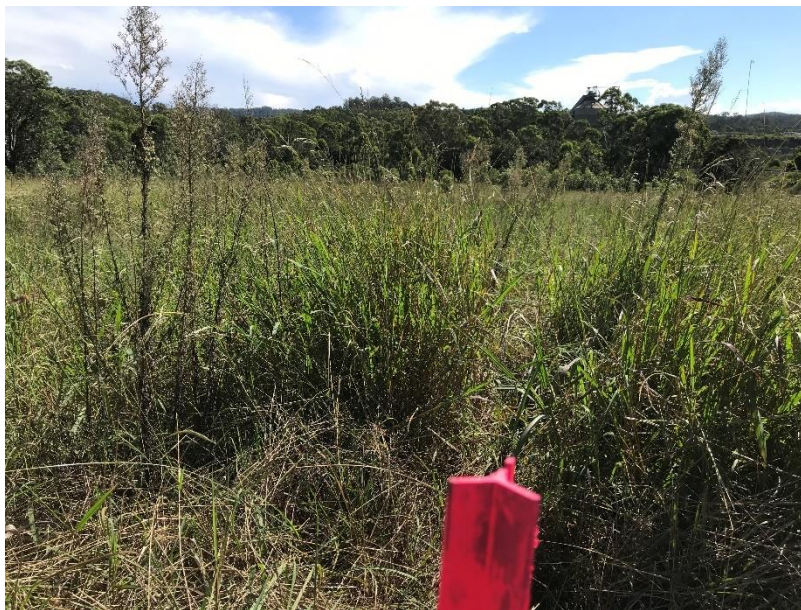
**Plate 3:** VMU T looking west showing dominance of exotic groundcovers

With no canopy or shrubs on this VMU, no EFA was conducted. This VMU does have naturally regenerating canopy and shrubs species at its extremities, just visible in **Plate 3**. The VMU itself is dominated by exotic grasses, *Paspalum dilatatum* and Narrow-leafed Carpet Grass (*Axonopus filiformis*) and forbs although the flora species count is evenly divided between native species (nine) and exotics (11 species) for a total of 20 species, a slight increase on the previous survey.

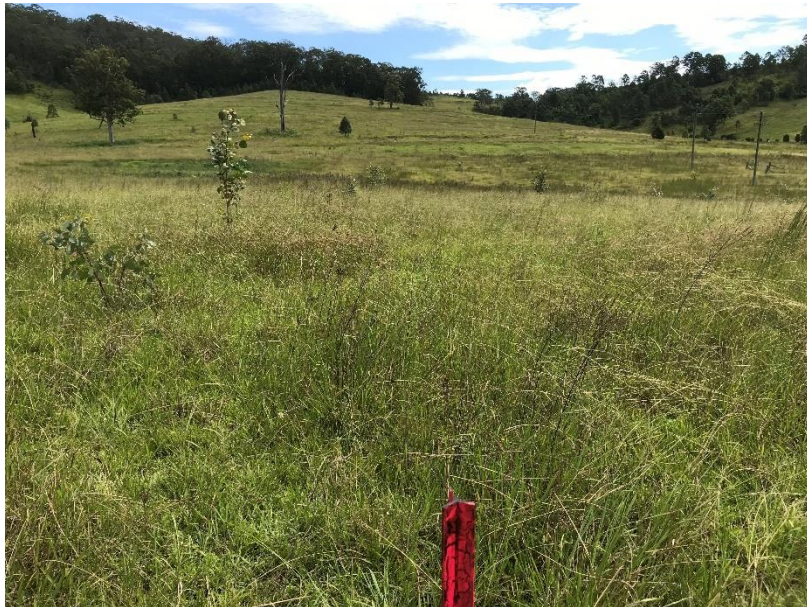
**Plate 4: VMU W looking west. Several of the planted trees are visible. The taller tree is a survivor from the original revegetation effort.**

The flora monitoring identified a total of 22 species, evenly divided between natives and exotics with 11 species each. Wild Tobacco was encroaching from the rail corridor to the east.

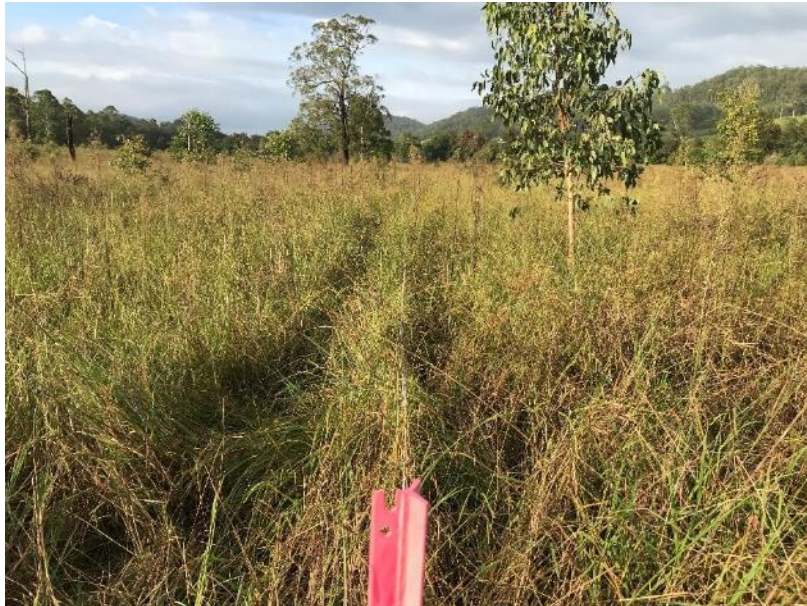
**Plate 5: VMU Y looking south along the LFA transect. Note the numerous trees from the revegetation planting and the large paddock Ironbark in the background**

The flora survey recorded a total of 23 species, 10 natives and 13 exotics. This the exotic dominated groundcover nature of the VMU (**Plate 5**). The walkover survey recorded many individual woody weeds including Wild Tobacco and Privet, mainly emerging from the remnant vegetation along Mammy Johnson Cr, while Blackberry was found scattered throughout the VMU. Evidence of weed control works was also observed where Blackberry patches had been sprayed. Unfortunately, evidence of herbicide overspray damaging, and occasionally killing planted canopy stems was also observed.

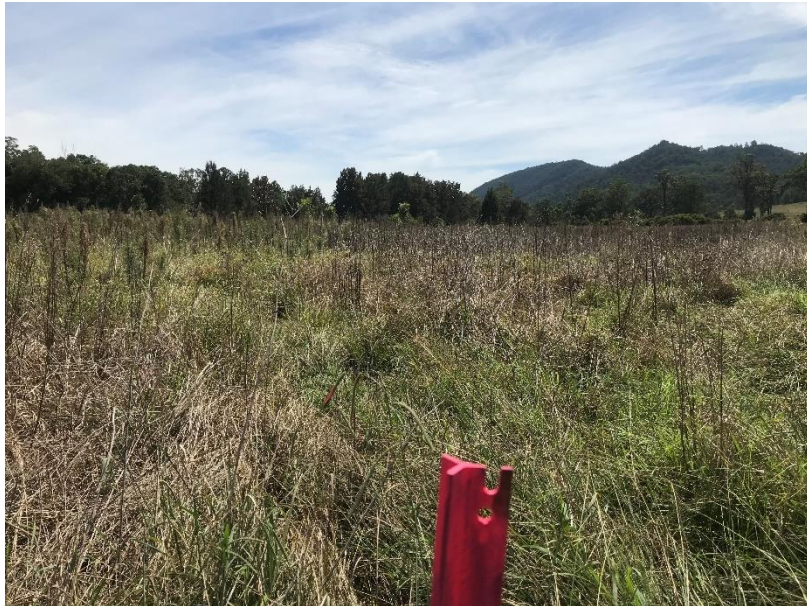
**Plate 6:** VMU AD looking North from the LFA transect showing dense exotic ground cover in the foreground and large paddock trees in background. Several of the planted trees are visible in front of the paddock trees.

The flora survey recorded a total of 23 species, composed of seven native species and 16 exotic species. This area is dominated by a dense exotic grass and herb groundcover that has made recording survival of the planted stems difficult. Woody weeds Privet and Wild Tobacco are encroaching from the vegetation along Mammy Johnson Creek, while Blackberry was commonly observed throughout the VMU during the walkover.

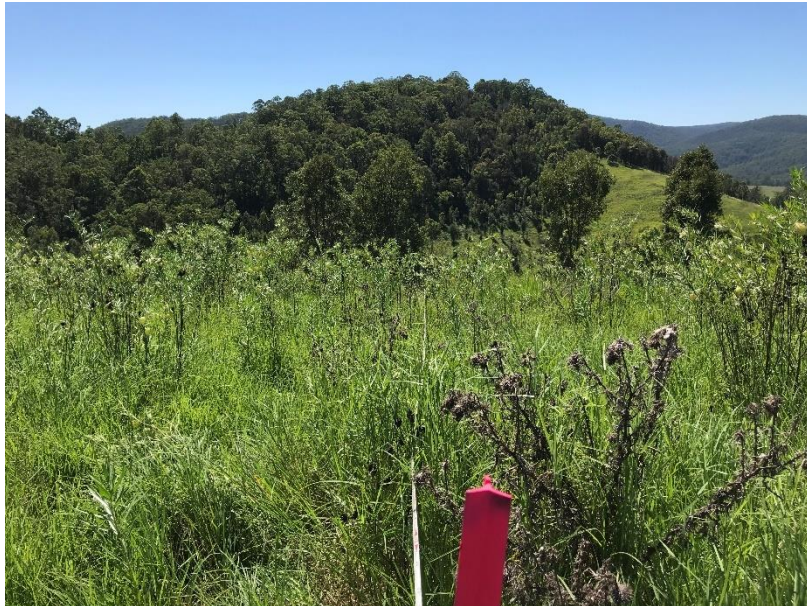
**Plate 7: VMU I - looking downslope from top of LFA transect showing largely exotic grasses and herbaceous weeds at this section of the transect**

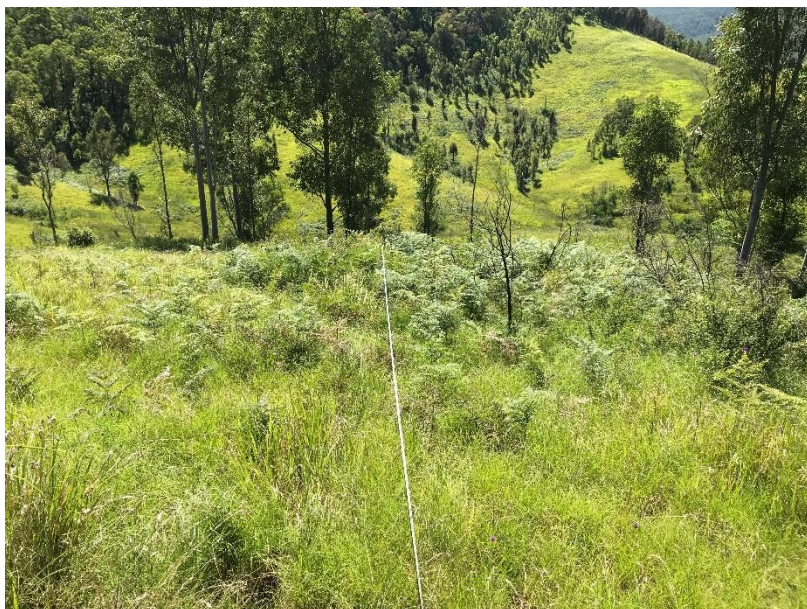
**Plate 8: VMU I - looking down the LFA transect from approximately the half-way point showing native grasses and shrubby regeneration. The taller trees are *Acacia implexa*.**

The flora survey recorded a total of 48 species composed of 35 native and 13 exotic species, a very slight increase of the natives compared to last year’s survey. No major woody weeds were recorded during the survey of this VMU, but the 2019 fire has served to stimulate some of the herbaceous weeds particularly Narrow-leaved Cotton Bush (*Gomphocarpus fruticosus*), which is very pronounced at the top of the transect (**Plate 7**). The vegetation in the vicinity of the transect is divided quite clearly between exotic grasses and weeds at the top of the transect, whereas lower down the slope, native grasses dominate, and shrubby regeneration is occurring (**Plate 8**).

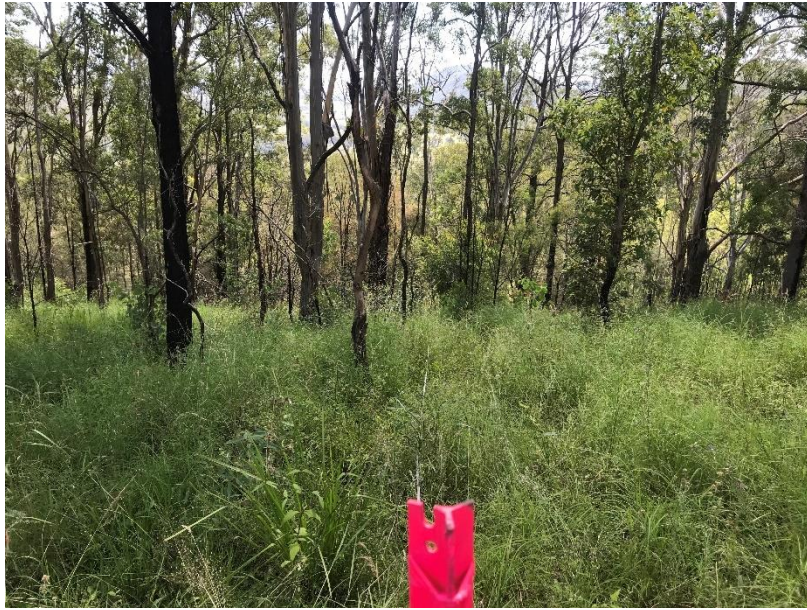
**Plate 9: VMU P looking down the LFA transect showing the excellent recovery from the effects of the 2019 bushfire**

recorded was Lantana, making a comeback after the 2019 fire. The remaining additional exotic species are herbaceous colonisers after disturbance such as Cobblers Pegs (*Bidens pilosa*) and Fleabane (*Conyza bonariensis*).

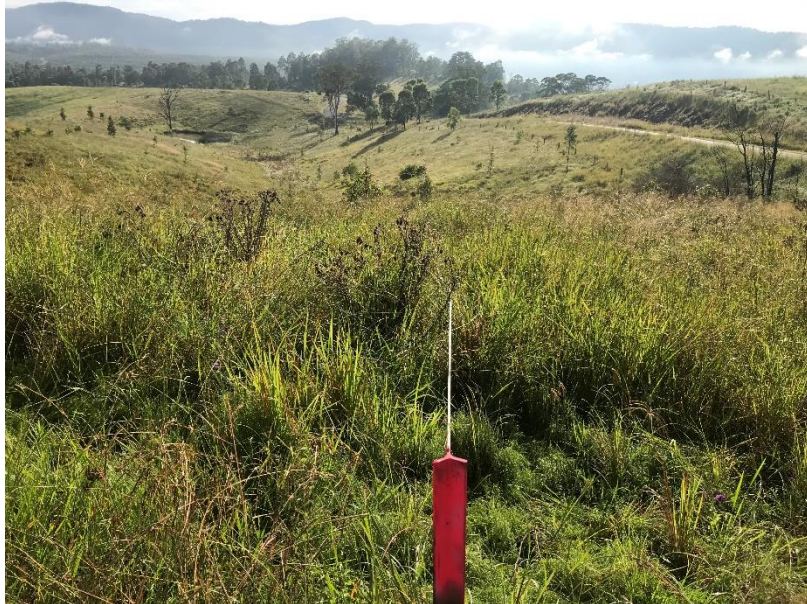
**Plate 10: VMU U looking downslope along the LFA transect showing largely exotic groundcover and planted canopy**

The EFA results recorded 65 stems/ha at an average spacing of 12.4m with “excellent” data. These were entirely planted species, and all but one was *C. maculata*. The flora survey recorded a total of 30 flora species composed of 17 natives and 13 exotic species. The groundcover was a mix of exotic and native grass species with the planted canopy beginning to emerge and become visible (**Plate 10**). Woody weeds observed included Lantana, Wild Tobacco and Blackberry. These were concentrated in the naturally regenerating areas of the VMU, on the steeper and rocky sections and along the ridgeline. Weed control, while desirable will be difficult and potentially hazardous to personnel due to the slope and difficult footing.

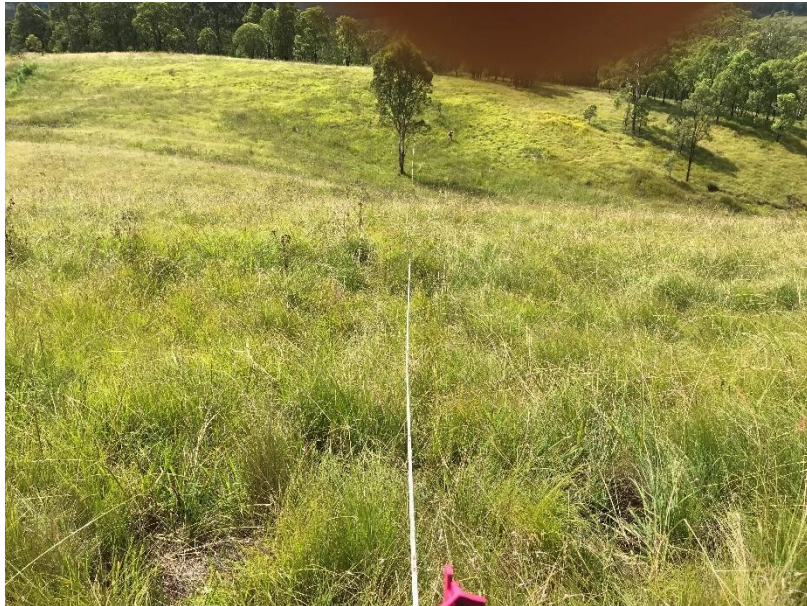
**Plate 11: VMU V looking down the LFA transect. The ground cover is largely native grasses. Planted canopy and shrubs are too small to see at this stage of monitoring**

The flora survey recorded a total of 41 species, 25 natives and 16 exotic species. No woody weeds were recorded along the transect. Lantana was observed in the remnant and regenerating areas, while blackberry was observed scattered throughout the VMU, with a large patch near the entrance gate.

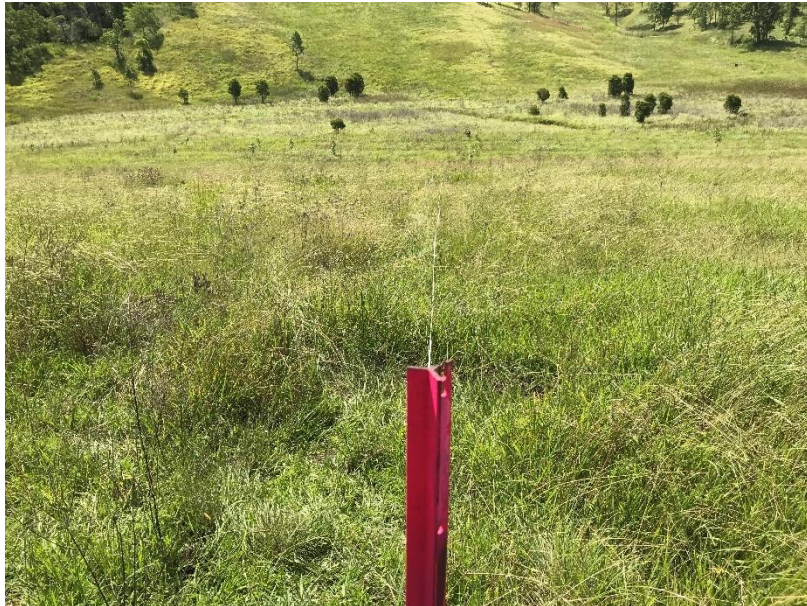
**Plate 12: VMU X looking down the LFA transect. Groundcover is dominated by Paspalum, but there is good native grass species diversity. VMU W is at the base of the slope, VMU V on the opposite slope.**

The flora survey recorded a total of 30 species, 20 natives and 10 exotics. Of the ten grass species recorded on the transect, nine were native with Paspalum the lone exotic grass. No woody weeds were observed. This VMU is isolated from remnant vegetation with few paddock trees. Natural regeneration was not observed.

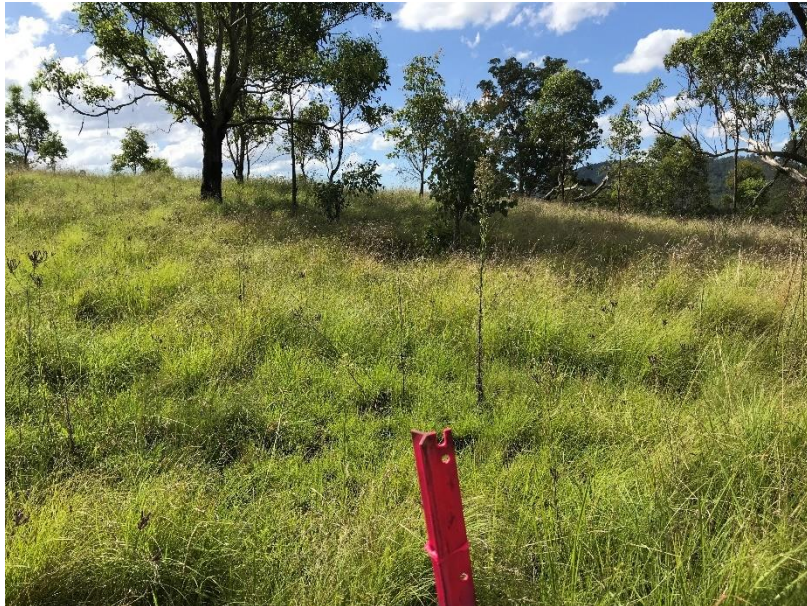
Plate 13: VMU AA looking North towards remnant vegetation.

As EFA surveys have been conducted previously for this VMU, EFA was conducted this survey. Results recorded 32.9 stems/ha at an average spacing of 17.43m with data rated as "good". A combination of naturally regenerating and planted canopy stems were recorded, while the few shrub species stems recorded were all planted. The flora survey recorded 28 species composed of 17 natives and 11 exotics. Natural regeneration was observed adjacent to the transect where paddock trees of Grey Box (*Eucalyptus moluccana*) were included in the EFA (**Plate 13**), and along the eastern border of the VMU where remnant vegetation is slowly recolonising the grassland.

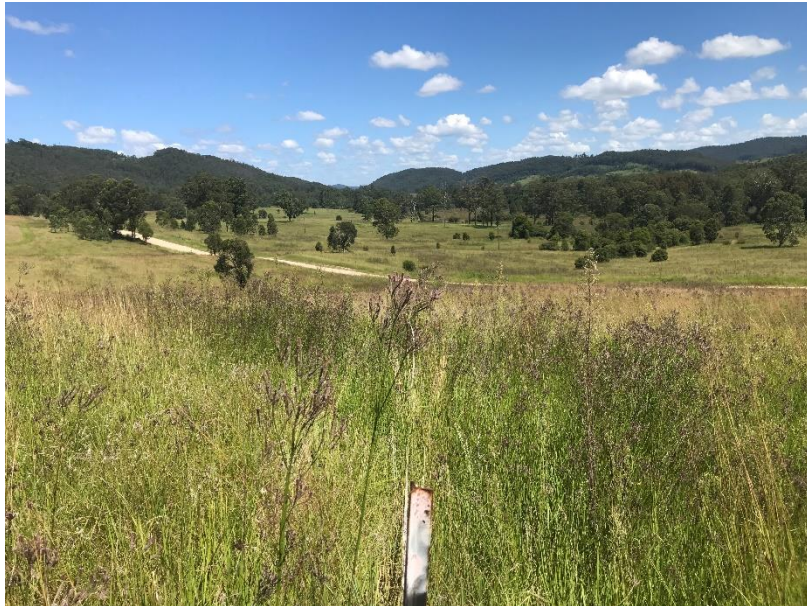
**Plate 14: VMU AC looking SW down the LFA transects towards Johnsons Creek Rd**

The flora survey recorded a total of 27 species with 19 natives and eight exotics. The area was dominated by native grasses but did have areas with high levels of herbaceous weeds such as Purpletop (*Verbena bonariensis*) and Fleabane. Natural regeneration was observed in many areas of this VMU, not unexpected given that the area is relatively narrow with remnant vegetation upslope of the grassy areas.

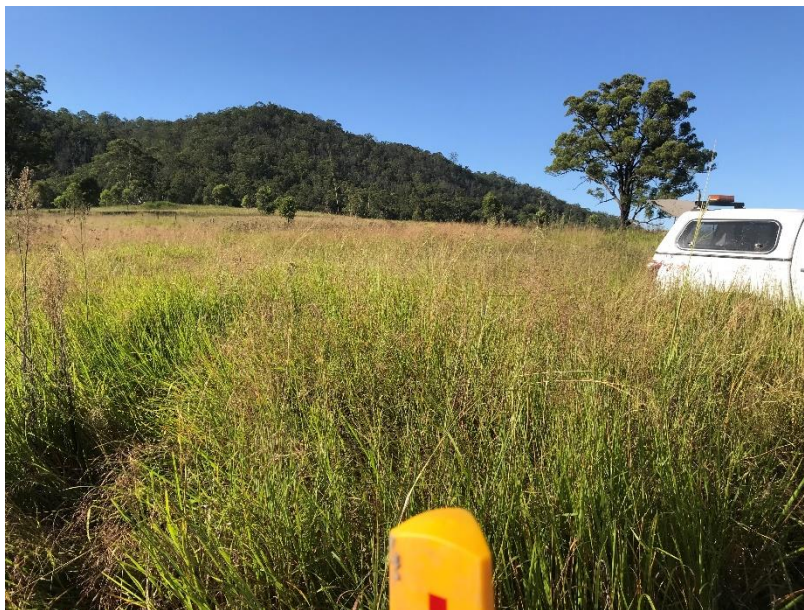
Plate 15: VMU Z looking south towards paddock trees where natural regeneration is evident.

The flora survey recorded 18 species, 14 natives and four exotics. This area was dominated by Blady Grass (*Imperata cylindrica*). Some minor generation from surviving seeding was recorded along the transect. Natural regeneration was observed along the northern edges of the VMU and from paddock trees (**Plate 15**). Blackberry treated areas were observed in the ephemeral drainage lines.

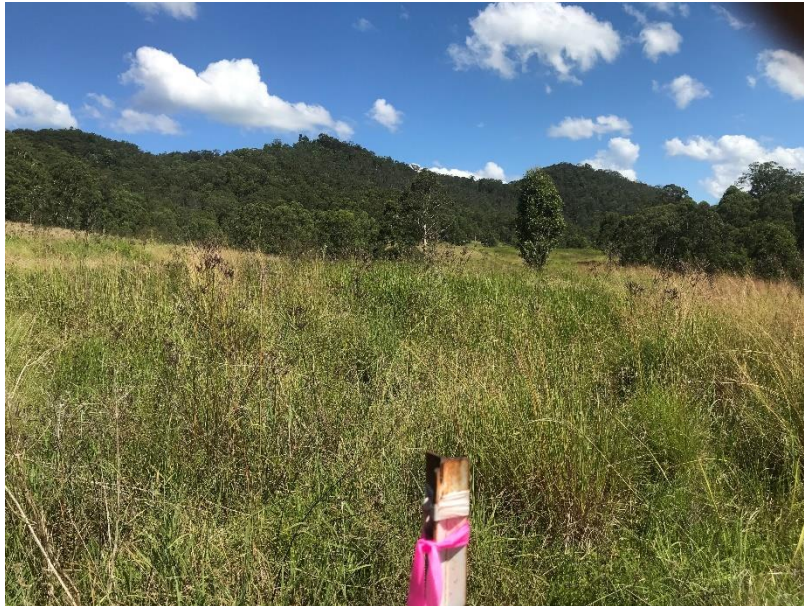
**Plate 16:** VMU AB looking south from transect start showing mainly exotic grasses and forbs and remnant vegetation

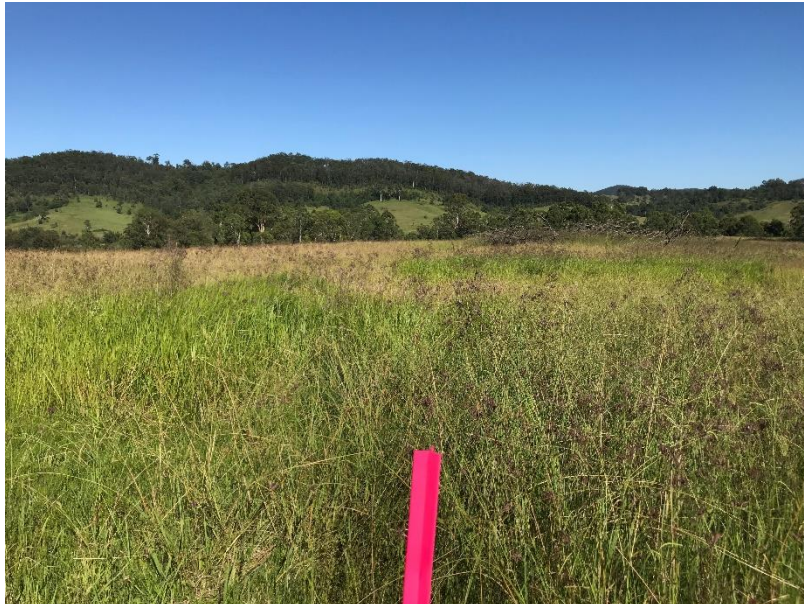
**Plate 17: VMU AE looking west from the transect**

The LFA results for this VMU were as follows. Stability Index  $63.0 \pm 2.5$ , Infiltration Index  $29.6 \pm 6.5$ , and the Nutrient Cycling Index  $20.5 \pm 0.0$  (**Chart 3**). The Stability Index result was below all comparison scores while the remaining indices were equivalent to the 2013 Baseline and 2013 VC averages.

The flora survey recorded a total of 23 species, 14 natives and nine exotics. This area largely open pasture with exotic grasses dominating on the lower slopes and native grasses dominating the further upslope and east towards the remnant vegetation (**Plate 17**). Natural regeneration was observed along the eastern boundary with good recruitment of both canopy and shrub species, while the remaining stands of paddock trees also act as areas of recruitment, albeit with less diversity, restricted largely to the offspring of the largest trees in the stand. Evidence of Blackberry treatment was observed, and no other large infestations of woody weeds were recorded during the surveys.

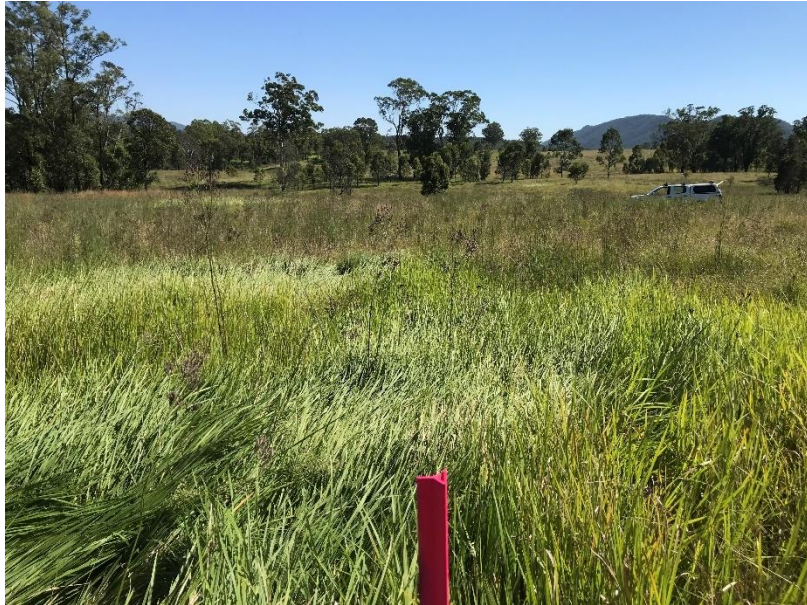
**Plate 18: VMU AF looking north from transect showing native and exotic groundcovers and regenerating canopy in the background**

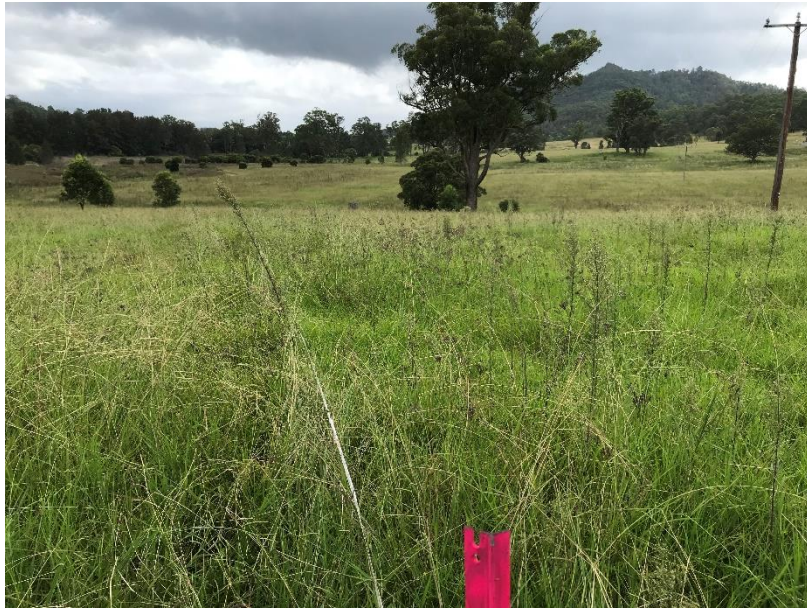
**Plate 19: VMU AH looking north showing largely exotic ground cover with isolated paddock trees**

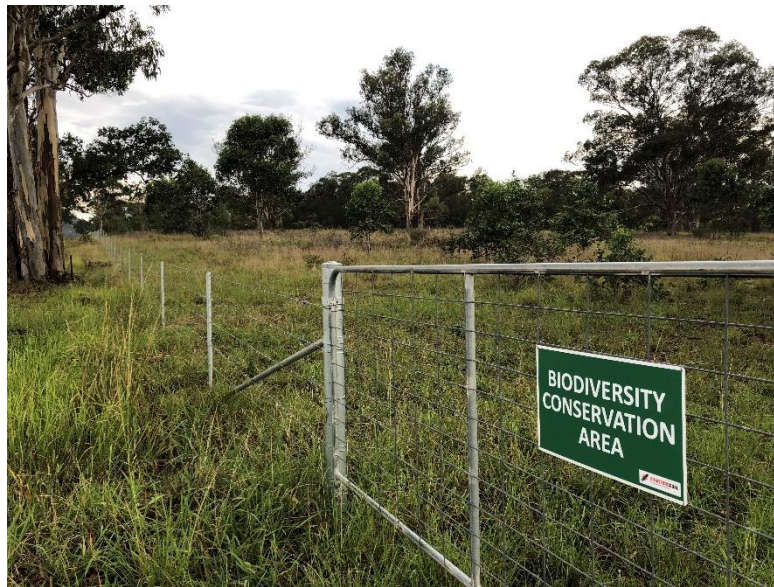
Plate 5 – Biodiversity Offset fencing and signage

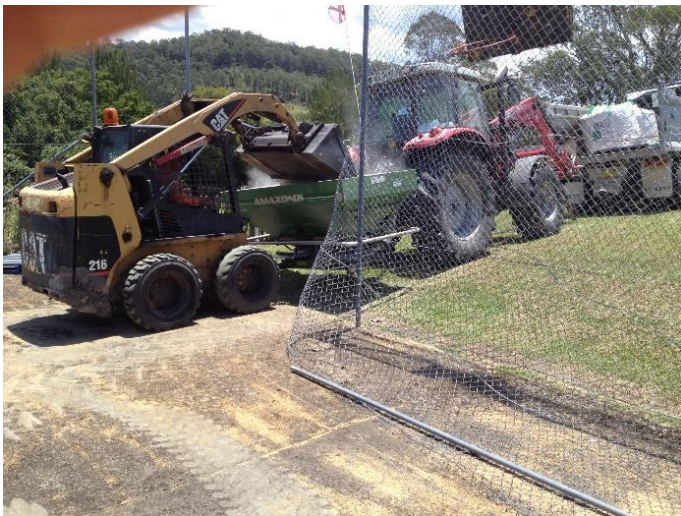
**Plate 8** - Loading seed for revegetation works.

Revegetation works in VMUs AF, AE, AA and Z were undertaken during **December 2016** and included ground preparation and direct seeding of approximately 80 hectares. Due to the inability to undertake controlled burning, slashing was undertaken as an alternative option prior to direct and broadcast seeding.

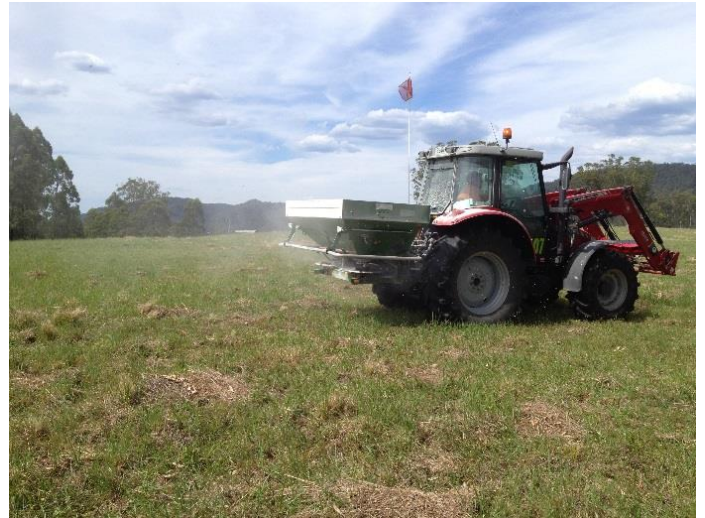
**Plate 9** - Spreading native tree and shrub seed.

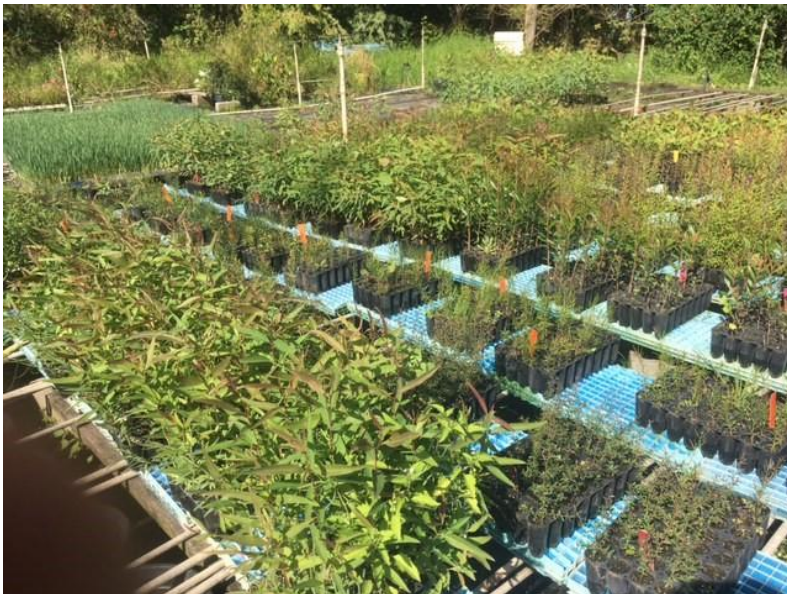
**Plate 10:** Tube-stock being prepared for the biodiversity offset.

Tubestock was propagated during Summer 2016/2017 in preparation for Autumn planting in 2017. VMUs Y, AD and S, (approximately 40 hectares), located on alluvial flats near Mammy Johnsons River were prepared for planting by slashing, spraying for weeds and ripping. This was followed by the planting of approximately 7,200 tube-stock in **April 2017**. The results of the 2017 re-vegetation activities are reported in the *DCM Biodiversity Offsets Revegetation Program Report Spring 2016 - Autumn 2017*.

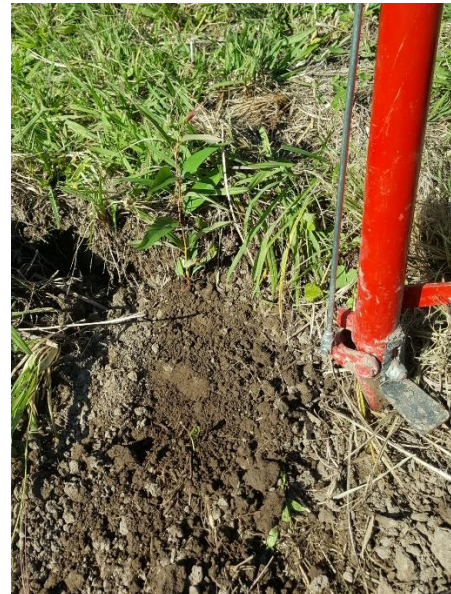
**Plate 11:** Planted tube-stock.

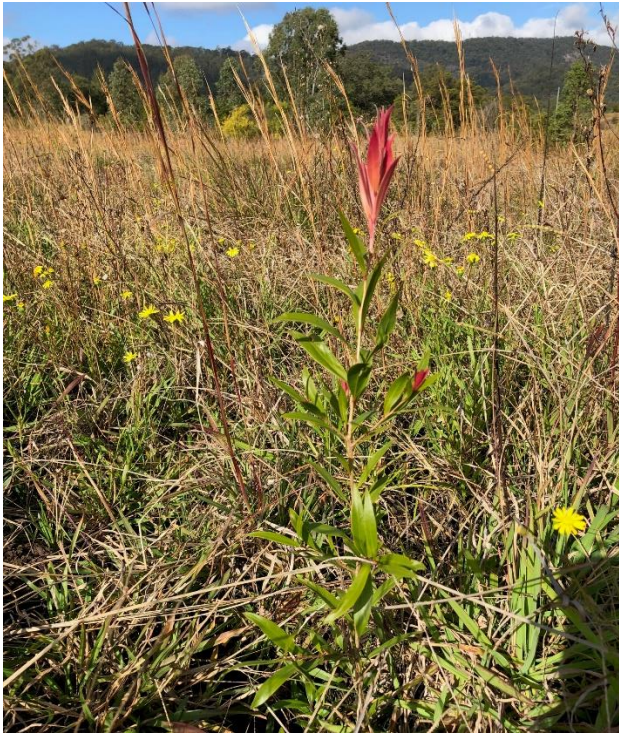
**Plate 12:** *Tubestock planted in September 2018.*

Tube-stock planting of VMUs F, V, W and X was proposed for Autumn 2018 including approximately 16,000 plants over 61 hectares. The native tree seed was propagated over the Summer of 2017/2018 by Cumberland Plain Seeds. However, due to the slower than expected establishment of the tubestock, planting was postponed during winter and completed in **September 2018**. The results of the 2018 re-vegetation activities are reported in the *DCM Biodiversity Offsets Results of Spring 2018 Planting Report*.

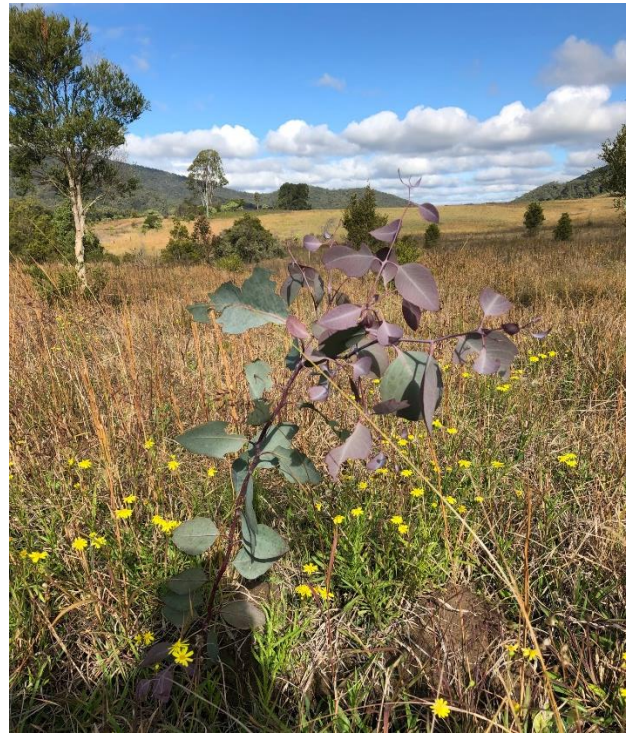
**Plate 13:** *Tubestock planted in September 2018.*

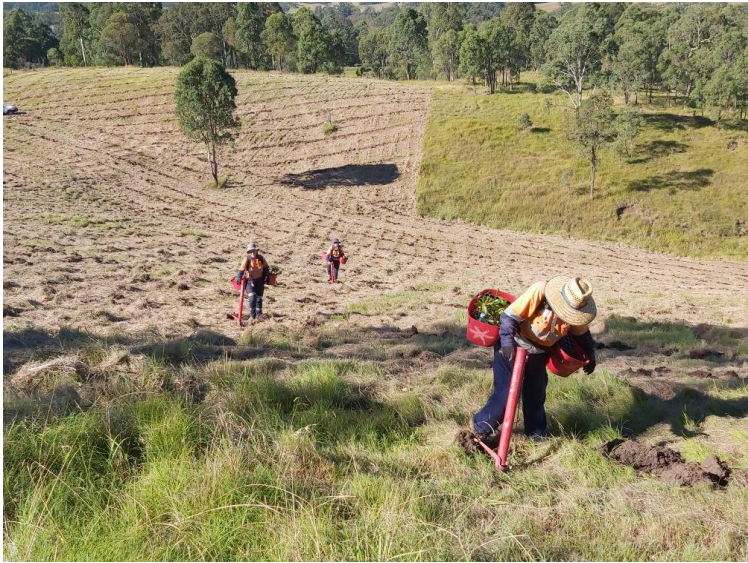
Plate 14: Tubestock planting in VMU V in Mar 2020.

The 2021 Duralie Offsets Planting Program revegetated, or in-fill planted into seven VMUs. The 2021 planting campaign successfully installed 24, 718 plants over 112 ha of the Offsets areas. This included the large sections of Grey Box – Forest Red Gum – Grey Ironbark Open Forest in VMUs AB, AE, AF and Z, 89 ha of the total. These areas had been unsuccessfully seeded previously, potentially due to drought conditions. The installation of the tubestock and hikos ensures that revegetation of the three strata has begun.

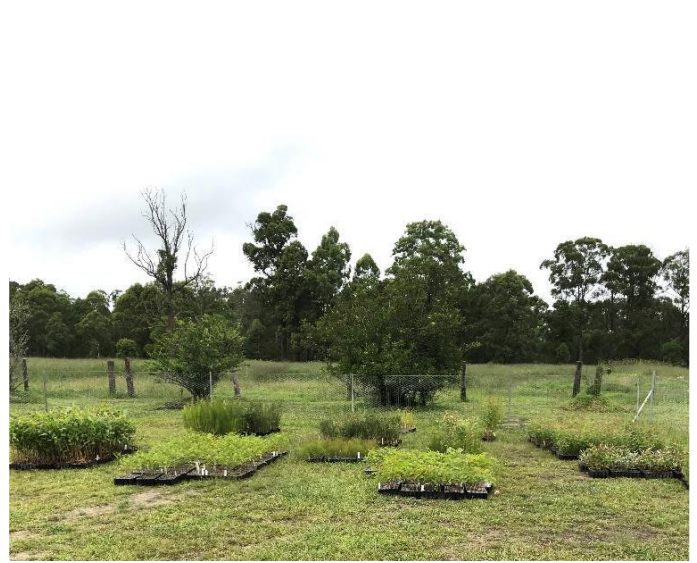
Plate 15: Tubestock preparation in 2020.
