# Charbon Colliery - Modification 2

Geochemistry assessment

Prepared for Centennial Coal Company Limited  
August 2020

## Geochemistry assessment

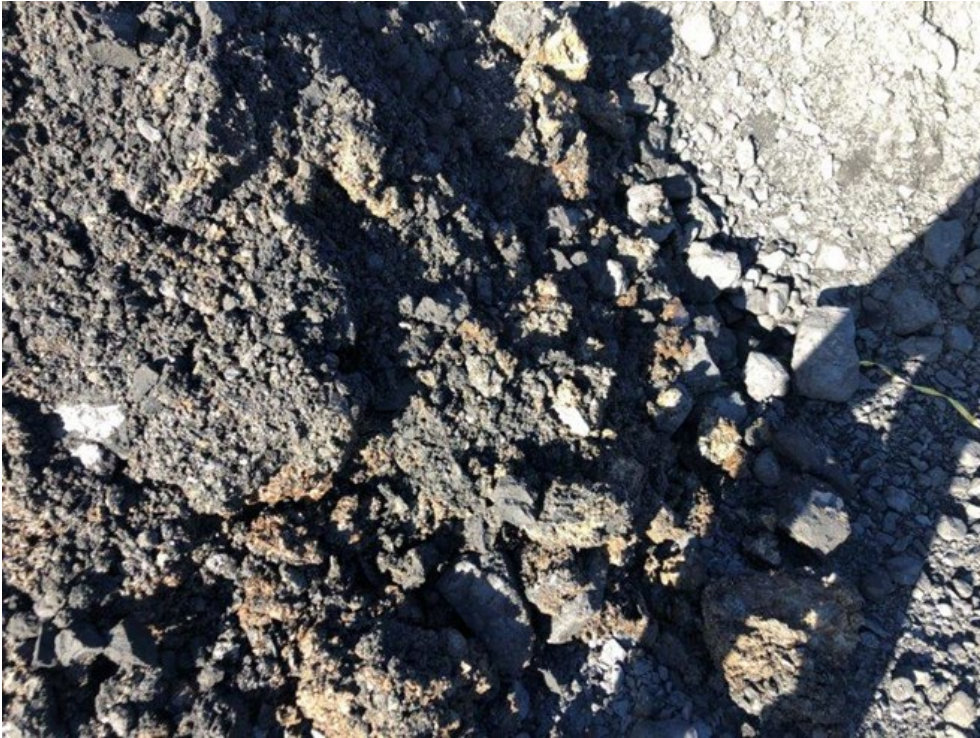
**Photograph 2.1**      REA6 sampling - surface grab samples

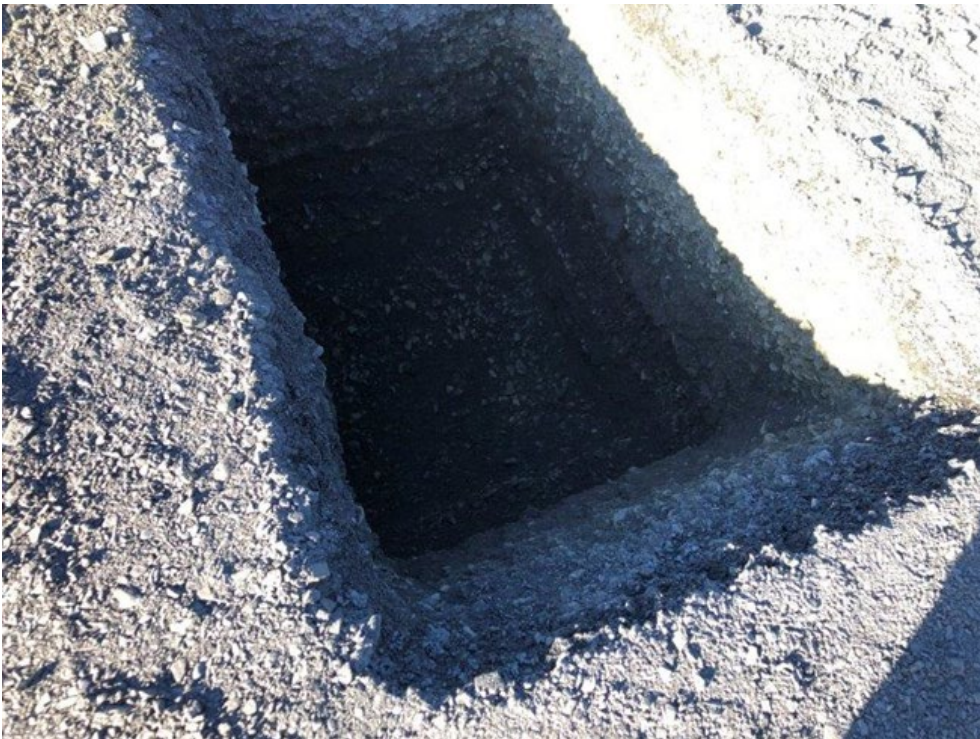
**Photograph 2.2**      REA6 sampling – sample excavation
