## Charbon Colliery - Level crossing impact assessment

## Charbon Colliery - Modification 2

Level crossing impact assessment

Prepared for Charbon Coal Pty Limited  
August 2020

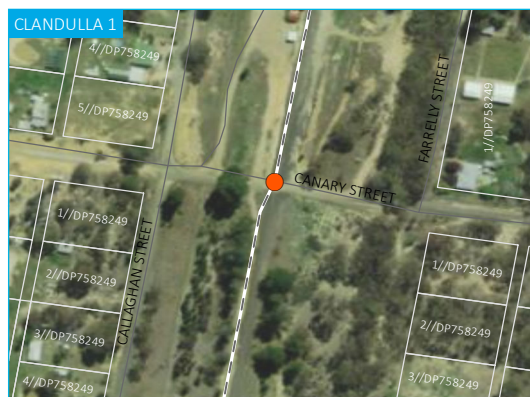
Charbon Colliery – Modification 2  
Level crossing impact assessment  
Figure 1.2

Rail level crossings (north)

| Figure reference | Level crossing | Level crossing location | Type of control | Daily road traffic volume range | Existing daily train movements |
|---|---|---|---|---|---|
| Figure 1.2 | Clandulla 1 | Canary Street, Clandulla | Passive -stop signs | 50-100 | 2 |
| Figure 1.2 | Clandulla 2 | Cooper Drive, Clandulla | Active (boom barrier, flashing lights and bells) | 150-300 | 2 |
| Figure 1.2 | Clandulla 3 | Flatlands Road off Brogans Creek Road, Clandulla | Passive -stop signs | <20 | 2 |
| Figure 1.2 | Weenga | Minor road off McDonalds Hole Road, Weenga | Passive -stop signs | <20 | 2 |

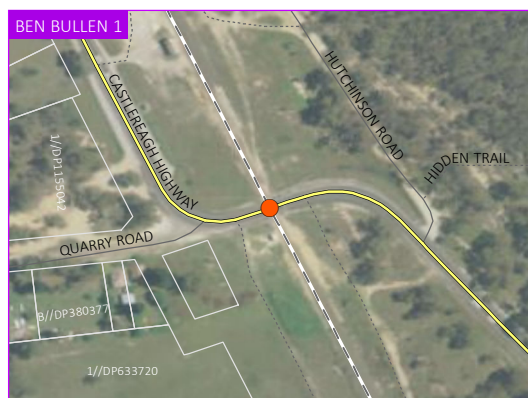
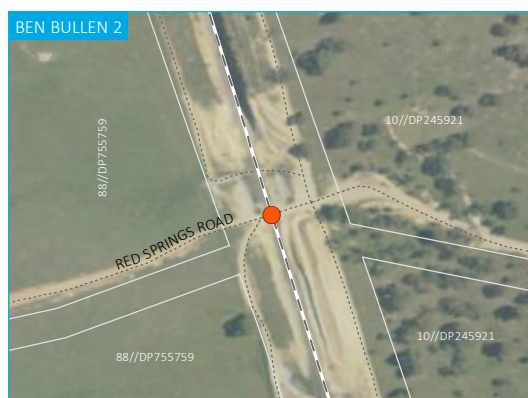
Charbon Colliery – Modification 2  
Level crossing impact assessment  
Figure 1.3

Rail level crossings (north central)

| Figure reference | Level crossing | Level crossing location | Type of control | Daily road traffic volume range | Existing daily train movements |
|---|---|---|---|---|---|
| Figure 1.3 | Torbane 1 | Minor road, Torbane | Passive -stop signs | Private and service traffic only* | 4 |
| Figure 1.3 | Torbane 2 | Minor road, Torbane | Passive -stop signs | Private and service traffic only* | 4 |
| Figure 1.3 | Ben Bullen 1 | Castlereagh Highway, Ben Bullen | Active (flashing lights and bells) | 500-1,000 | 4 |
| Figure 1.3 | Ben Bullen 2 | Red Springs Road, Ben Bullen | Passive -stop signs | <20 | 4 |

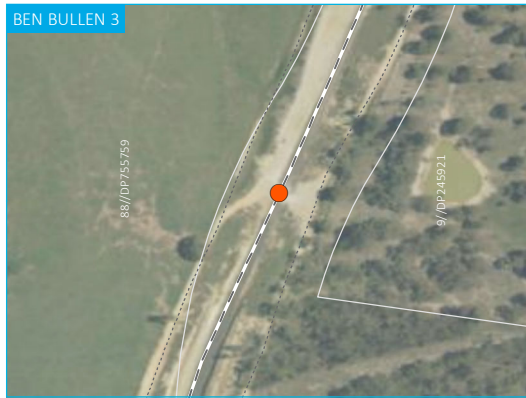
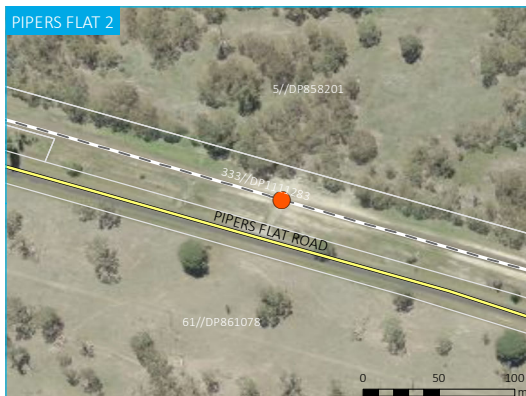
Charbon Colliery – Modification 2  
Level crossing impact assessment  
Figure 1.4

#### Rail level crossings (central)

| Figure reference | Level crossing | Level crossing location | Type of control | Daily road traffic volume range | Existing daily train movements |
|---|---|---|---|---|---|
| Figure 1.4 | Ben Bullen 3 | Minor road south of Red Springs Road, Ben Bullen | Passive -stop signs | Service traffic only* | 4 |
| Figure 1.4 | Cullen Bullen | Portland Cullen Bullen Road, Cullen Bullen | Active (flashing lights and bells) | 500-1,000 | 4 |
| Figure 1.4 | Portland | Williwa Street, Portland | Active (flashing lights and bells) | Approximately 1,000 | 4 |
| Figure 1.4 | Pipers Flat 1 | Minor road off Pipers Flat Road near Range Road, Wallerawang | Passive -stop signs | <20 | 4 |
| Figure 1.4 | Pipers Flat 2 | Minor road off Pipers Flat Road, Wallerawang | Passive -stop signs | <20* | 4 |

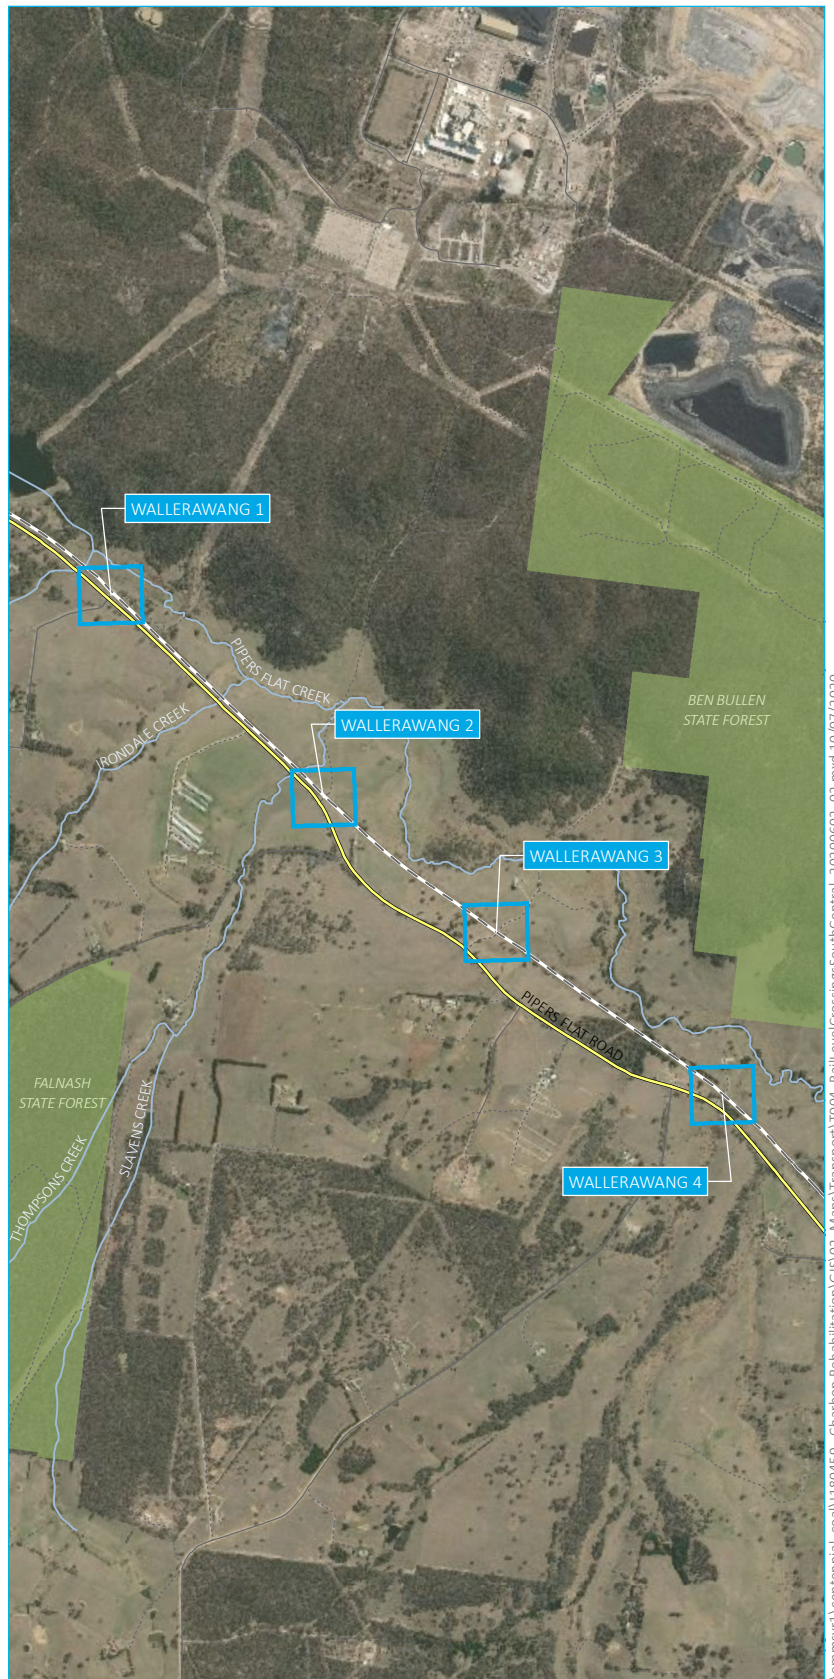
Charbon Colliery – Modification 2  
Level crossing impact assessment  
Figure 1.5

Rail level crossings (south central)

| Figure reference | Level crossing | Level crossing location | Type of control | Daily road traffic volume range | Existing daily train movements |
|---|---|---|---|---|---|
| Figure 1.5 | Wallerawang 1 | Minor road off Pipers Flat Road near Irondale Road, Wallerawang | Passive -stop signs | <20 | 4 |
| Figure 1.5 | Wallerawang 2 | Minor road off Pipers Flat Road, Wallerawang | Passive -stop signs | <20 | 4 |
| Figure 1.5 | Wallerawang 3 | Minor road off Pipers Flat Road, Wallerawang | Passive -stop signs | <20* | 4 |
| Figure 1.5 | Wallerawang 4 | Minor road off Pipers Flat Road, Wallerawang | Passive -stop signs | <20 | 4 |

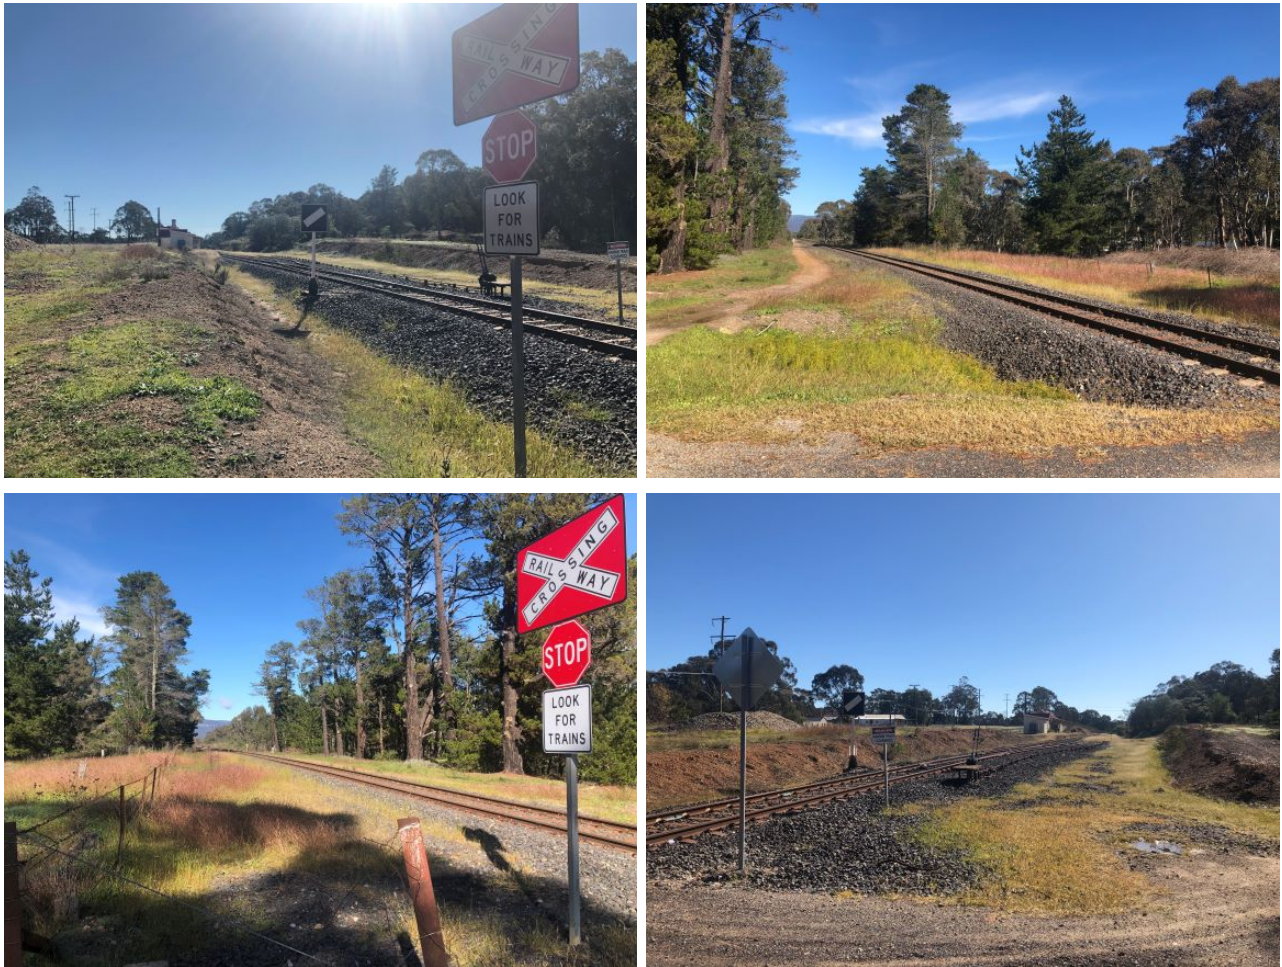
**Plate 4.1** Sight distances from Canary Street (Clandulla 1)

Generally, the observed rail corridor sight distances were a minimum of 200–300 m either side of each level crossing which is acceptable for train travel speeds of up to 80 km/hr and typically most sight distances were in the range 300-500 m which is acceptable for train travel speeds of up to 100 km/hr.

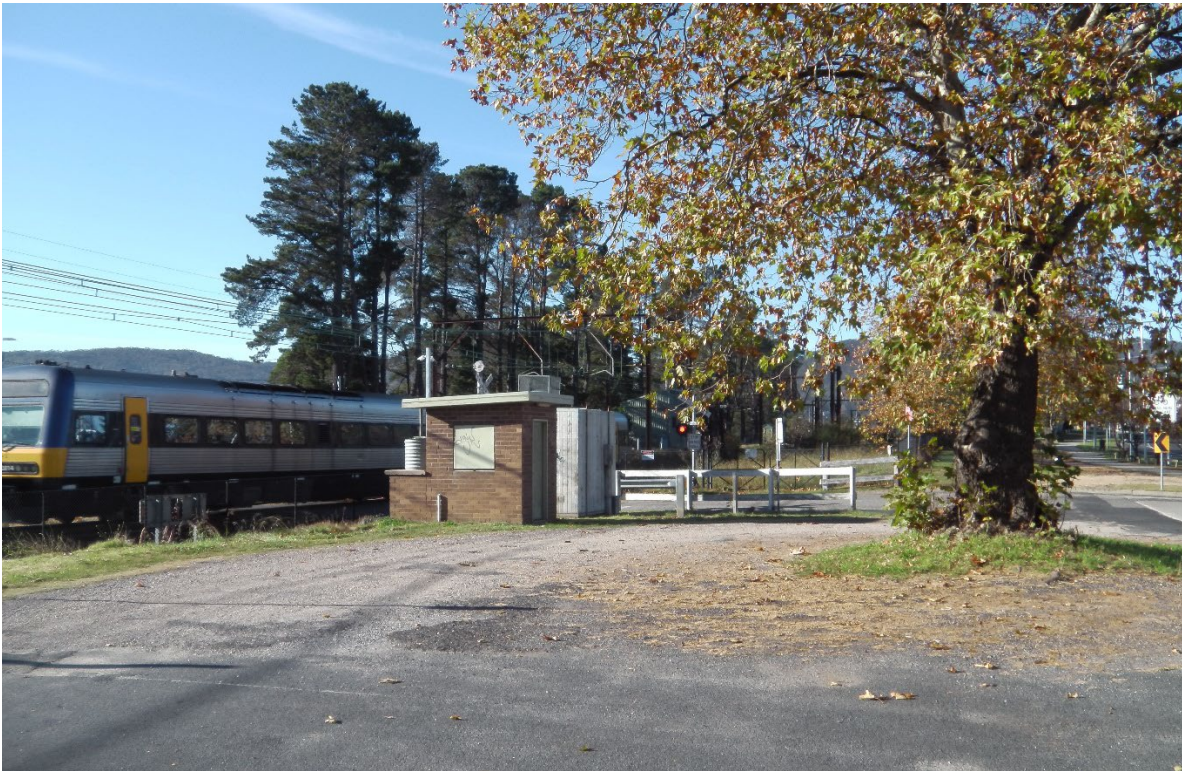
**Photograph 4.1**      **Passenger train 1 traversing the level crossing at Bowenfels 2**

During the site inspection, two passenger trains were observed during the level crossing inspection at Geordie Street, Bowenfels (Bowenfels 2), which is a dual track level crossing on the western main line (Photograph 4.1 and Photograph 4.2). The observed warning times and other delay components for road traffic at this active level crossing (boom barrier, flashing lights and bells) were recorded (Table 4.2).

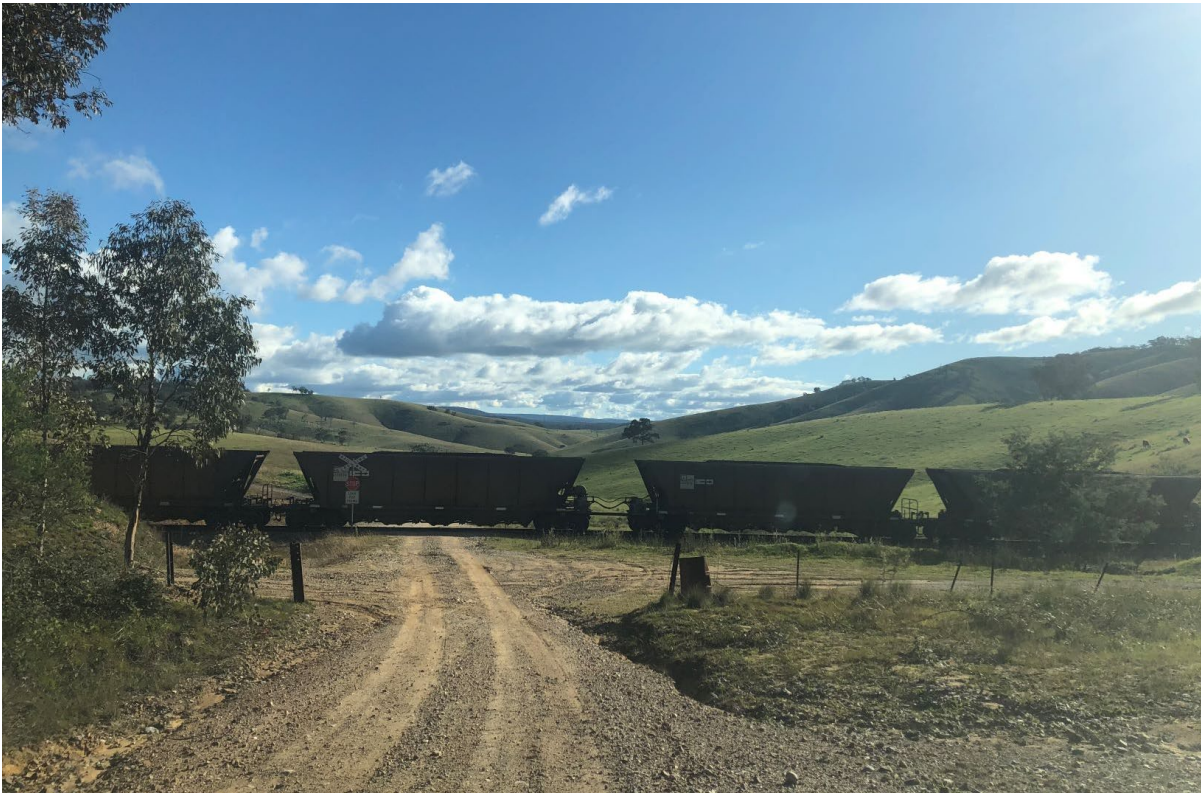
**Photograph 4.3** Coal train traversing Ben Bullen 2

In addition to the passenger train observations, a single loaded coal train was also observed traversing the passive level crossing at Red Springs Road, Ben Bullen (Ben Bullen 2) which had an observed passing time of 70 seconds (Photograph 4.3). Freight trains do not normally pass each level crossing at their maximum speed. Assuming the loaded coal trains are normally operating at lower average speeds than the empty coal trains, the corresponding typical passing time for an empty coal train is estimated at approximately 47 seconds (ie  $70 \times 0.66$ ).

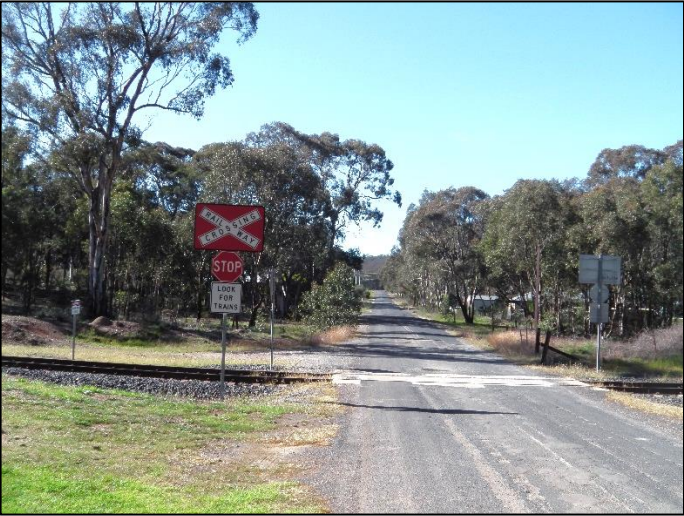
**Location 1 – Clandulla 1 – Canary Street**

| Type of crossing<br>(Passive - stop sign) | |
| Road width<br>(sealed or unsealed) | 6.6 m sealed (Concrete slab at crossing) |
| Other rail line or road traffic observation | Rail line is single track and runs moderately downhill to the south, but generally level to the north<br>Old Railway Station (Clandulla) is located approximately 100 m to the north |

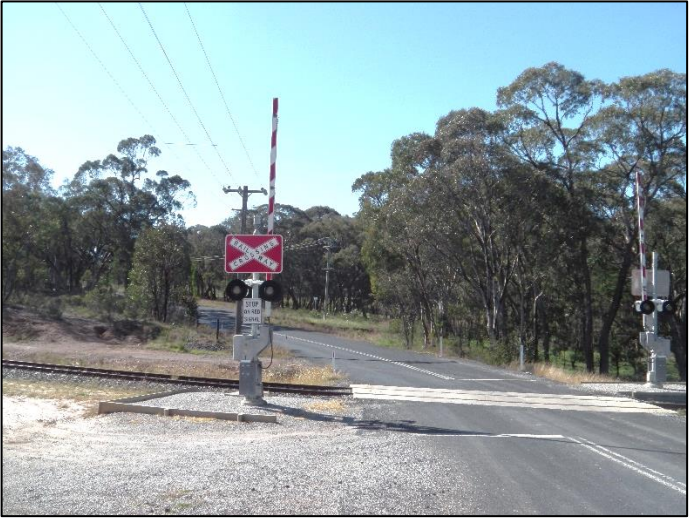
**Location 2 – Clandulla 2 – Cooper Drive**

| Type of crossing<br>(Active – flashing lights with barriers) | |
| Road width<br>(sealed or unsealed) | 8.3 m sealed (Concrete slab at crossing) |
| Other rail line or road traffic observation | Rail line is single track and runs moderately uphill to the north and downhill to the south. |

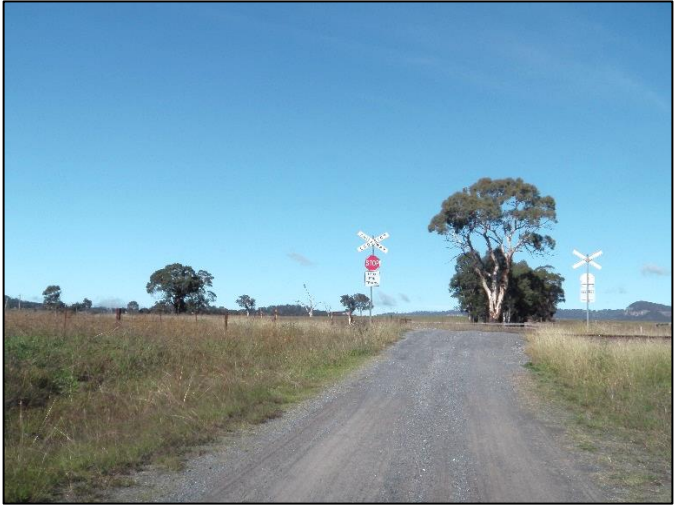
**Location 3 – Clandulla 3 – Flatlands Road (off Brogans Creek Road)**

| Type of crossing<br>(Passive - stop sign) | |
| Road width<br>(sealed or unsealed) | 3.4 m unsealed (Metal plate at crossing) |
| Other rail line or road traffic observation | Rail line is single track and runs moderately uphill to the north but is generally level to the south |

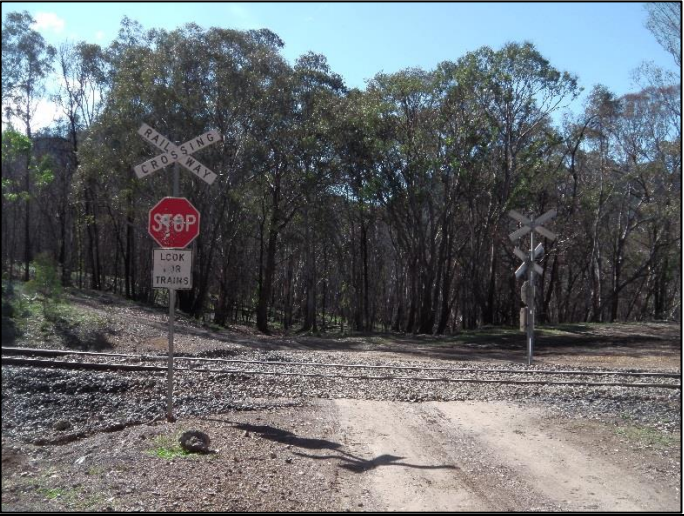
**Location 4 – Weenga – Minor road (off McDonalds Hole Road)**

| Type of crossing<br>(Passive - stop sign) | |
| Road width<br>(sealed or unsealed) | 3.5 m unsealed |
| Other rail line or road traffic observation | Rail line is single track and runs moderately downhill to the south and uphill to the north.<br>Site of Old Railway Station (Weenga) is located approximately 200 m to the north |

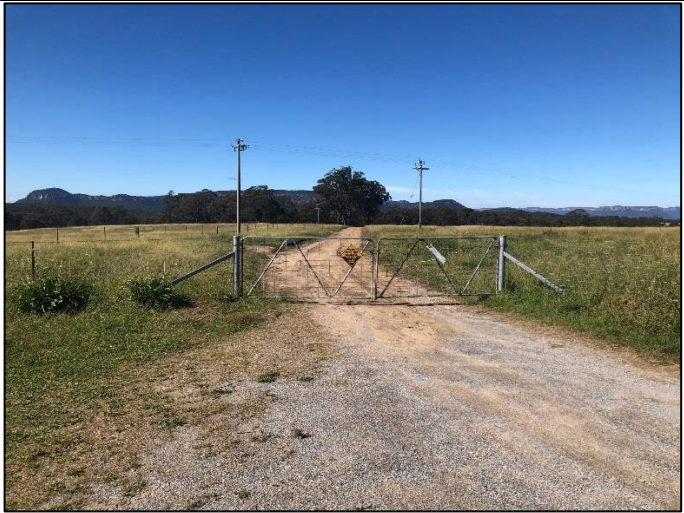
**Location 5 – Torbane 1 - Minor road (unsealed)**

| Type of crossing<br>(Passive - stop sign) | |
| Observed road traffic<br>(10 minute survey = no traffic) | Locked gate at Green Gully Orchard (Likely Private Property and Rail Corridor service traffic only) |
| Road width<br>(sealed or unsealed) | 3 m unsealed |

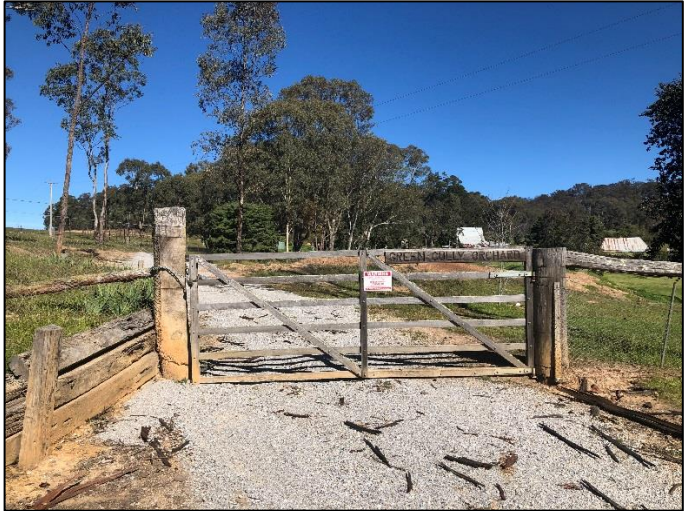
**Location 6 – Torbane 2 – Minor road (unsealed)**

| Type of crossing<br>(Passive - stop sign) | |
| Observed road traffic<br>(10 minute survey = no traffic) | Locked gate at Green Gully Orchard (Likely Private Property and Rail Corridor service traffic only) |
| Road width<br>(sealed or unsealed) | 3 m unsealed |

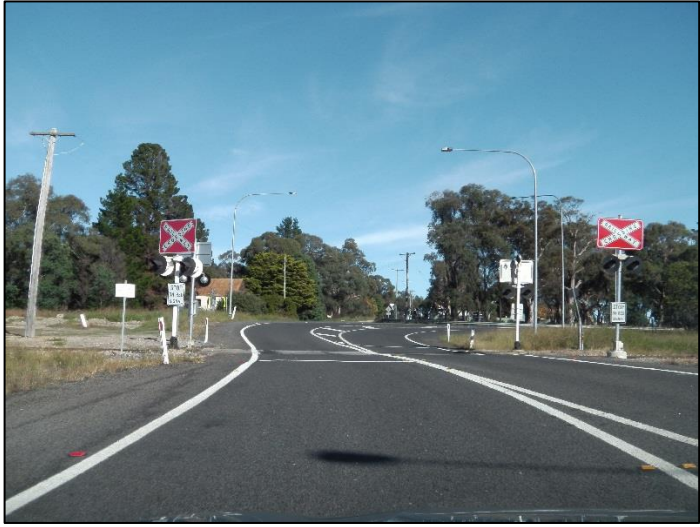
**Location 7 – Ben Bullen 1 – Castlereagh Highway**

| Type of crossing<br>(Active – flashing lights) | |
| Road width<br>(sealed or unsealed) | 7.9 m sealed (Concrete slab at crossing) |
| Other rail line or road traffic observation | Rail line is single track and runs moderately downhill to the south, but generally level to the north<br>Old Railway Station (Ben Bullen) is located approximately 100 m to the north |

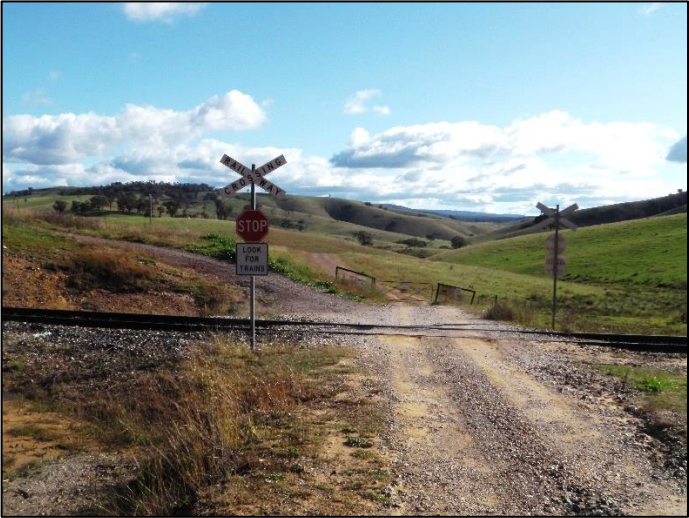
**Location 8 – Ben Bullen 2 – Red Springs Road**

| Type of crossing<br>(Passive - stop sign) | |
| Road width<br>(sealed or unsealed) | 3.2 m unsealed |
| Other rail line or road traffic observation | Rail line is single track and runs moderately uphill to the north and downhill to the south |

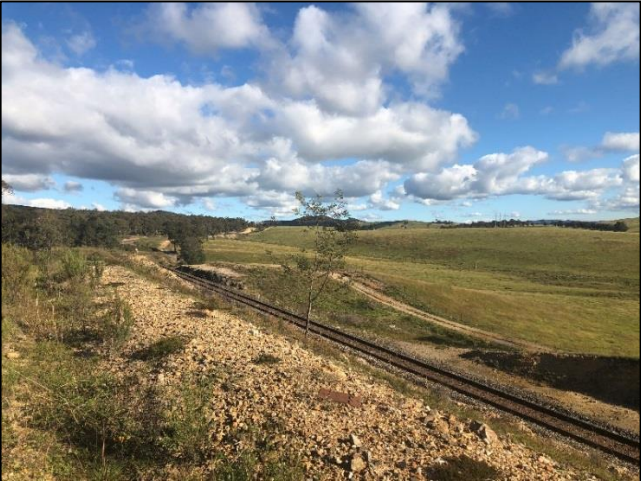
**Location 9 – Ben Bullen 3 – Minor road (south of Red Springs Road)**

| Type of crossing<br>(Passive - stop sign) | |
| Observed road traffic<br>(10 minute survey) | Unsealed access road follows the rail line corridor from Red Springs Road (Likely Rail Corridor service traffic only) |
| Road width<br>(sealed or unsealed) | 3 m unsealed (Rocky surface) |

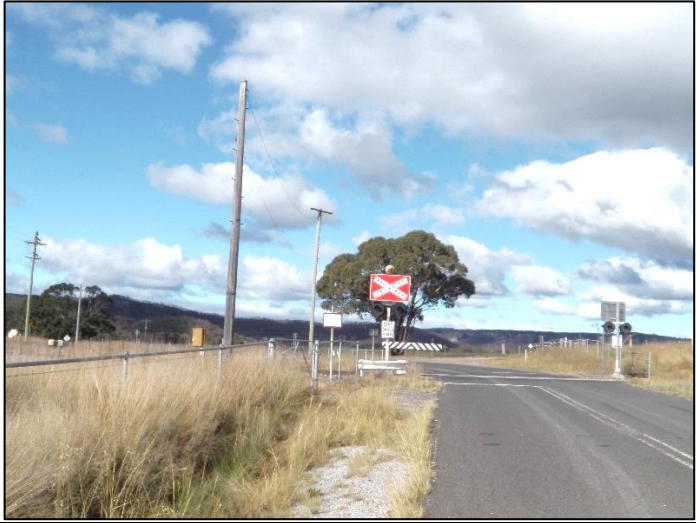
**Location 10 – Cullen Bullen - Portland Cullen Bullen Road**

| Type of crossing<br>(Active – flashing lights) | |
| Road width<br>(sealed or unsealed) | 6.3 m sealed (Concrete slab at crossing) |
| Other rail line or road traffic<br>observation | Rail line is single track and runs generally level to the north and moderately downhill to the south |

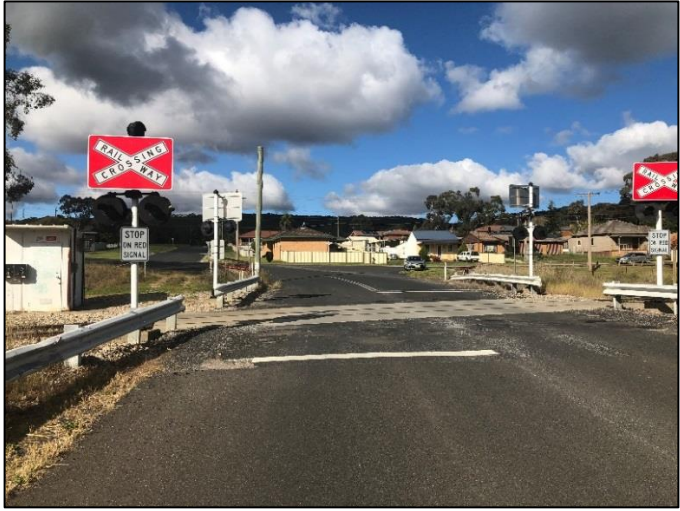
**Location 11 – Portland - Williwa Street**

| Type of crossing<br>(Active – flashing lights) | |
| Road width<br>(sealed or unsealed) | 9.6 m sealed (concrete slab at crossing) |
| Other rail line or road traffic observation | Rail line is single track and runs generally level to the north and moderately downhill to the south. Road traffic includes school buses |

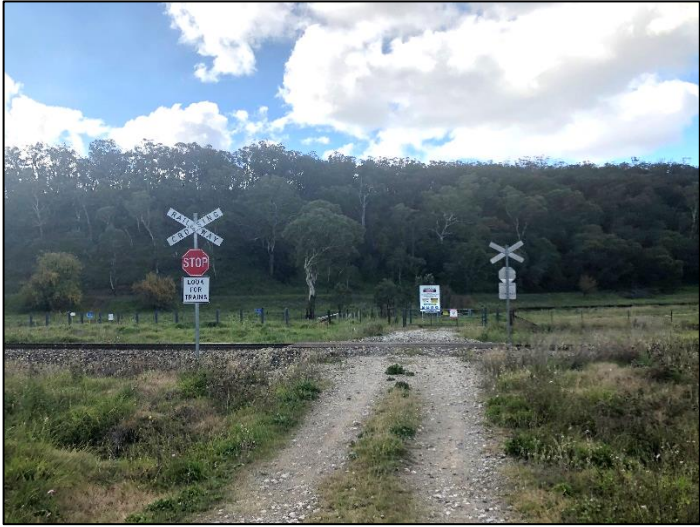
**Location 12 – Pipers Flat 1 – Minor road (off Pipers Flat Road) near Range Road**

| Type of crossing<br>(Passive - stop sign) | |
| Road width<br>(sealed or unsealed) | 3 m unsealed (Metal plate at crossing) |
| Other rail line or road traffic<br>observation | Rail line is single track and runs moderately downhill to the south |

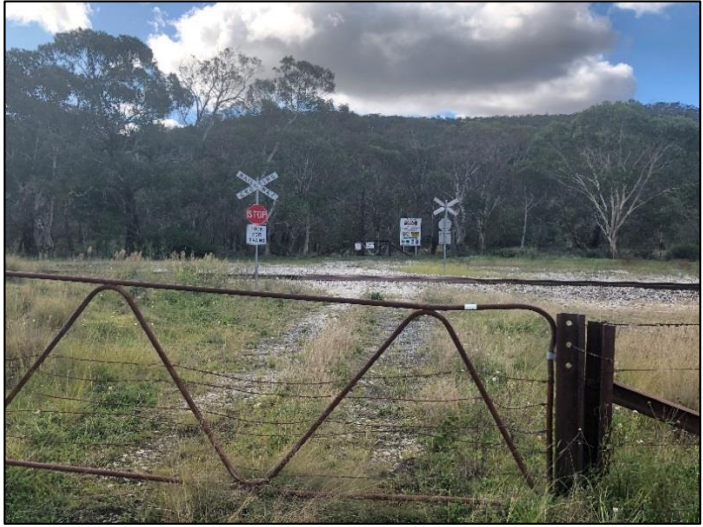
**Location 13 – Pipers Flat 2 – Minor road (off Pipers Flat Road)**

| Type of crossing<br>(Passive - stop sign) | |
| Observed road traffic<br>(10 minute survey = no traffic) | Not Publicly Accessible (Centennial Coal and Rail Corridor Access). Probably less than 10 daily vehicles |
| Road width<br>(sealed or unsealed) | 3 m unsealed (Metal plate at crossing) |

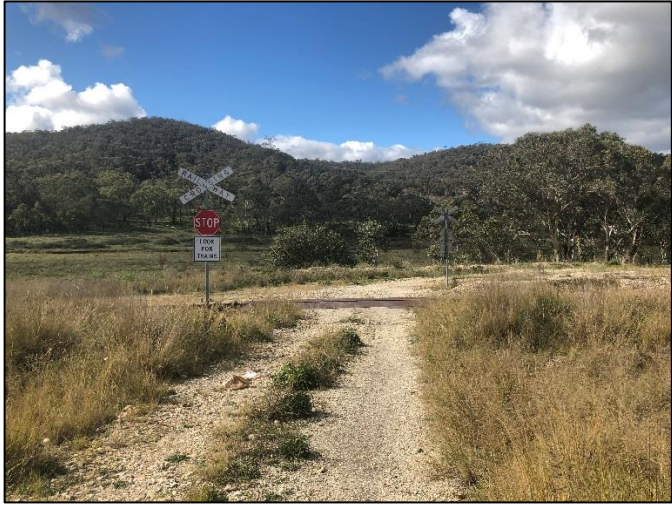
**Location 14 – Wallerawang 1 – Minor road (off Pipers Flat Road) near Irondale Road**

| Type of crossing<br>(Passive - stop sign) | |
| Road width<br>(sealed or unsealed) | 3.3 m unsealed (Metal plate at crossing) |

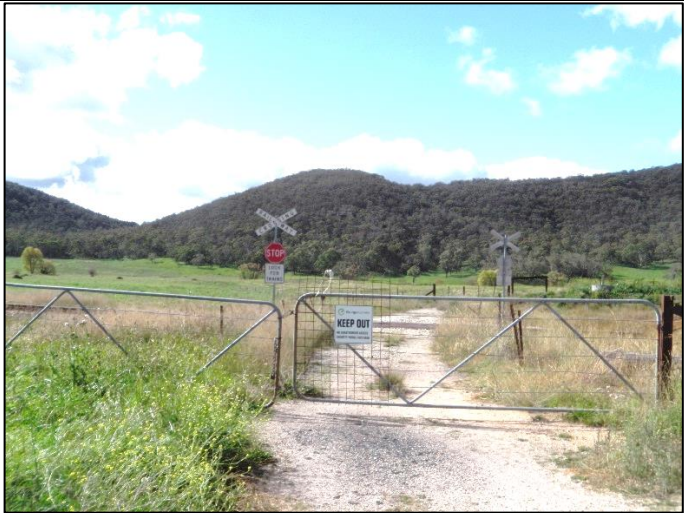
**Location 15 – Wallerawang 2 – Minor road (off Pipers Flat Road)**

| Type of crossing<br>(Passive - stop sign) | |
| Observed road traffic<br>(10 minute survey = no traffic) | Gate locked not publicly accessible (Energy Australia)<br>Probably less than 10 daily vehicles |
| Road width<br>(sealed or unsealed) | 3 m unsealed (Metal plate at crossing) |

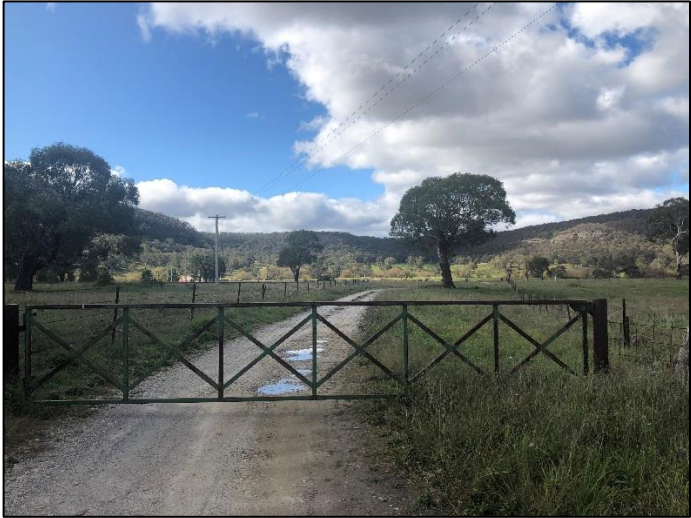
**Location 16 – Wallerawang 3 – Minor road (off Pipers Flat Road)**

| Type of crossing<br>(Passive - stop sign) | |
| Observed road traffic<br>(10 minute survey = no traffic) | Gate locked (not publicly accessible) Probably less than 10 daily vehicles |
| Road width<br>(sealed or unsealed) | 3 m unsealed |

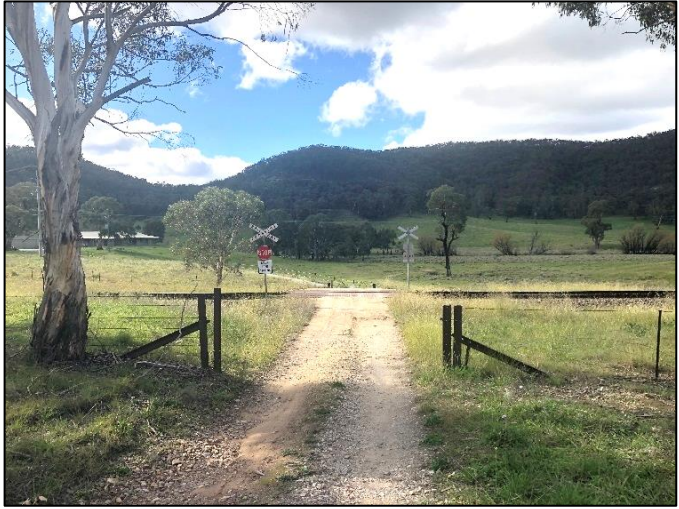
**Location 17 – Wallerawang 4 – Minor road (off Pipers Flat Road)**

| Type of Crossing<br>(Passive - stop sign) | |
| Road width<br>(sealed or unsealed) | 3 m unsealed (Metal plate at crossing) |

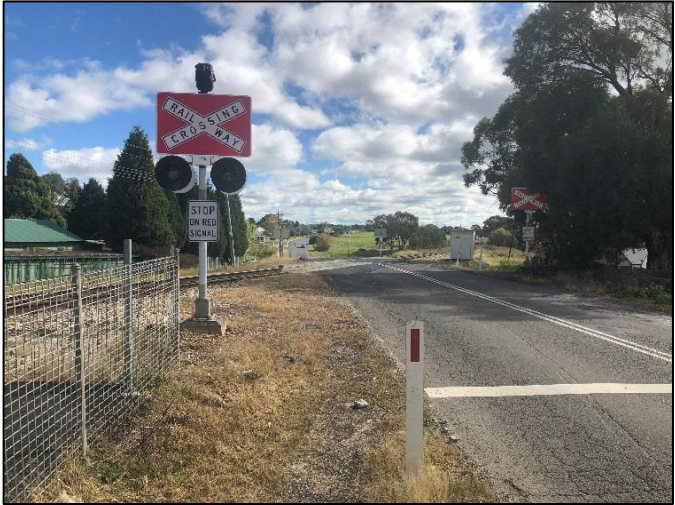
**Location 18 – Wallerawang 5 – Pipers Flat Road**

| Type of crossing<br>(Active – flashing lights) | |
| Road width<br>(sealed or unsealed) | 7.5 m sealed (Concrete slab at crossing) |

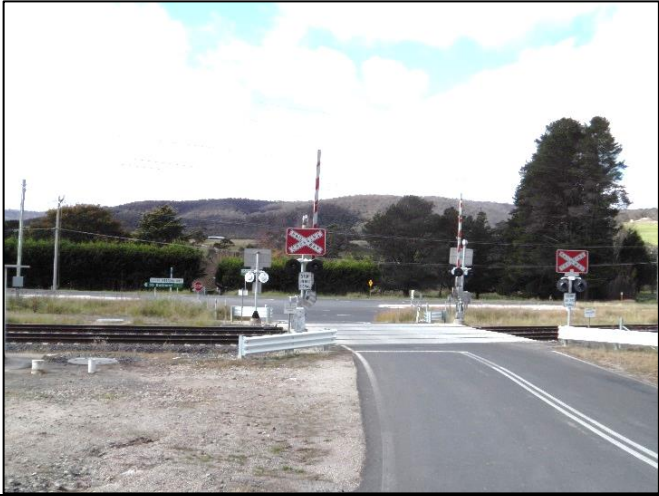
**Location 19 – Marangaroo – Oakey Forest Road**

| Type of crossing<br>(Active – flashing lights with barriers) | |
| Road width<br>(sealed or unsealed) | 7.0 m sealed (Concrete slab at crossing) |

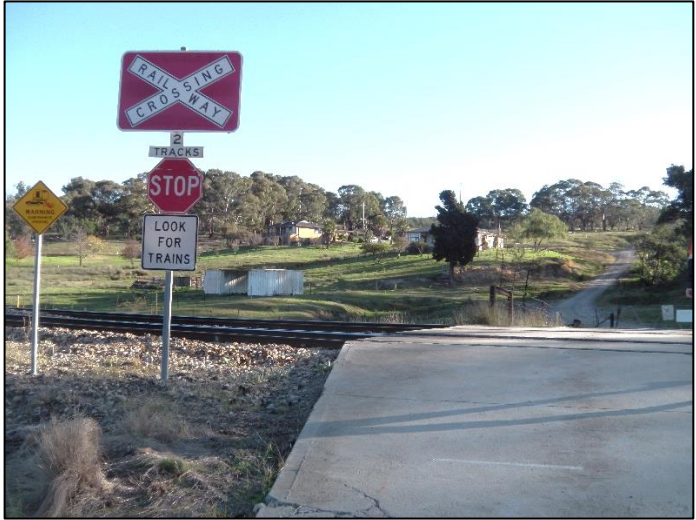
**Location 20 – Bowenfels 1 - Minor road (off Great Western Highway)**

| Type of crossing<br>(Passive - stop sign) | |
| Road width<br>(sealed or unsealed) | 3.3 m unsealed (Concrete slab at crossing) |

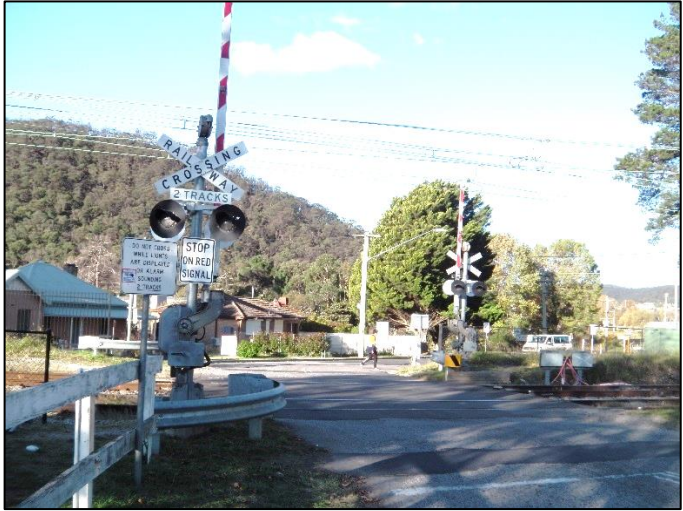
**Location 21 – Bowenfels 2 – Coorwull Road – Geordie Street**

| Type of crossing<br>(Active – flashing lights with barriers) | |
| Road width<br>(sealed or unsealed) | 9.3 m (either sealed or concrete surface) |
| Other rail line or road traffic observation | Rail line is dual track and generally level.<br>Large Brick Hut and visitor centre carpark by the Level Crossing (west side).<br>Old Bowenfels Station is approx. 150 m to the west. |
