# **LIDSDALE SIDING UPGRADE PROJECT**

## **IMPACT ASSESSMENT - AQUATIC ECOLOGY**

## **REPORT PREPARED FOR Centennial Ivanhoe**

**MARINE POLLUTION RESEARCH PTY LTD**  
**August 2012**

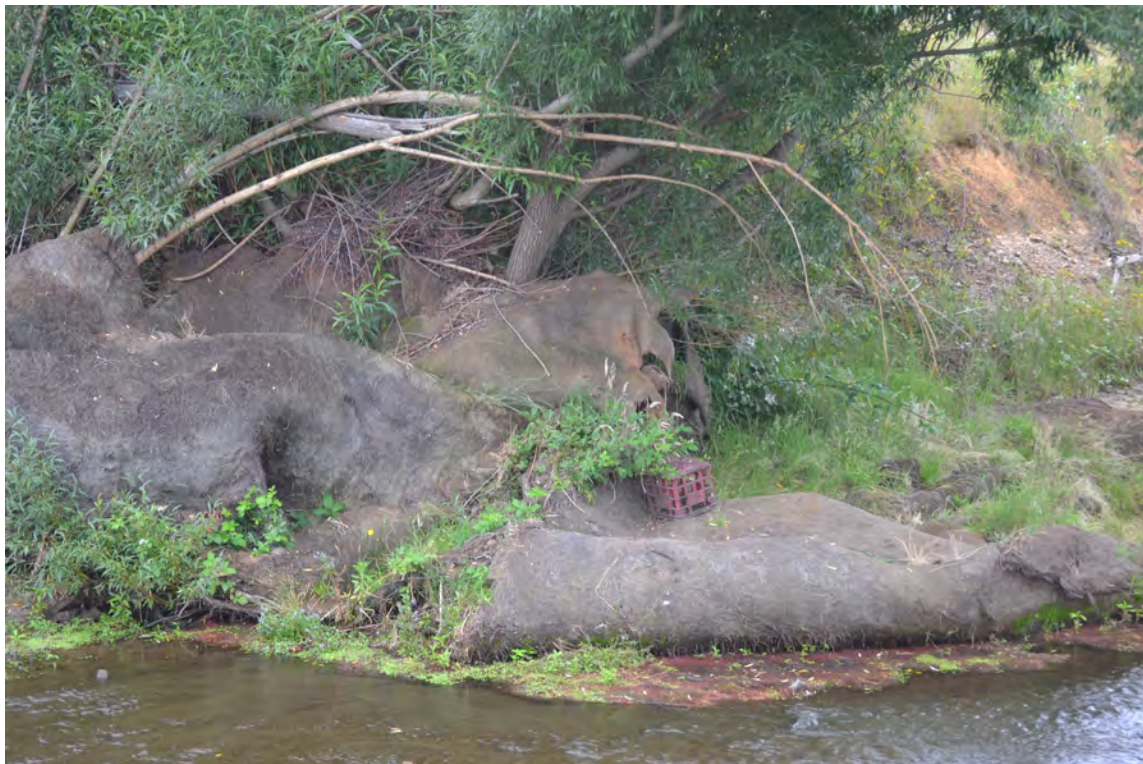
An additional site walk-over was undertaken on 20 December 2011 specifically for this assessment. There had been another high flow event in Pipers Flat Creek since the field sampling survey in late November 2011. This event uprooted some of the willows established at a nick point at the lower end of the straight portion of the re-aligned creek line where it turns to the north (Figure 5).

Figure 5 Photo of nick point in Pipers Flat Creek diversion channel where willows have established. Storm flows prior to the date of this photo (20 December 2011) had uprooted some of the willows and flow under the root mat has doubled the willow root mat over itself as indicated, partially clearing the creek obstructions at this point.

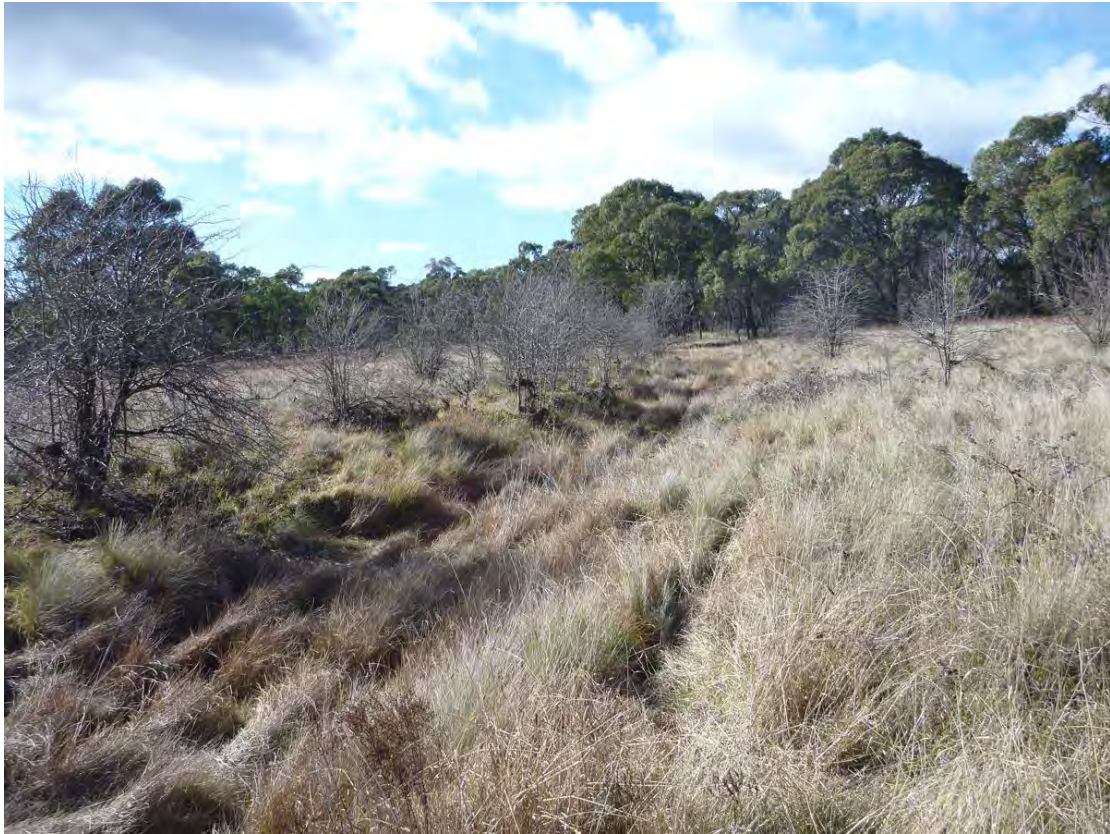
Plate 5: Looking downstream at former drainage channel on northern side of existing Pipers Flat Creek channel.

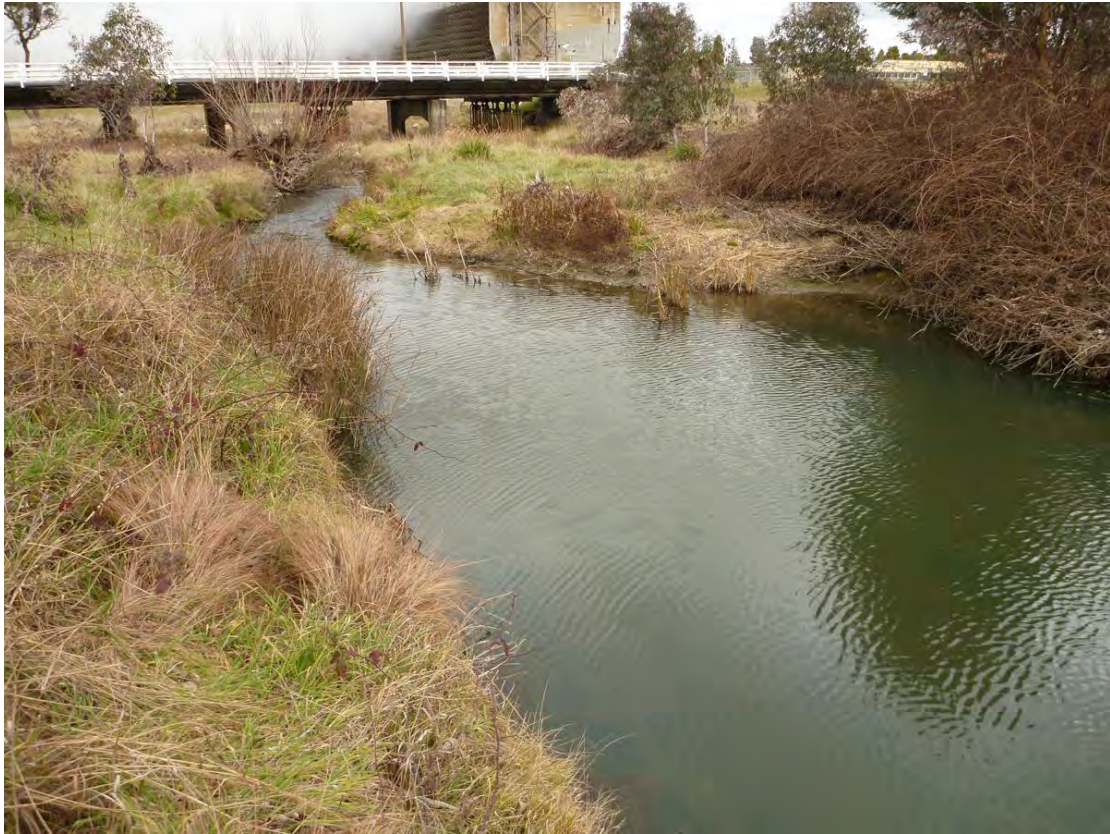
Cumbungi is the most commonly occurring macrophyte throughout the Coxs River sites, at times forming extensive stands along the river edges. However, as observed between consecutive surveys cumbungi can undergo seasonal fluctuations due to die-back and is also subjected to scouring by flooding (such as that observed at CR5 during the period between Spring 2010 and Autumn 2011).

Plate 24: CR5 looking downstream toward bridge (Autumn 2011). Note the absence of cumbungi (emergent reed) from this photo when compared with Spring 2010 (Plate25).

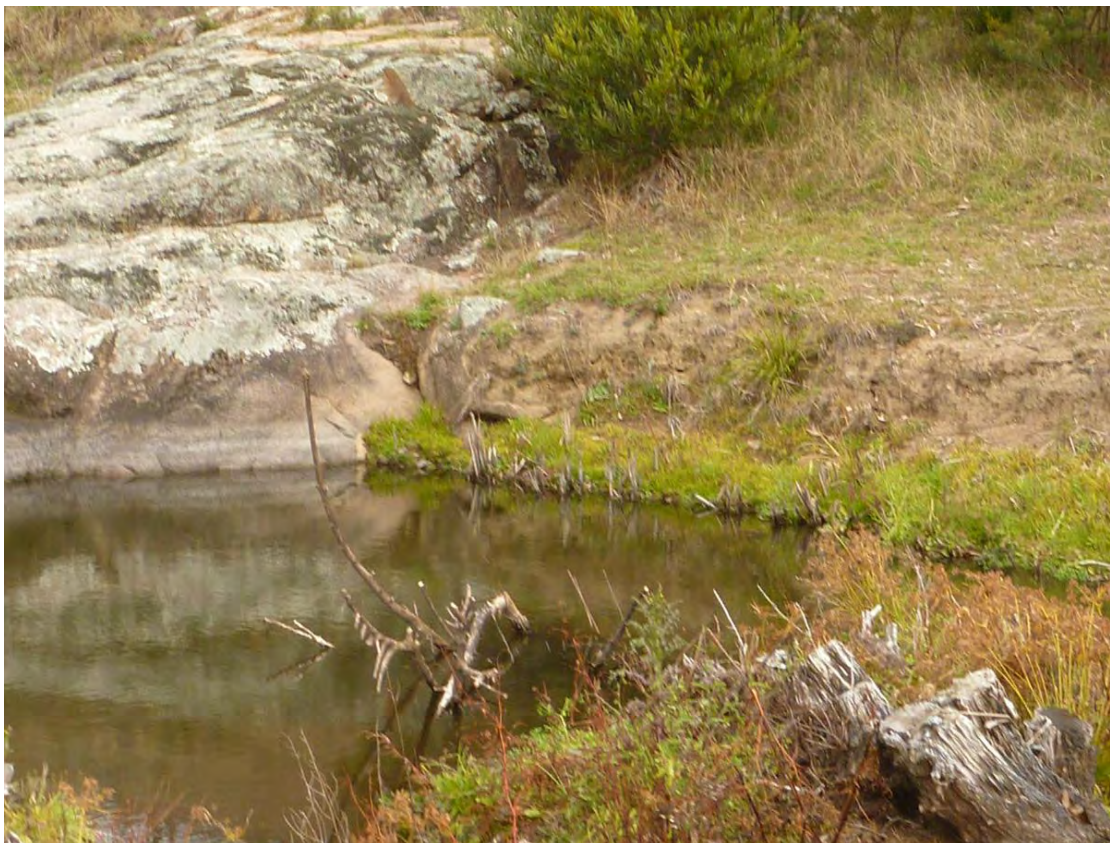
At The Coxs River study sites CR5 and CR6 there was evidence that high flow water levels had reached between 2.5m and 3.5m above the normal prevailing water levels, and caused the removal of instream and edge bank vegetation (mainly cumbungi (*Typha* sp) stands). At CR6 there had also been some minor bank erosion. At Pipers Flat Creek site PFdn there were a number of established willow (*Salix* sp) trees that had been toppled from the high flow event (see Annexure A site photographs 19 to 21).

Plate 29: CR6 edge bank area scoured free of vegetation (Autumn 2011).

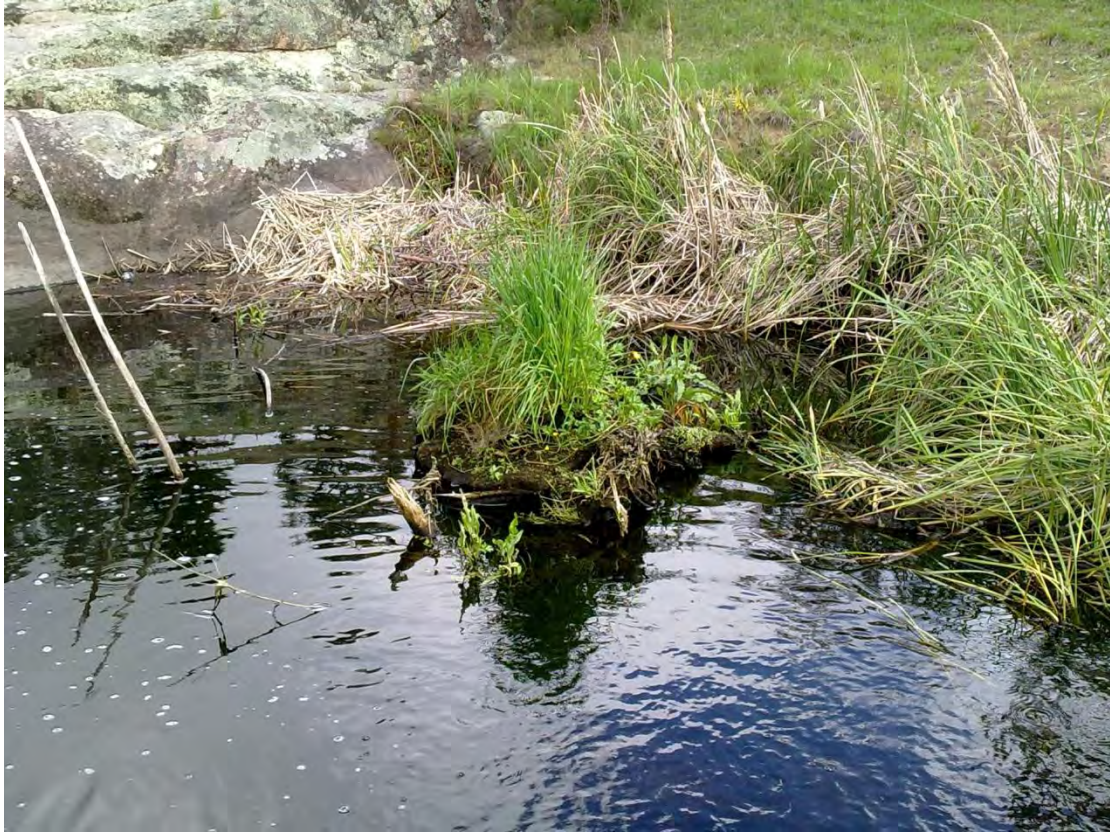
Plate 30: Spring 2010 CR6 same location as Plate 29- note the variation in edge vegetation between surveys.
