***CENTENNIAL COAL***  
***Lidsdale Siding***  
***2021 ANNUAL REVIEW***

**February 2022**

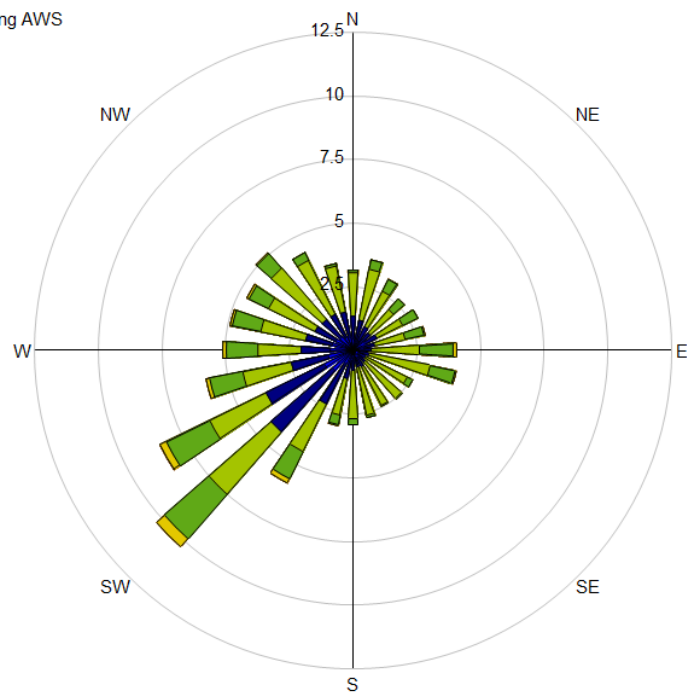
Wind speed and direction have been plotted in a wind rose in Figure 6-3. The predominate wind direction in the reporting period was SW.

**Figure 6-3 2021 Windrose**

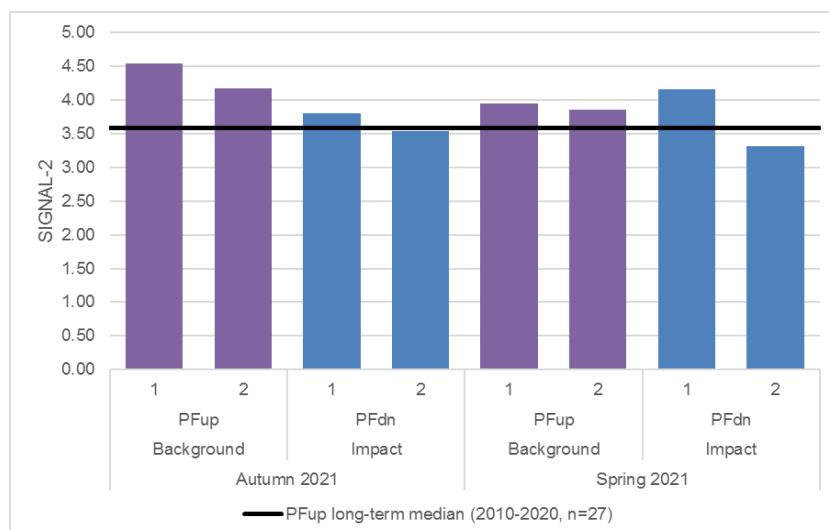
**Figure 5A-3 SIGNAL-2 in Pipers Flat Creek samples in 2021**

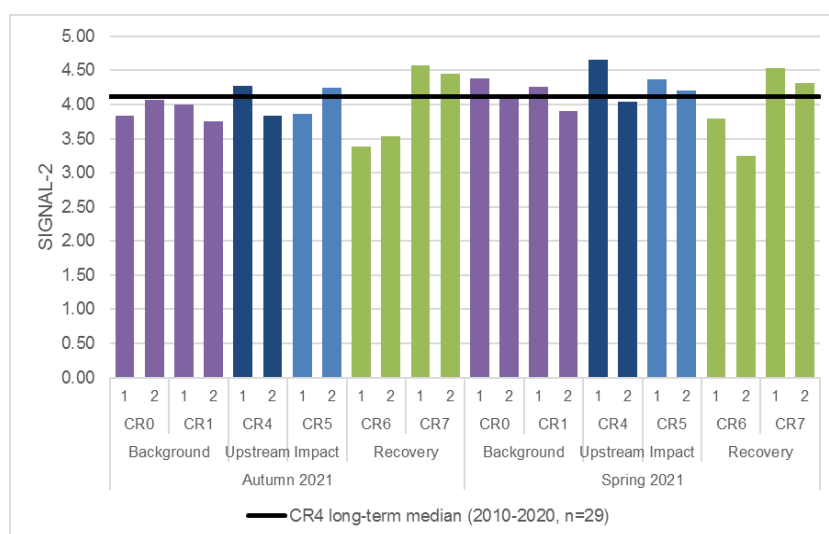
Figure 5A-6 SIGNAL-2 in Coxs River samples associated with Lidsdale Siding in 2021
