## **Manilla Combined MPS / Health One**

### **Stage 1 Preliminary Environmental Site Investigation**

Geotechnical & Environmental  
Report No. 08-GO37B  
December 2008

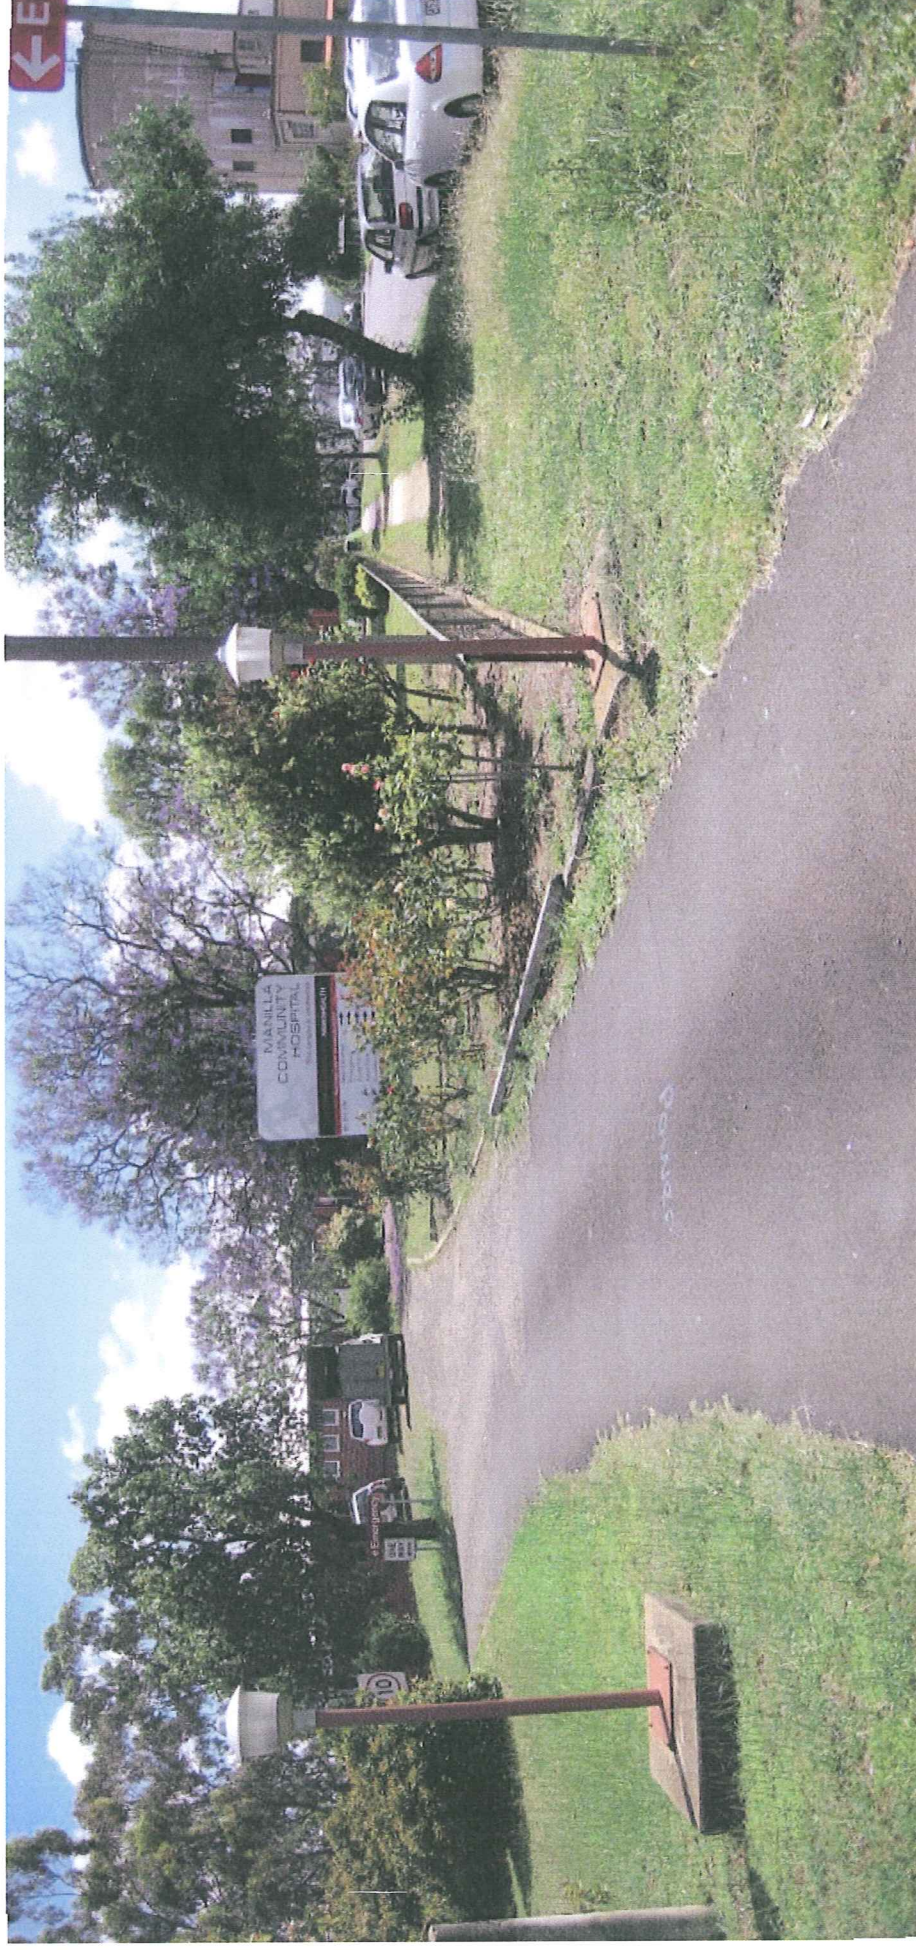
**PLATE 1 : View towards the north-east of the hospital site, showing the existing access road leading to the main hospital building. Court Road in on the far right.**

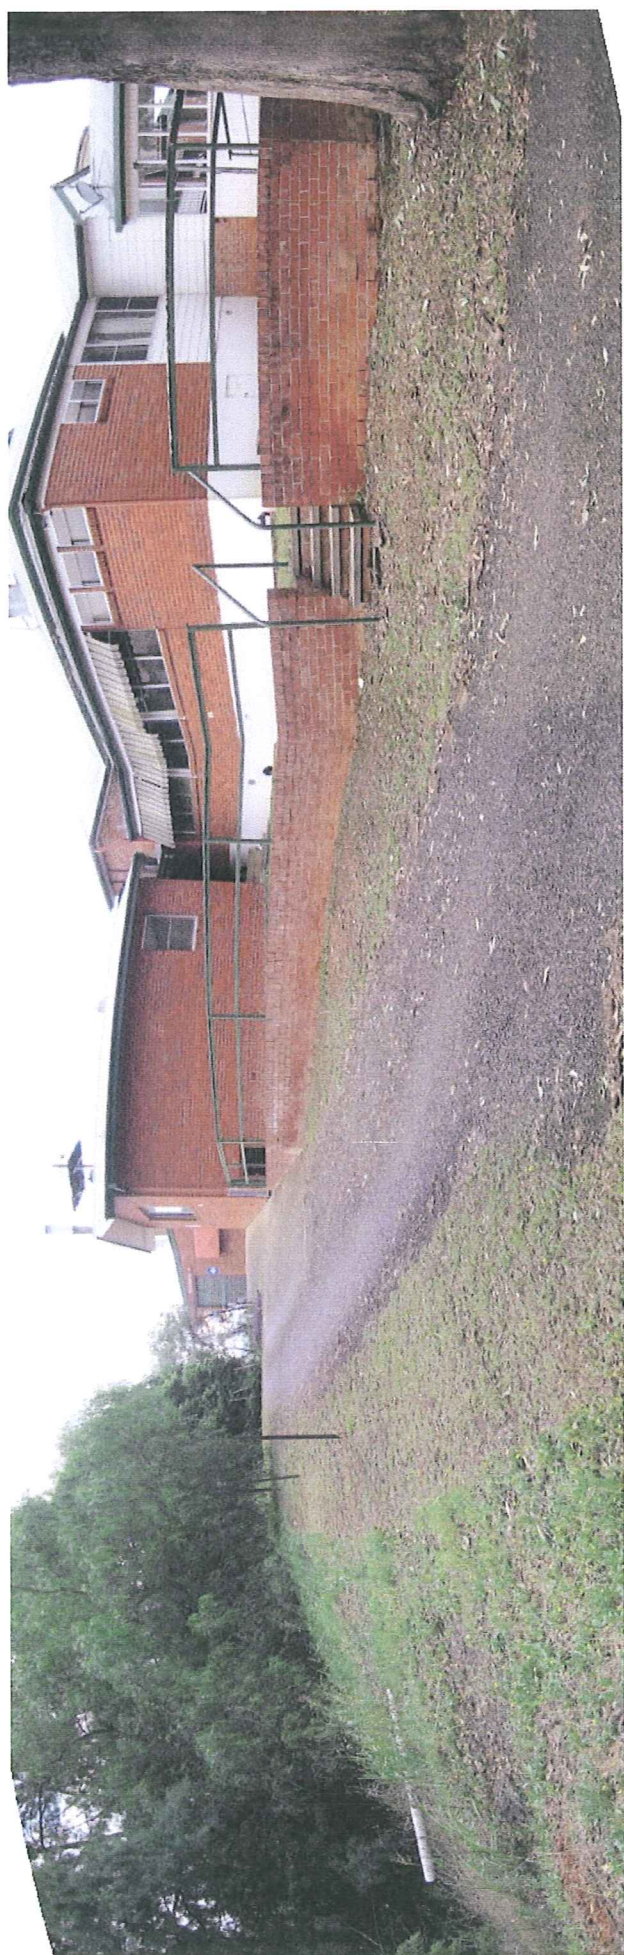
**PLATE 2 : View towards the south-east of the hospital site, showing part (physiotherapy/mortuary) of the main hospital building. Steep fill batter is on the left.**

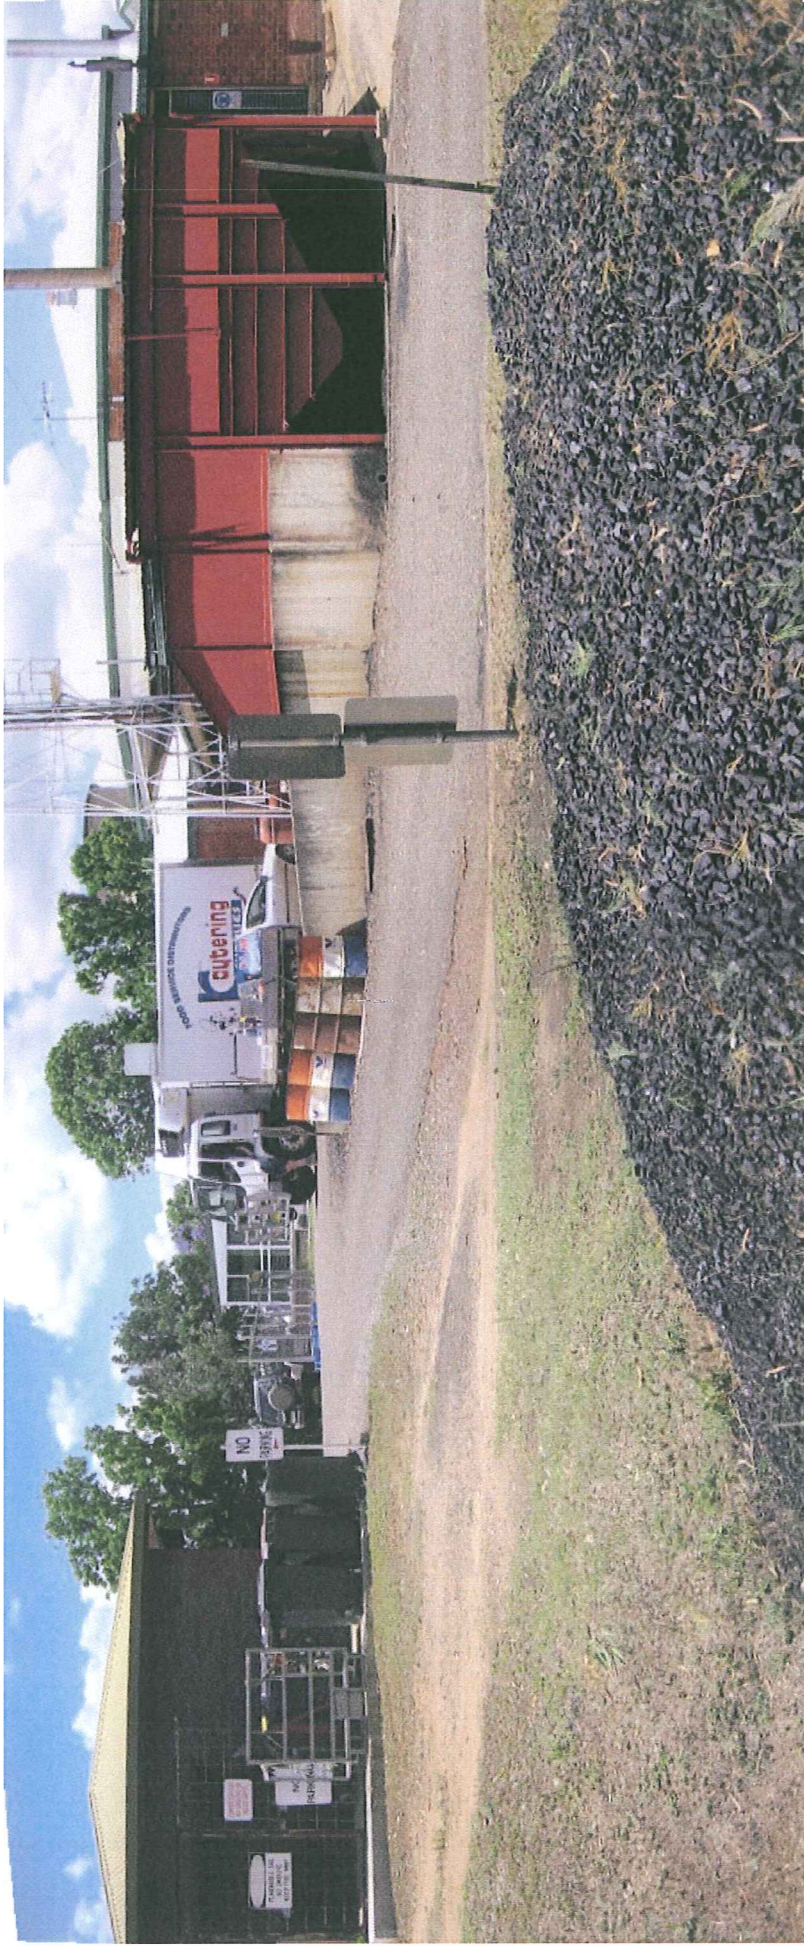
**PLATE 3 : View towards the south of the hospital site. Coal bin associated with the boiler house is on the far side. An underground fuel storage tank (barely visible) is located next to the right corner of the coal bin. A stockpile of coal is in the near side. Workshop is on the left.**

- There is potential of heavy metals and PAH contamination as a result of possible spreading of ash from the coal boiler.
- There is potential for petroleum hydrocarbon (TPH, BTEX and PAH) and lead (Pb) contamination as a result of the old UST possibly leaking.

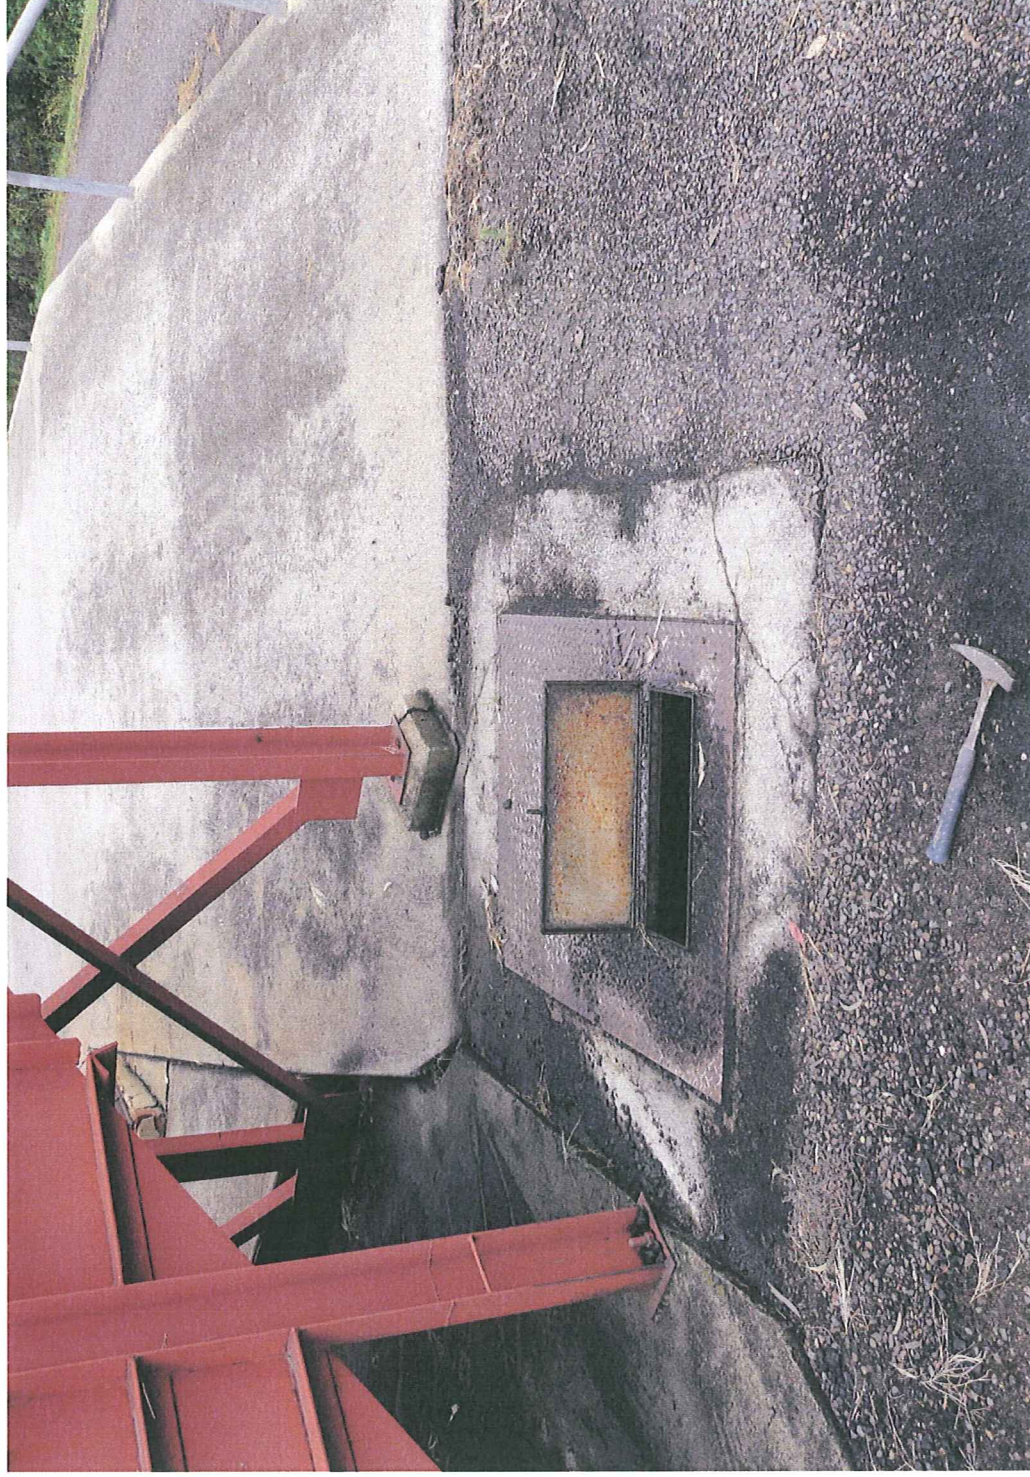
**PLATE 4 : A close up view of the underground fuel storage tank with the lid open, next to coal bin.**

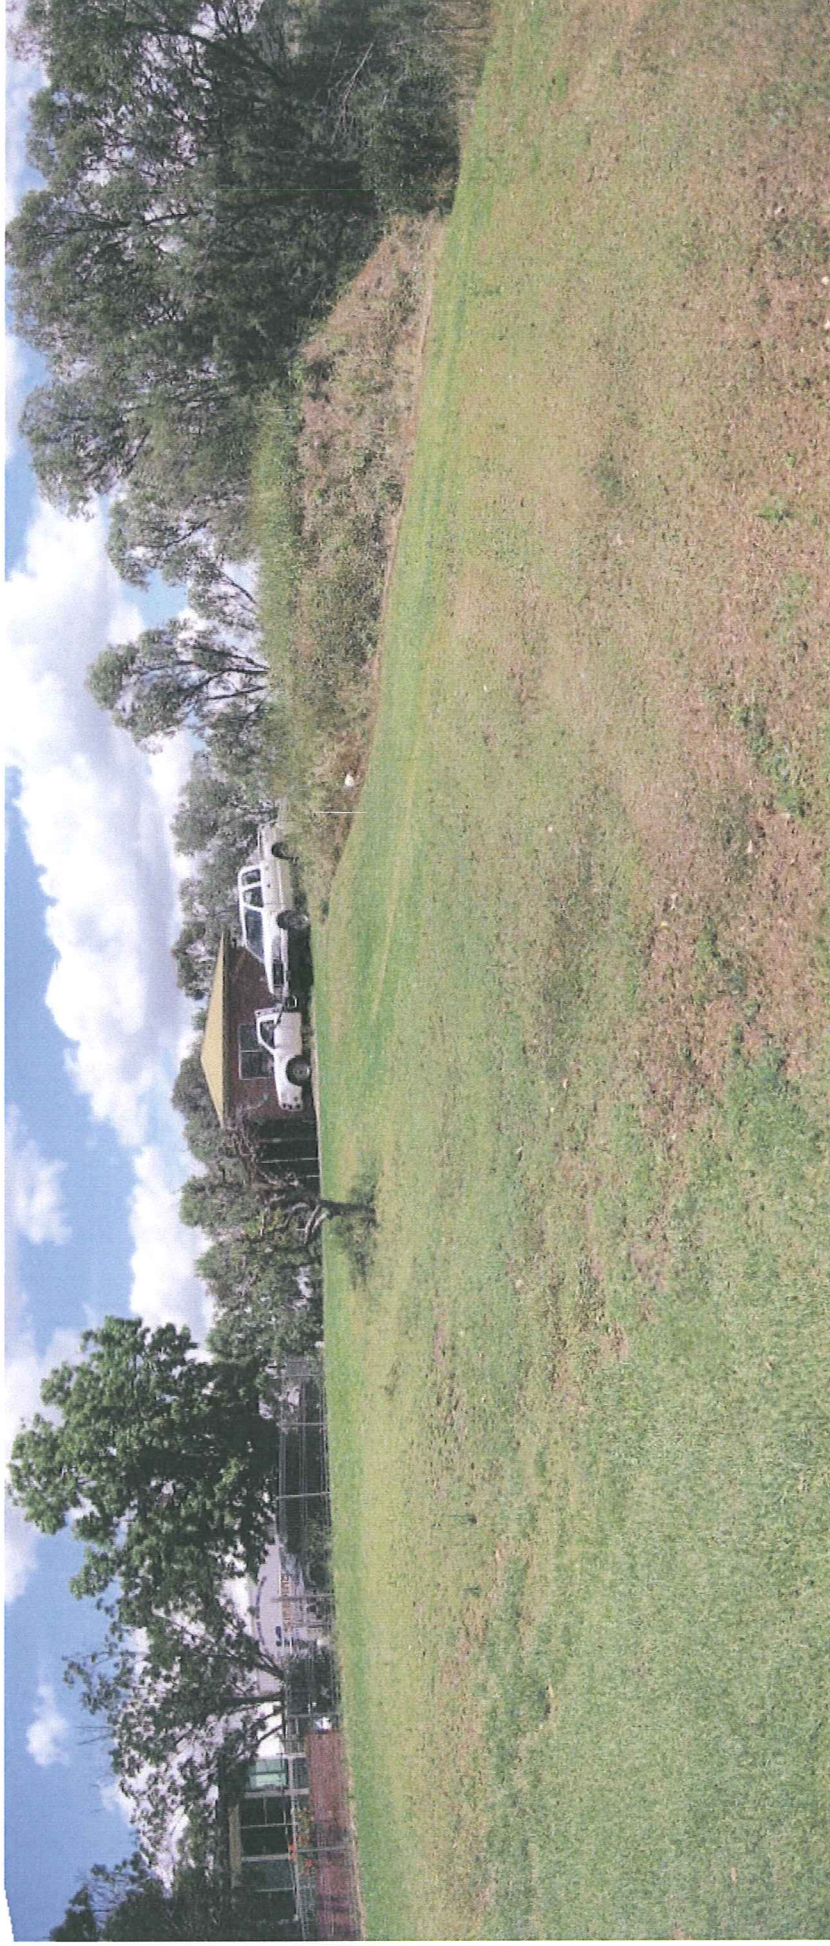
**PLATE 5 : View towards the north-west of the hospital site, showing the Acacia Wing of the main hospital building in on the far left. A steep fill batter in on the right (far side).**

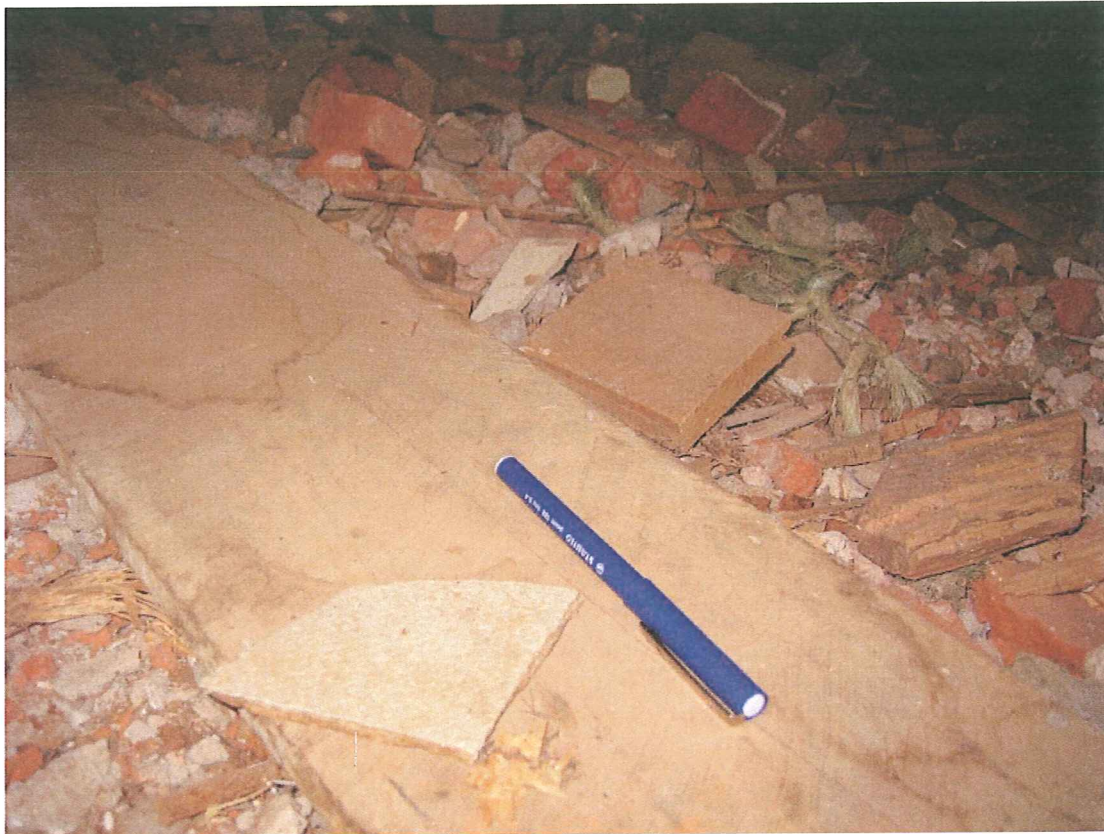
**PLATE 6 : Part view of a number of fibrous fragments nixed with demolition debris inside the subfloor of part (physiotherapy) of the main hospital building.**

- Asbestos containing debris could be buried in the surface soil subsequent to the demolition of former old buildings (likely to contain asbestos containing material). The debris could also have been used to form part of the fill batter. It should be noted that asbestos cement fragments were scattered throughout the sub floor area of physiotherapy part and Acacia Wing of the main hospital building. Also, in the separate geotechnical investigation, fibrous fragments (likely to contain asbestos) were observed on the surface of fill batter in the vicinity of the mortuary/coal bin.

It is recommended that a further Stage 2 Detailed Environmental Site Investigation (“DESI”) is to be undertaken, in accordance with the NSW EPA *Guidelines for Consultants Reporting on Contaminated Sites* (1997). Objectives of the DESI are to define the extent and degree of contamination, to assess potential risk posed by contaminants to health and the environment, and to obtain sufficient information for the development of a remedial action plan (if required).

It is recommended that a further Stage 2 Detailed Environmental Site Investigation (“DESI”) is to be undertaken, in accordance with the NSW EPA *Guidelines for Consultants Reporting on Contaminated Sites* (1997). Objectives of the DESI are to define the extent and degree of contamination, to assess potential risk posed by contaminants to health and the environment, and to obtain sufficient information for the development of a remedial action plan if required.
