**Manilla MPS and Health One Facilities  
(Manilla Hospital)  
RTF 0801673**

**Geotechnical Investigation**

Geotechnical and Environmental  
Report No. 08-GO37A  
June 2009

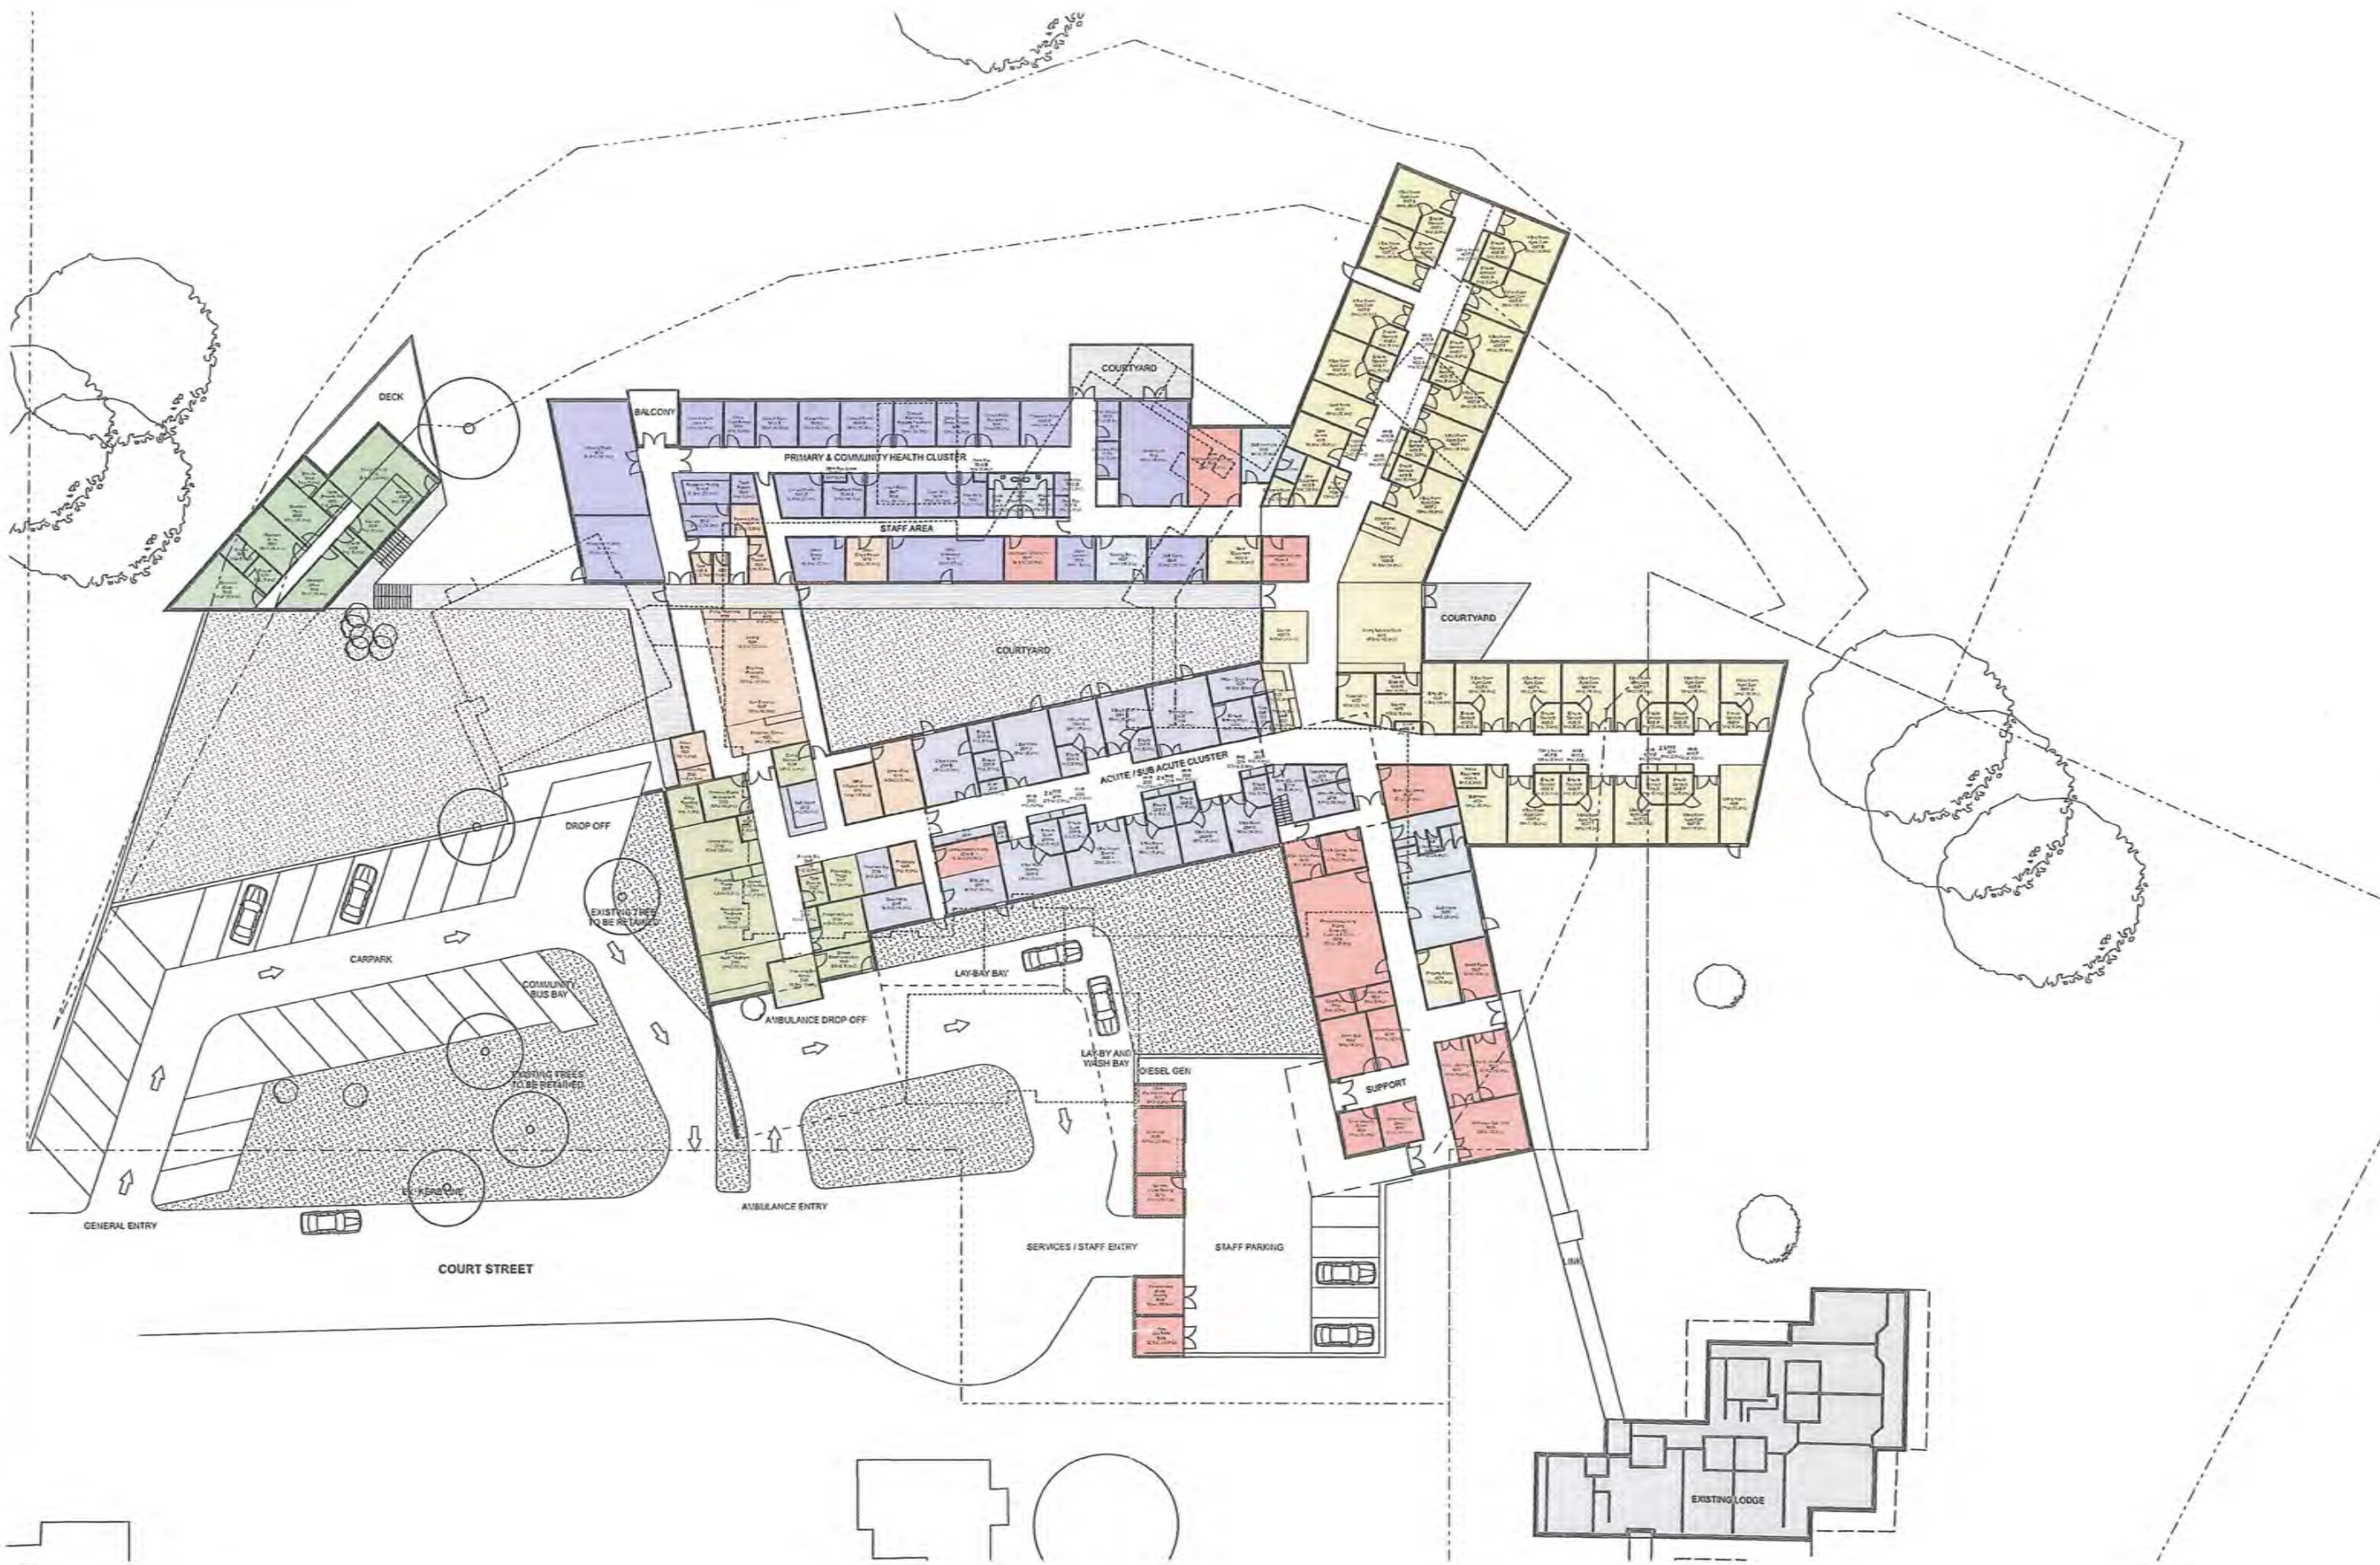
FILE NO.  
G0978  
DRAWING NO.  
3

MANILLA MPS & HEALTH ONE  
Survey Plan showing location of Boreholes

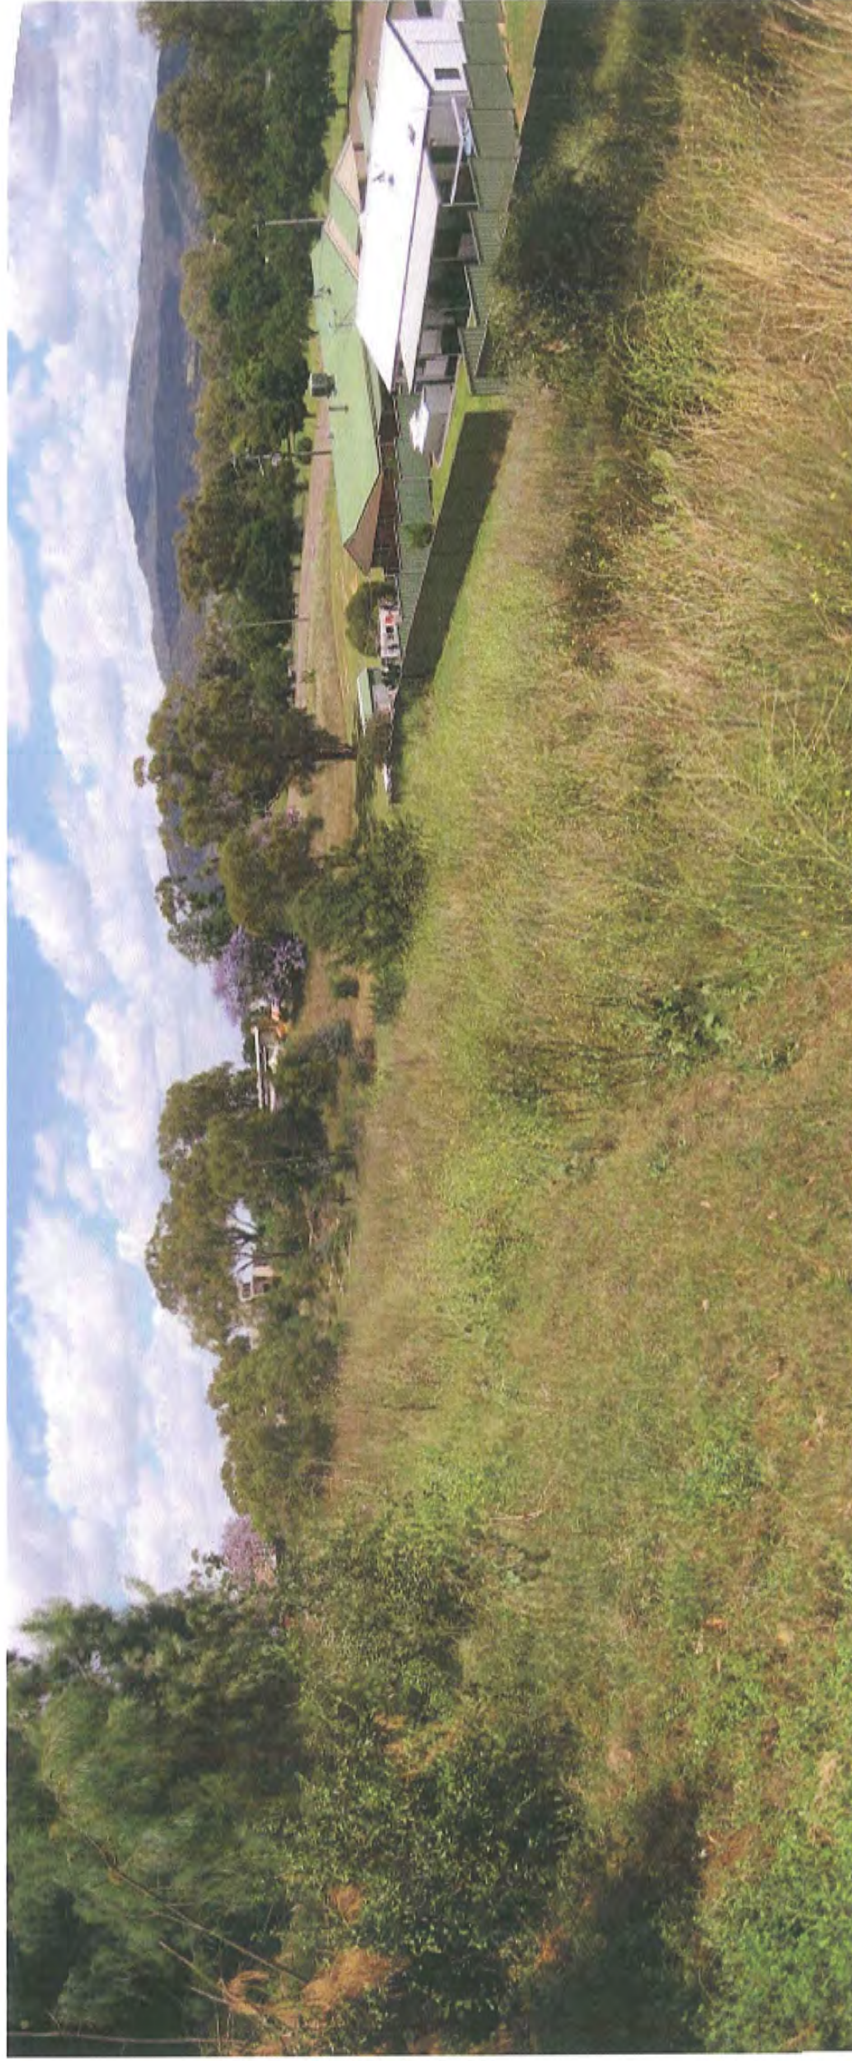
**Plate 2:** General view of partially filled and natural slope to the north of the existing perimeter fence (looking north-west)

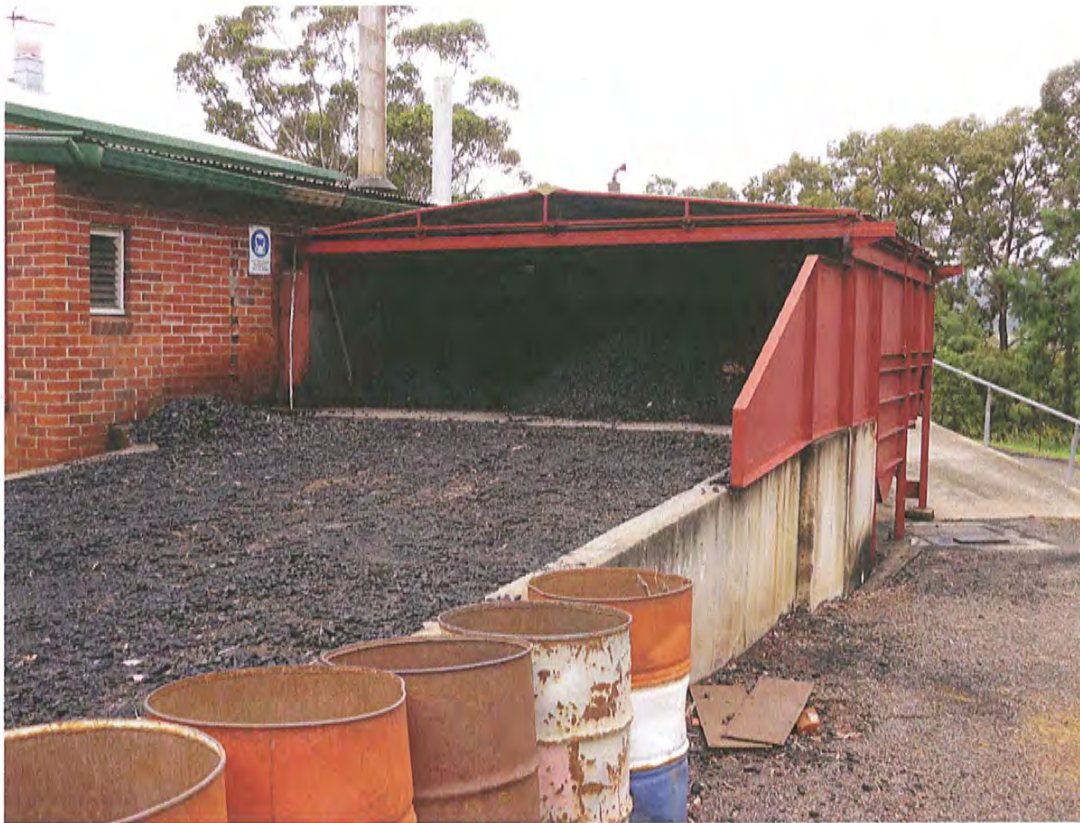
**Plate 5:** View of the existing coal bin.

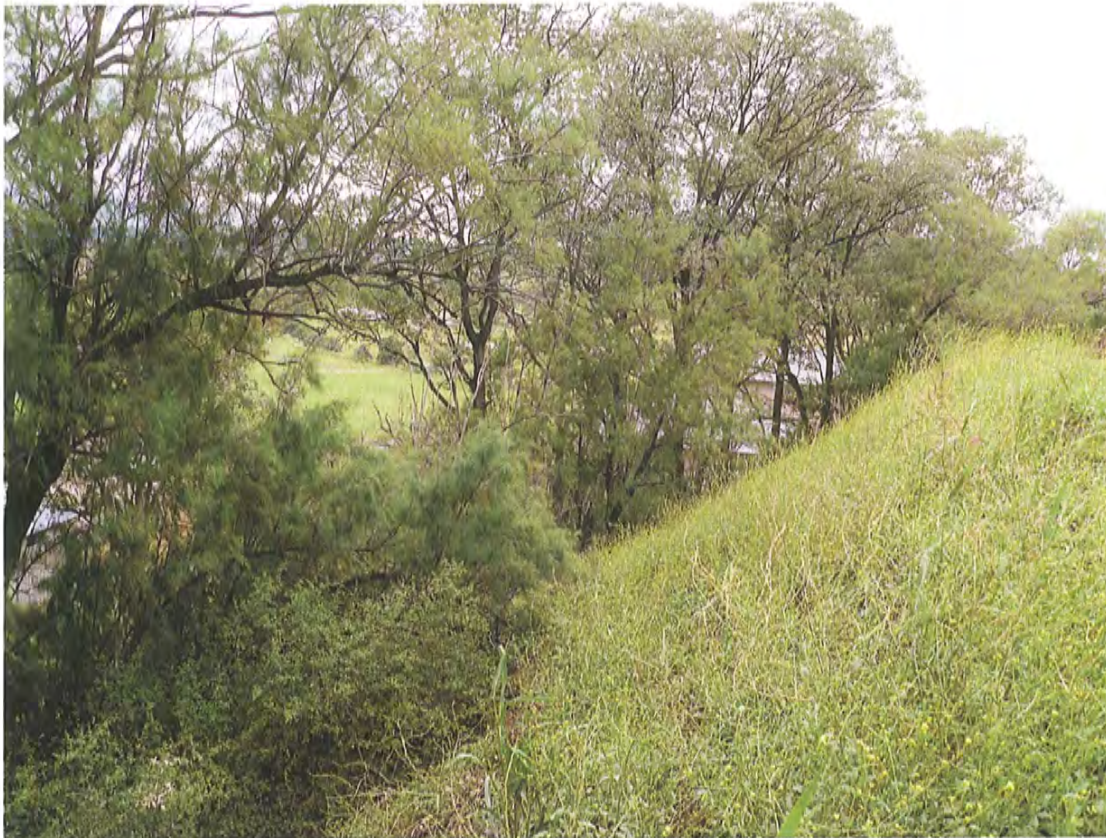
**Plate 7:** View of the filled batter, opposite the coal bin, looking east/north-east towards the workshop. Batter is overgrown with native grasses. The perimeter fence is tree-lined.

The investigation revealed that the edge and upper part of batter slopes are extensively filled and the fill is highly variable and uncontrolled. The fill comprises cobbles and coarse gravel, meta-siltstone rock fragments, furnace refuse consisting of ash, slag, burnt coal fragments, silty sand and clayey silt and contain varying concentrations of foreign inclusions including building rubble, bricks/ brick fragments, concrete, iron pipes, tin, pieces of steel, wood and bituminous fragments.

The slopes are moderately steep to steep. Currently, though there is no strong sign of slope instability observed, it should be cautious that there is a potential for slope instability, especially if the existing conditions of slope and the site are to be altered. It is recommended that any construction traffic to be confined to the existing road.

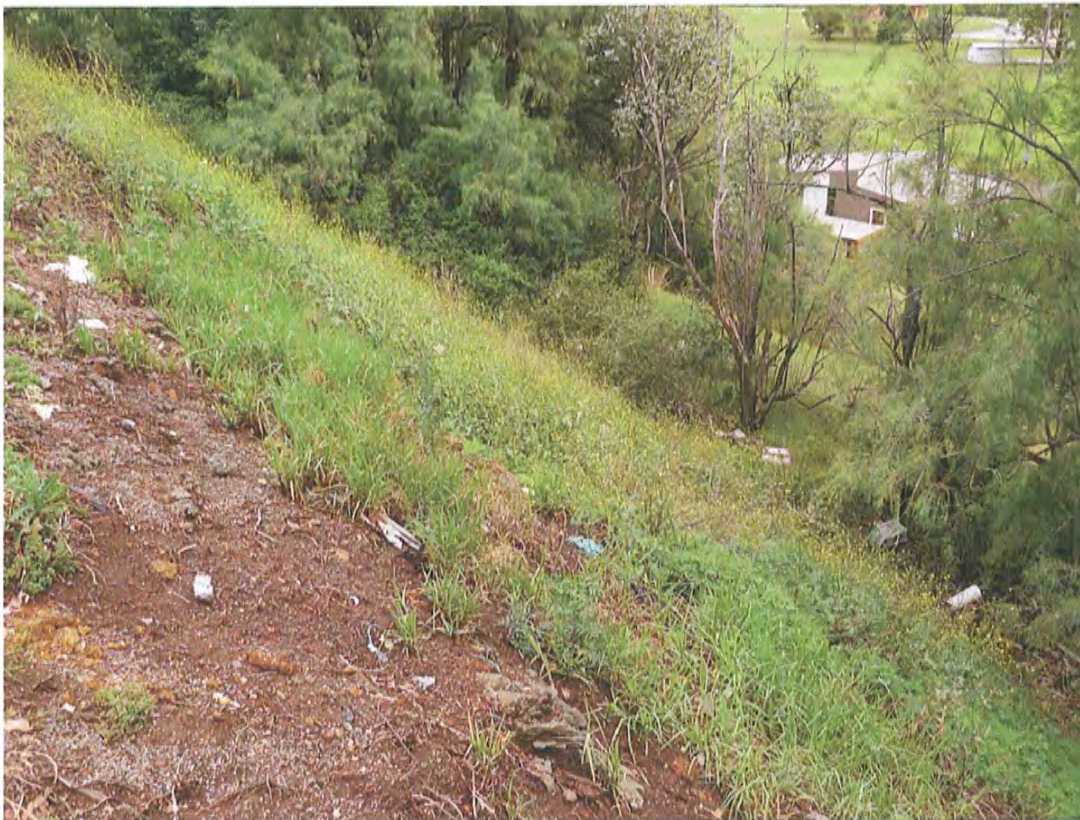
**Plate 8:** View of the fill batter at the rear of the workshop, looking north-west.

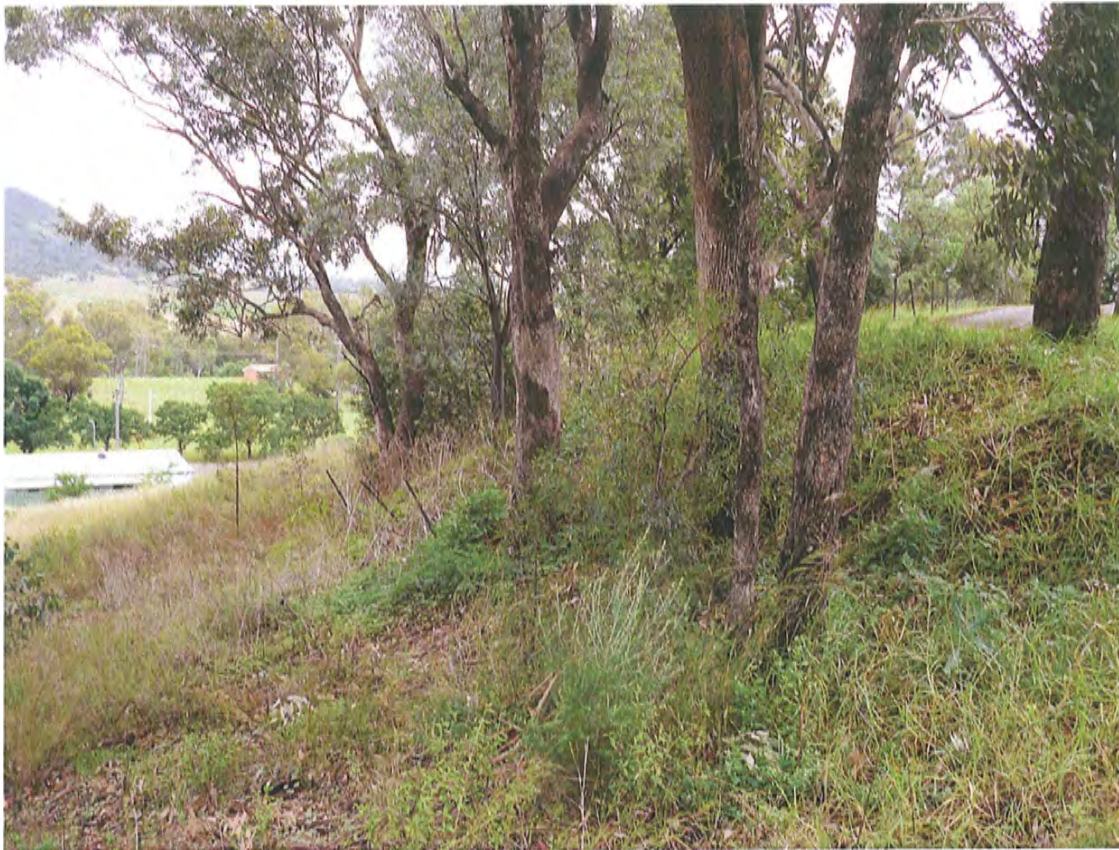
**Plate 9:** General view of filled batter slope, looking north-east from proposed nurses quarters.

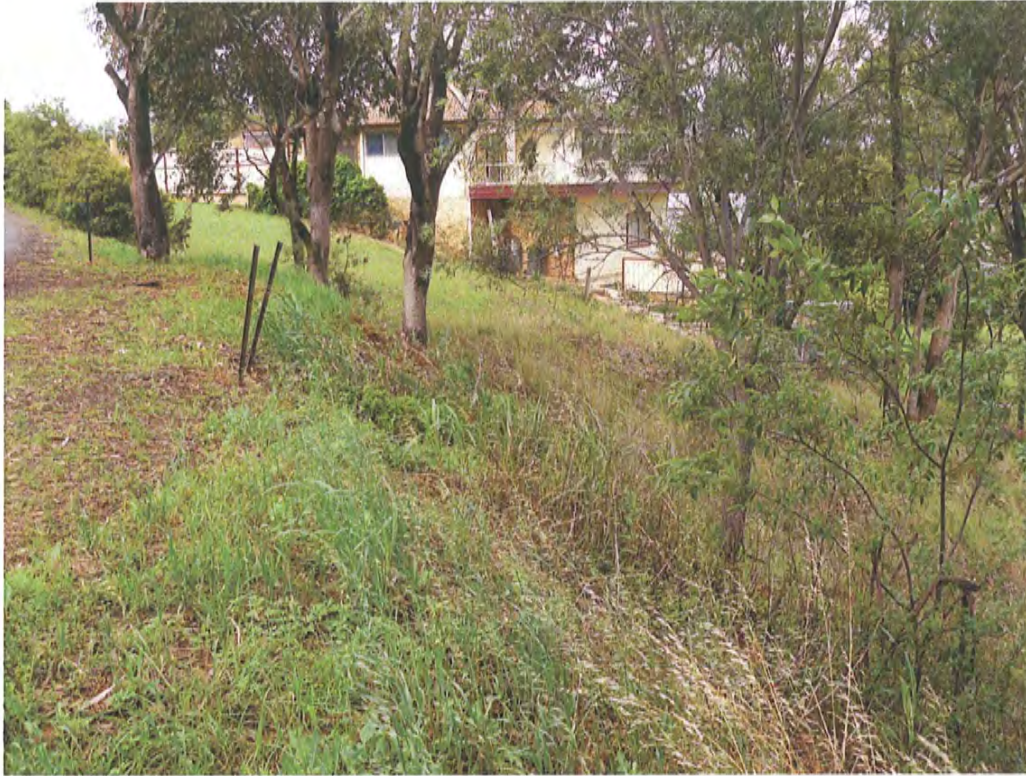
**Plate 11:** View of the filled batter slope in the north-western part of the complex. The site of proposed nurses quarters.

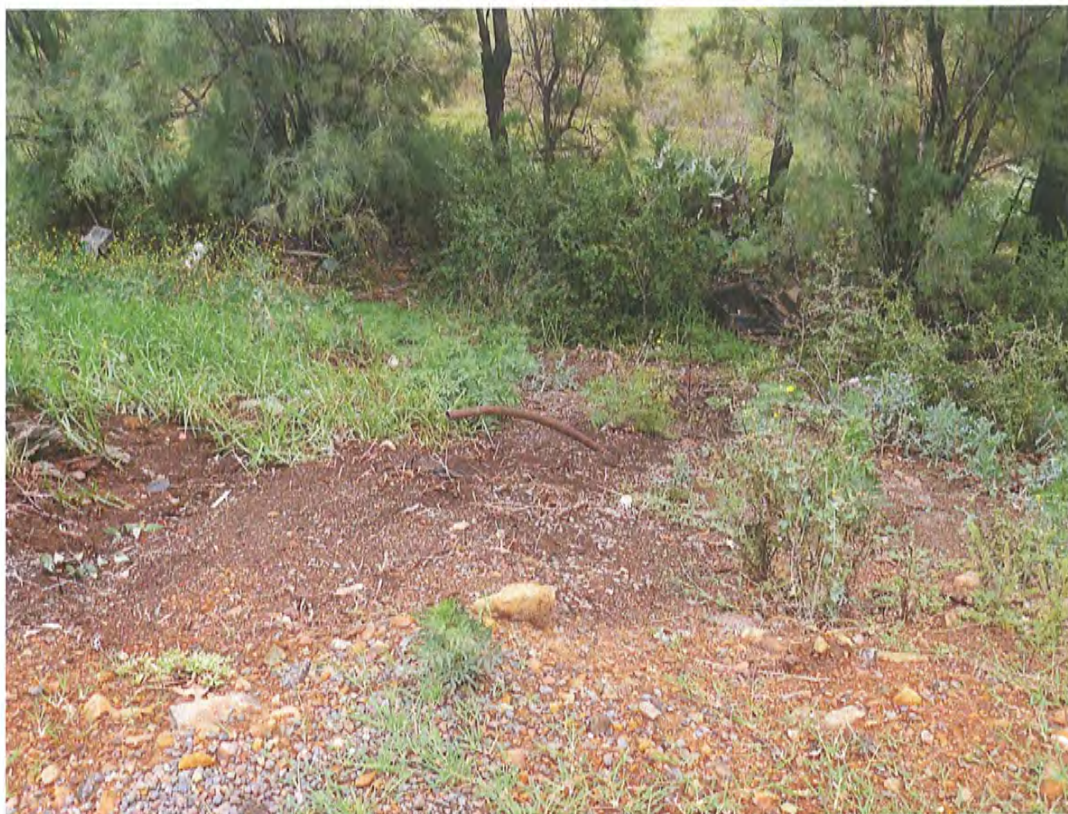
The fill materials exposed on the slope and along the fence line includes rubble (concrete fragments, bricks/brick fragments), pieces of steel, rock fragments, general litter and adjacent to the coal bin, furnace refuse including ash, burnt coal, etc. (see **Plate 13**).

**Plate 13:** Close up of fill materials in the batter at the rear of the workshop.

The fill material is not considered to be suitable founding material neither suitable for slope stabilisation. The fill material from within building area should be excavated and put in spoil, and the batter slope be stabilised under supervision of
